Development, Field Testing, and Implementation of Improved Bridge Parapet Designs

Prepared for:
The Ohio Department of Transportation,
Office of Statewide Planning & Research

State Job Number **134818**

Final Report

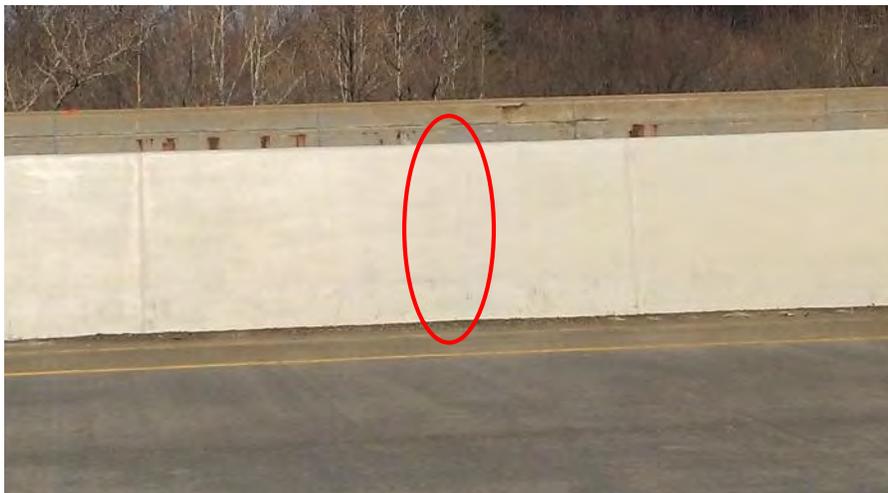
Due to the narrow shoulder on this side of the bridge, it was not possible to safely perform a crack survey of the north parapet. However, when looking from the side of the south parapet, a large crack could be seen that formed midway between the control joints. A picture from the other side of the bridge was taken. It is hard to make out the crack, but it is circled in Figure 26. It is unknown exactly when this crack formed; however, the crack was discovered on September 30, 2013. The control joints were spaced 10 feet (3.0 m) apart along the length of the wall.

Figure 26: EB Big Creek Bridge North Parapet Crack (Photograph by Lauren Hedges)

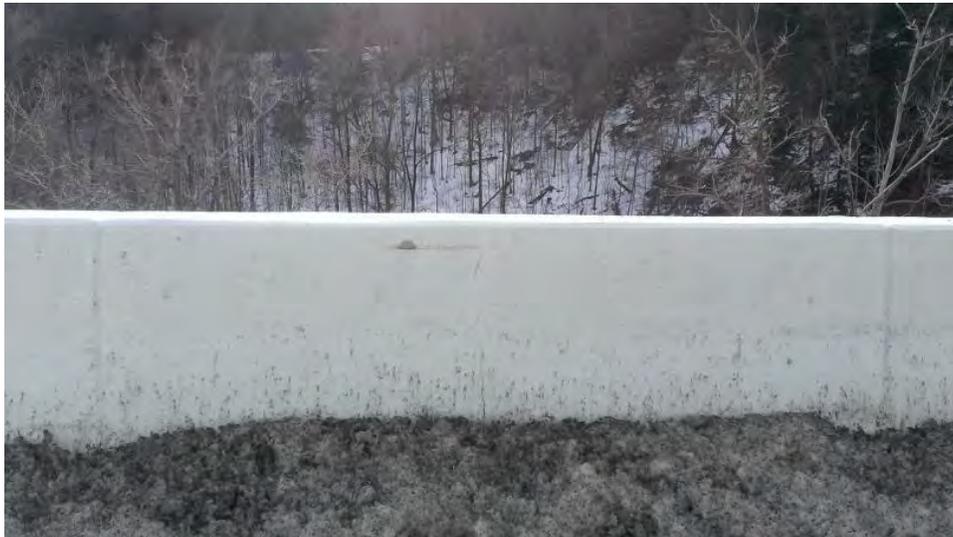
A crack survey was performed on the south parapet of the eastbound Big Creek Bridge. The control joints on this bridge were spaced 10 feet (3.0 m) apart along the length of the parapet. Again, a crack was found midway between the control joints as shown displayed in Figure 27. Figure 28 is a picture looking down at the top of the parapet showing that the crack continued all the way through the thickness of the wall. It also continued all the way down the back side of the parapet. This crack was not discovered until February 27, 2014, and it is unknown exactly when the crack formed.

Figure 27: EB Big Creek south parapet crack (Photograph by Lauren Hedges)

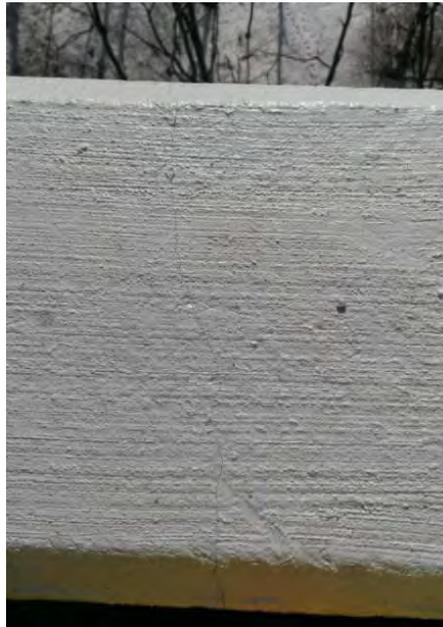
Figure 28: Crack along top of parapet (Photograph by Lauren Hedges)

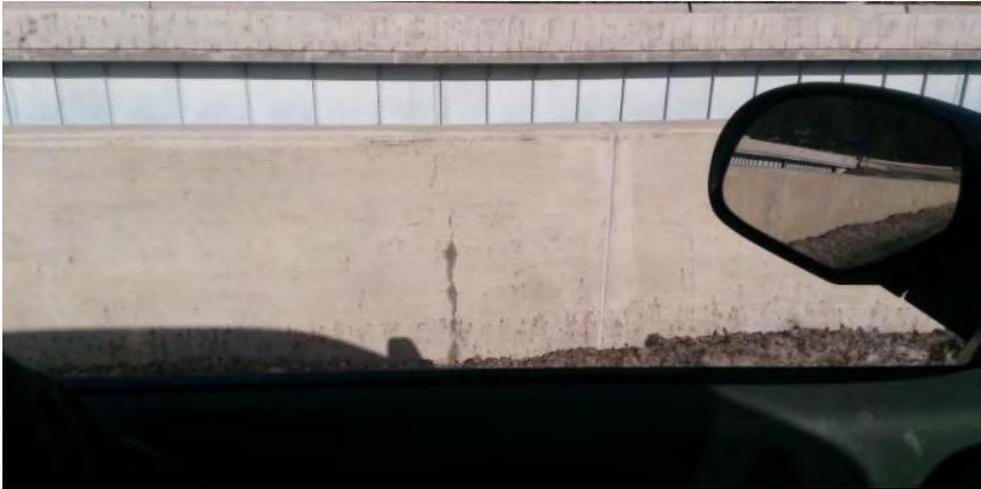
Figure 29 shows the crack from the front of the parapet, and Figure 30 was taken from the adjacent bridge showing the crack on the back side of the parapet.

Figure 29: EB Paine Creek north parapet crack near control joint (Photograph by Lauren Hedges)

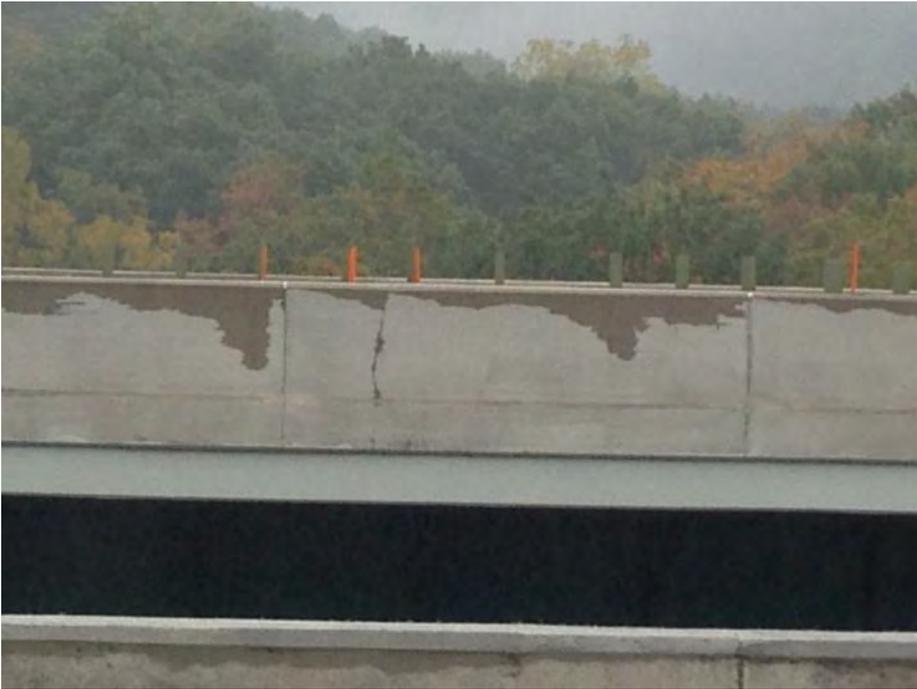
Figure 30: Looking at EB Paine Creek north parapet crack from adjacent bridge (Photograph by Lauren Hedges)

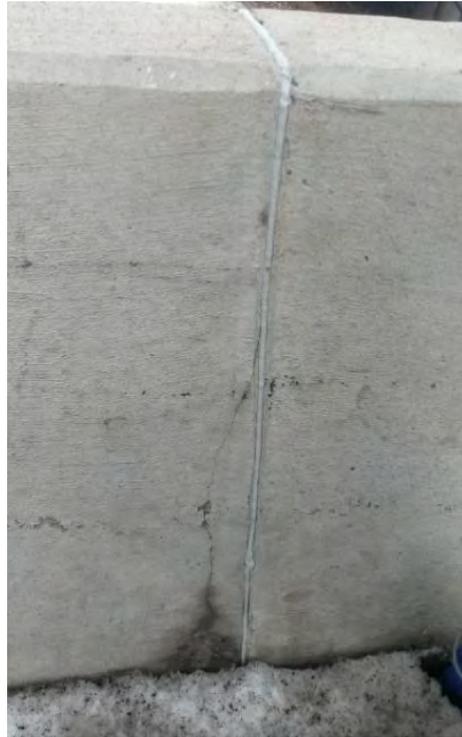
Figure 31: EB Paine Road north parapet crack propagating out of control joint (Photograph by Lauren Hedges)

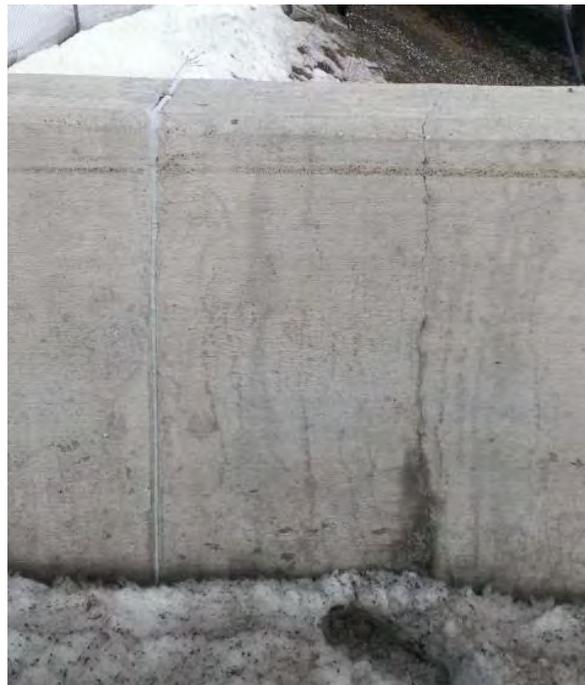
of the bridge and the pier. The second crack, in Figure 32, was found between the fourth and fifth control joints within the negative tension zone created by the pier.

Figure 32: EB Paine Road 2nd crack found between joints (Photograph by Lauren Hedges)

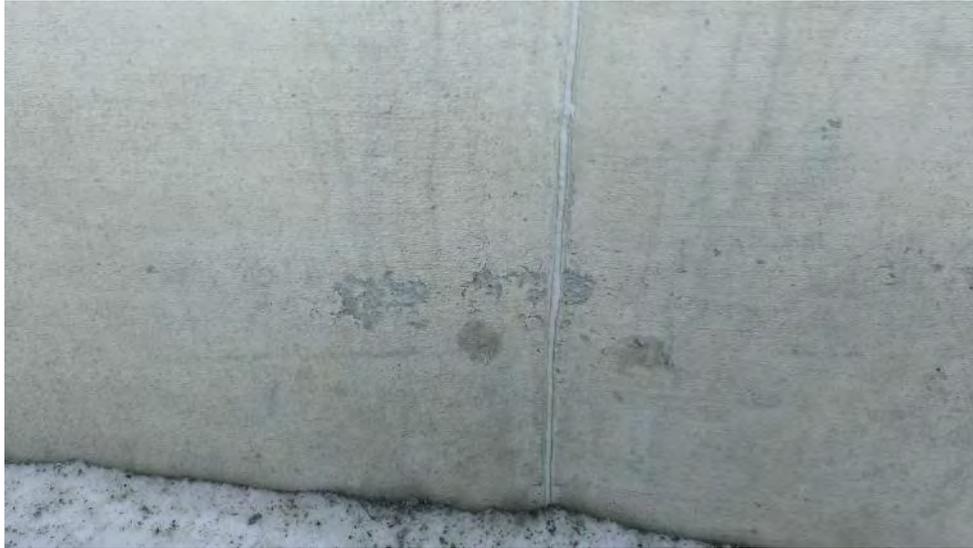
This parapet showed a lot of spalling along the section of the parapet where the horizontal reinforcement is located. This may indicate there was not enough cover provided over the reinforcement. Figure 33 shows where the spalling began. As defined by the American Concrete Institute (ACI), spalling is “the development of a fragment, usually in the shape of a flake, detached from a larger mass by a blow, the action of weather, pressure, or expansion within the larger mass” (ACI Concrete Terminology 2014).

**Figure 33: Spalling on EB Paine Road north parapet along location of horizontal reinforcement
(Photograph by Lauren Hedges)**

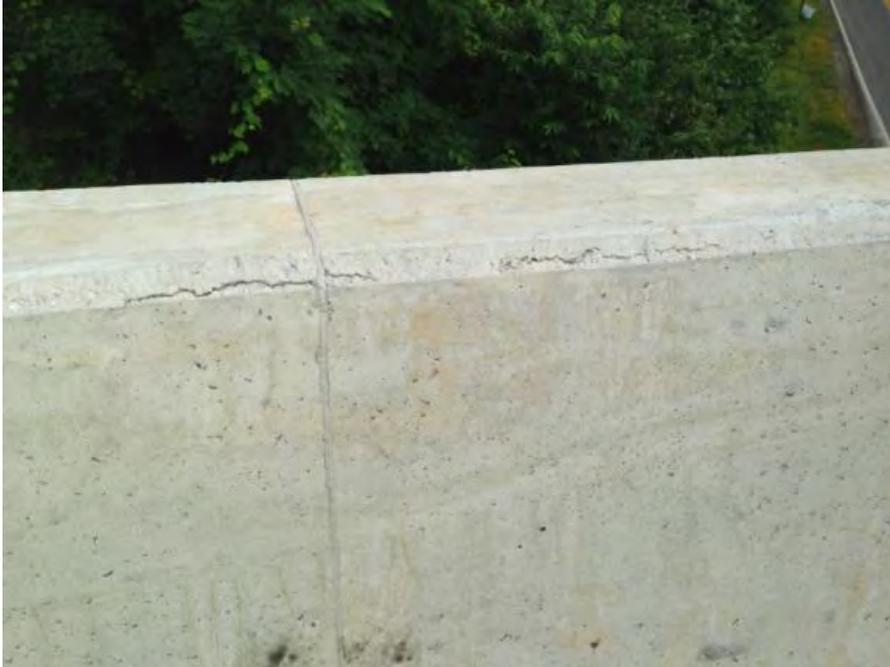
When the forms were stripped, UPV was performed over the control joints and on the parapet before the wall was covered with wet burlap to cure for seven days. The parapet was also inspected for early age cracking. Other than flaws from formwork removal, no cracks were identified. Figures 34 and 35 show the bug holes and small surface cracks observed along the parapet.

Figure 34: EB Hermitage Road north parapet surface cracks (Photograph by Amy Kalabon)

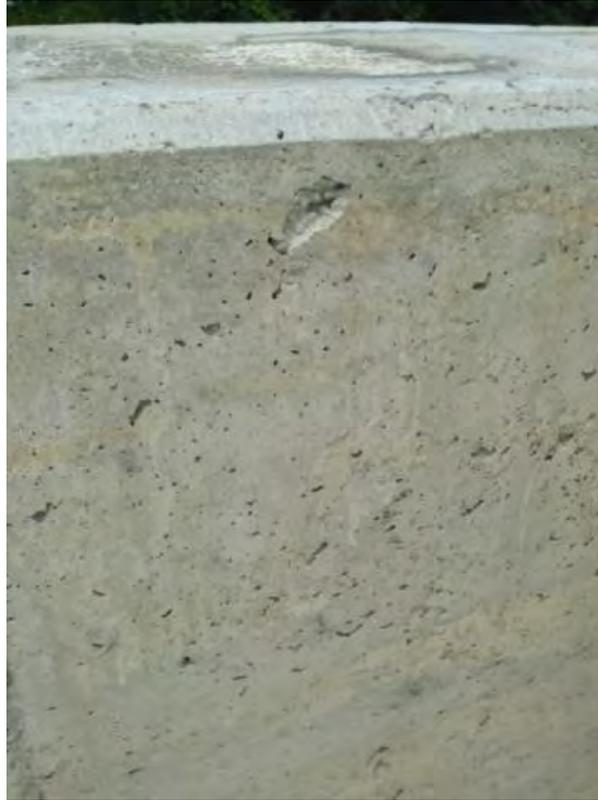
Figure 35: EB Hermitage Road north parapet typical bug holes (Photograph by Amy Kalabon)

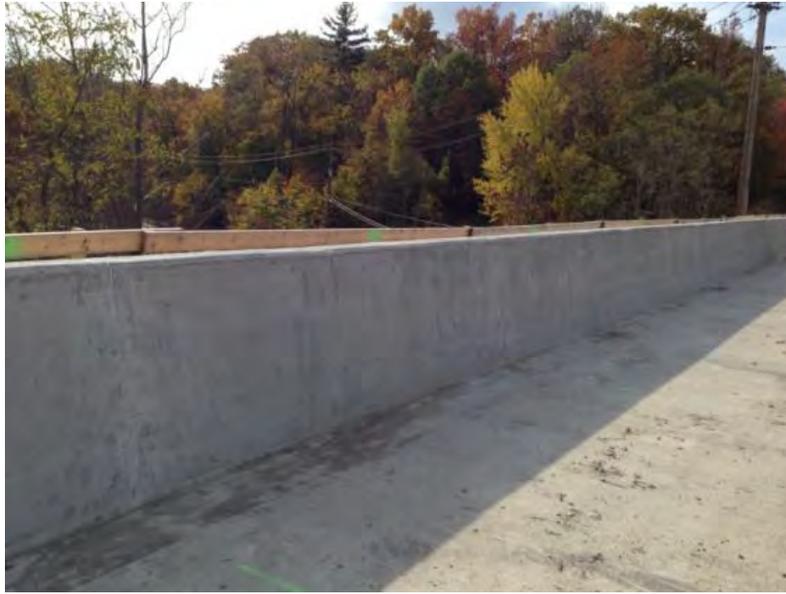
After the parapet finished curing, a site visit was made to perform a crack survey and UPV tests. The parapet had no surface flaws such as holes or surface cracks. The condition of the parapet can be seen in Figure 36. No cracks were found; therefore UPV was only performed on the parapet and over the control joints. The average UPV velocities from both the parapet and the cylinder samples after curing are displayed in Table 9.

Figure 36: EB Hermitage south parapet condition (Photograph by Amy Kalabon)

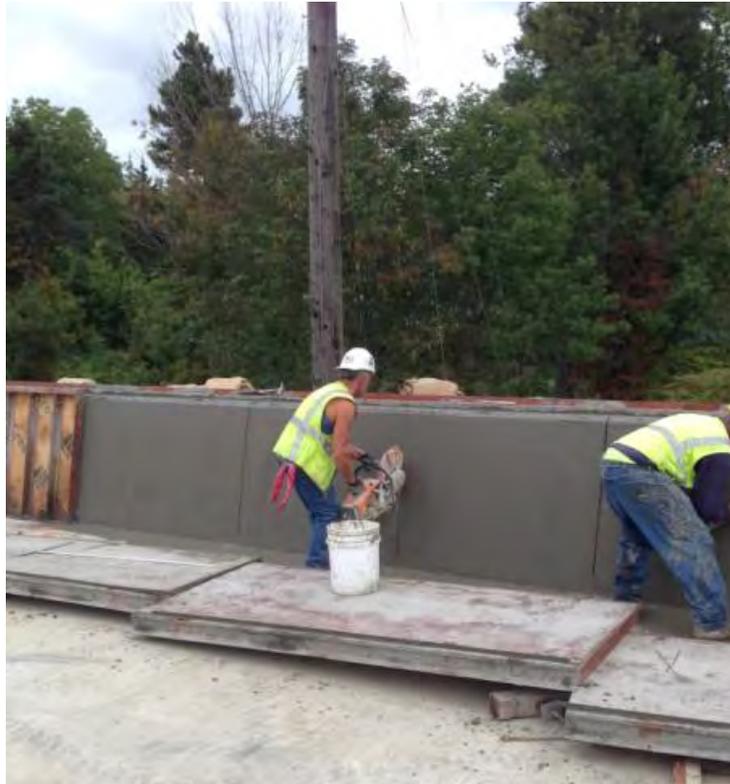
Figure 38: WB Paine Road north parapet performance of saw cuts (Photograph by Amy Kalabon)

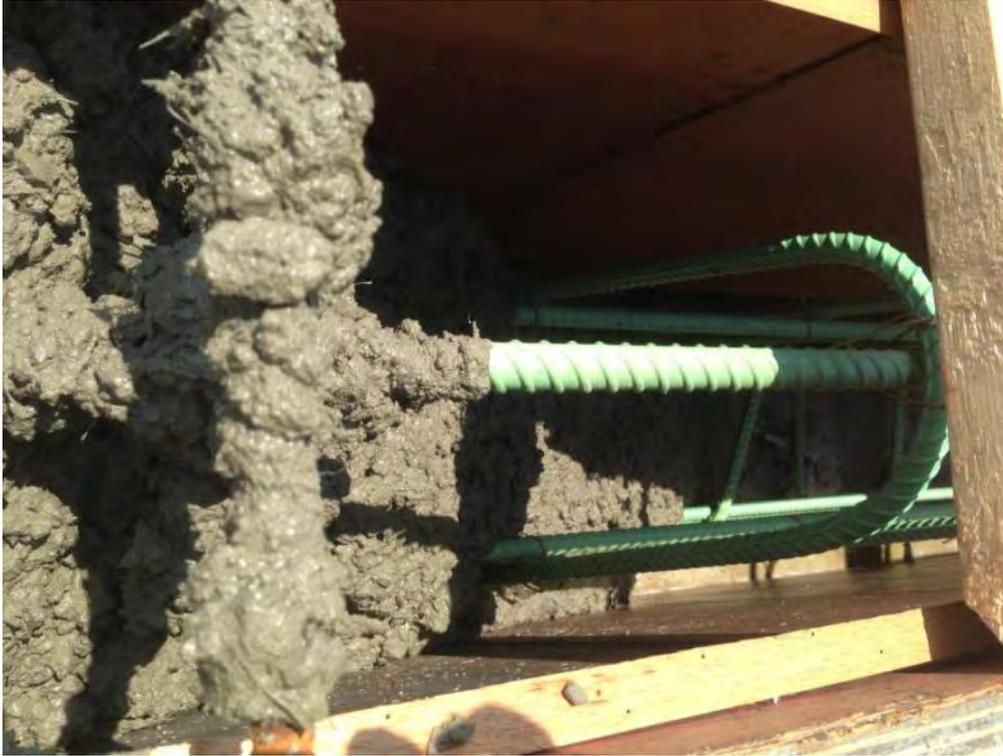
Figure 41: Consolidation of the concrete on WB Paine Road south parapet (Photograph by Amy Kalabon)

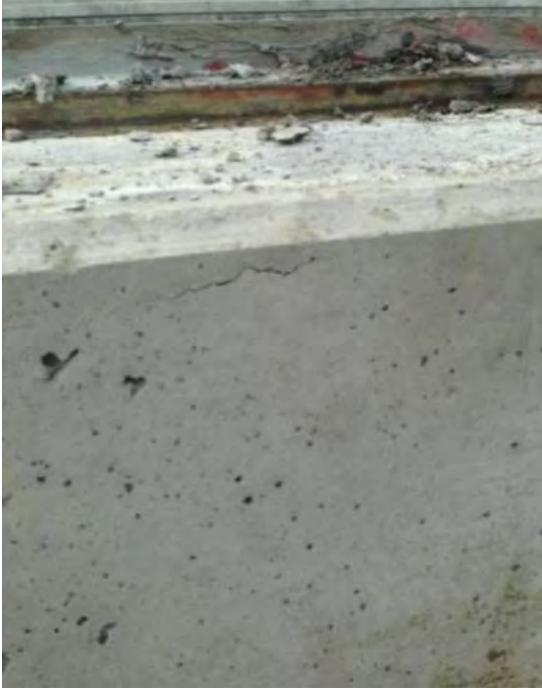
Figure 42: WB Paine Road south parapet bug holes (Photograph by Amy Kalabon)

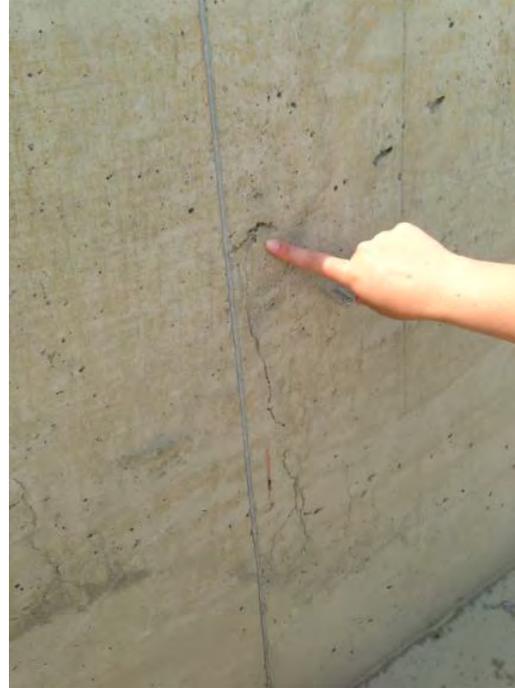
Figure 43: Surface cracks found on WB Paine Road south parapet (Photograph by Amy Kalabon)

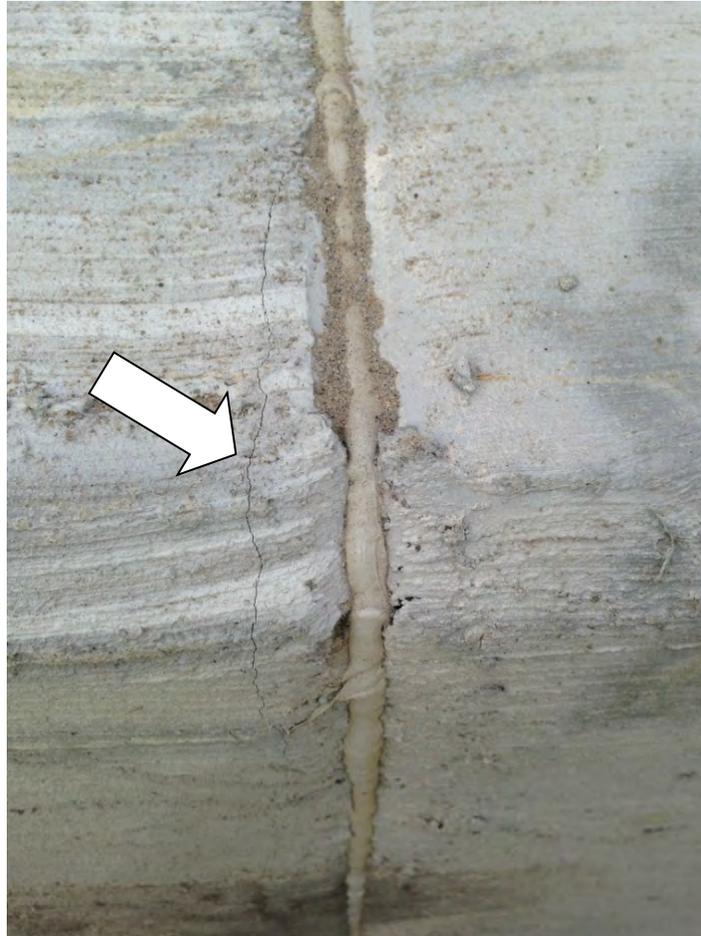
**Figure 45: WB Paine Creek north parapet crack looking down from top of parapet
(Photograph by Amy Kalabon)**

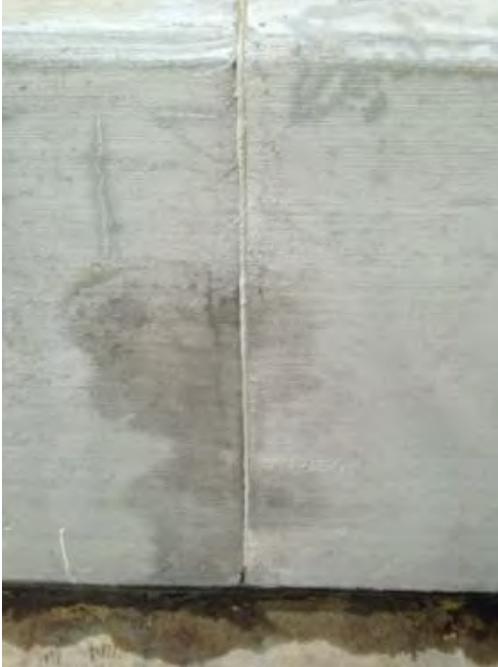
Figure 46: WB Paine Creek north parapet crack (Photograph by Amy Kalabon)

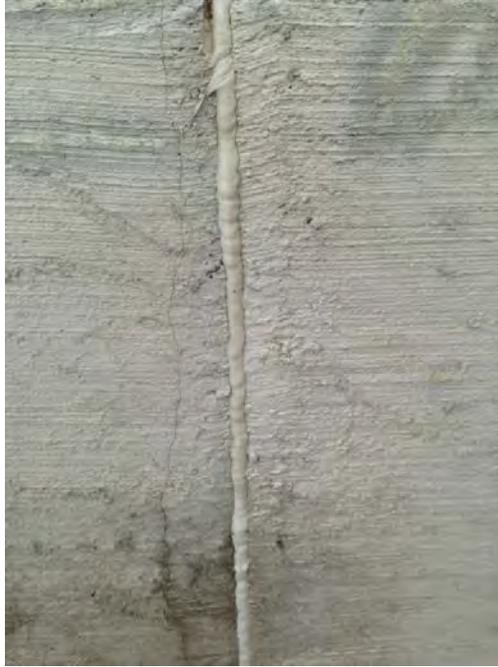
Figure 47: WB Paine Creek north parapet crack zoomed in view (Photograph by Amy Kalabon)

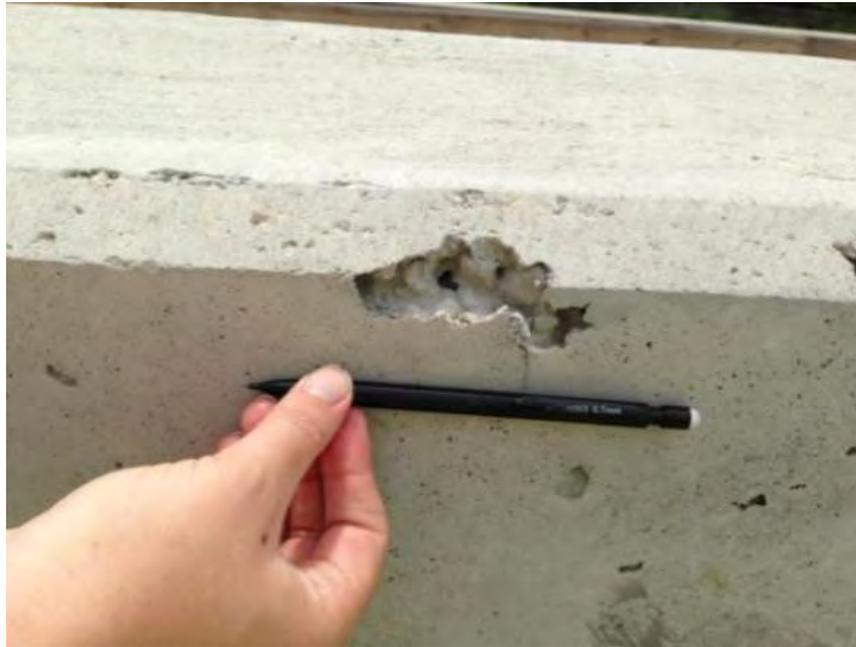
Figure 48: WB Paine Creek south parapet poor consolidation at the surface (Photograph by Amy Kalabon)

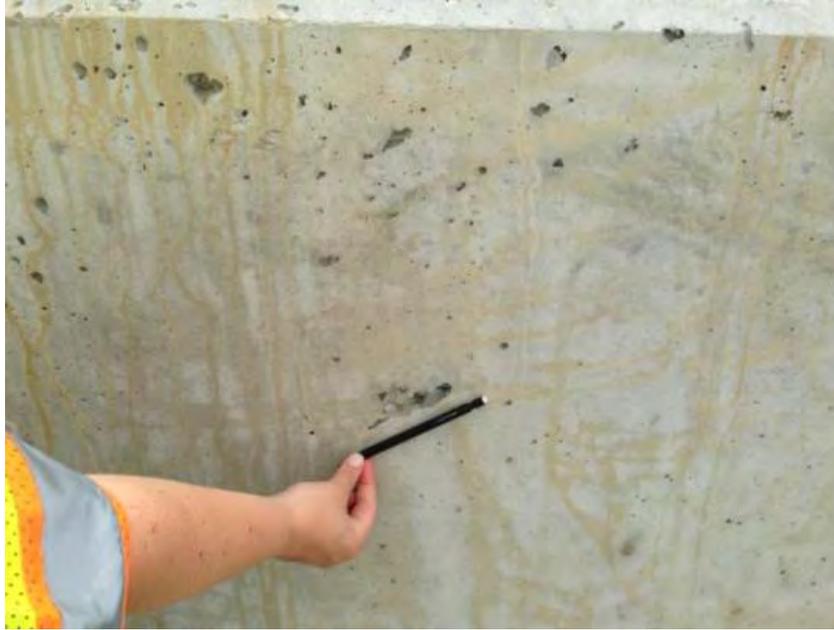
Figure 49: WB Paine Creek south parapet holes on the surface (Photograph by Amy Kalabon)

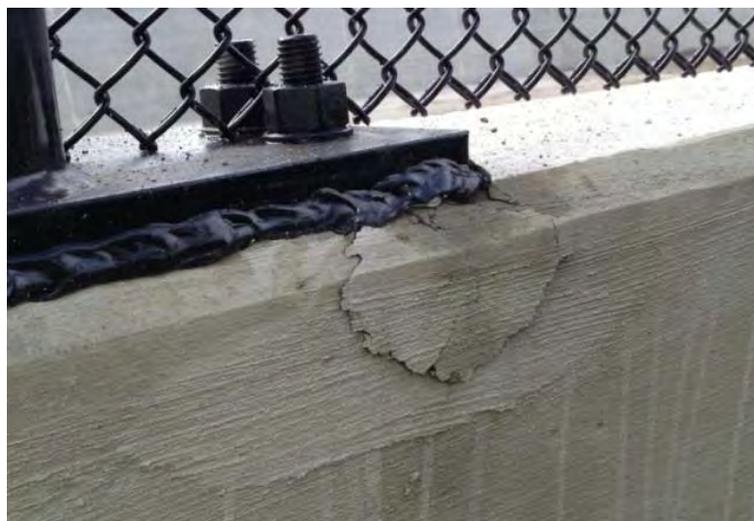
Cracking near the bolts on VPF post base plates occurred on both the north and south parapets of the South Marginal Bridge. This may be due to the shortened curing time the concrete experienced, but design details for the base plate anchorages, as well as when the base plates were anchored into the concrete may have caused the cracking. It is possible that drilling the bolt holes may have caused enough stress in the concrete to cause it to crack in these specific locations. Redesign of the post anchorage details or installations method may still be necessary to prevent cracking on parapets with vandal protection fences.

Figure 53: South Marginal north parapet crack at VPF post base plate (Photograph by Amy Kalabon)

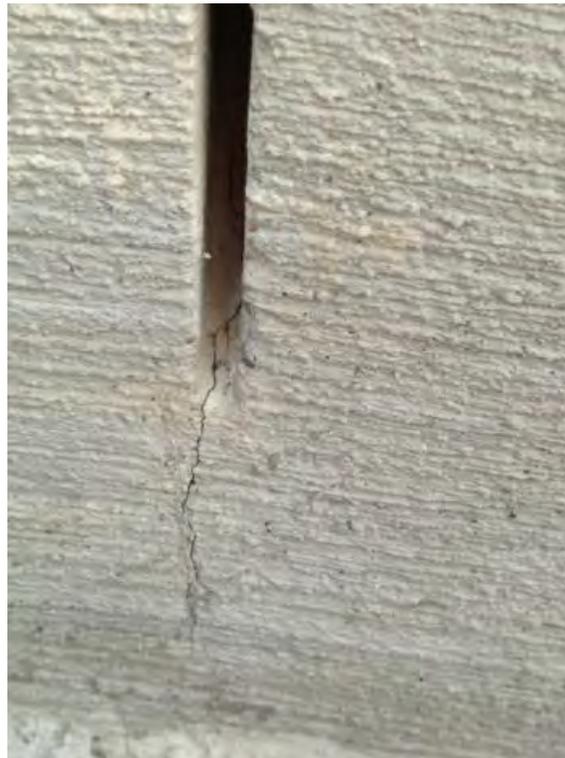
Figure 54: South Marginal north parapet cracks where control joint terminates (Photograph by Amy Kalabon)

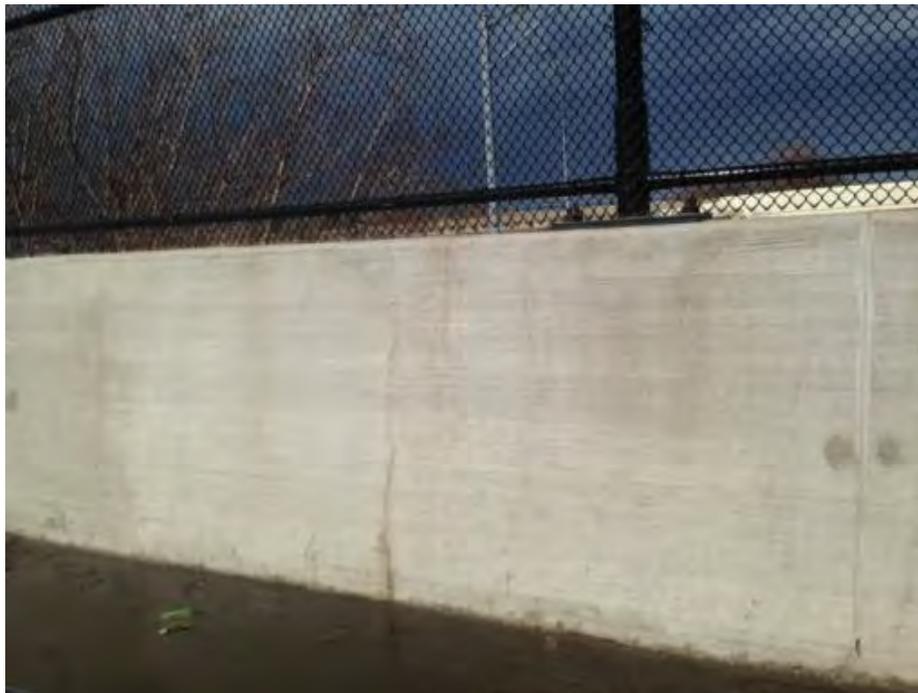
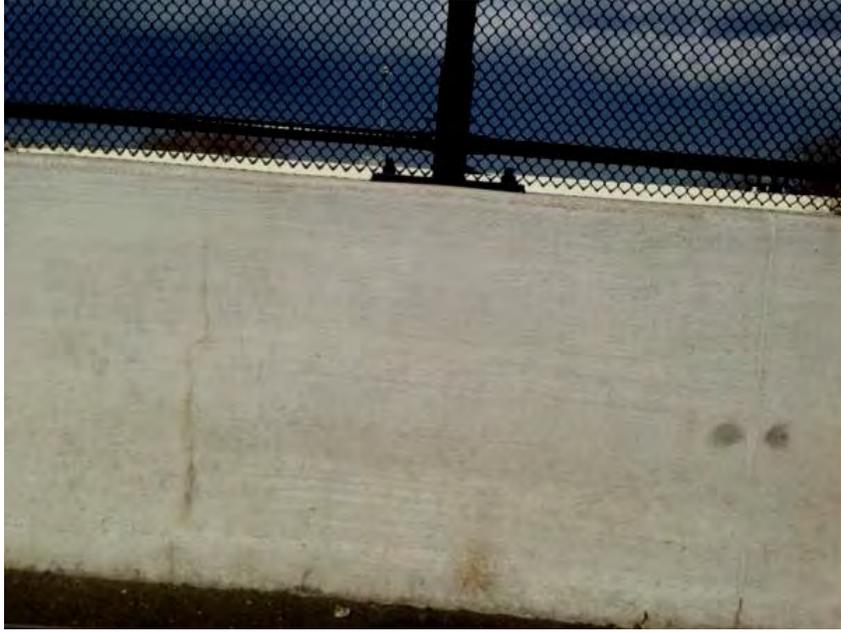
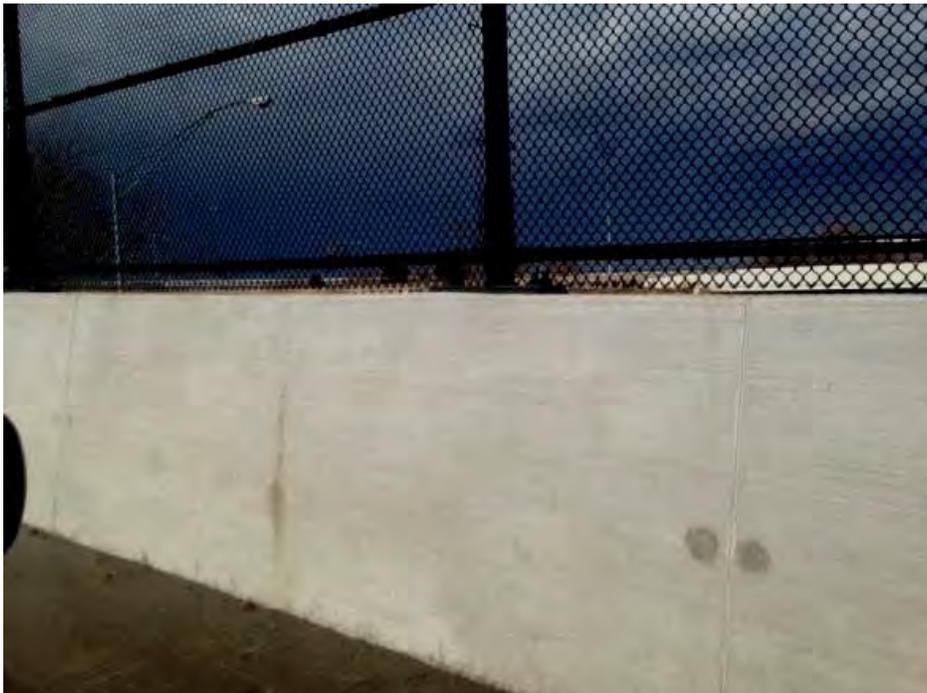
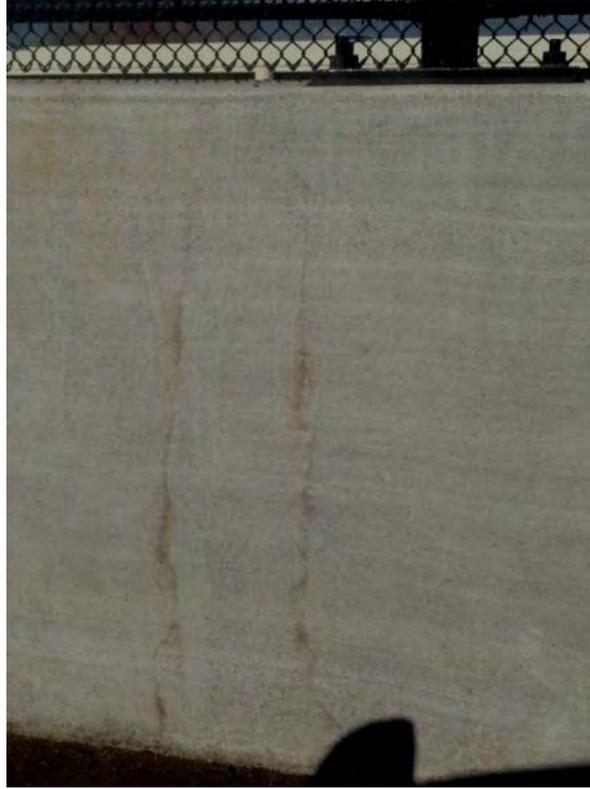
Figure 55: South Marginal north parapet mid-panel cracking (Photograph by Amy Kalabon)

Figure 56: South Marginal north parapet mid-panel cracking (Photograph by Amy Kalabon)

Figure 57: South Marginal north parapet mid-panel cracking (Photograph by Amy Kalabon)

Figure 58: South Marginal north parapet mid-panel cracking (Photograph by Amy Kalabon)

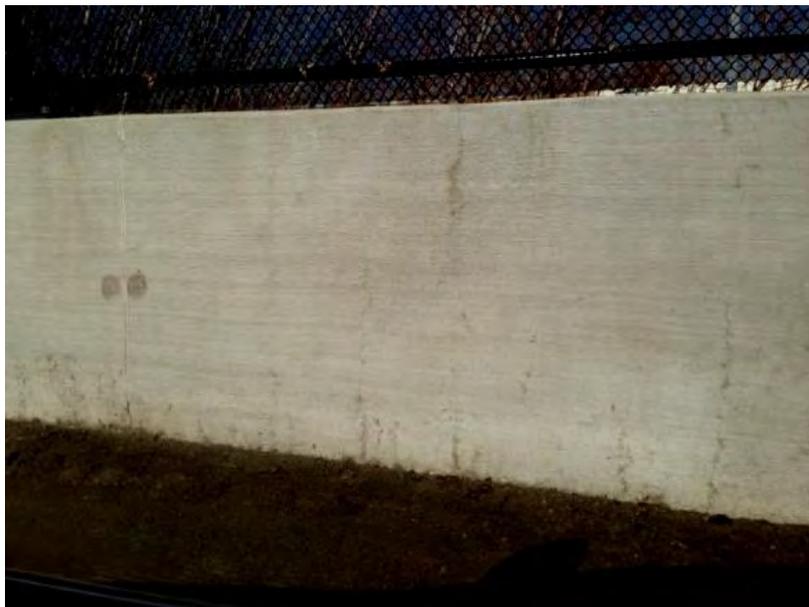
There were many additional fine cracks elsewhere along the parapet, as shown in Figure 59, but most were too small to photograph.

Figure 59: South Marginal north parapet small cracking (Photograph by Amy Kalabon)

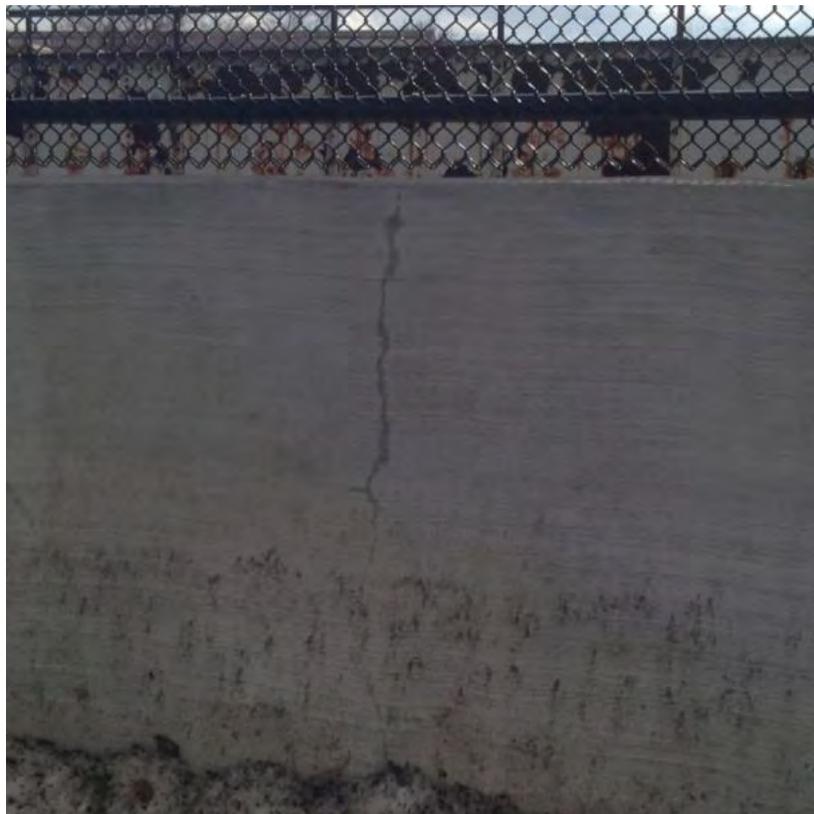
Figure 60: South Marginal south parapet mid-panel crack (Photograph by Amy Kalabon)

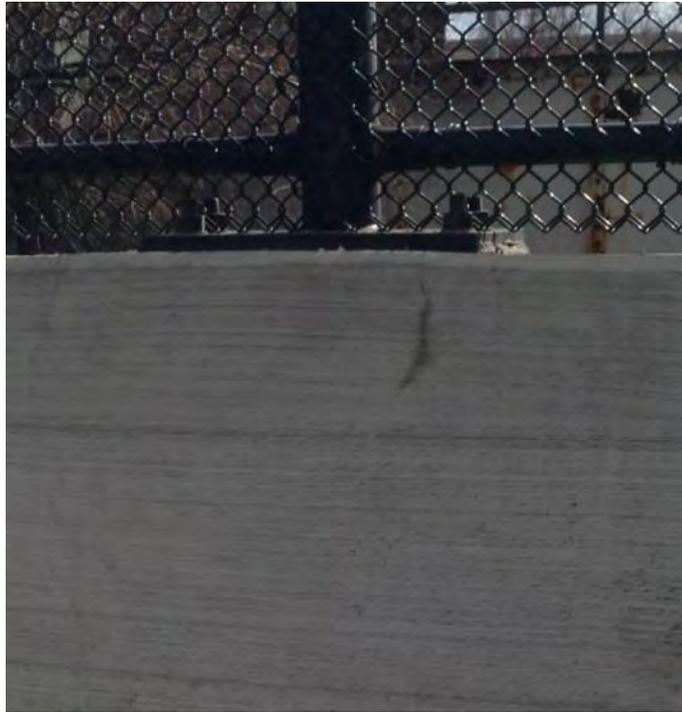
Figure 61: South Marginal south parapet VPF post base plate crack (Photograph by Amy Kalabon)
