COPIES	NUMBER	DESCRIPTION	CODE
1		FRP Fabrication NCR 12 - Rafts 1 & 2 - Misaligned Bolt Hole	H

**KENWAY
CORPORATION**

Brookfield BRFLBR (2)
Misaligned bolt hole – Raft #2

Nonconformance

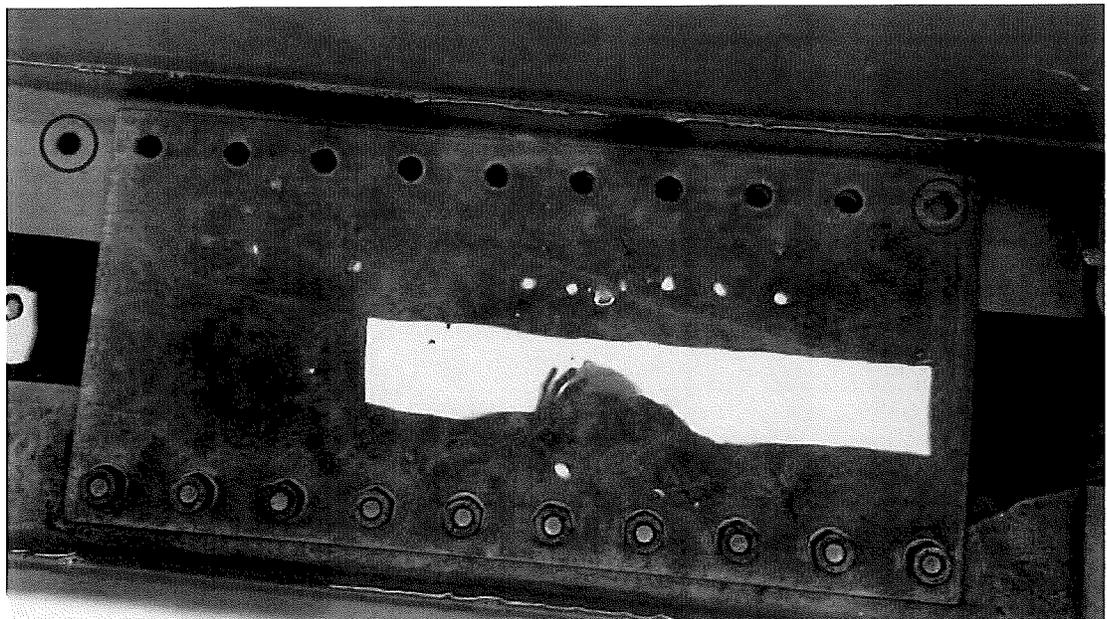
During joining operations between Rafts 1 and 2, Miller identified misaligned bolt holes along one edge of the outer bottom flange (16.5" x 34.5") splice plate connection.

While drilling the first set of 1/8 in. pilot holes in the large splice plate between Rafts 1 and 2, two or three 1/8 in. drill bits were broken and stuck in the corners of the template due to an excessively tight fit inside the bushing. At that point, the technician switched to 7/64 in. drill bits to avoid the issue. Also, given the difficulty associated with reaching the

bottom flange holes, only the corner holes in the templates were initially drilled, the templates repositioned once the rafts were separated, and remaining pilot holes drilled. Looking back, it appears that the template was shifted over one hole in order to make use of it until the stuck drill bit(s) could be removed. Unfortunately, the template must have been shifted in the wrong direction on Raft 2 once it had been separated from Raft 1.

To correct the discrepancy, Kenway plans to drill the missing bolt hole in place using an extension if necessary to clear the water. The steel plate will be used as a template to align the bit. If the Agency is concerned about drill spoils, a wet/dry vacuum could be used while drilling in an attempt to capture as much debris as possible. An epoxy resin that cures underwater could be used to seal the hole if desired. The extra bolt hole will simply remain open.

Once the 7/64 in. pilot bits were used and the stuck bits removed from the template, there have been no other issues piloting bolt holes. All pilot holes (not just the corners) are being drilled at the same time in every plate location at the initial placement of the template. Along with QA inspection procedures, this will ensure the misaligned bolt hole issue will not be repeated.
