# MILLER CONSTRUCTION, INC.

COPIES	NUMBER	DESCRIPTION	CODE
1		FRP Fabrication NCR 5 - Top Plate 2-9 Wrinkles	H

**Brookfield BRF FLBR (2)**

Nonconformance

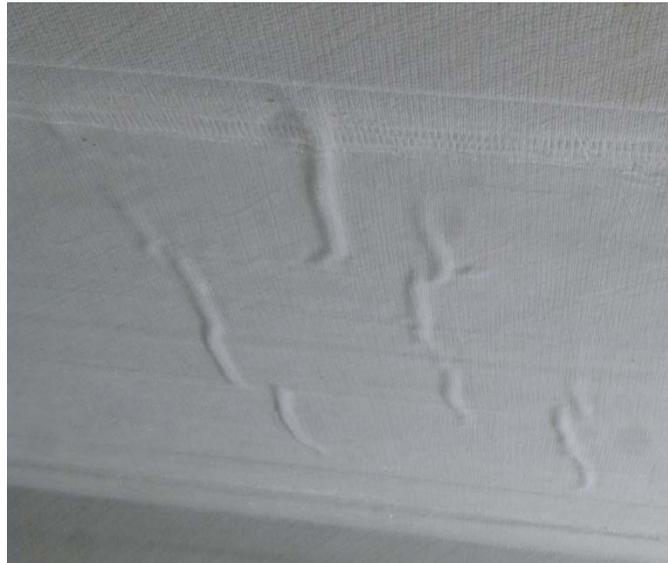
After de-molding the Top Plate (Part 2-9a) from the mold, Kenway noticed three wrinkles on the part. The mold surface has resin rich lines and the bag side of the part displays wrinkles that protrude less than 1/4 in. above the surface, less than 3/4 in. wide, and extend parallel to the short dimension of the part about from 12 in. to 38 in. in length. The wrinkles do not conform to: ASTM D2563, Table 1, Allowable Defects – Level II.

The wrinkles were likely caused by working on top of the part while adding sequential layers of material. Movement of feet and knees on the un-infused layers during part layup may have caused slight wrinkling of the initial layers and may have been exaggerated when the part was put under vacuum. The wrinkles were not identified during the pre-infusion inspection.

1. Grind down the proud areas on the bag surface to satisfy flatness requirements.
2. Grind out the resin rich areas on the mold surface at a 4:1 taper.

3. Replace ground out material with glass specified for the project with each ply tapered to fit the cavity.
4. Vacuum infuse the area with resin specified for the project and allow to cure.
5. Remove infusion consumables from the area and inspect for proper wet out.

Future Top Plate construction will include the use of spray adhesive on all areas that require a person to work on top of the material during layup. Included in the corrective action plan will be a “hold” for final inspection by the Quality Assurance Manager prior to infusion.
