# MILLER CONSTRUCTION, INC.

COPIES	NUMBER	DESCRIPTION	CODE
1		FRP Fabrication NCR 7 - Pontoon 3 Dry Spots	H

**Brookfield BRF FLBR (2)**

Nonconformance

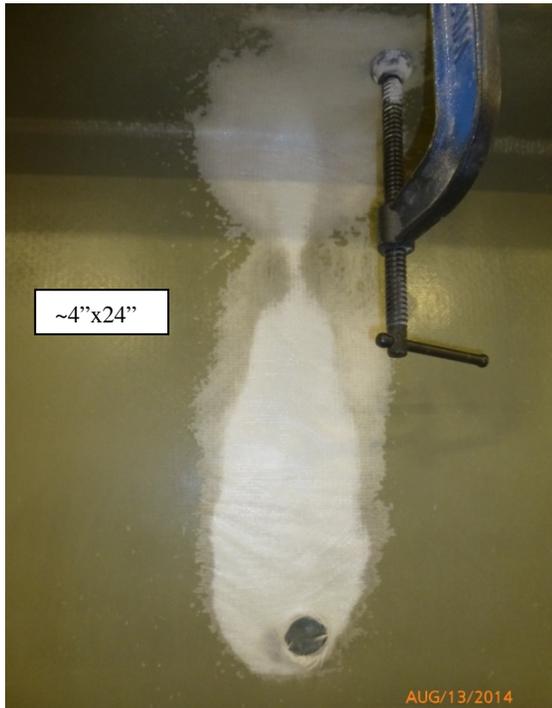
After de-molding the hull for Pontoon 3, Kenway discovered 4 areas of dry fabric on the exterior (mold side). These regions are shown in Figures 1 – 4.

The dry fabric was caused by a slow leak in the rod bulkhead alignment sleeves through the hull mold. Kenway attempted to identify the source of a leak or leaks that was causing erratic drop test results over the course of an entire week. After exhausting every tool and trick, and more than 110 manhours, the decision was made on Friday, August 8 to infuse the hull and react to any observations during infusion.

**Figure 1 – West End, Radius Side**

1. Place a smooth caul plate (such as a sheet of HDPE) over the affected area having a series of small resin feed holes along the centerline of the dry area.
2. Place vacuum lines parallel to the line of feed holes on both sides of the caul.
3. Pull vacuum and establish the required drop test conditions.
4. Infuse the area, allow to cure, and inspect using visual and UT methods.

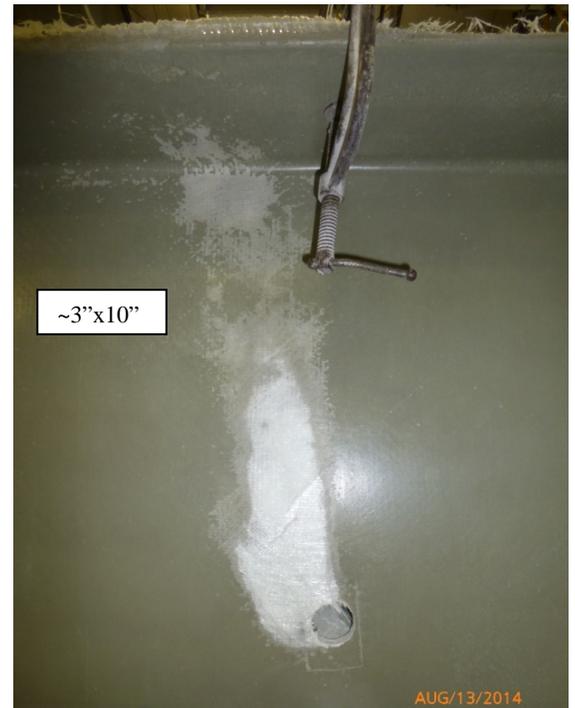
**Figure 2 – Middle, Radius Side**

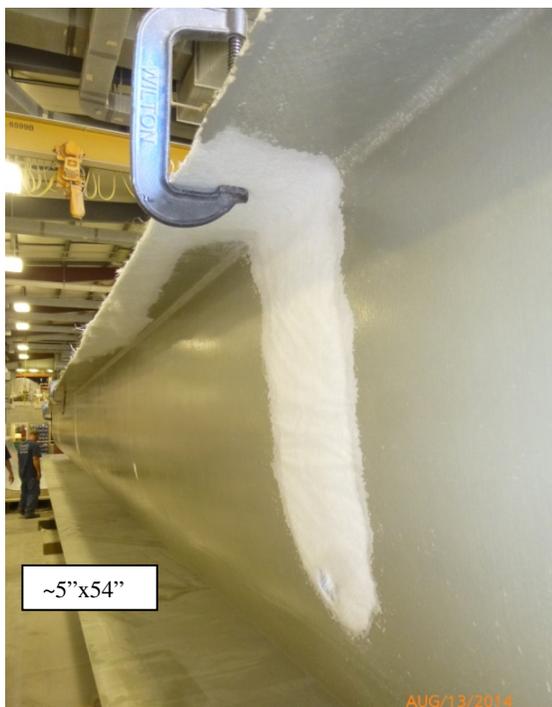
Further evaluation of these areas reveals that the dry fabric is predominantly limited to the C-veil layer with minimal isolated dry fiber on the outer surface of the mat only on the 4008 layer. The one exception is the East End, Radius Side where the dry fabric in the flange extends through the thickness. These areas are perfect candidates for reinfusion.

**Figure 3 – East End, Radius Side**

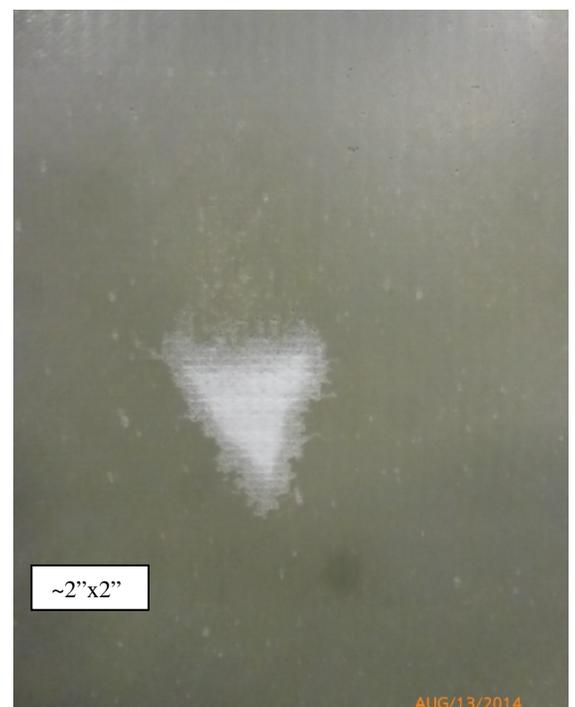
**Figure 4 – West-Middle, Radius Side**

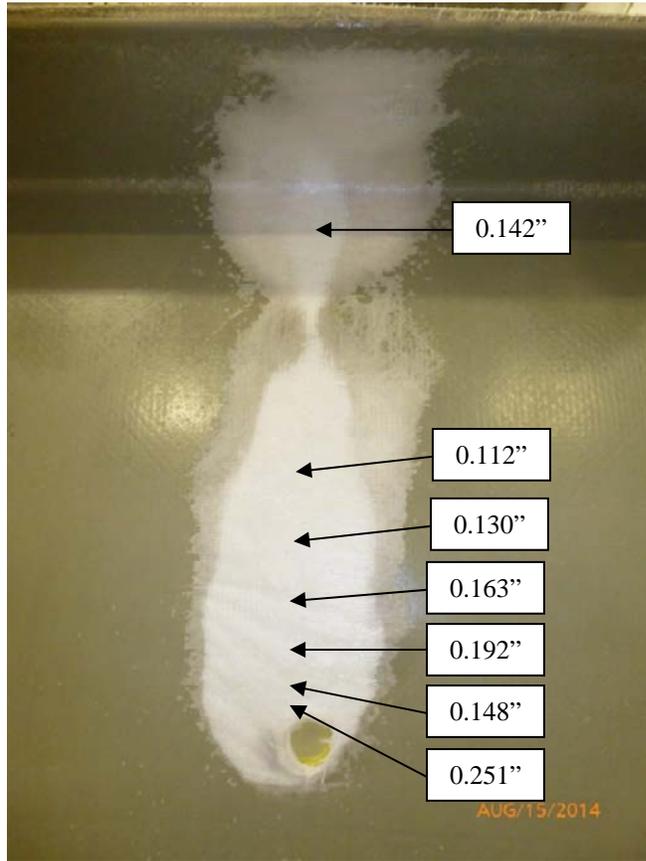
**Figure 3 – West End, Radius Side: Dry Fabric Depth**

<b>Location</b>	<b>Max Dry Depth</b>	<b>Mean Dry Depth</b>	<b>Min Resin Thick</b>	<b>Mean Resin Thick</b>
West, Radius	0.251	0.163	0.356	0.444
Middle, Radius	0.155	0.107	0.452	0.500
Mid/East, Radius	0.056	0.056	0.551	0.551
East, Radius	0.356	0.215	0.251	0.392
East, Vertical	0.012	0.012	0.595	0.595
Middle, Vertical	0.024	0.024	0.583	0.583
West, Vertical	0.034	0.034	0.573	0.573

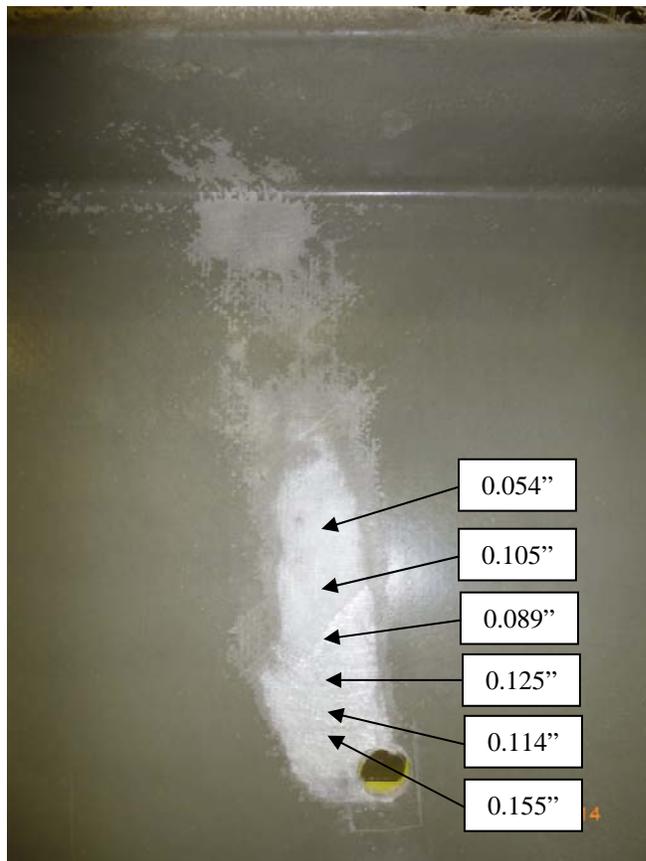
**Figure 4 – Middle, Radius Side: Dry Fabric Depth**

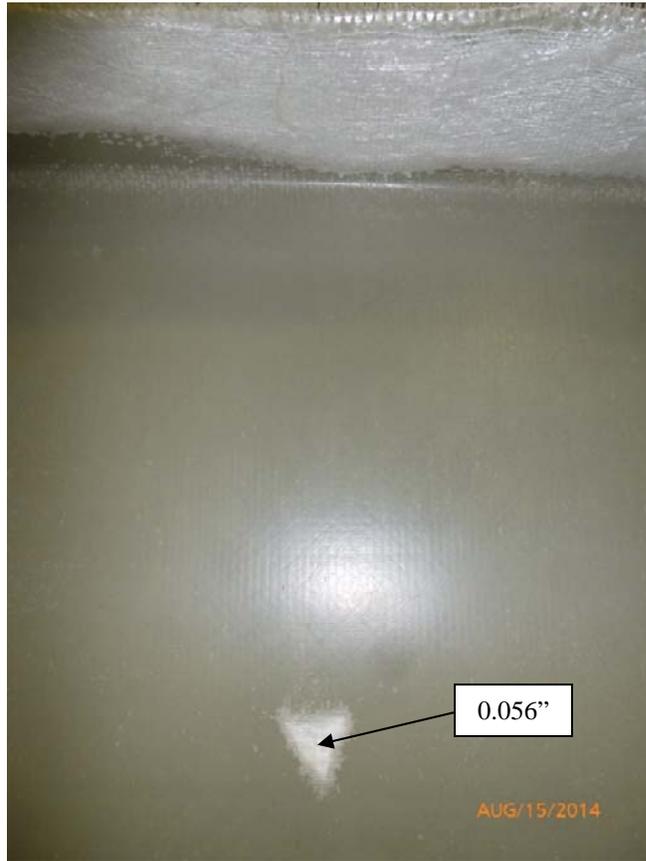
**Figure 5 – Between Middle and East End, Radius Side: Dry Fabric Depth**

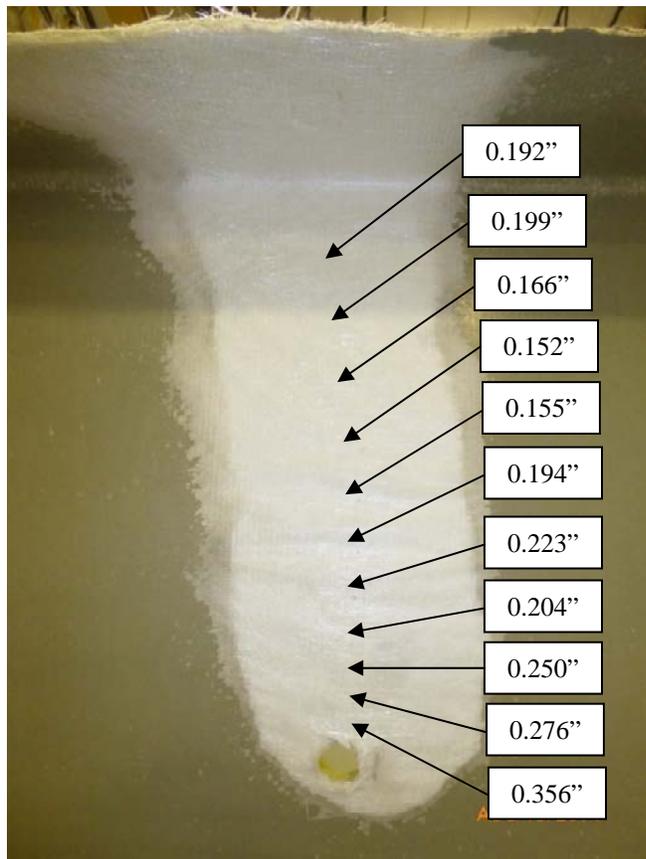
**Figure 6 – East End, Radius Side: Dry Fabric Depth**

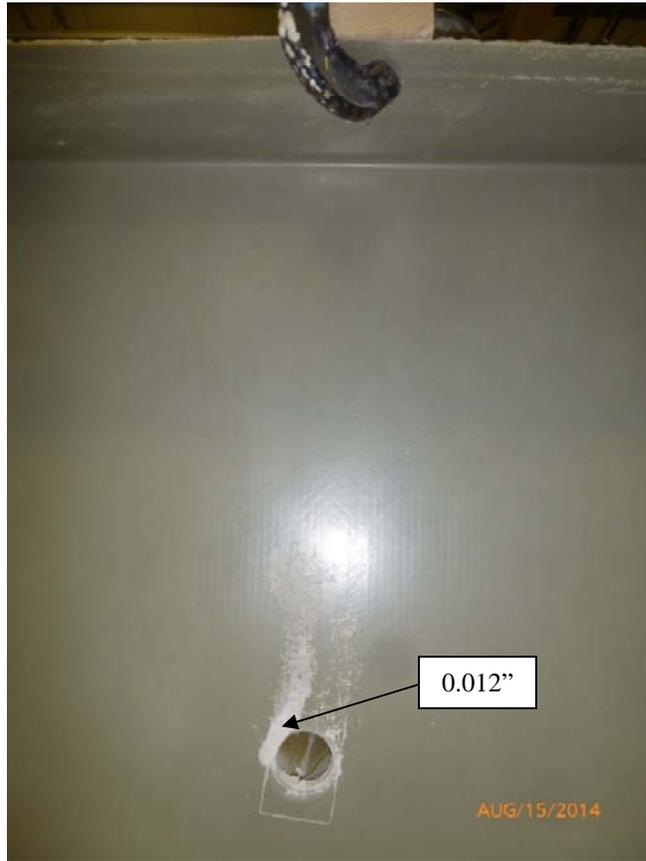
**Figure 7 – East End, Vertical Side: Dry Fabric Depth**

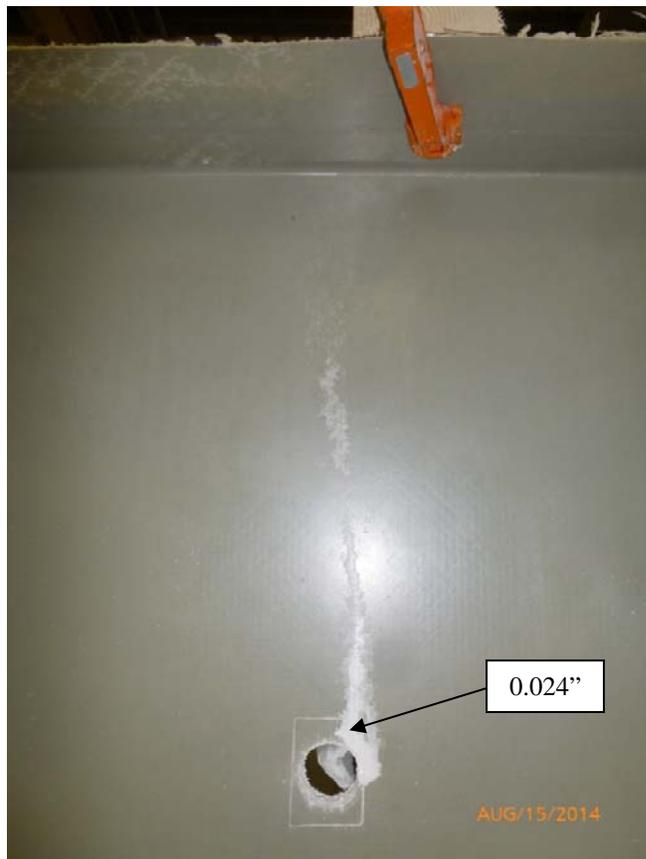
**Figure 8 – Middle, Vertical Side: Dry Fabric Depth**

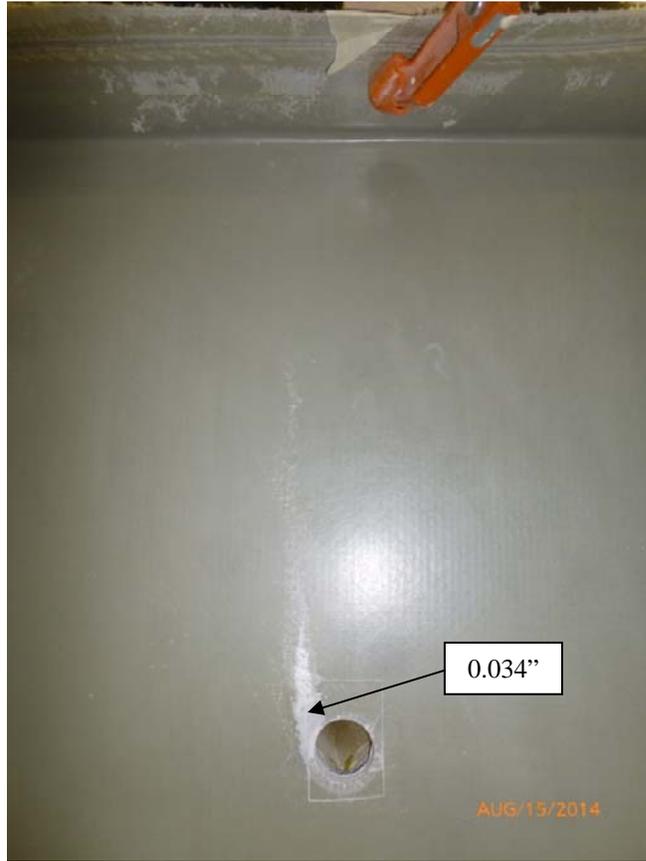
**Figure 9 – West End, Vertical Side: Dry Fabric Depth**
