**KENWAY
CORPORATION**

Brookfield BRFLBR (2)

Nonconformance

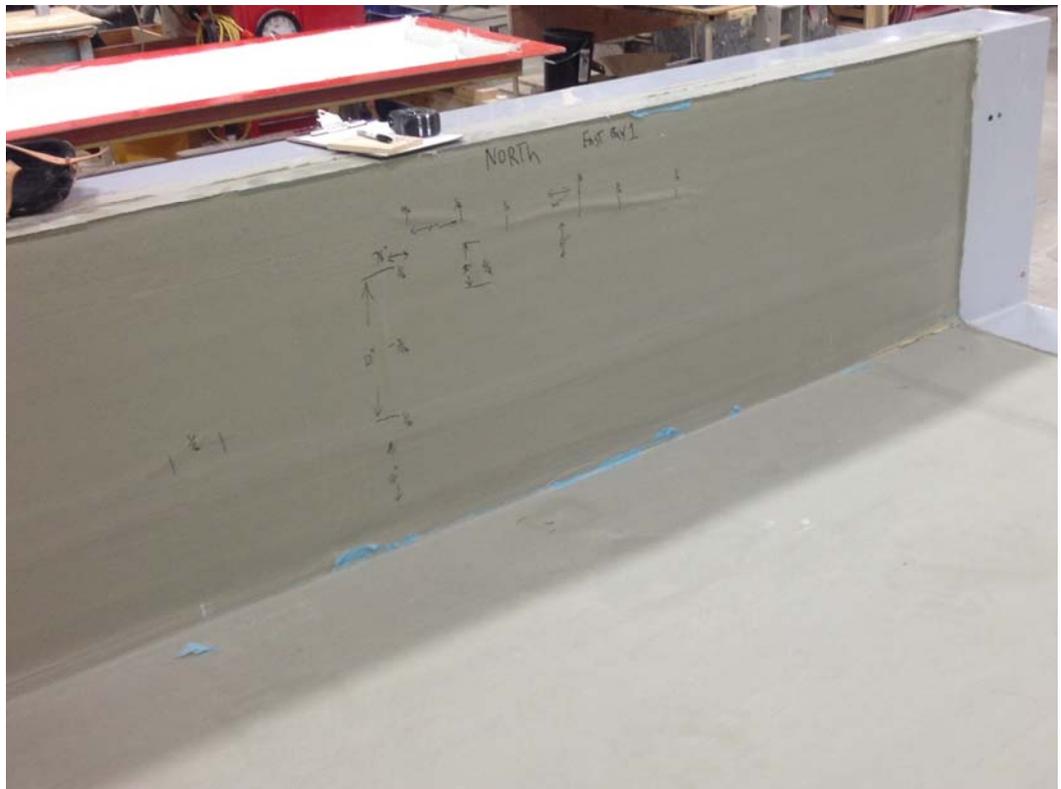
Figure 1 – Vertical Wall, Bay 1

After de-molding the hull for Pontoon 3 (PN 3-1), Kenway noticed several wrinkles on the part. The mold surface has resin rich lines and the bag side of the part displays wrinkles that protrude less than 3/16 in. above the surface (less than 1/8 in. beyond specification) and less than 3/4 in. wide. The wrinkles do not conform to: ASTM D2563, Table 1, Allowable Defects – Level II, which requires wrinkle height to be less than 10% of laminate thickness – in this case less than 1/16 in.

These wrinkles were not observed immediately after the part was laid up, but they became more pronounced after the part was under bag for a week during the stop work order. The wrinkles were likely caused or at least exacerbated by being held and cycled under vacuum during the week while vacuum leaks were being investigated. Also, movement of feet and knees on the un-infused layers during part layup may have caused slight wrinkling of the initial layers and may have been exaggerated when the part was put under vacuum. The wrinkles were not identified during the pre-infusion inspection.

Kenway recommends performing the following steps, which have been approved to repair wrinkles in PN 2-9a (NCR 5), to repair the 5 nonconforming areas where wrinkle height is equal to or greater than 1/8 in. and wrinkle length is equal to or greater than 12 in.

1. Grind down the proud areas on the bag surface to satisfy flatness requirements.
2. Grind out the resin rich areas on the mold surface at a 12:1 taper.
3. Replace ground out material with glass specified for the project with each ply tapered to fit the cavity.
4. Vacuum infuse the area with resin specified for the project and allow to cure.
5. Remove infusion consumables from the area and inspect for proper wet out.
