Re: Hartford Lateral Slide
 Project No.: IM 091-2(79)
 Contract ID.: 12A132

SUBMITTAL NO. : 48
Structural Steel Repair Procedure

Structural Steel Repair Procedure

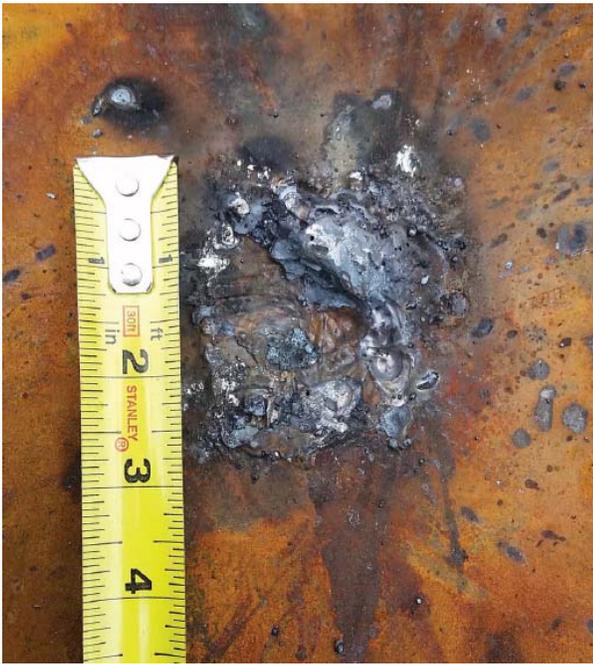
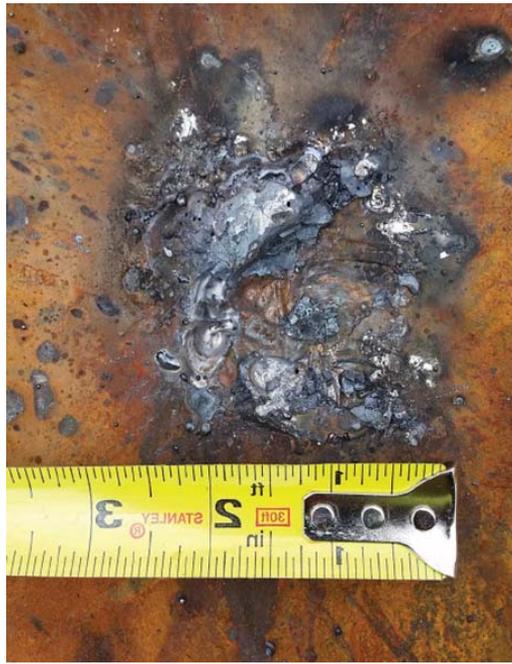
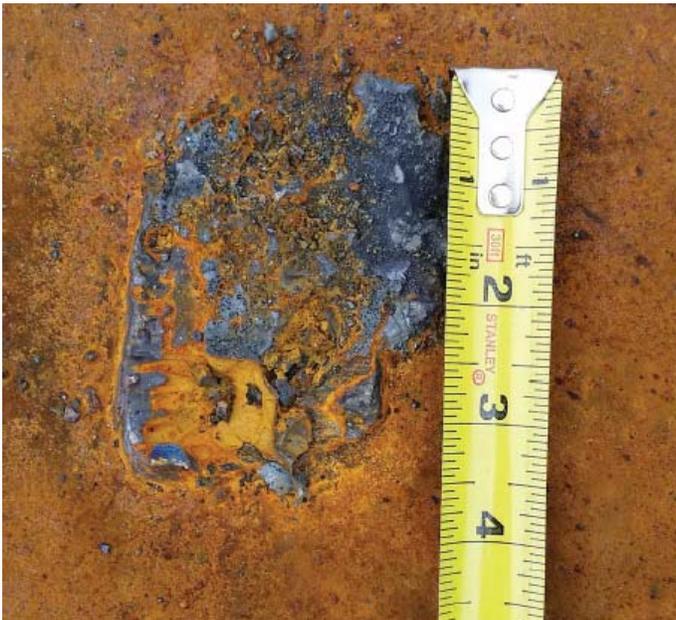
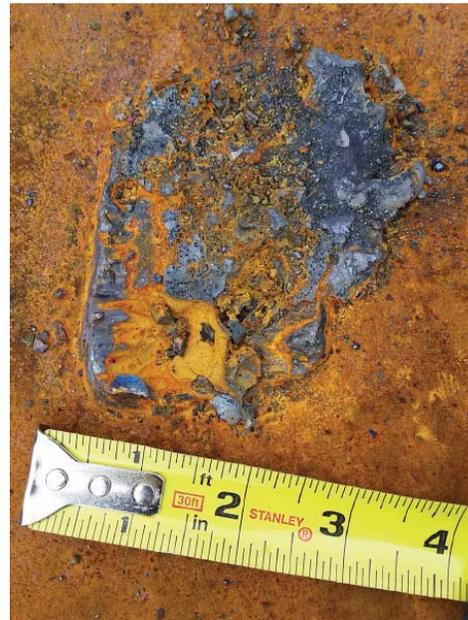
During inspection it was discovered that (2) small areas on I-91NB girder #6 were cut into with a torch. See pictures below for reference:

This happened when the welder cut and moved one of the legs for the fall protection. The welder has since been talked to as has the crew. If cutting of any temporary members is required grinders (not torches) are to be used. In no situation shall the permanent girders be damaged.

PCL proposes the following repair procedure:

1. **Grind off all latent materials**
2. **Fill divots with weld (E70XX)**
3. **Grind area to be flush with flange**
