Non-Conformance Report Rev. 5

Date Submitted: Thursday, July 23, 2015
 Job Name/No.: Castleton / #23456
 Piece Mark #'s: CT-NB2 (1)
 Production Date: 6/15/2015
 QA Inspector, Co.: R. Hamilton, KTA & B Girouard, HRV

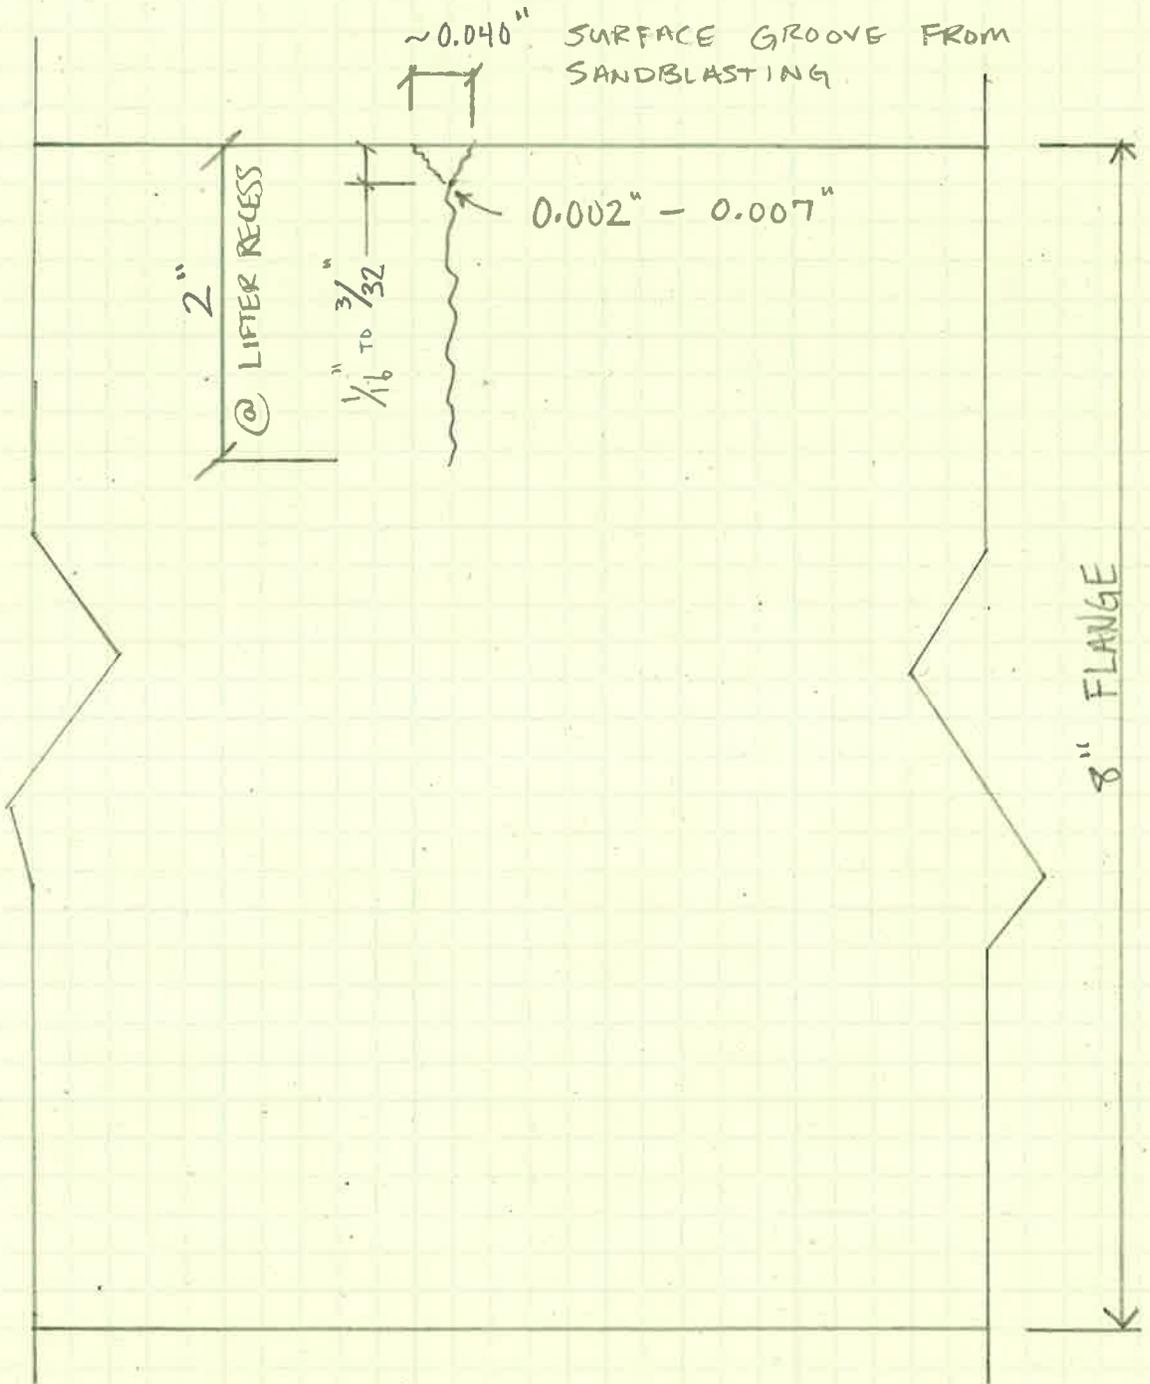
SK-1 NOT TO SCALE

- 14 *JPC does not find any cracks in the beam having a width of 0.04". The process of sandblasting the top surface of the beam rounds the edges of the cracks making them appear wider at the top surface, refer to attached Photos & SK1. Rounded edges of the cracks extend down approximately 1/16" to 3/32". Observed crack depths at flange edges and at lifter blockouts terminate at the top mat of reinforcing. The new crack map generated 7/22/15 records the length and width of each individual crack. JPC did not observe additional cracks or increase in widths resulting from shipping and handling. All cracks in the flange generated by shrinkage or tension have occurred and have been successfully restrained by the mild reinforcement.*

ELEVATION DETAIL OF TYPICAL CRACK POST BLAST

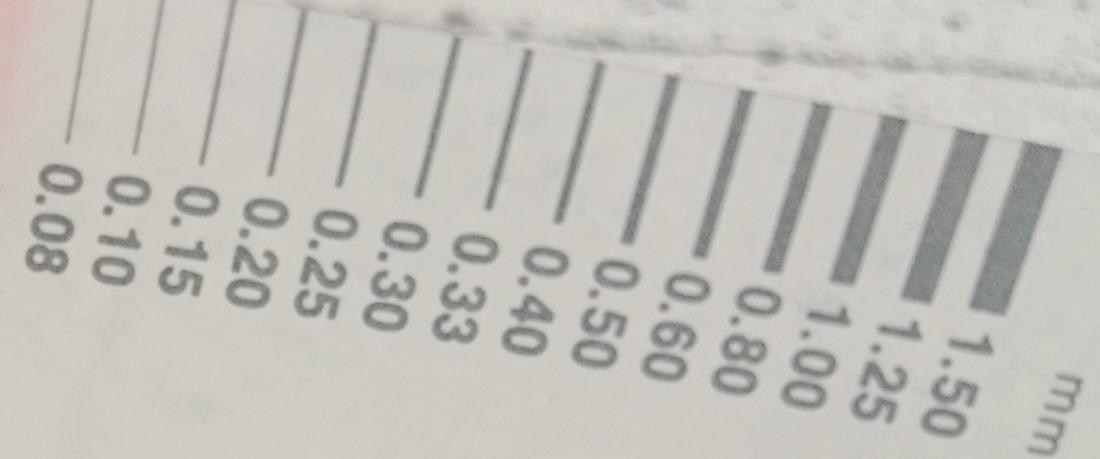
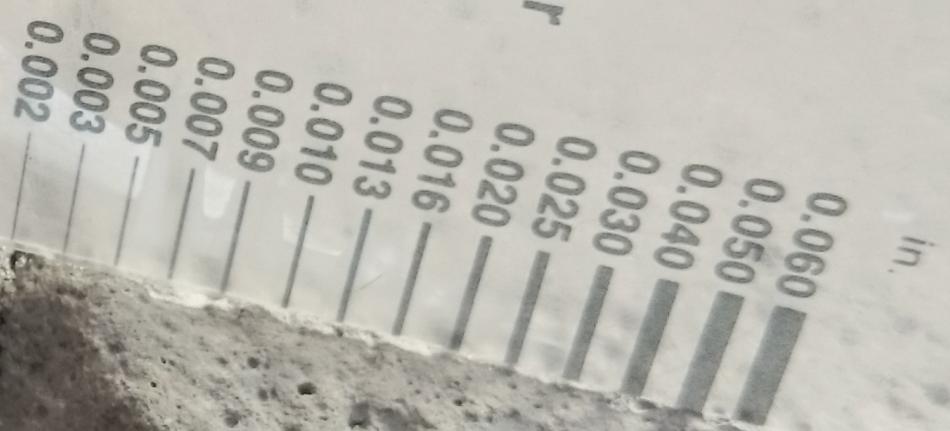
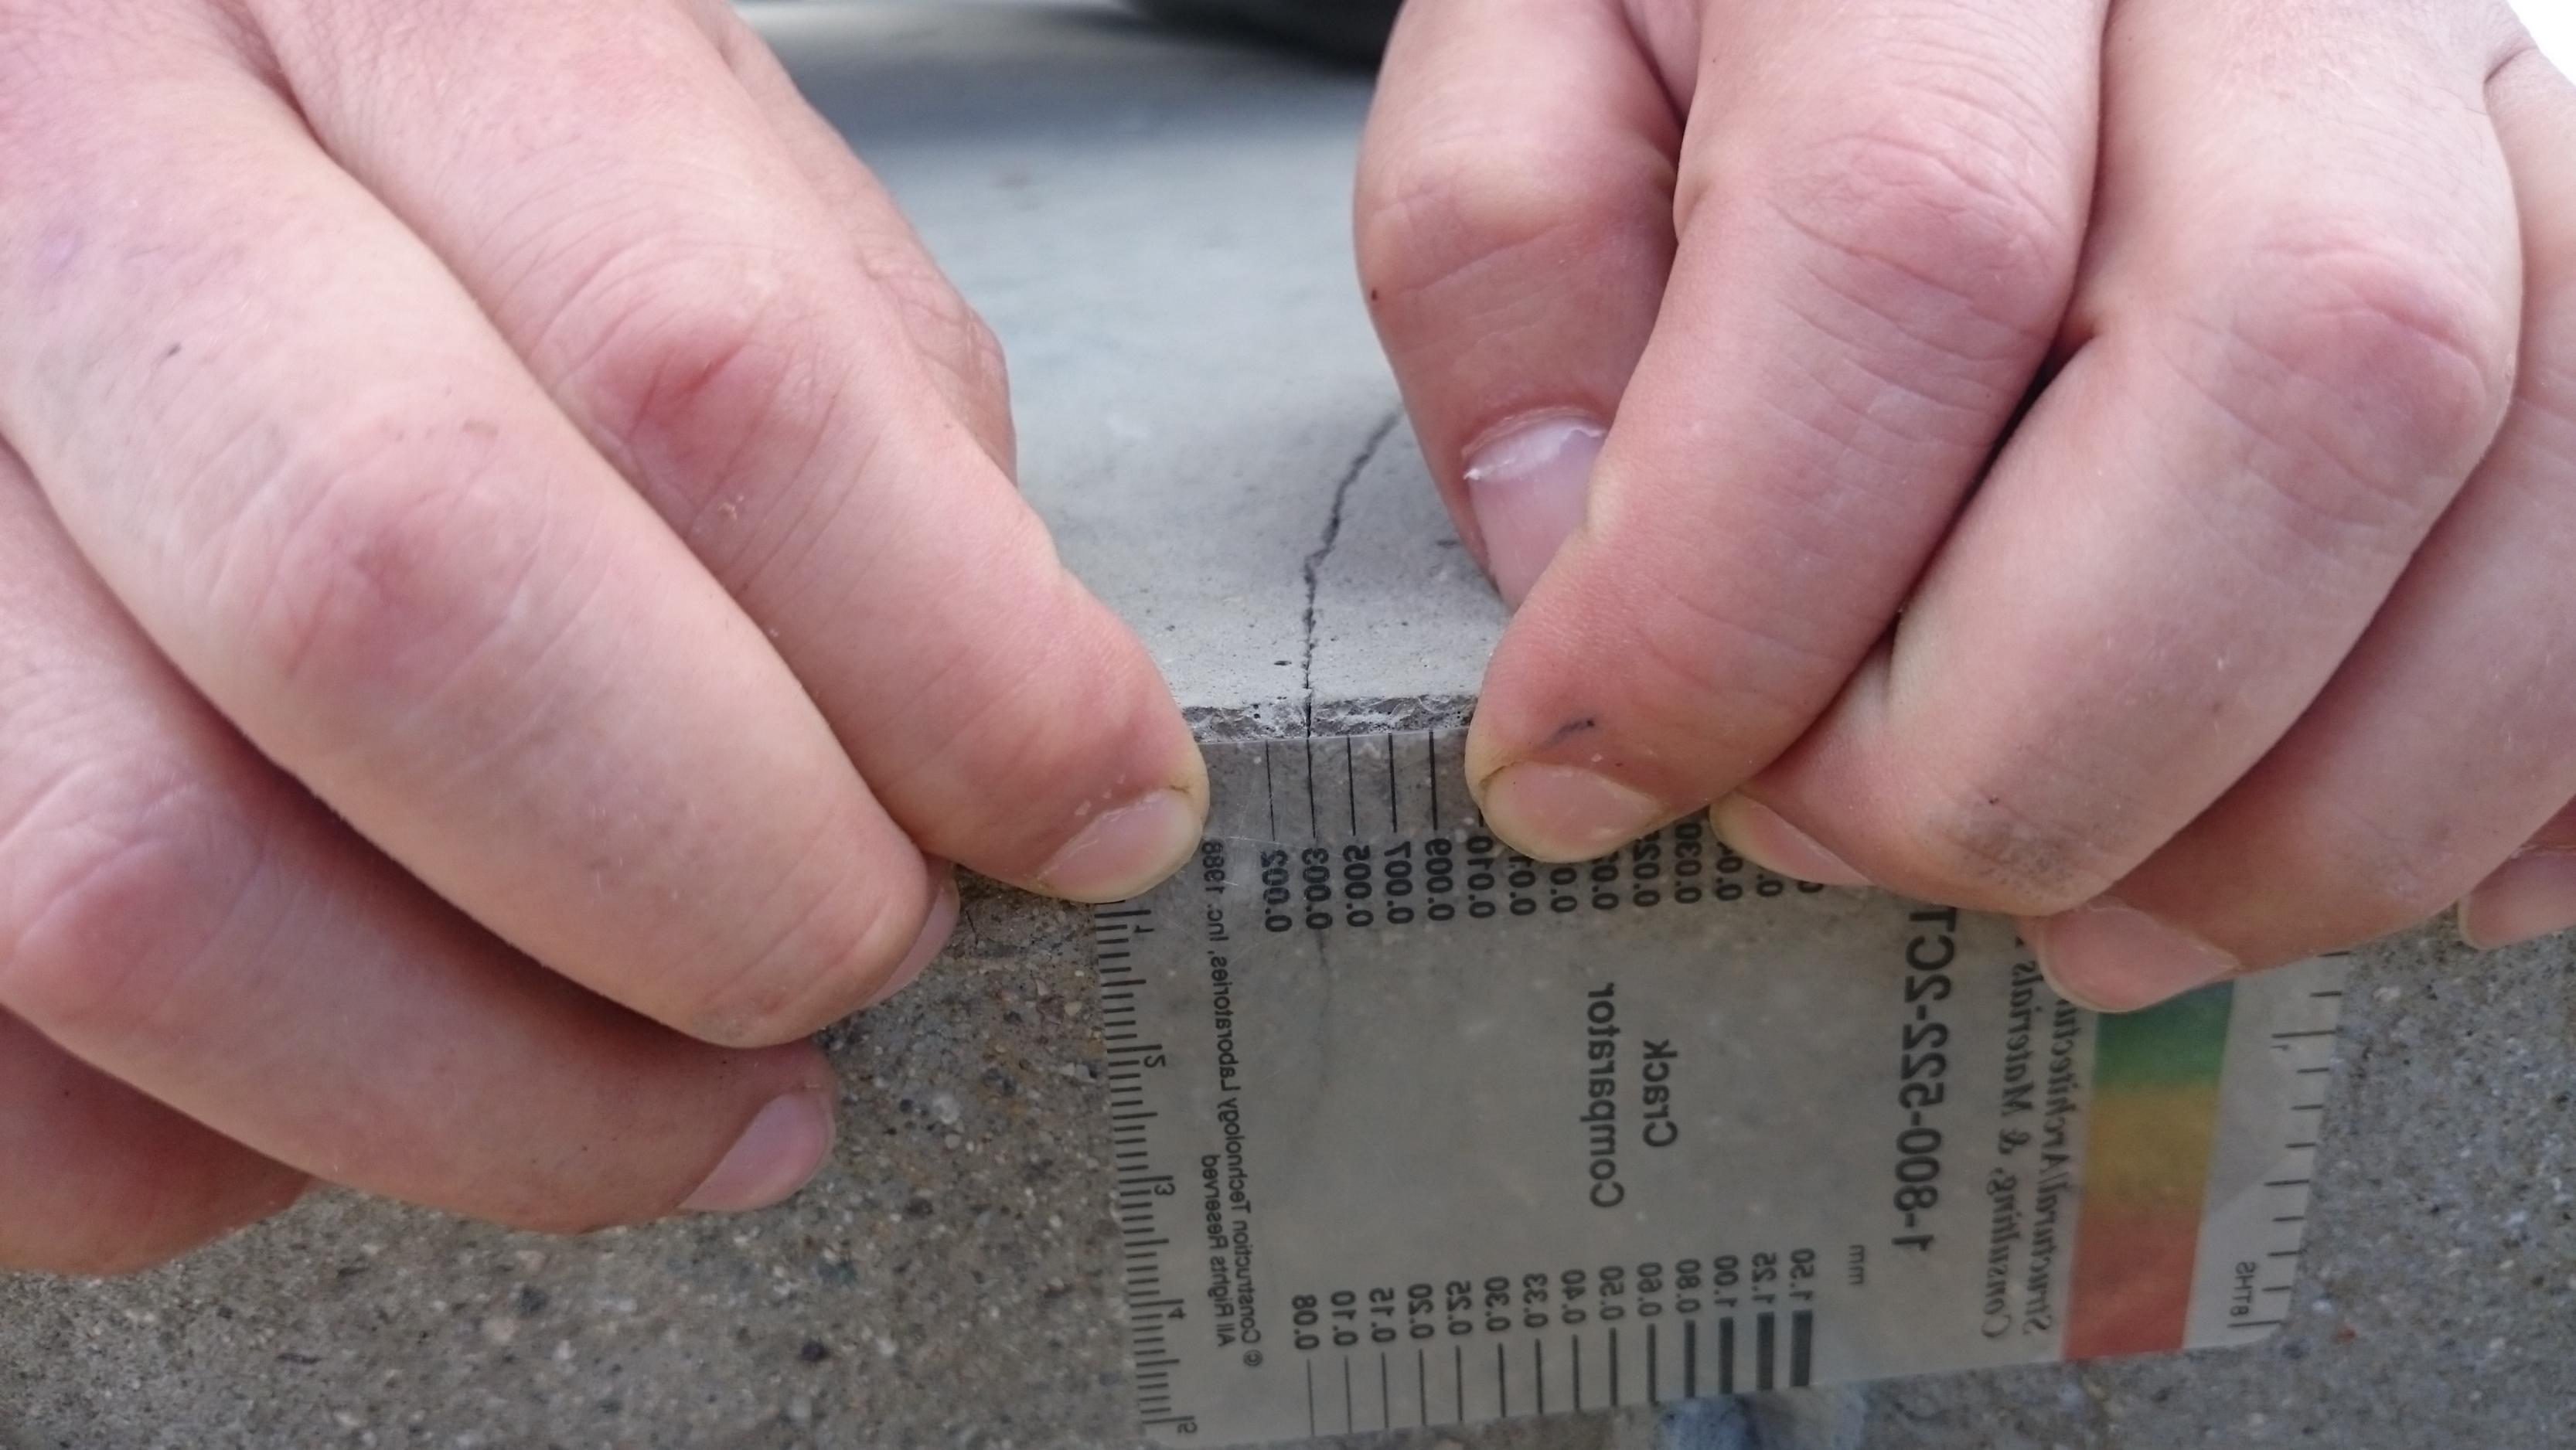
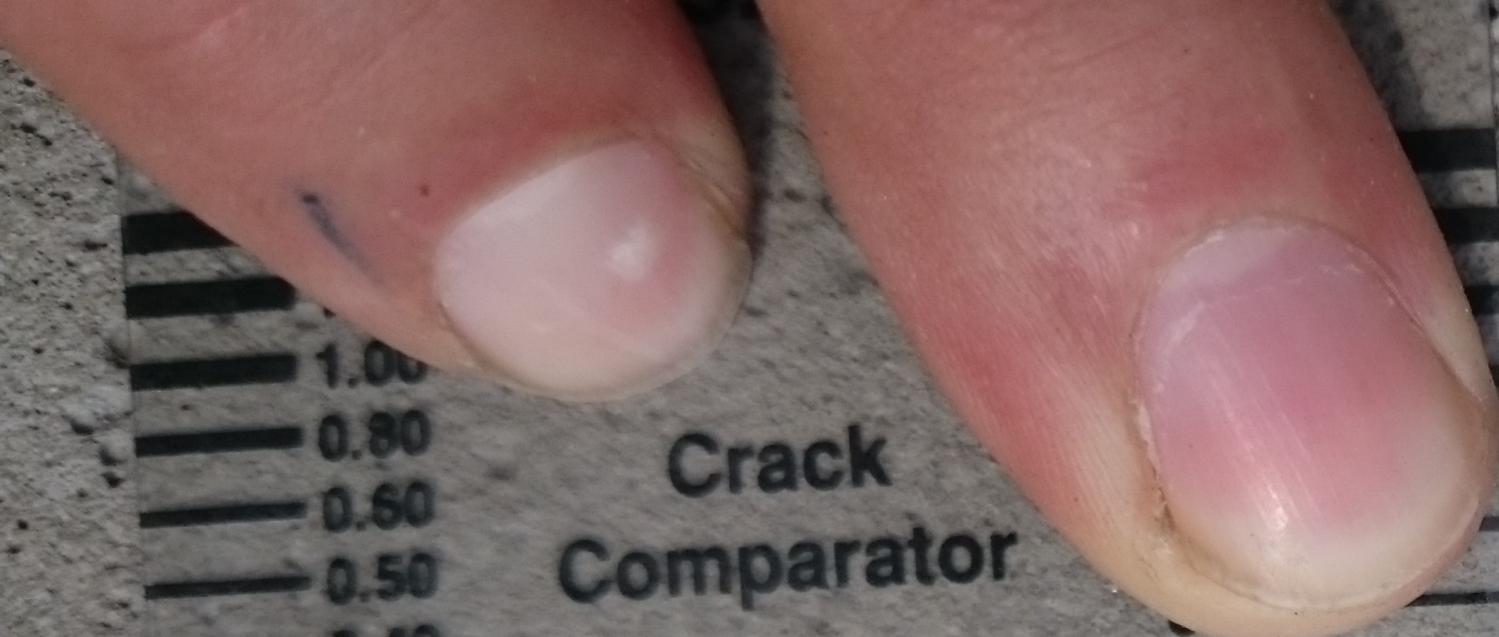
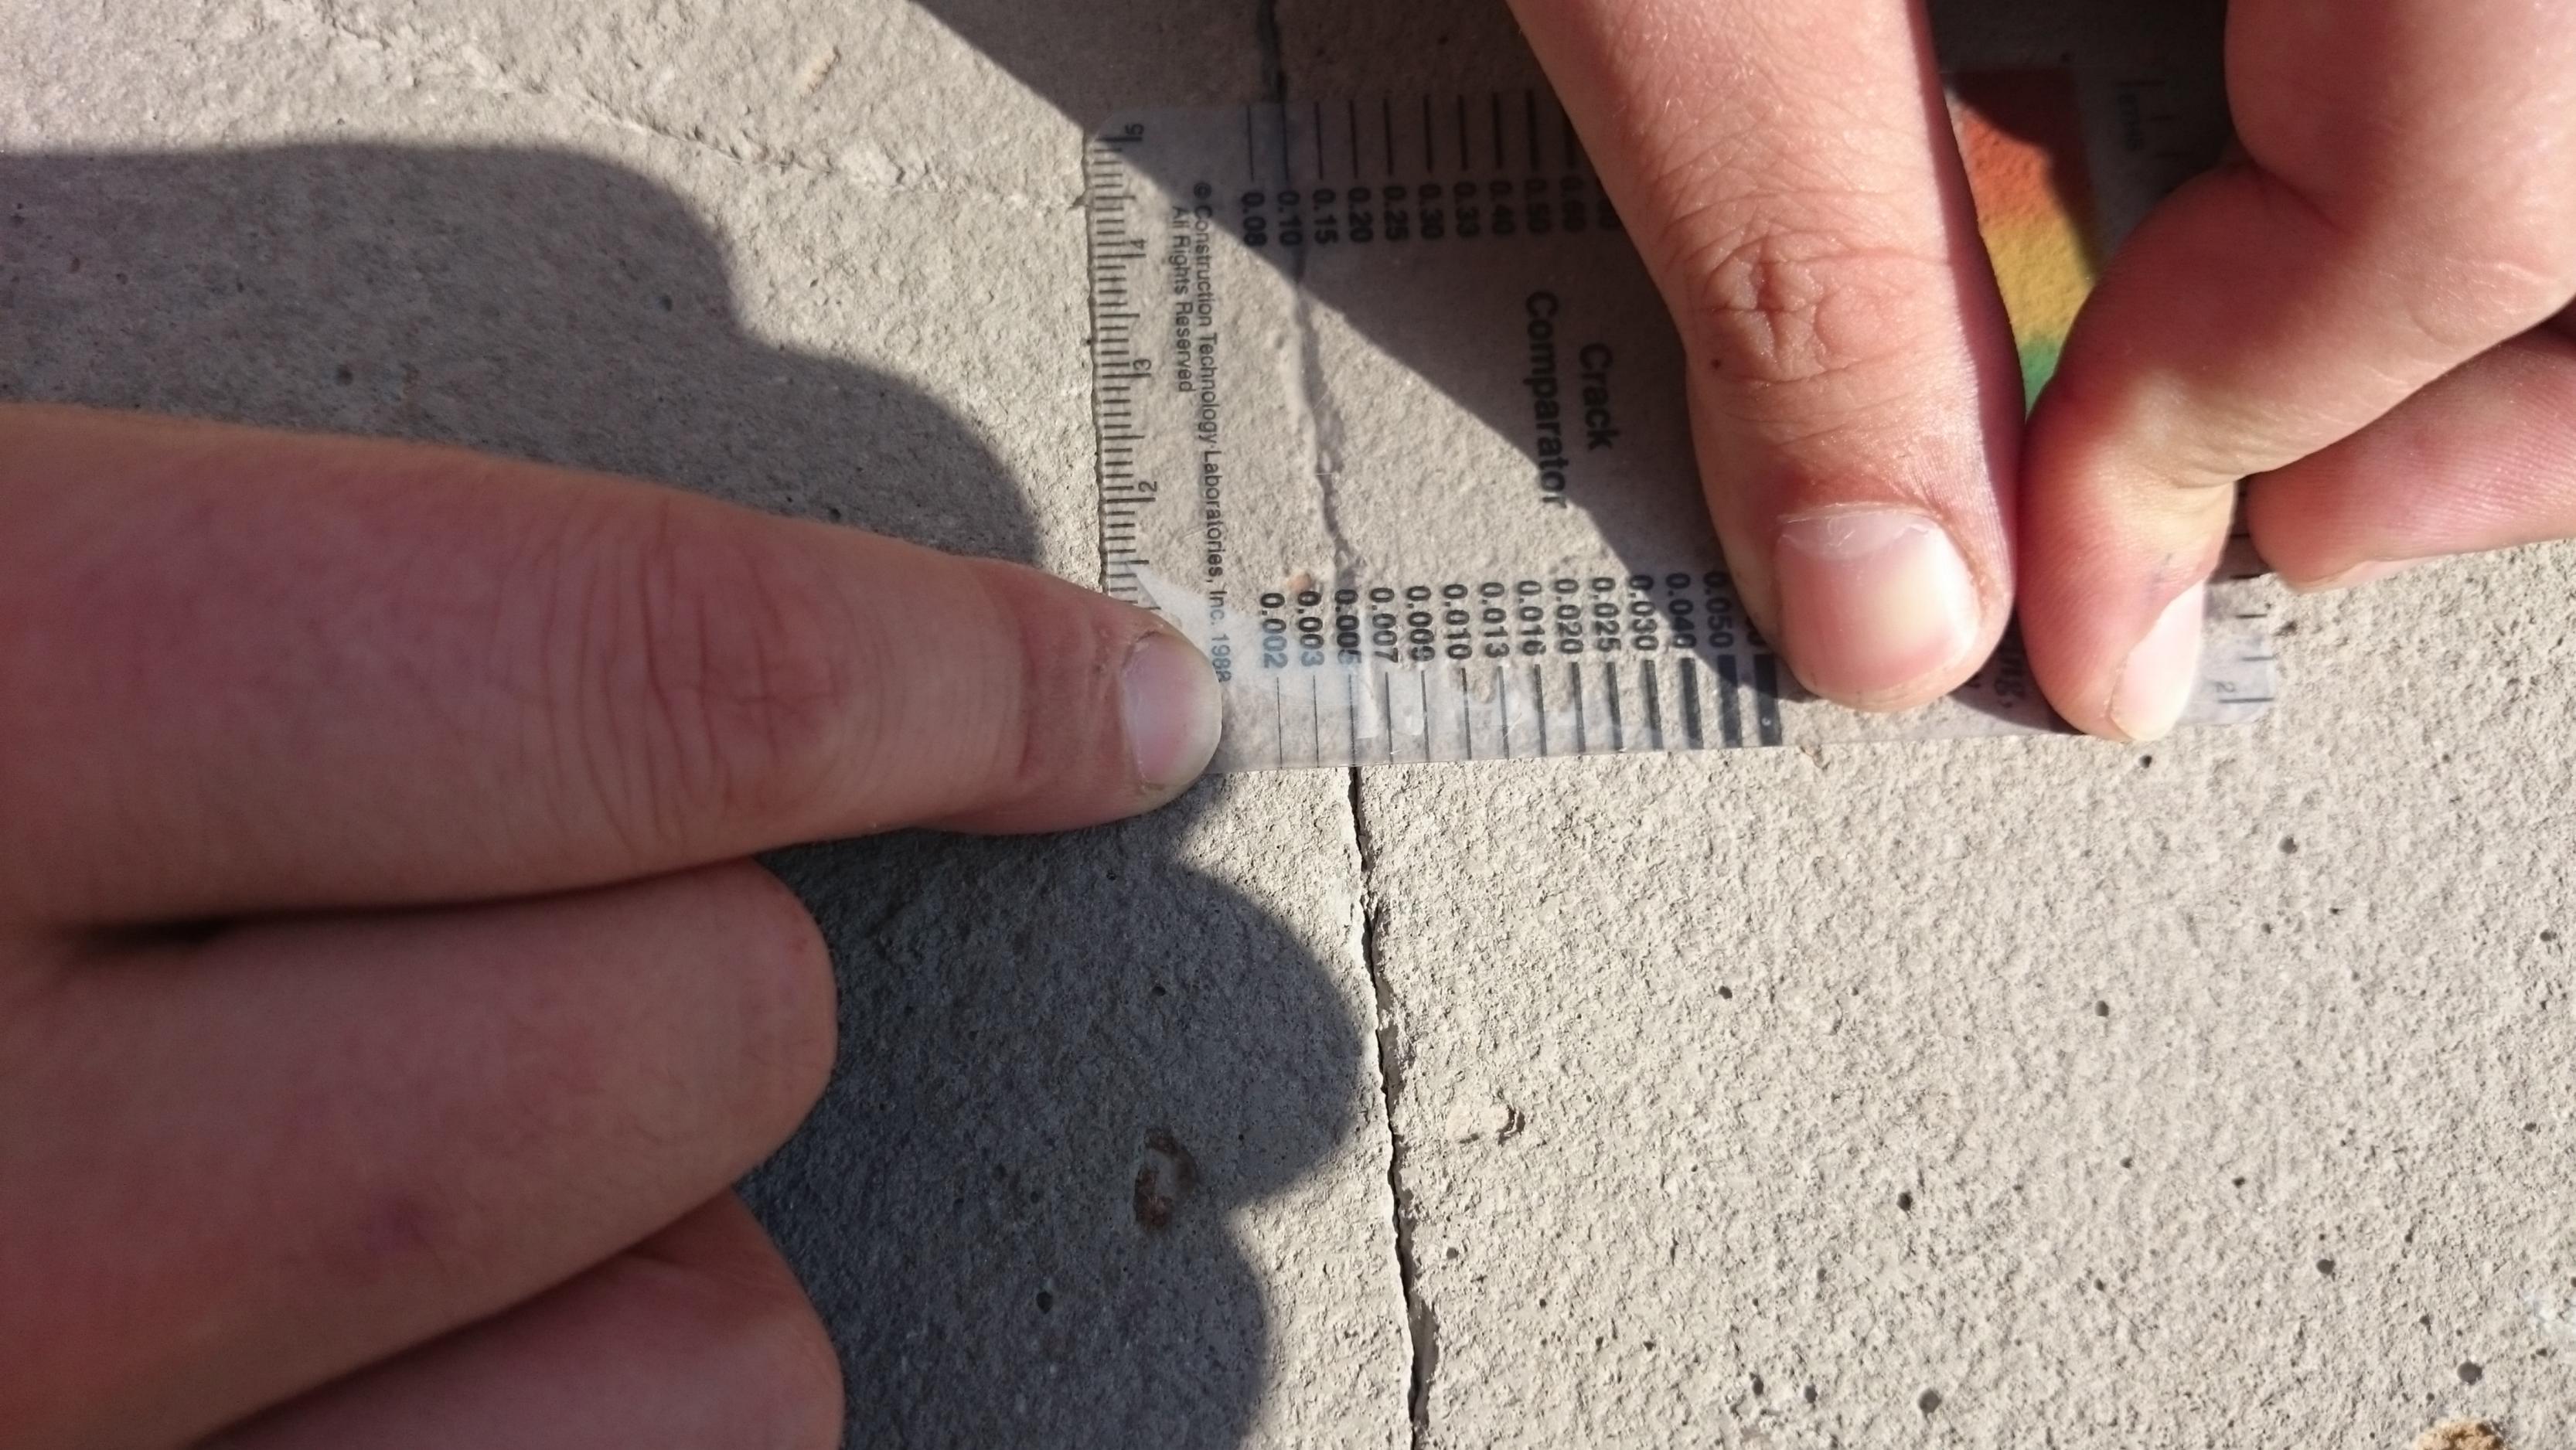
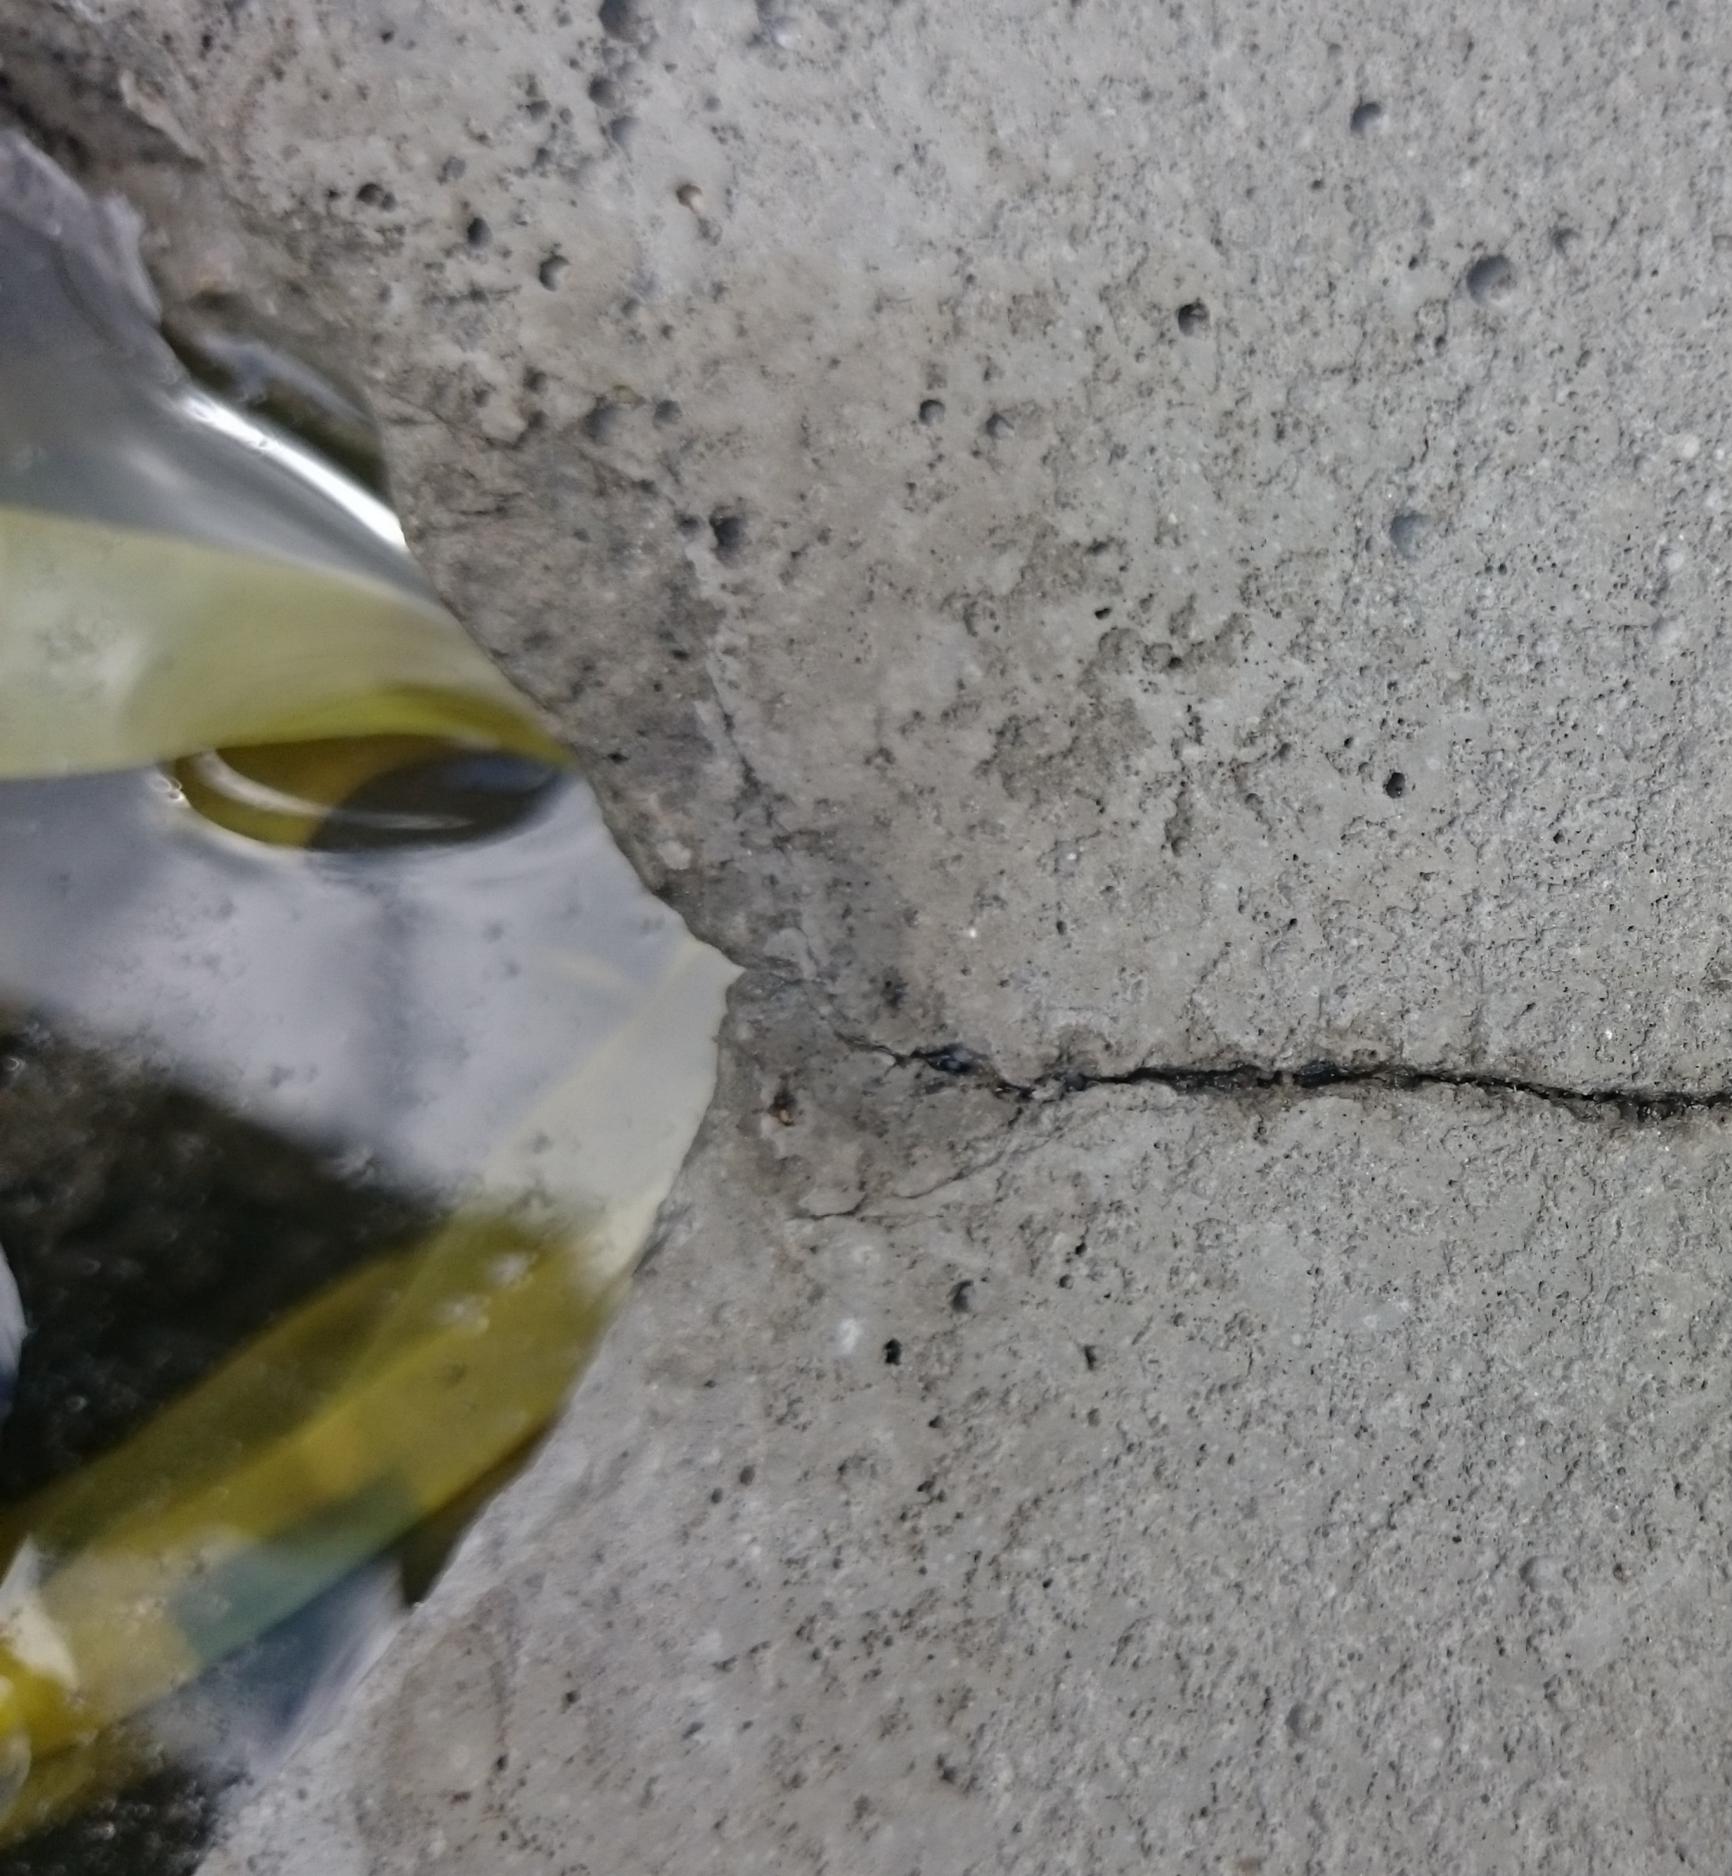
- 11 5. As per JPC Quality System Manual, final inspection of the unit was performed by Mr. Ben Cota and witnessed by the VTAOT QA. Upon completion of top flange sand-blasting operations, shrinkage cracks were better defined and were recorded on the crack map. The maximum width of cracks observed was 0.007" and in accordance with the JPC standard repair for sealing cracks submitted 7/13/15, which is in accordance with VTAOT subsection 510.08(l), the cracks were sealed with MasterProtect H 1000, a 100% penetrating silane sealer. JPC verified compatibility of the application of the MMA sealer over the silane sealer with the proposed MMA manufacturer with Mr. Peter Denicola of Evonik Corporation (732-981-5462).
