STATE OF VERMONT
DEPARTMENT OF PUBLIC SAFETY
VERMONT FORENSIC LABORATORY
P.O. BOX 47
WATERBURY, VERMONT 05676-0047

On July 15, 2013 I received a phone call from DSA Mary Morrisey of the Chittenden County State's Attorney's Office. She requested information regarding a possible problem with the February 2013 Routine Performance Check (RPC) conducted on DataMaster DMT 100132 located the Williston VSP Barracks. Upon receipt of records from the agency I was able to determine that there was a sample acceptance test failure followed by a successful test both completed on 2/19/2013. There was no indication of any malfunction or otherwise erroneous conditions of note on the failing RPC. The only possible cause for the sample acceptance test failure would have had to have been operator error. When the sample acceptance test is complete, the instrument will prompt the operator to choose either passing or failing. The operator most likely inadvertently chose failing causing the failed report.

ROUTINE PERFORMANCE CHECK REPORT

DataMaster DMT: 100132
Location: Williston VSP
Calibration Date: 12/14/2011
Certification Date: 12/14/2011
Installation Date: 05/31/2012
RPC Date: 02/19/2013
Superviso

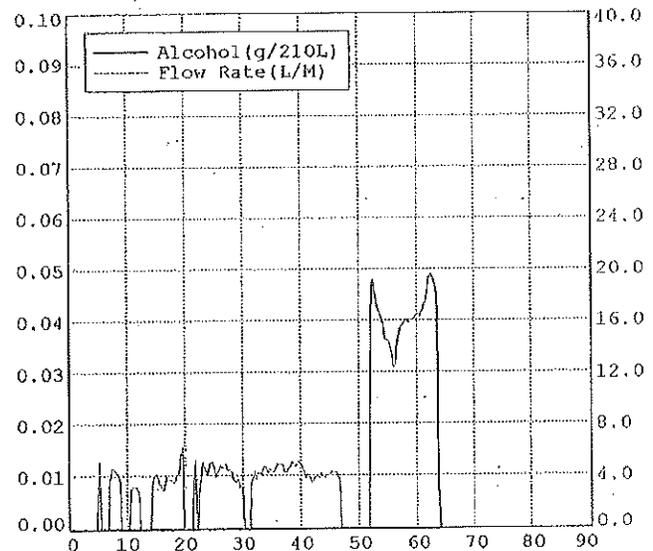
Routine Performance Check Failed

Failed

Todd,
I see nothing on this test which would cause the sample acceptance test failure. When the test was complete, there would have been a box that said "Did the sample acceptance test pass?" Is there a chance that you inadvertently selected NO instead of YES? That is the only possible explanation.

Yes, for some reason while I started to provide samples the machine never ran thru all of the breath testing sequence so it said it failed. So I ran it again and all went well

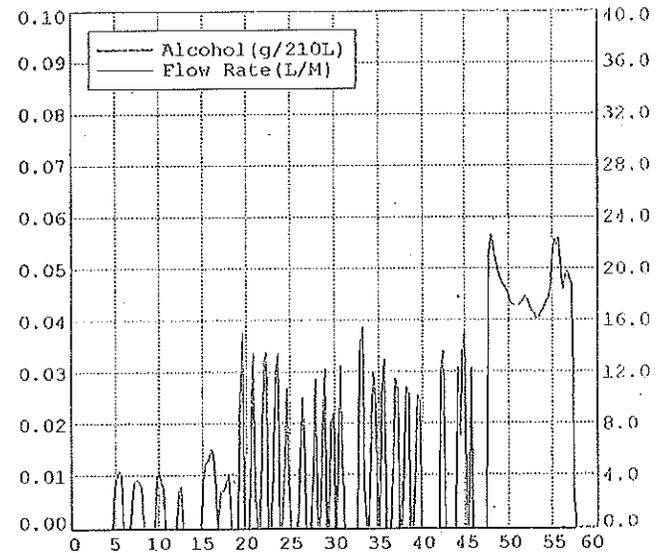
Passed

Routine Performance Check Passed
