# ROUTINE PERFORMANCE CHECK REPORT

DataMaster DMT: 100164  
Location: Rutland City PD  
Calibration Date: 08/31/2011  
Certification Date: 08/31/2011  
Installation Date: 12/01/2011  
RPC Date: 01/18/2015  
Supervisor Name: CHARLES G WHITEHEAD

DMT Serial Number #100164

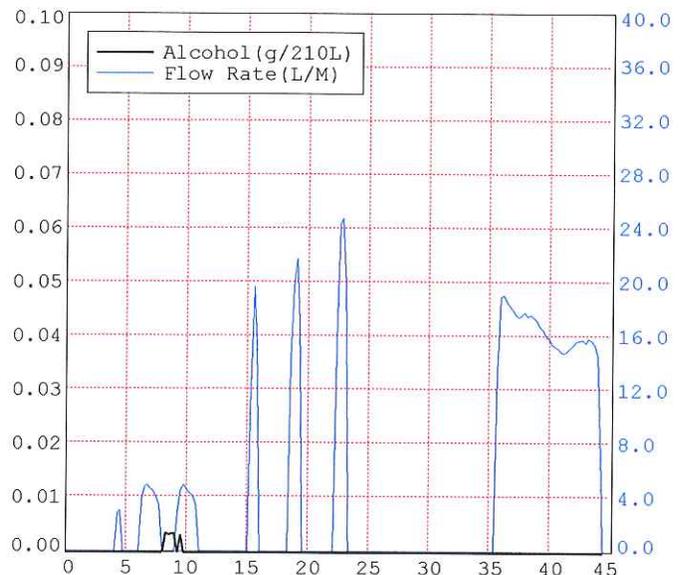
Failed

alcohol detected *RED 1/26/15*

Routine Performance Check Failed

I see that your passing RPC was accompanied by two failed copies. I see that the first one showed an alcohol blip during the sample acceptance and you made a note that alcohol was detected. The second fail showed an RF detection test failure, but no note explaining why? Please let me know what happened on that failed RPC, and in the future just make a note on the failed copy.
