# ROUTINE PERFORMANCE CHECK REPORT

DataMaster DMT: 122206  
 Location: Franklin County SO Enosburgh  
 Calibration Date: 01/09/2012  
 Certification Date: 01/10/2012  
 Installation Date: 01/27/2012  
 RPC Date: 06/23/2014  
 Supervisor Name: JAY H SWEENEY

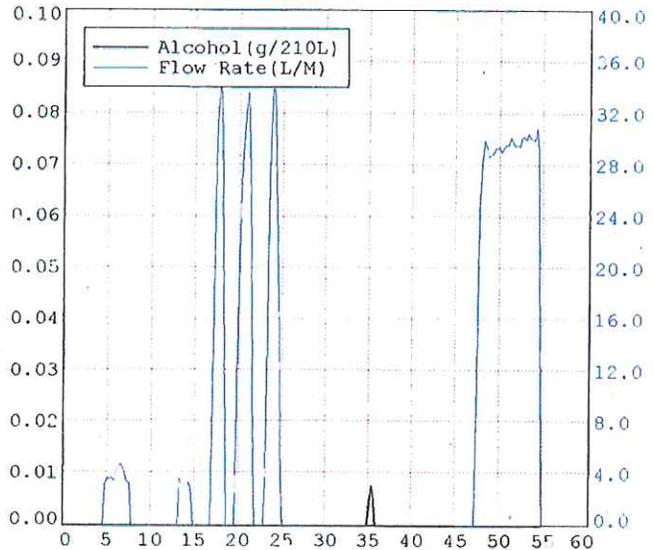
*See attached check-in for passing sample acceptance RED 7/21/14*

The Enosburg blip was caused by me sucking hard and then releasing which caused a little release of air into the unit. It was operator error and not the Machine.
