VERMONT FORENSIC LABORATORY

DATAMASTER TECHNICAL SUPPORT INQUIRY

Agency/Site: <u>Franklin CSO Richford</u>	DataMaster Serial #: <u>300386</u>
Date: <u>6/24/2014</u>	Requestor: <u>Jay Sweeny</u>
Instrument Supervisor: <u>Jay Sweeny</u>	Phone #: <u>(802)524-2121</u>
Taken By: <u>Rob Driscoll</u>	
Problem: <u>Suck back error during June RPC.</u>	
Laboratory Response: <u>DMT technician to troubleshoot on site.</u>	
Work Performed: <u>Tried to gently suck back on breath tube and noticed little resistance. Removed breath tube and found one-way valve not fully closing. Replaced breath tube and completed June RPC.</u>	
<input checked="" type="checkbox"/> On Site <input type="checkbox"/> In-house	Attachments: <u>5</u> pages
Performed By: <u>Rob Driscoll</u> <i>RD</i>	Date: <u>7/2/2014</u>
Final Review: <u><i>[Signature]</i></u>	Date: <u>7/15/2014</u>

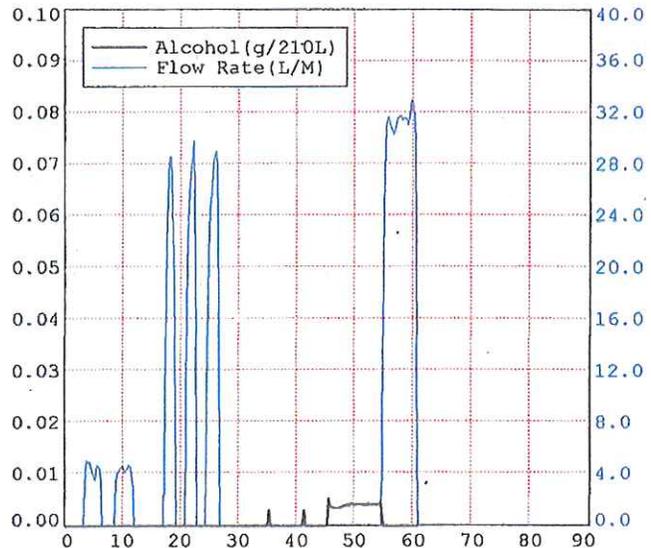
The Richford unit however I could suck back with little resistance. I changed mouthpieces and received the same result. May be a problem with the rubber flap.

Richford had a suck back error. Changed mouthpieces and had same problem. May want to look at it.
