UNITED STATES
NUCLEAR REGULATORY COMMISSION
OFFICE OF NUCLEAR REACTOR REGULATION
WASHINGTON, DC 20555-0001

August 1, 2011

NRC INFORMATION NOTICE 2011-15: STEEL CONTAINMENT DEGRADATION AND ASSOCIATED LICENSE RENEWAL AGING MANAGEMENT ISSUES

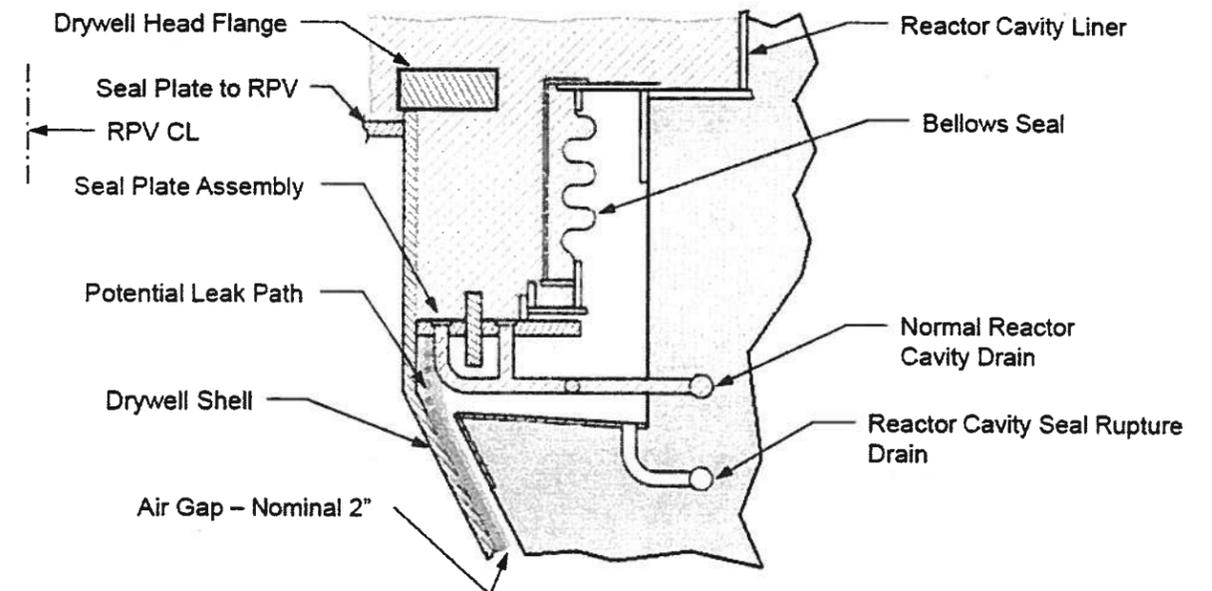
During its review of the Hope Creek Generating Station LRA, the NRC staff noted that during the 2009 refueling outage, the applicant observed in its BWR Mark I containment a small water leak from a drywell shield wall penetration sleeve J13 located in the drywell air gap region. The applicant did not observe any leakage from the drywell lower air gap drains that are located approximately 8-feet below the penetration. In its review, NRC staff identified the possibility that water might be trapped between the concrete and drywell steel below the penetration and that trapped water could lead to thinning of the drywell steel. During the subsequent 2010 refueling outage, the applicant observed leakage from the same penetration, but again no leakage was noted from the air gap drains located below the penetration. The applicant investigated and found that all four drywell air gap drains were blocked (see Enclosure Figures 4–7). The applicant subsequently performed ultrasonic testing (UT) to measure drywell thickness. The

Figure 5 Detail A: Configuration of Hope Creek Reactor Cavity Seal Area During Refueling Operation

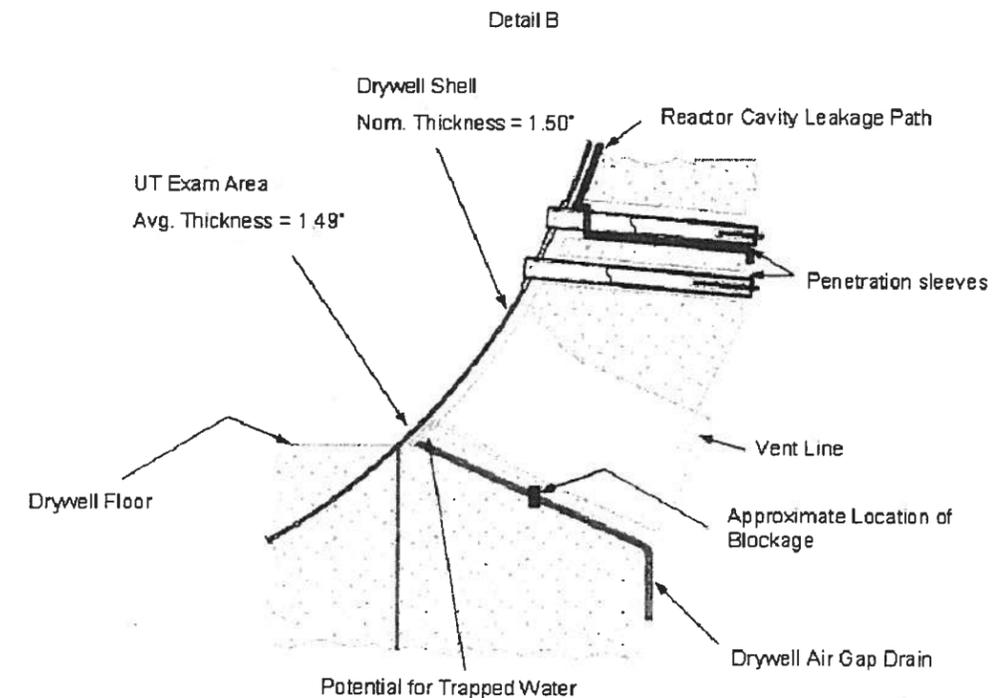
Figure 6 Detail B: Hope Creek Lower Drywell Area

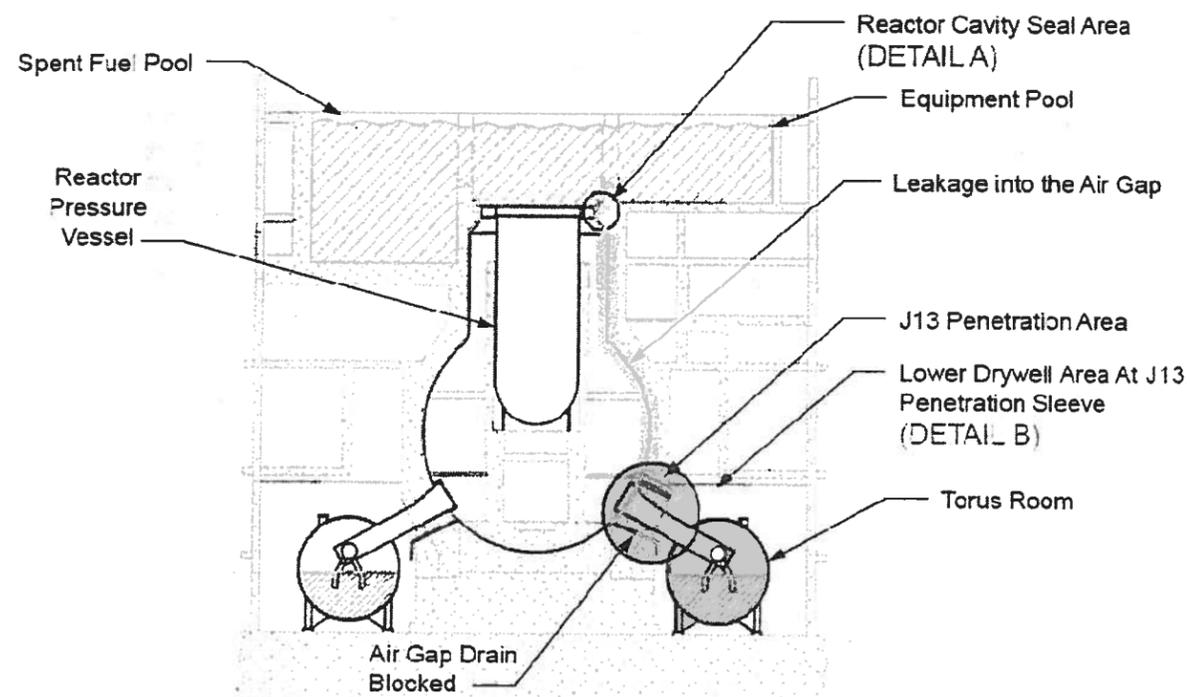
Figure 4 Hope Creek Mark I Containment During Refueling Operation

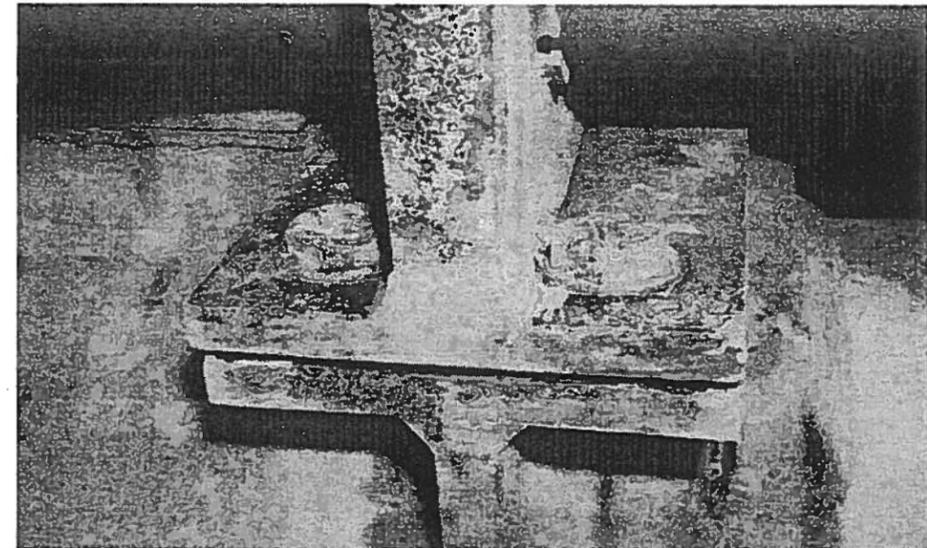
During its review of the Duane Arnold Energy Center license renewal application (LRA), the NRC staff noted that since 1977, when the applicant performed the first inspection of the torus after the initial coating application, the applicant has found numerous instances of localized corrosion and depletion of the coating of the torus shell (see Enclosure Figures 1 and 2) of its boiling-water reactor (BWR) Mark I containment. The applicant performed repairs in 1980 and 1983 prior to a full recoat of the suppression chamber in 1985. Since 1988, the applicant has been repairing degraded coatings and managing and tracking the effects of aging of the torus in accordance with the American Society of Mechanical Engineers (ASME) Boiler and Pressure Vessel Code Section XI, "Rules for Inservice Inspection of Nuclear Power Plant Components," Subsection IWE, "Requirements for Class MC and Metallic Liners of Class CC Components of Light-Water Cooled Power Plants." Since 1995, the torus coating has been repaired at more than 15,000 locations, all below the water line, which is equivalent to approximately 5 percent of the underwater coating surface inside the torus. The torus steel behind the degraded coating has corroded locally at some of these locations. The applicant evaluated this degradation of

Figure 1 Duane Arnold Energy Center—Depletion of Zinc Coating on Torus Shell and Supporting Steel

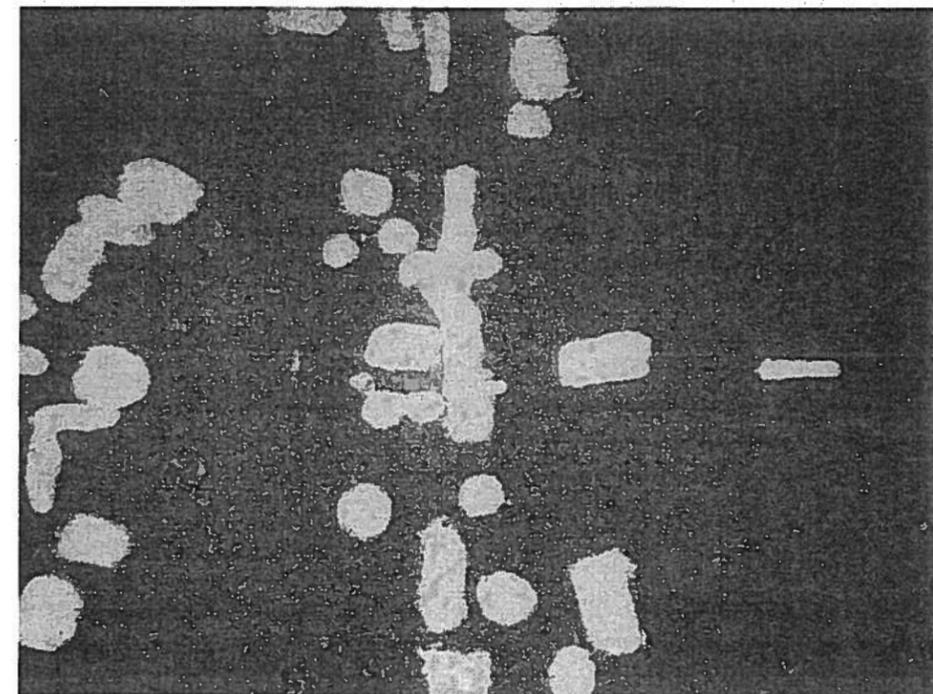
coating of the torus and determined that the degradation has not affected the structural integrity of the torus. In addition, the applicant performed detailed analysis and determined that localized corrosion of the torus shell was acceptable without repair. The NRC staff requested that the applicant address the possibility of localized galvanic corrosion (pitting) due to degraded coatings during the period of extended operation since the normal life of the underwater zinc coating is approximately 15 to 20 years and aging management of the torus steel minimizes the potential for pitting corrosion to extend through-wall. In response to NRC requests for additional information during the license renewal review, the applicant committed to recoating the suppression pool interior surfaces below the water line prior to startup from the first refueling outage during the period of extended operation (applicant letter, dated March 9, 2010, Agencywide Documents Access and Management System (ADAMS) Accession No. ML100700248). The applicant subsequently stated that the current project plan ensures that recoating will extend well above any fluctuations in water level, including the 2-foot wide splash band at the water level (applicant letter, dated April 2, 2010, ADAMS Accession No. ML100960277).

Figure 2 Duane Arnold Energy Center—Torus Coating Repairs
