Vermont Agency of Transportation

Scoping Report for Pittsfield BHF 022-1(24) Bridge #126 VT Route 100

July, 2012

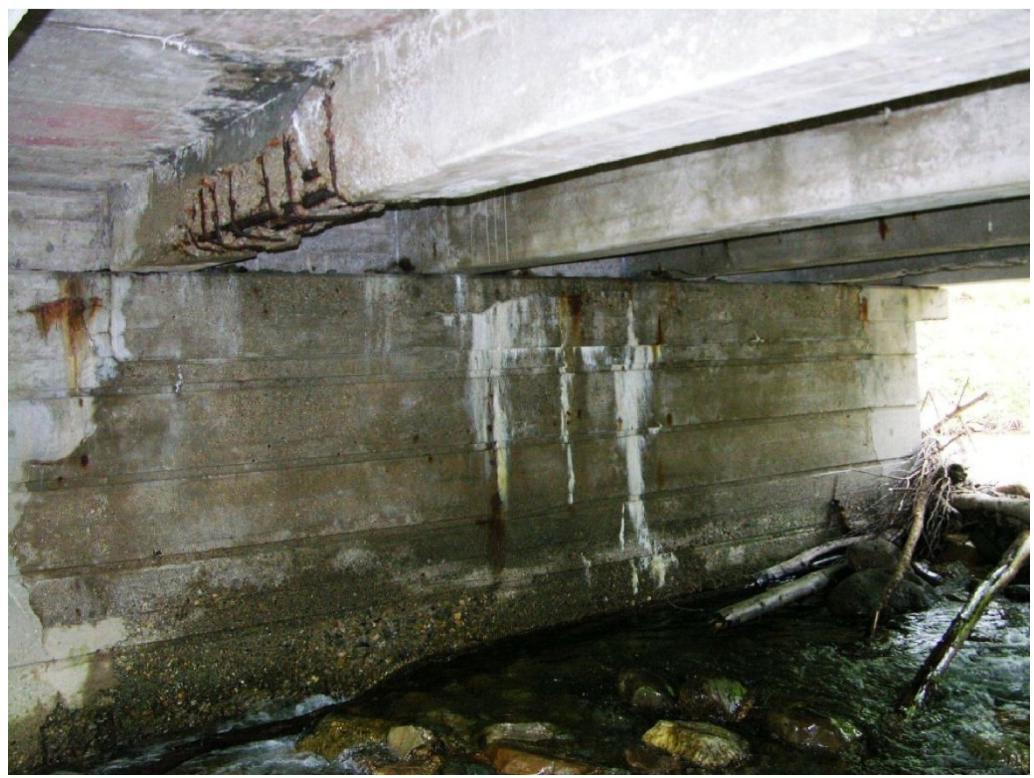
05/23/11 Deck is in poor condition along center bay and potential for full depth failures possible. T-beams have areas of spalling with exposed rebar and in sp 2 t beam 4 the stirrups are rusted off.

Abutment and tee-beam deterioration

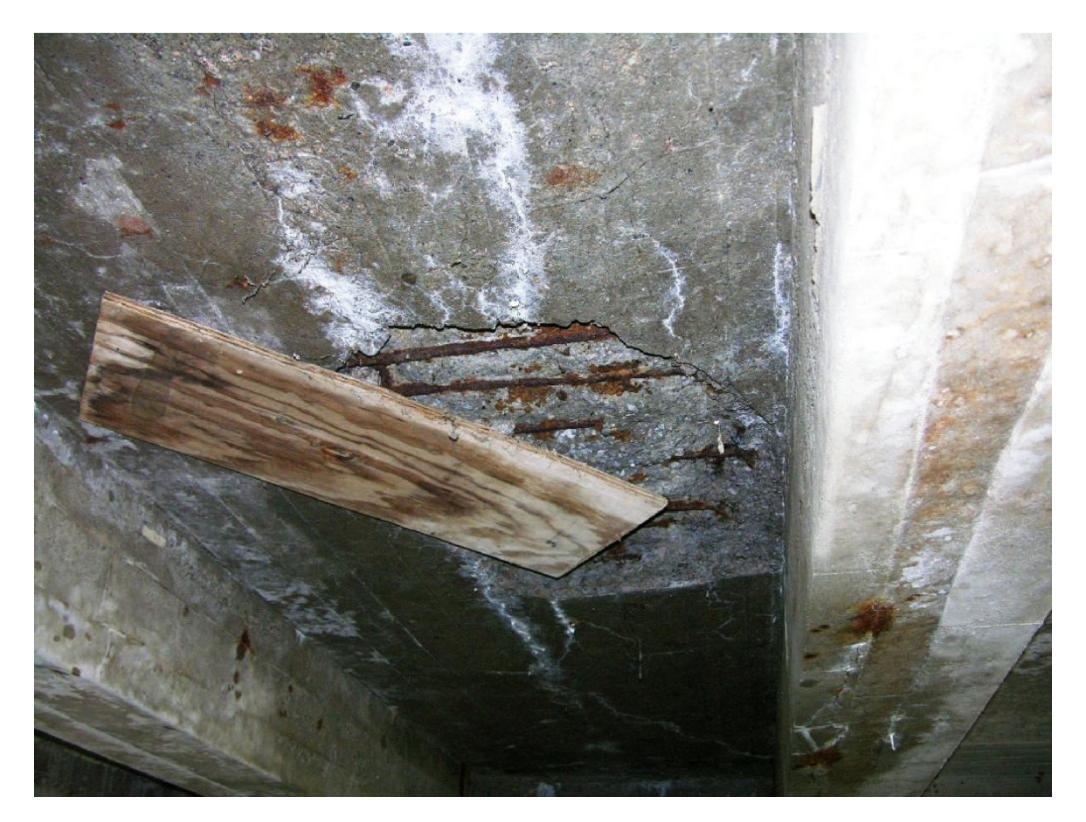
Deck deterioration

5/23/11 Deck is in poor condition along center bay and potential for full depth failures possible. T - beams have areas of spalling with exposed rebar and in sp 2 t beam 4 the stirrups are rusted off.

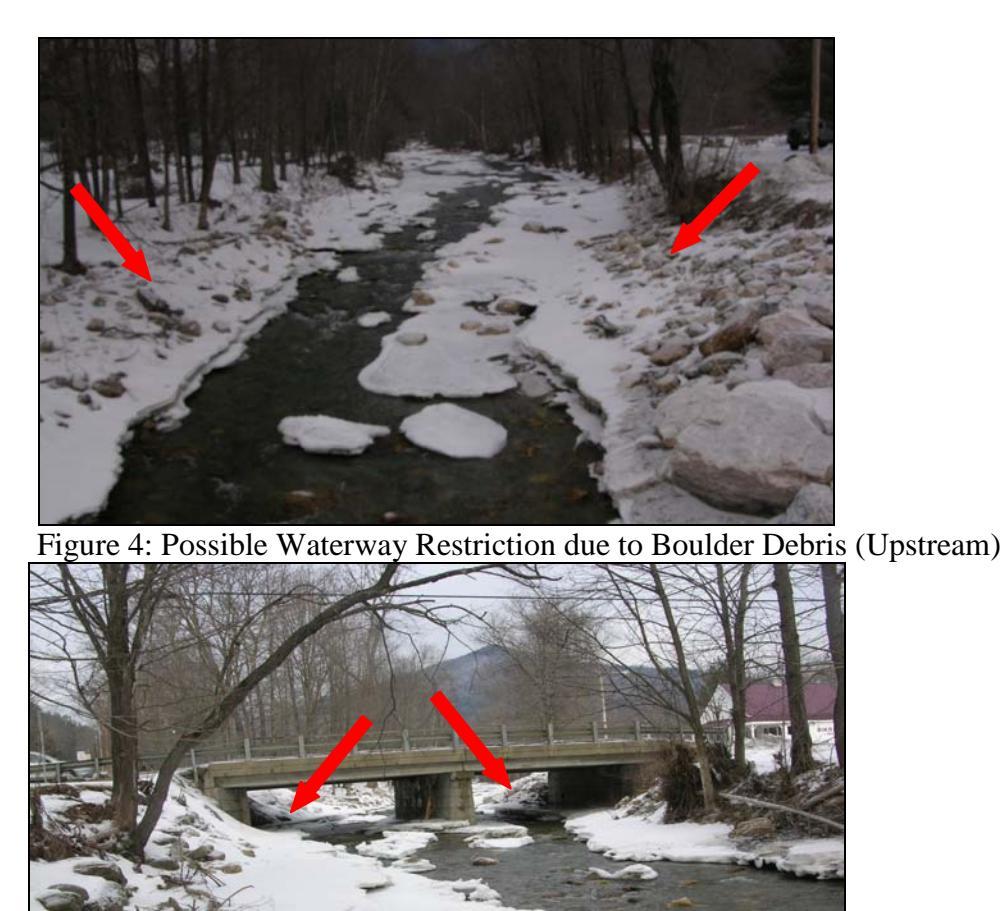
Tropical Storm Irene had a severe impact on this watershed. Adjacent to Bridge 126, a large home and mobile home were displaced from their foundations while boulders and debris were moved downstream clogging waterways. At bridge 126 the remnants of a boulder debris field can be seen in Figure 4; the boulders have been placed on either side of the waterway thereby reducing the pre-flood channel volume. In addition, emergency repairs necessitated the placement of large diameter rip-rap material behind the upstream retaining walls to fill in scour holes; however, the large rip-rap is reducing the effective waterway opening, see Figure 5.

Figure 5: Possible Waterway Restriction due to Large Rip-Rap

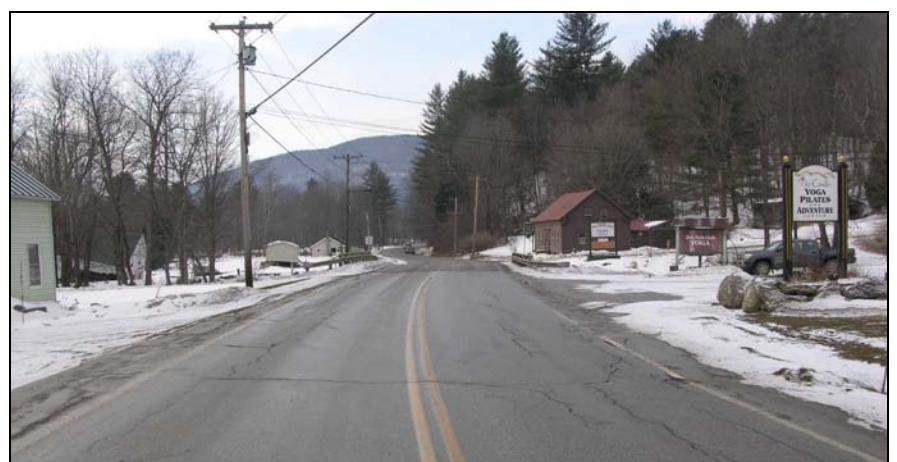
Power lines exist on both sides of VT 100 and cross the stream along the southern edge of Bridge 126. There is a medium size (24" +/-) corrugated metal pipe serving as an outlet for the surface drainage along the northern side of VT 100. There is a drainage inlet just east of the "Yoga Pilates Adventure" sign.

Figure 5: Roadway Profile / Overhead Utility Locations at BR 126

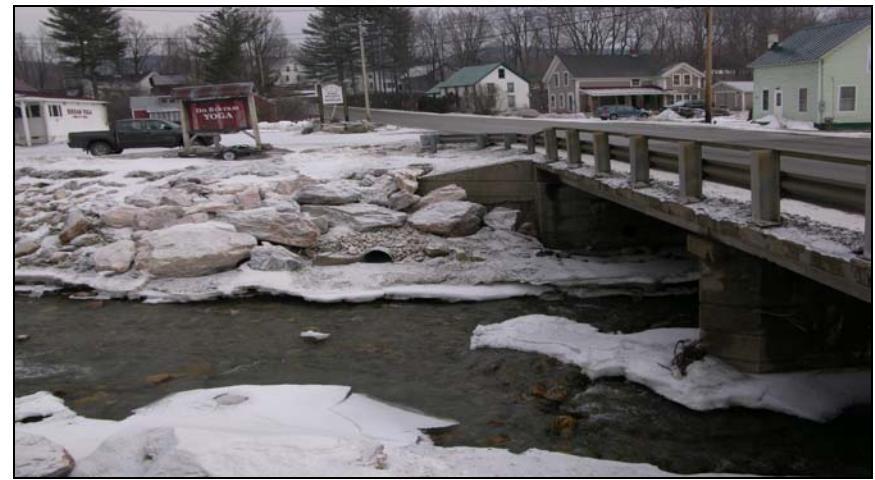
Figure 6: CMP Outlet at Northeast Wingwall **5.0 Construction Considerations**
