Danby BF 0130(4)

Project Update – Scope Re-Evaluation

FAS Route 130 (TH 1/Brook Road) – Bridge 7 over Mill Brook

April 11, 2024

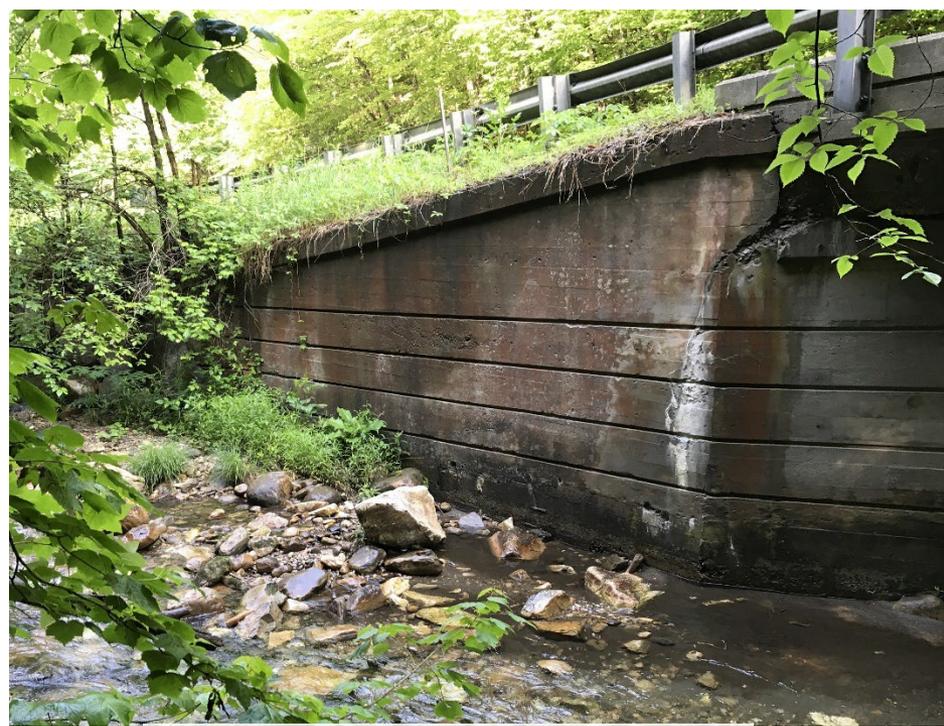
Wingwall 2

Typical Abutment & Wingwall Condition

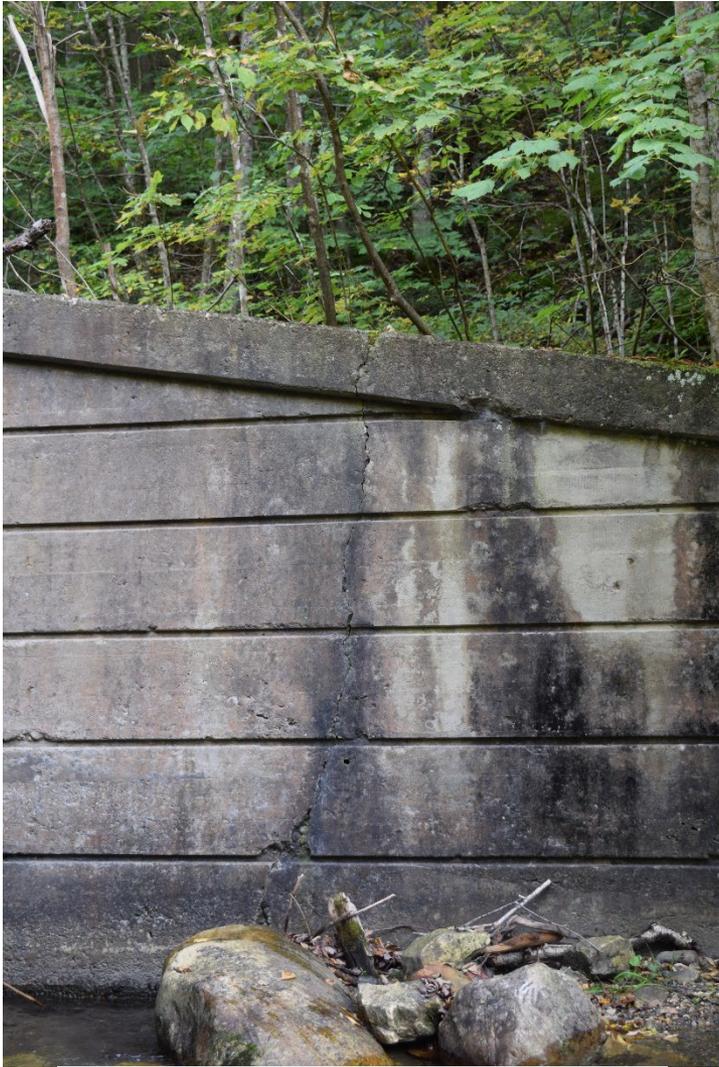
Wingwall 4

Full-Height Vertical Cracking

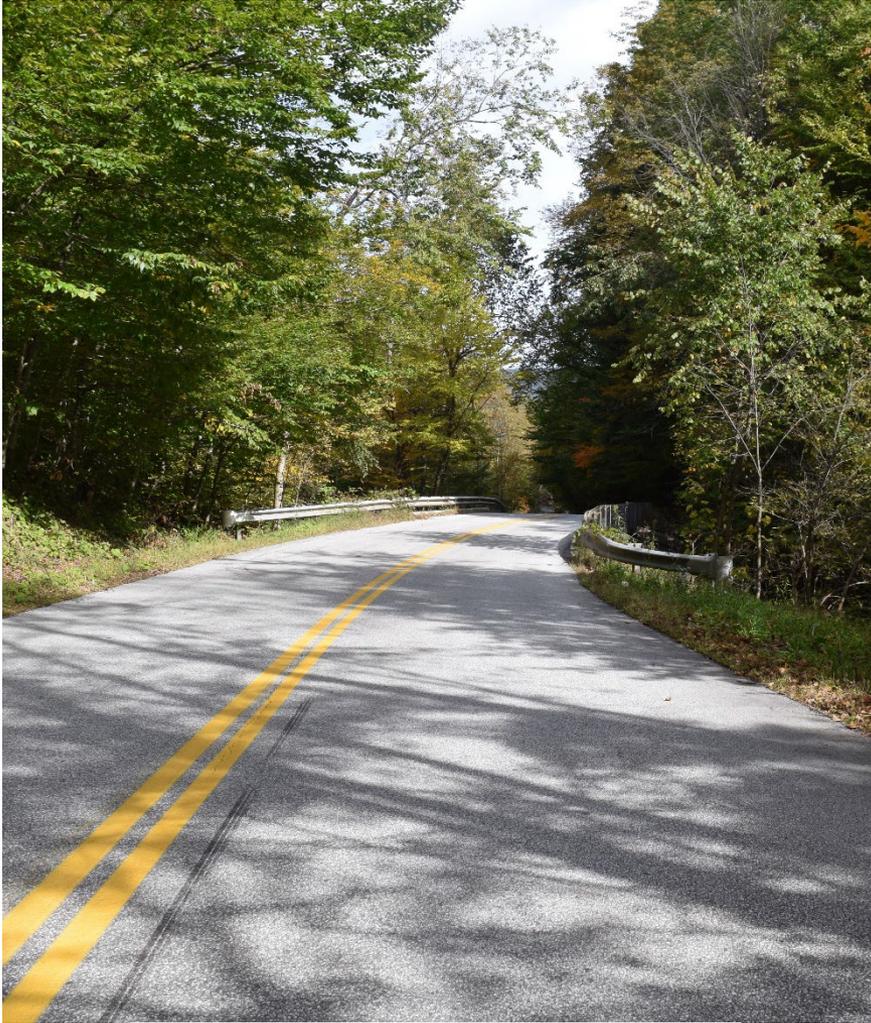
West Approach

Substandard Roadway Geometry
