State of Vermont PDD/Structures Design Section

TO:	Wayne Symonds, P.E., Structures and Hydraulics Program Manager		
FROM:	Jennifer Fitch, P.E., Structures Project Manager		
DATE:	10/19/16		
SUBJECT:	Recommended Alternative: Hinesburg BF 021-1(35)

The intent of this memo is to seek concurrence on the recommended alternative for the above referenced project, Culvert 24, a culvert (cattle pass) located along VT Route 116 in Hinesburg.

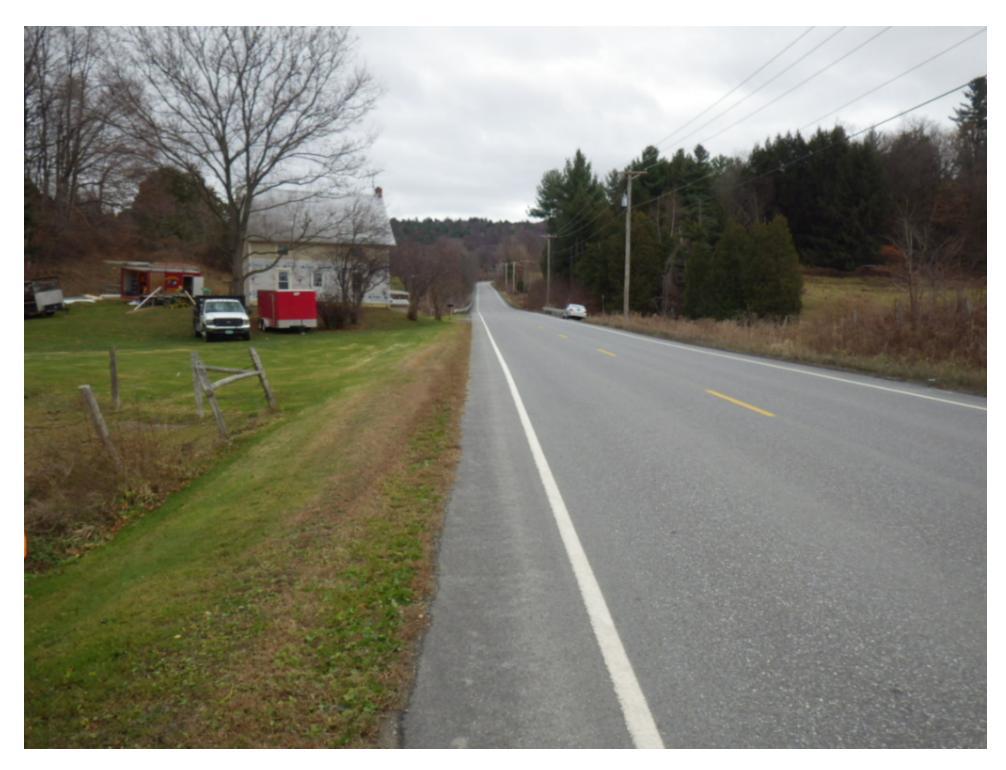
Looking East on VT Route 116 from culvert 24

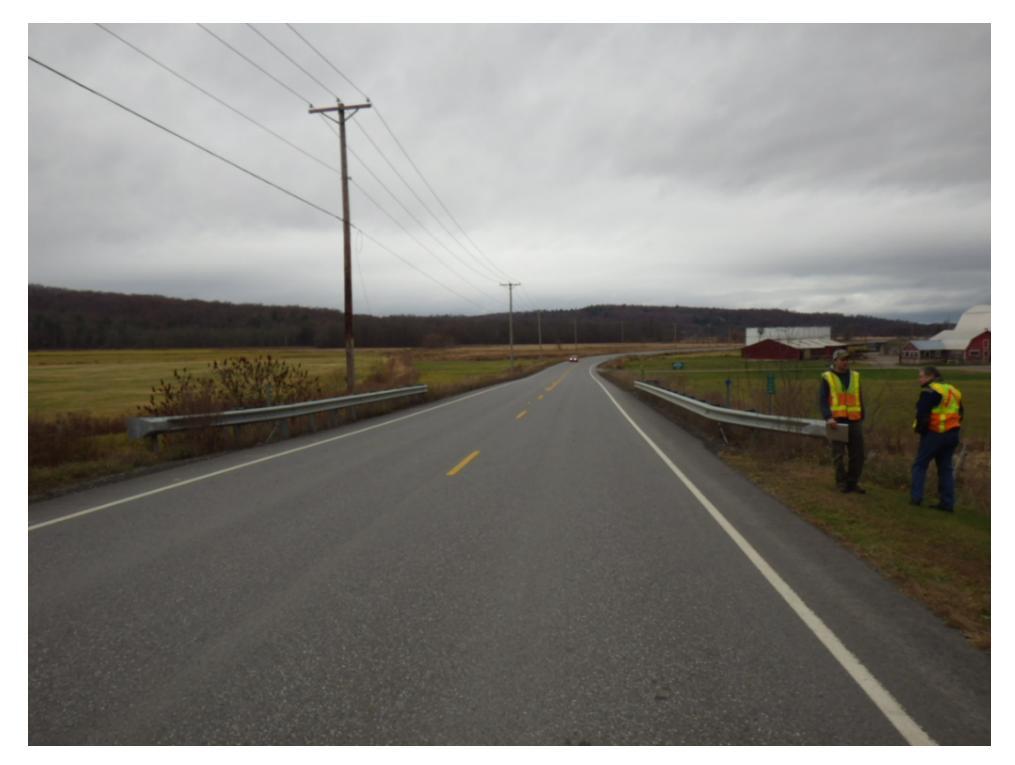
Looking West on VT Route 116 from culvert 24

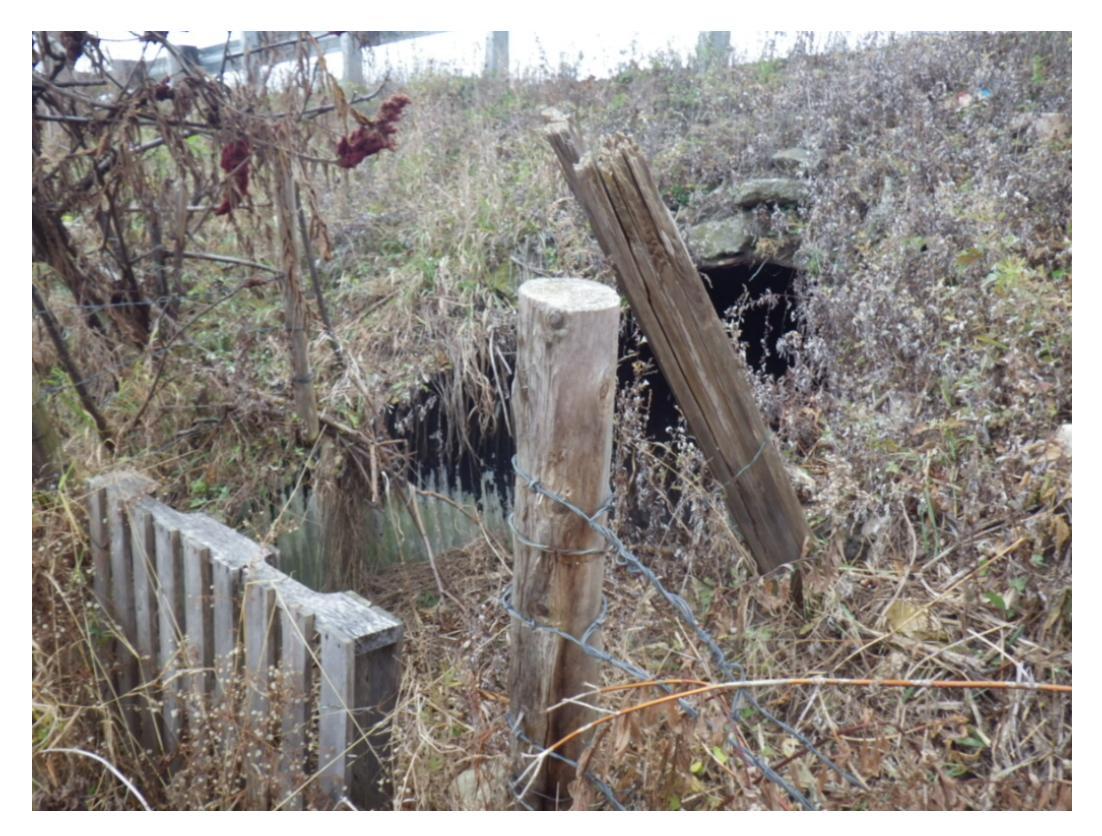
Northern opening of culvert 24

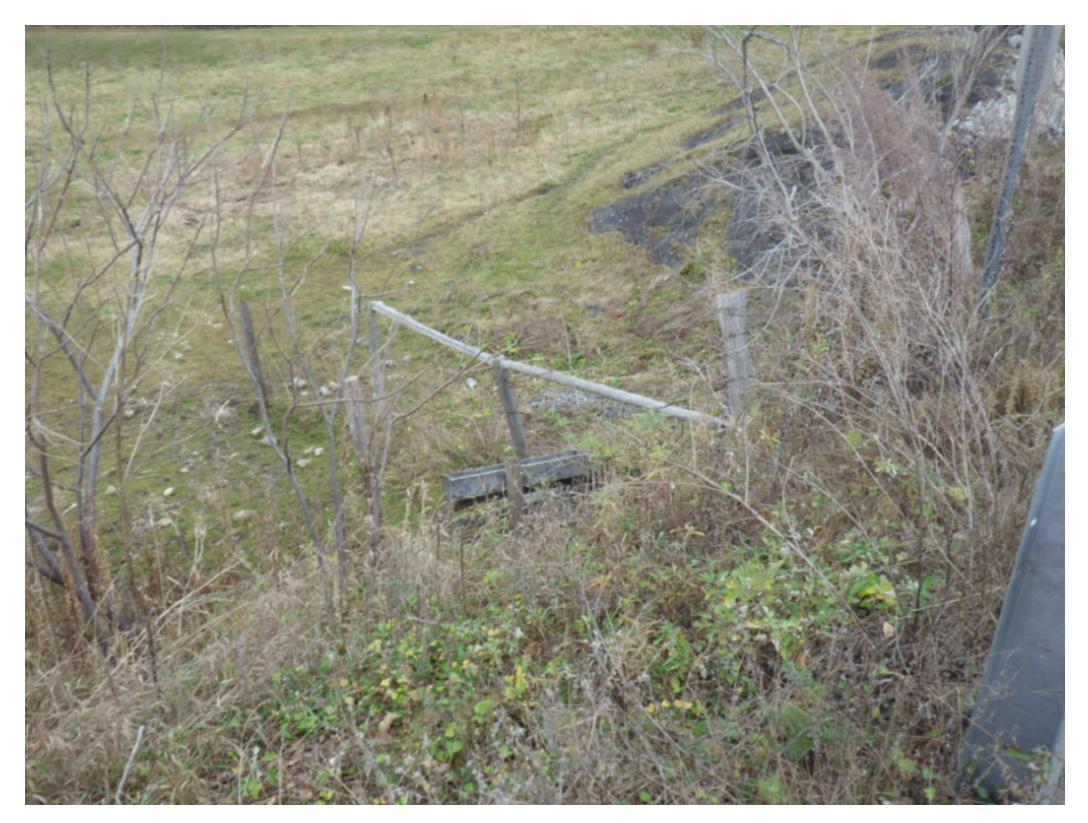
Ledge outcropping near northern opening of culvert 24

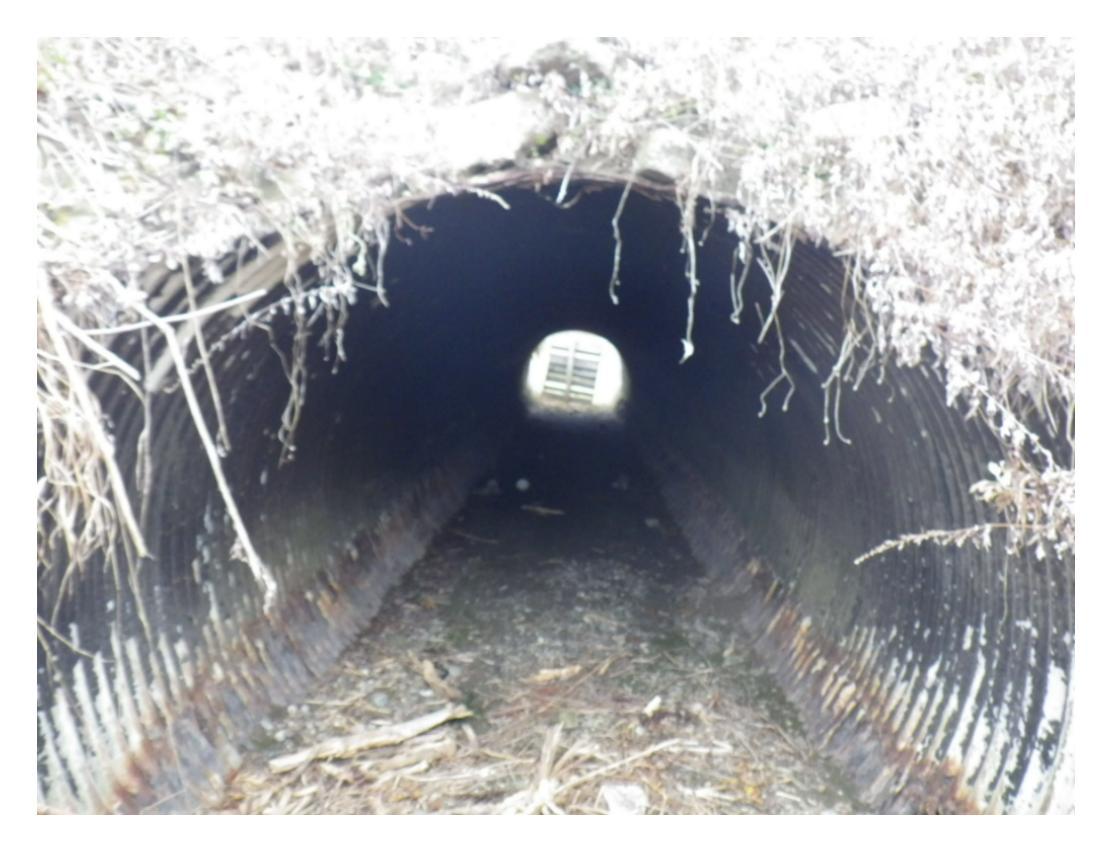
- Culvert 24 has degraded to a 'serious' condition, with random perforations smaller than 2" in diameter throughout the culvert.
- The culvert is beginning to lose structural integrity (to crush).

Looking through culvert 24.

Alternative 5 is recommended, filling the existing culvert with concrete grout and constructing side slopes while traffic is maintained along VT Route 116. It is important to note that this alternative is contingent on a "Quit Claim Deed" from the property current owners. Otherwise, the existing culvert will need to be replaced with another structure to facilitate cattle passage.
