Springfield BM19201
Regional Concerns Meeting
VT Route 106 – Bridge 4 over unnamed brook

March 13, 2023

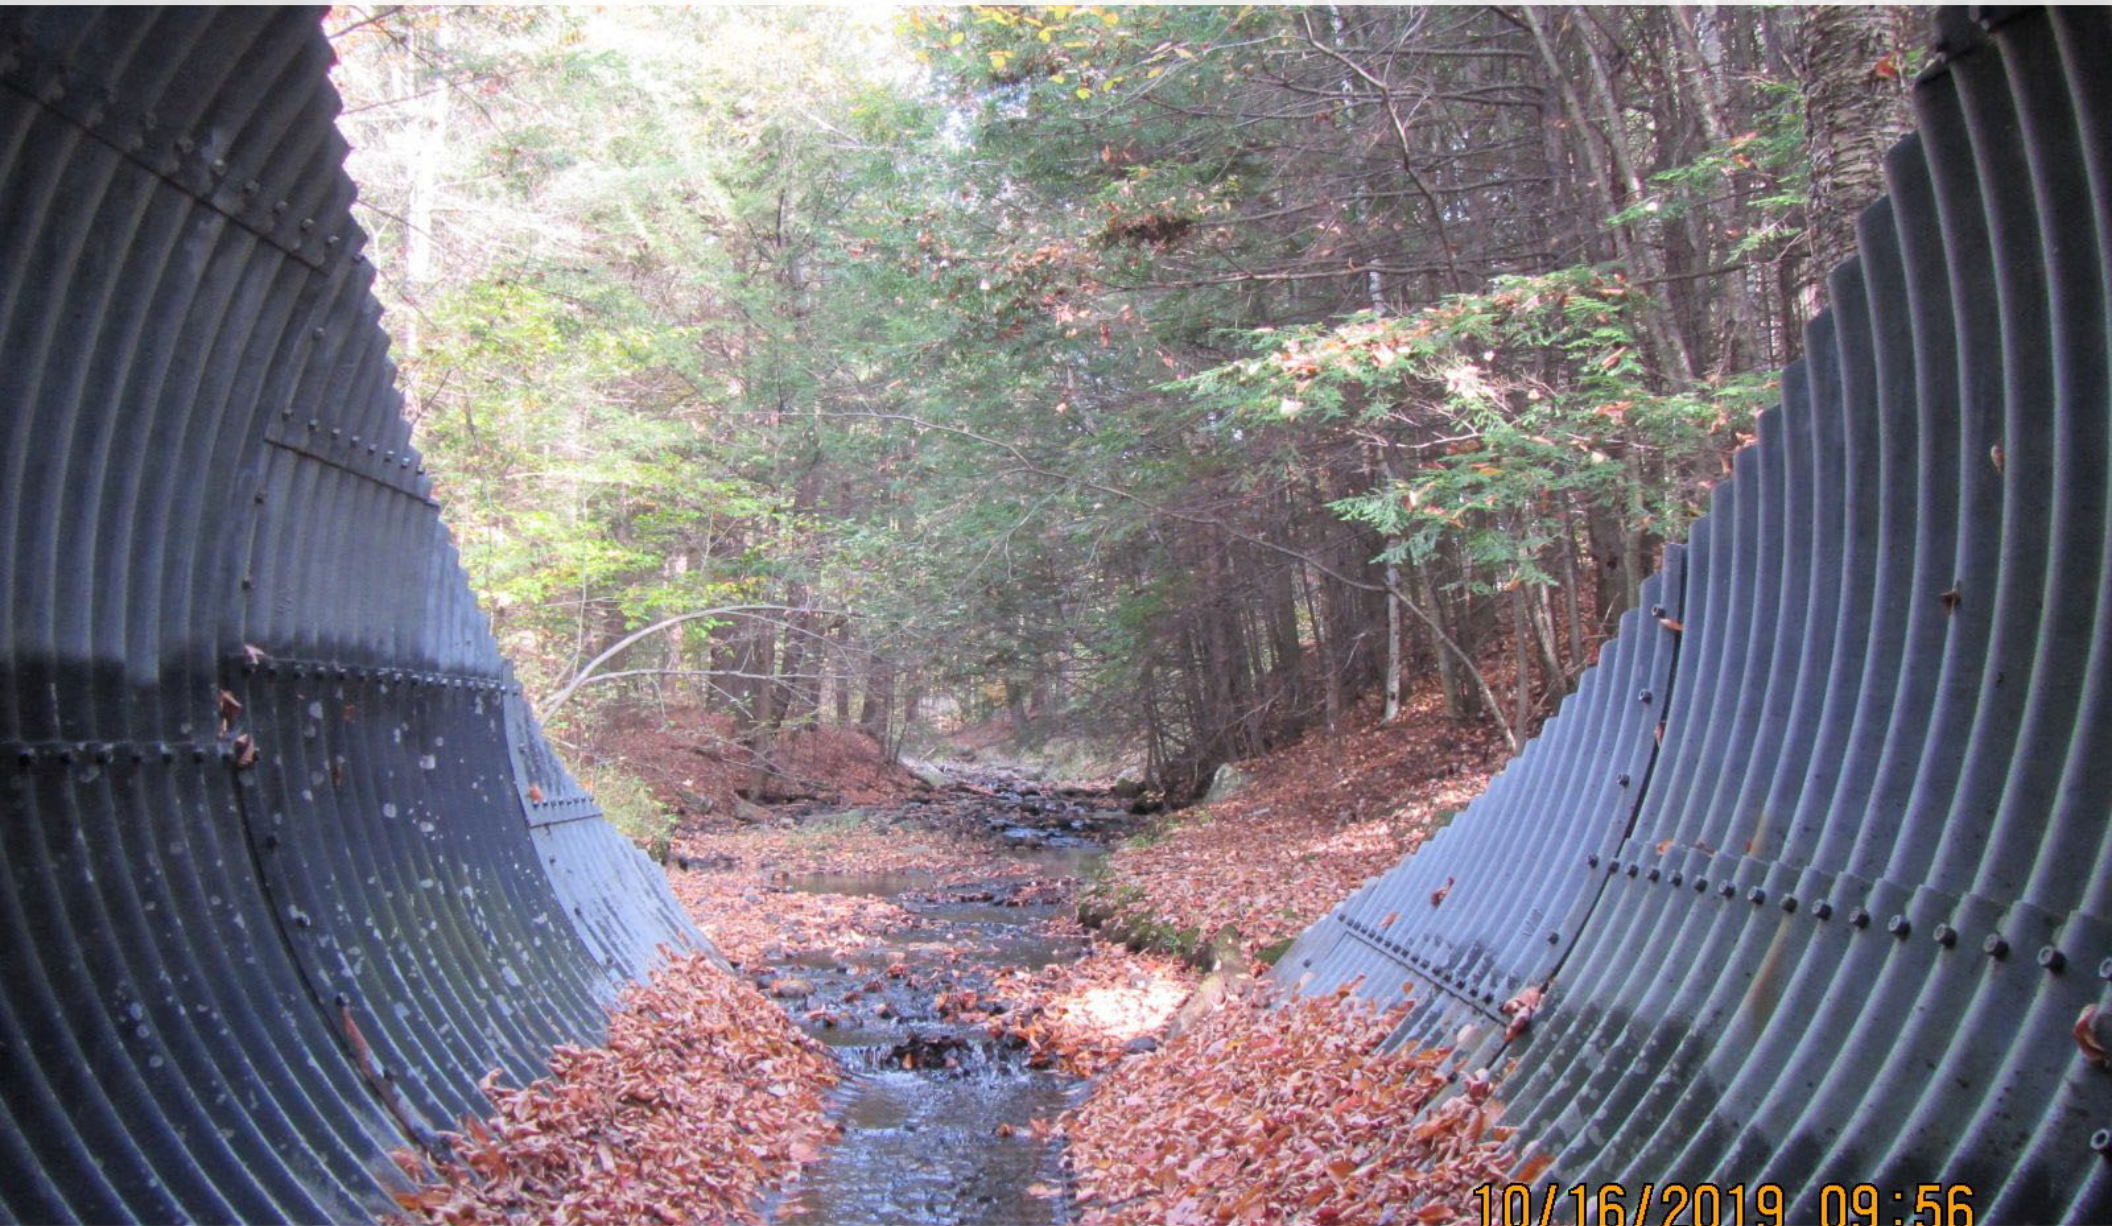
Looking North (Upstream)

- Culvert Rating 4 (Poor)
- Channel Rating 6 (Satisfactory)

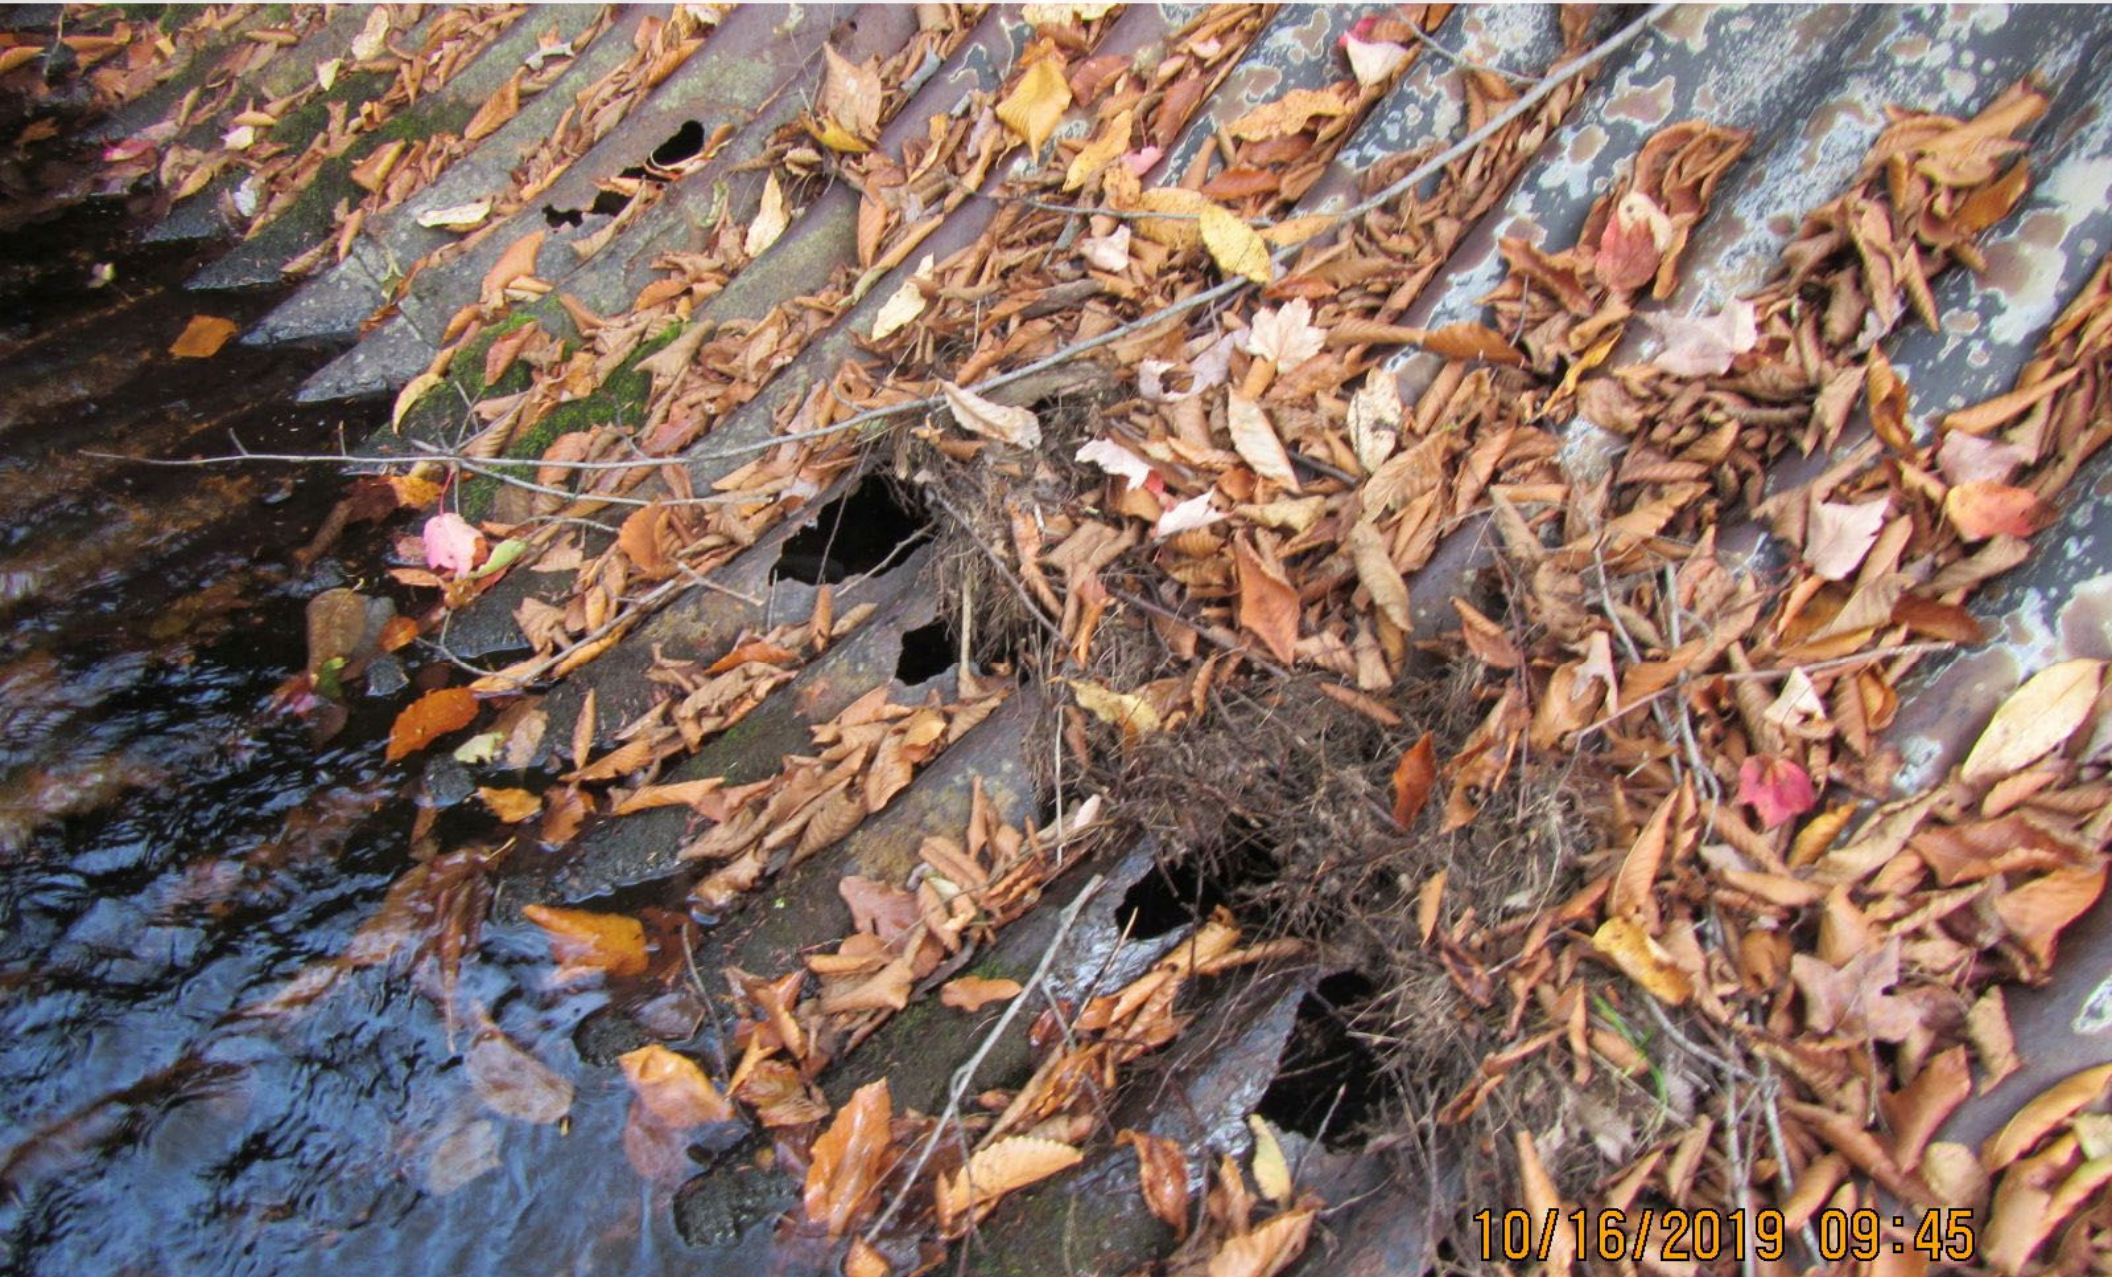
Large Perforations

- Replace the existing culvert with a new 3-sided buried frame
 - 21' span with natural bottom for AOP and to meet minimum BFW
 - 12'/8' typical to match existing
 - 11'/4' is standard typical section
 - 75-year design life

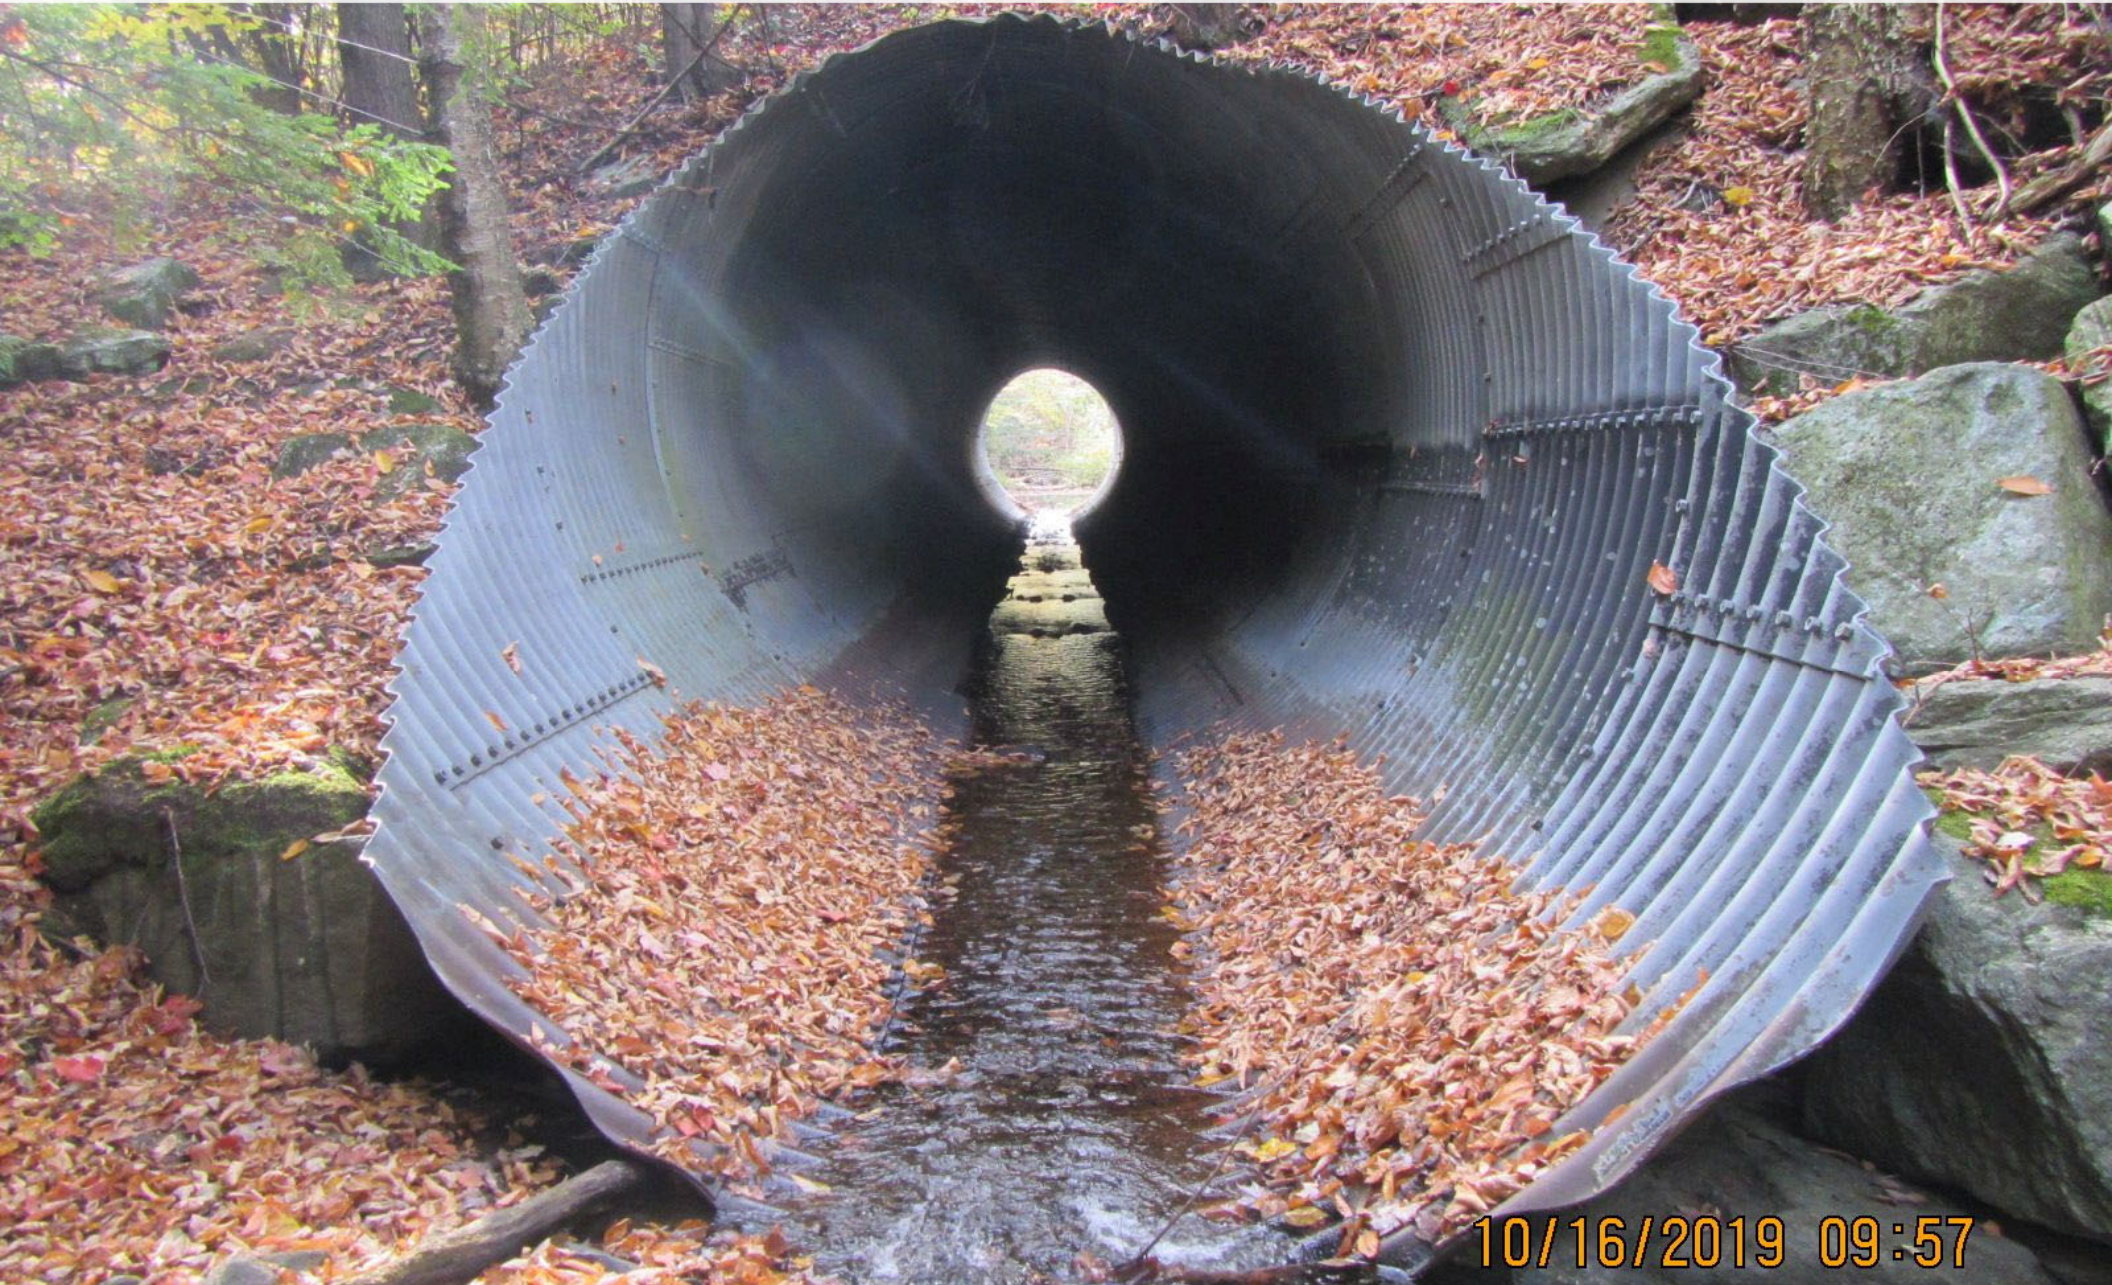
Inlet Undermining

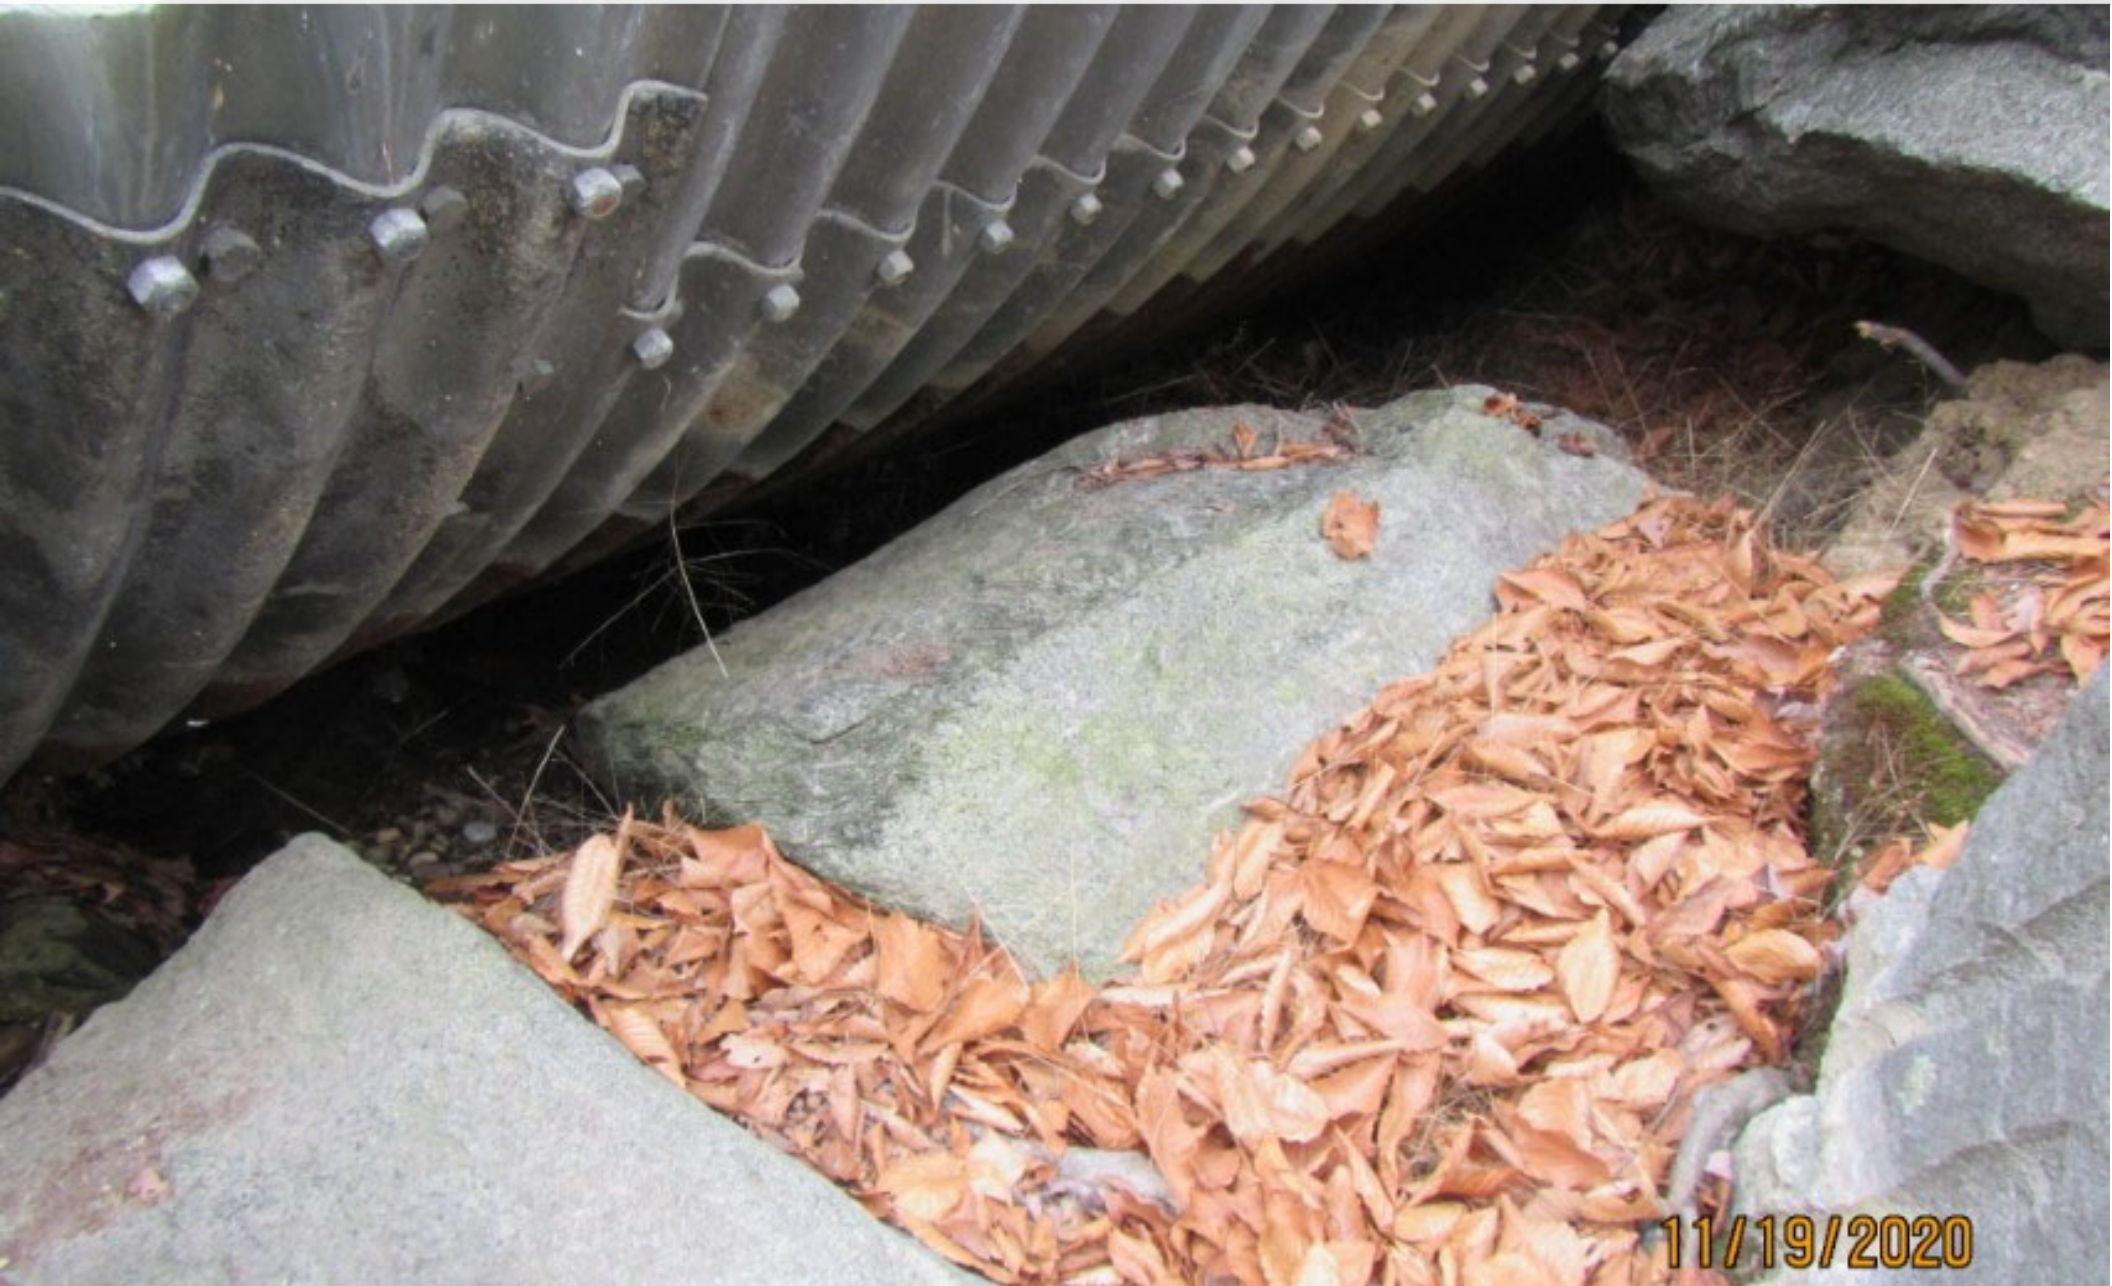
- The culvert is in poor condition. The structure has heavy rust scale with deep pitting, moderate to heavy section loss, and scattered varying sized perforations along the rust/water line. The outlet end has perforations with visible piping occurring and measurable undermining of 8 to 9-inches. There are large perforations with much of the lower corrugation gone along the invert.
- The existing 13.5-foot clear span does not meet the state stream equilibrium standard of 21 feet for bank full width

Outlet Undermining

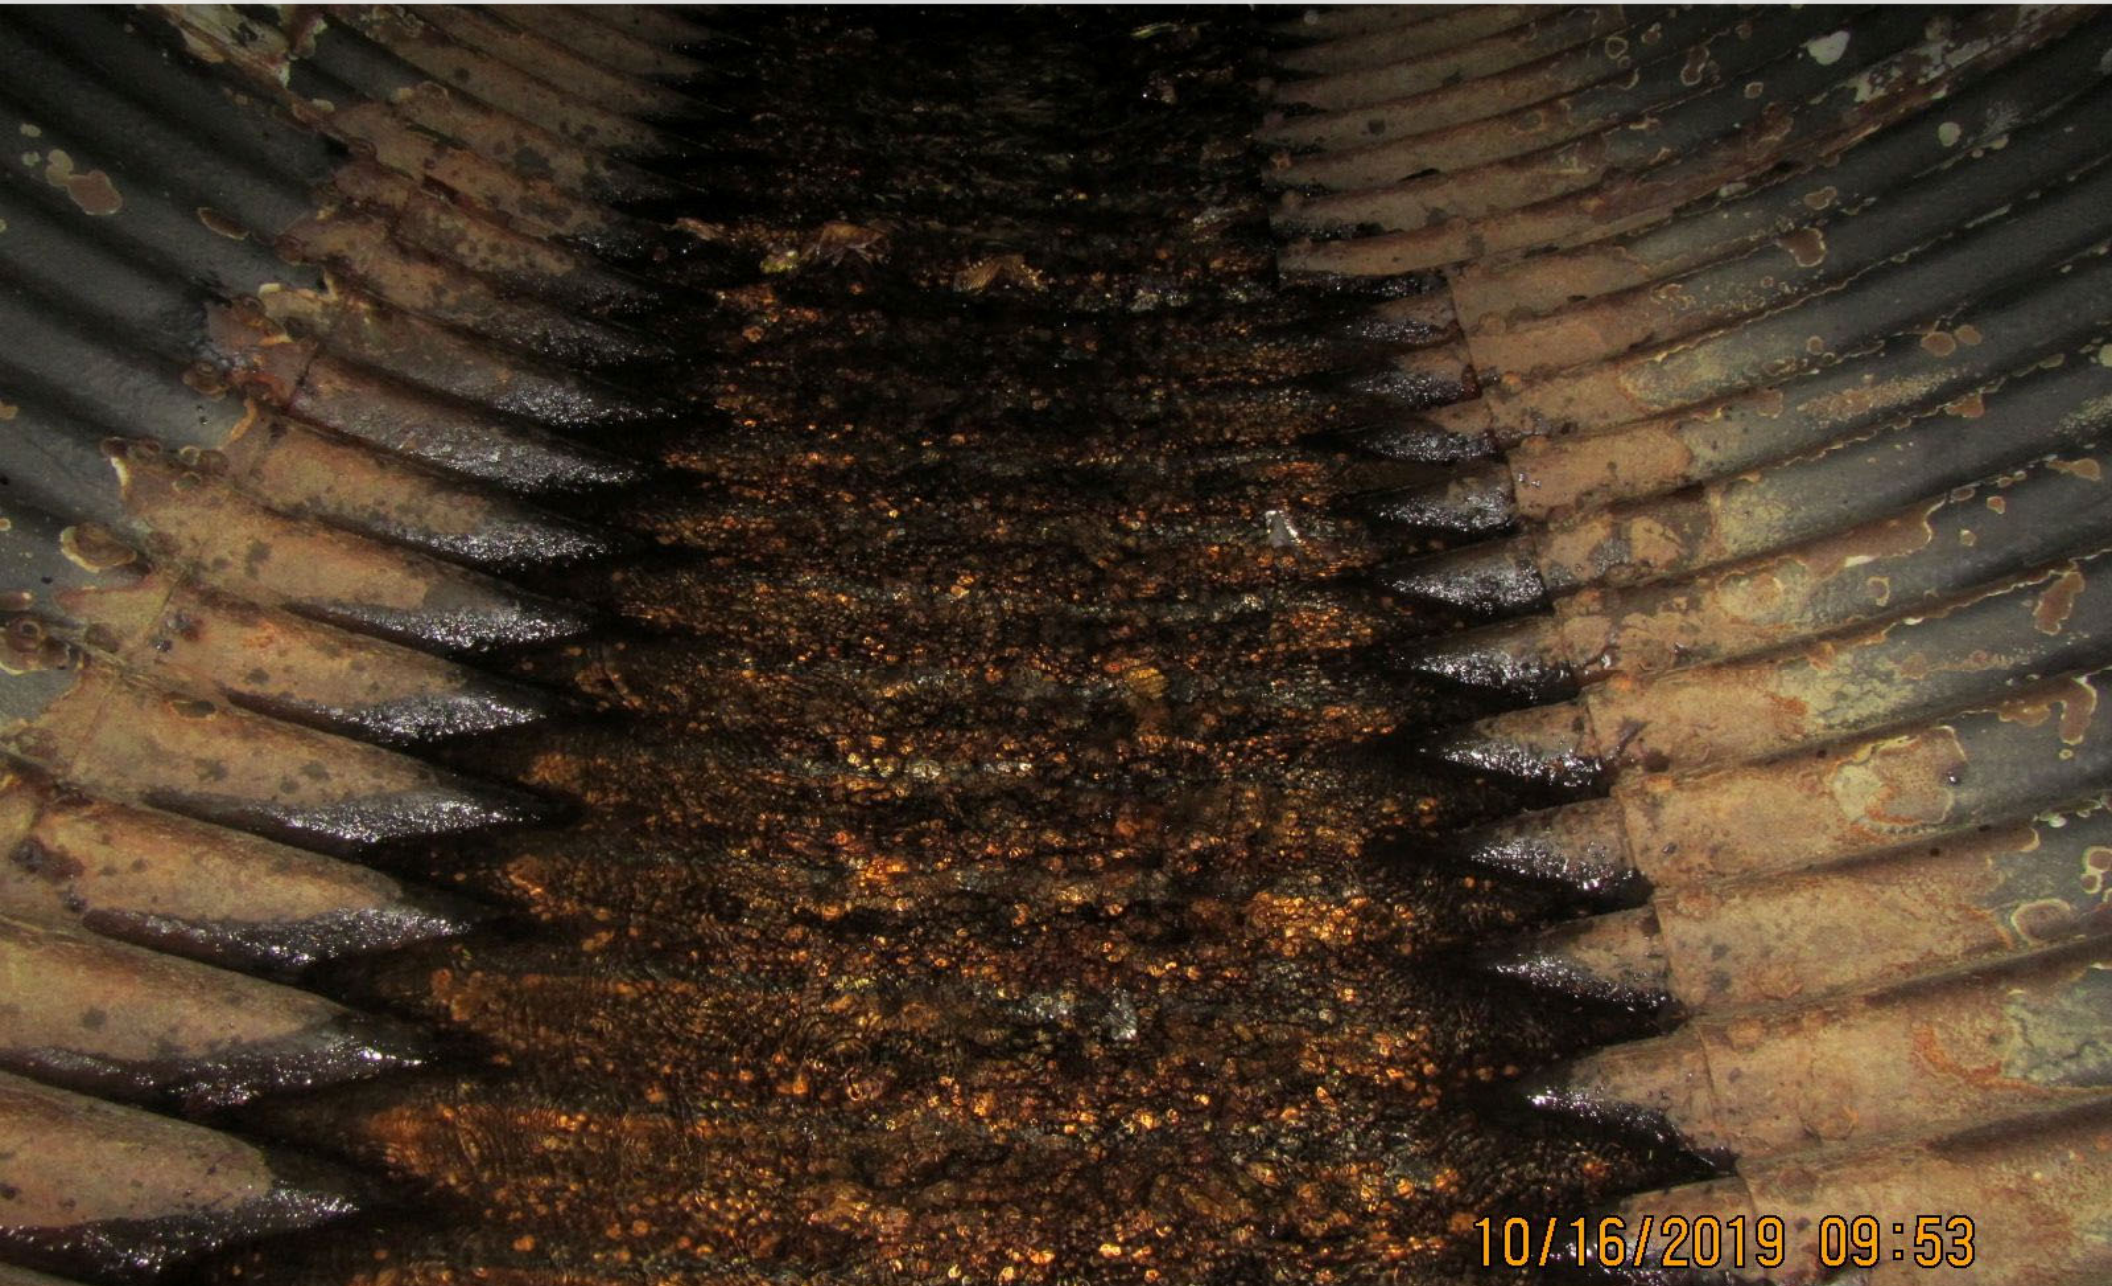
Excessive Rust
