Lowell STP CULV(65)
Regional Concerns Meeting
VT Route 100 – Bridge #237 over Unnamed Brook

October 27, 2020

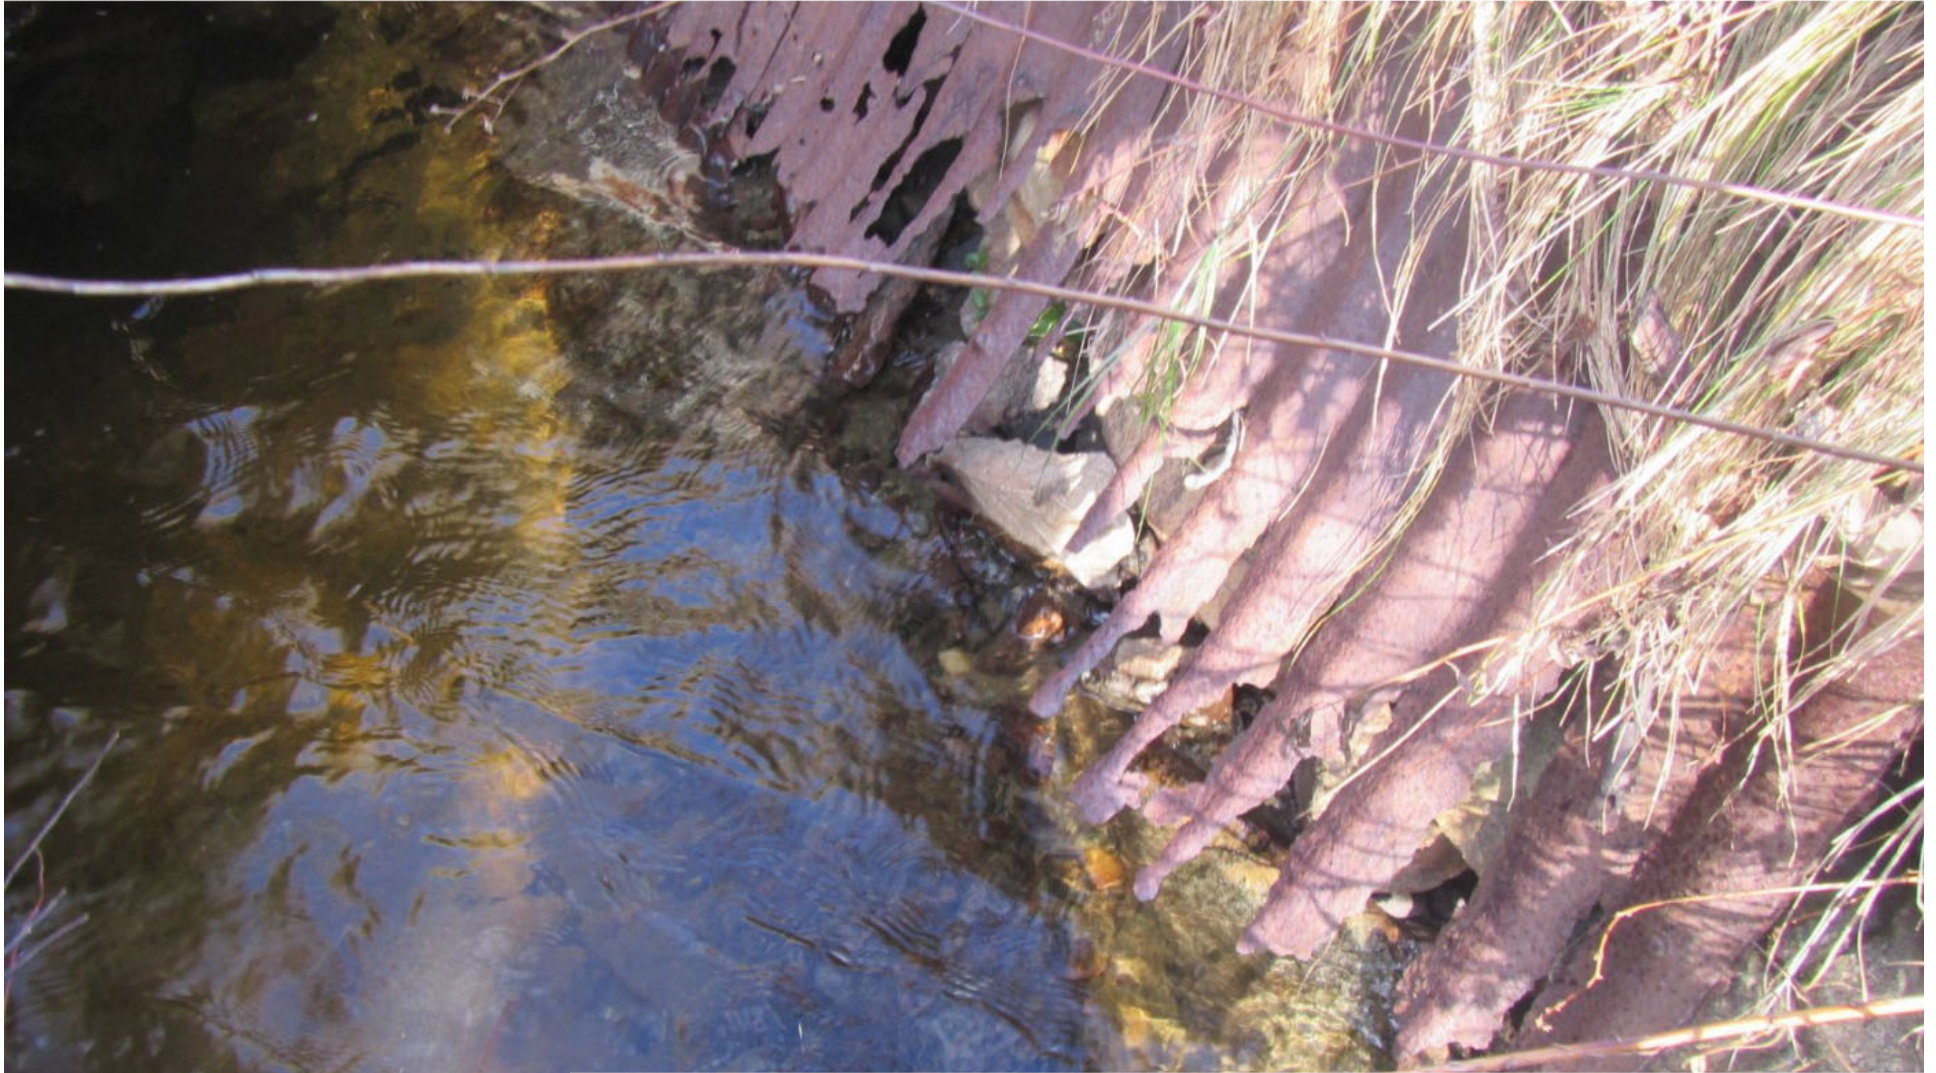
11/04/2019

- The culvert is in poor condition with significant deformation, misalignment, large perforations, heavy rust scaling and pitting present.
- The existing culvert does not meet the calculated or measured bank full width.

Distortion!

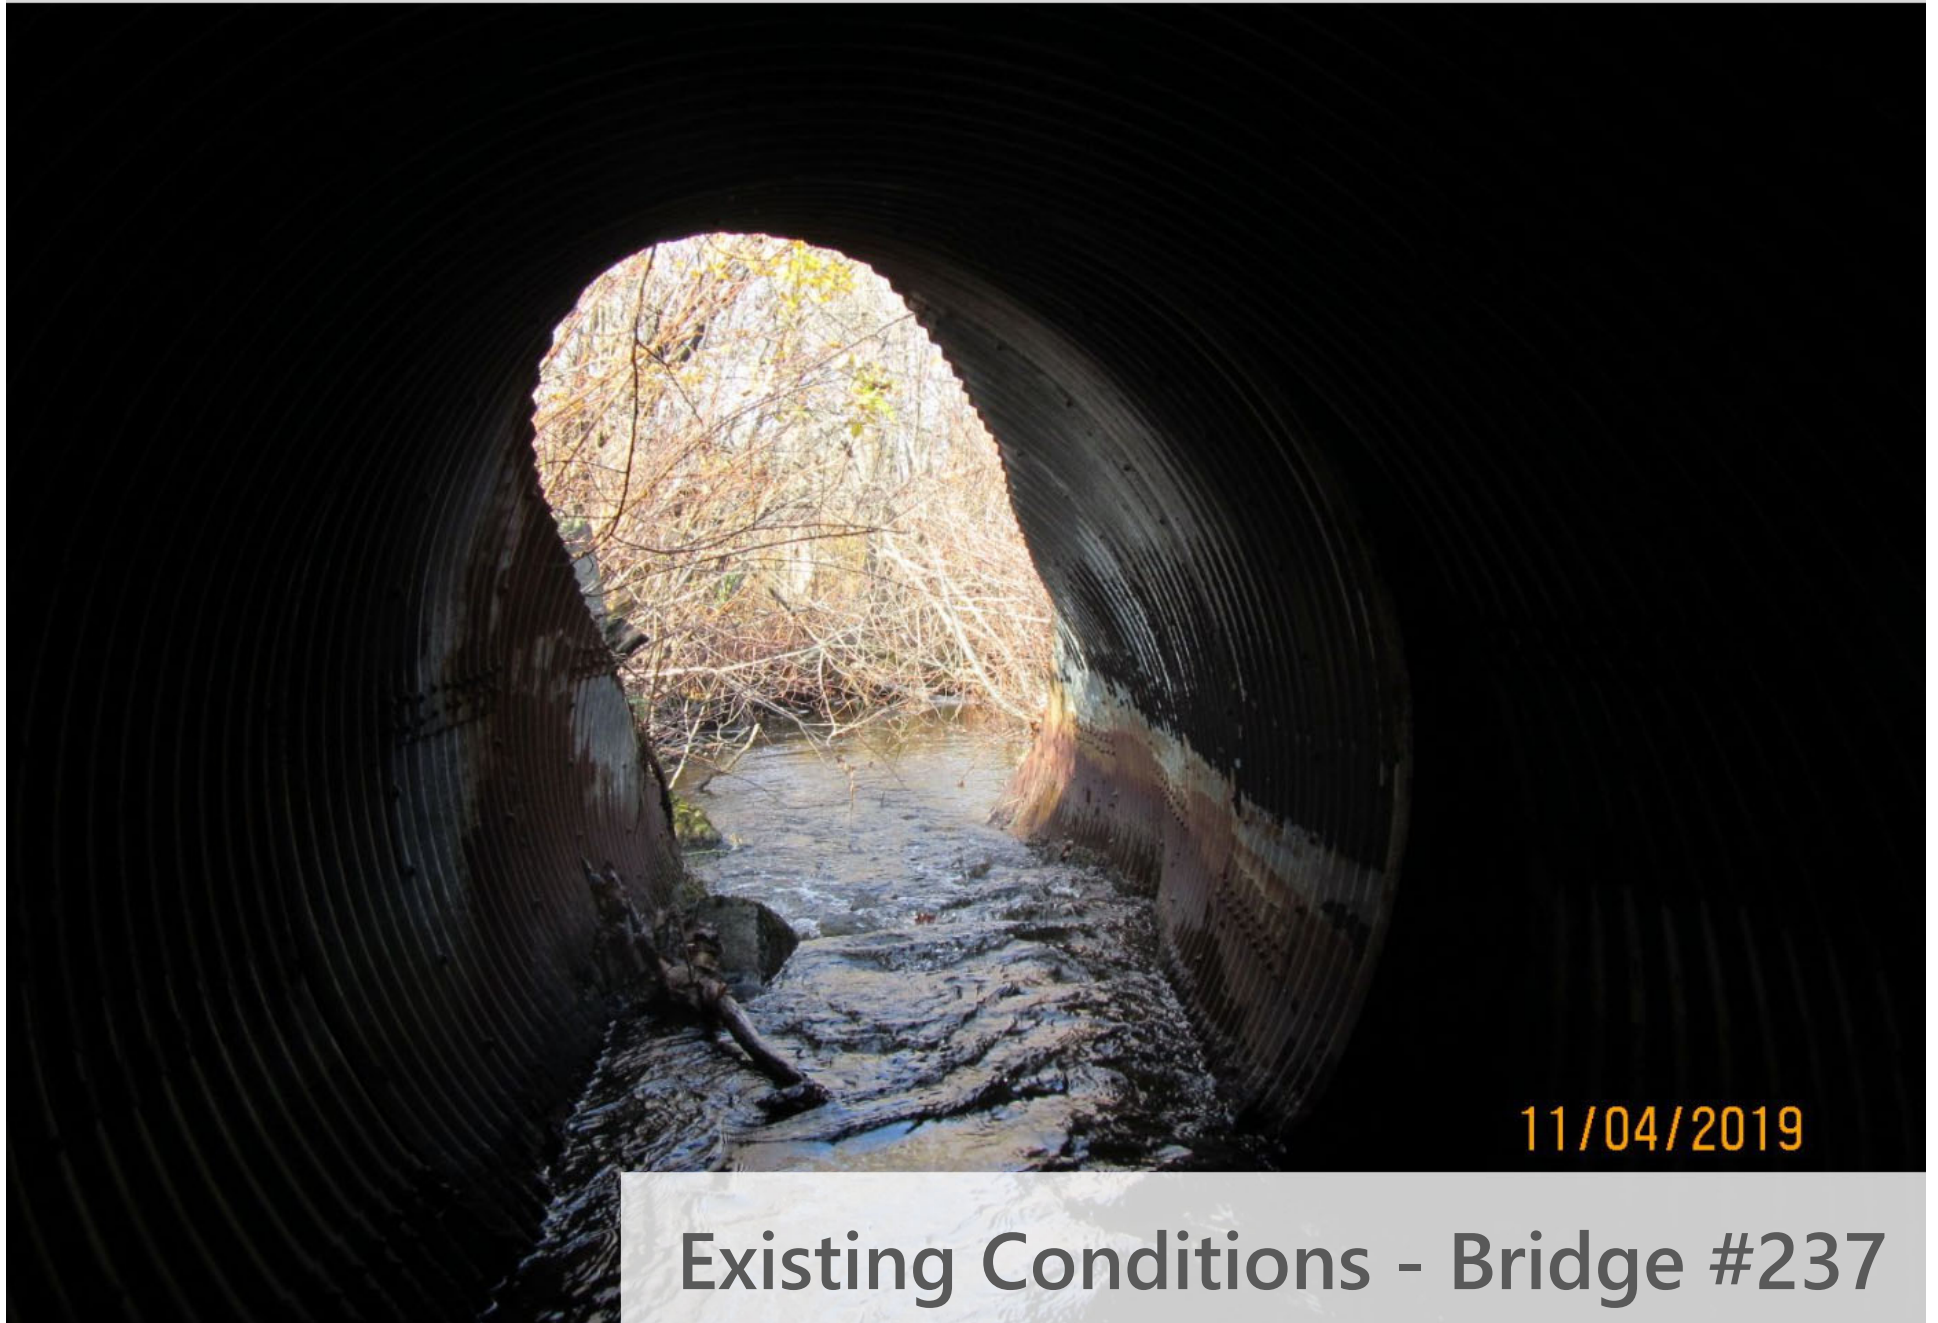
11/04/2019

Separation!

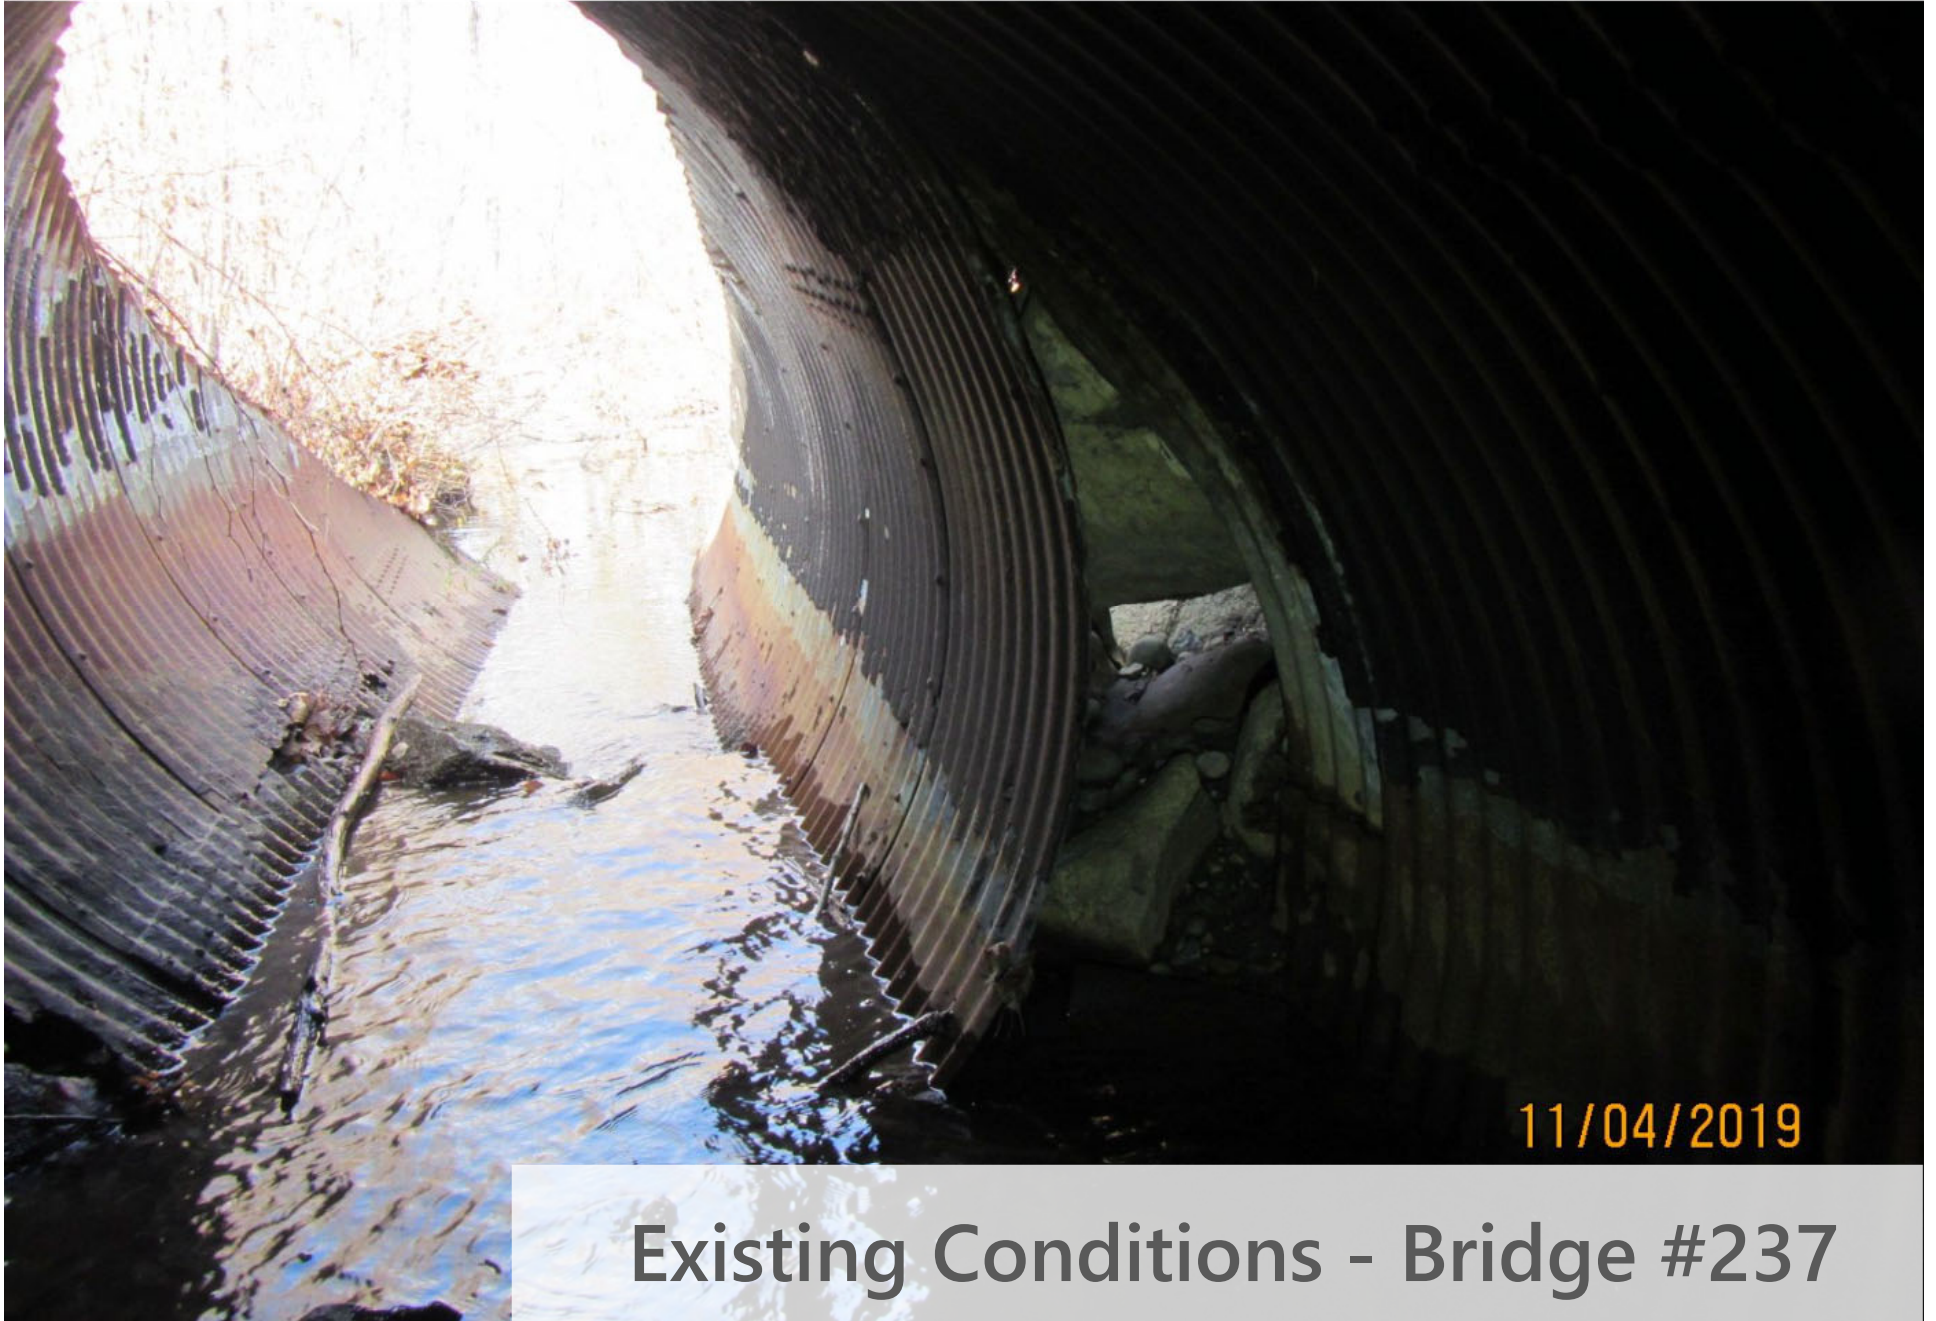
11/04/2019

Perforations in the Invert!
