**Irasburg STP DECK(50)
Regional Concerns Meeting**
VT Route 14 – Bridge #124 over Black River

November 25, 2020

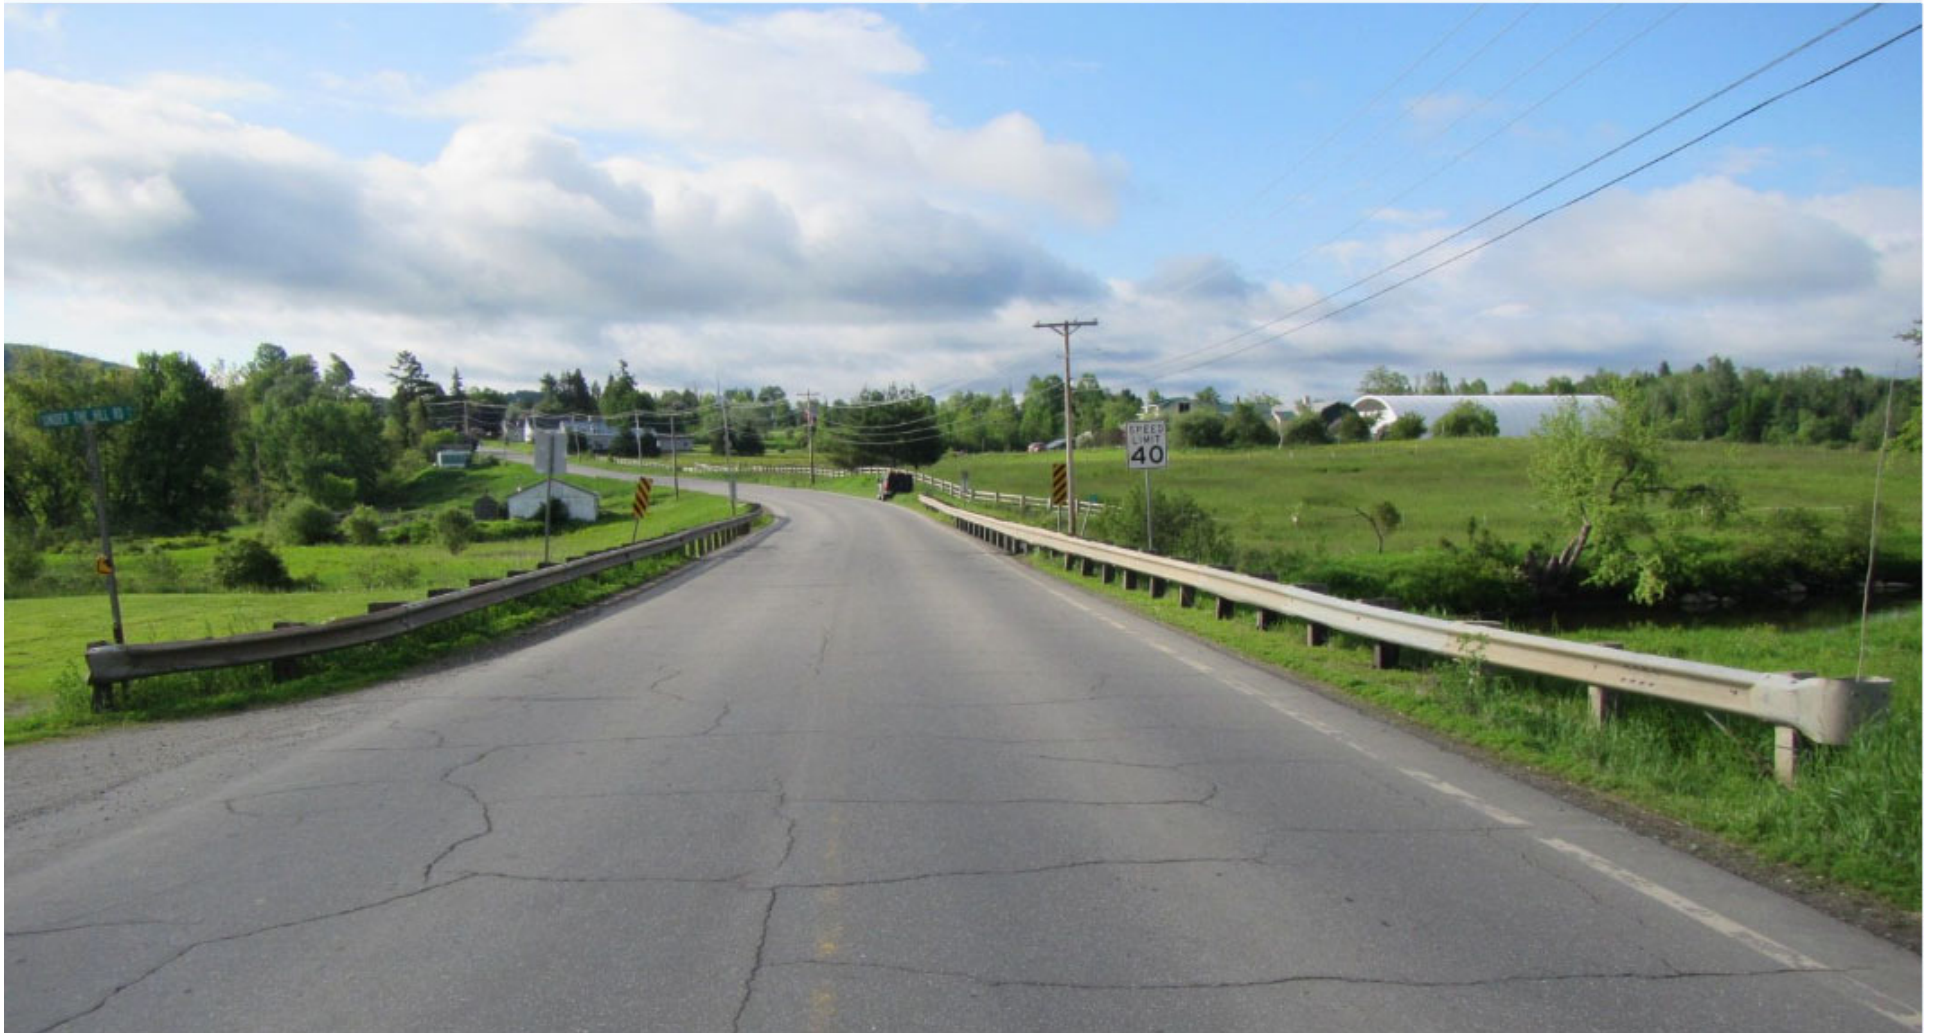
- Aerial Utilities

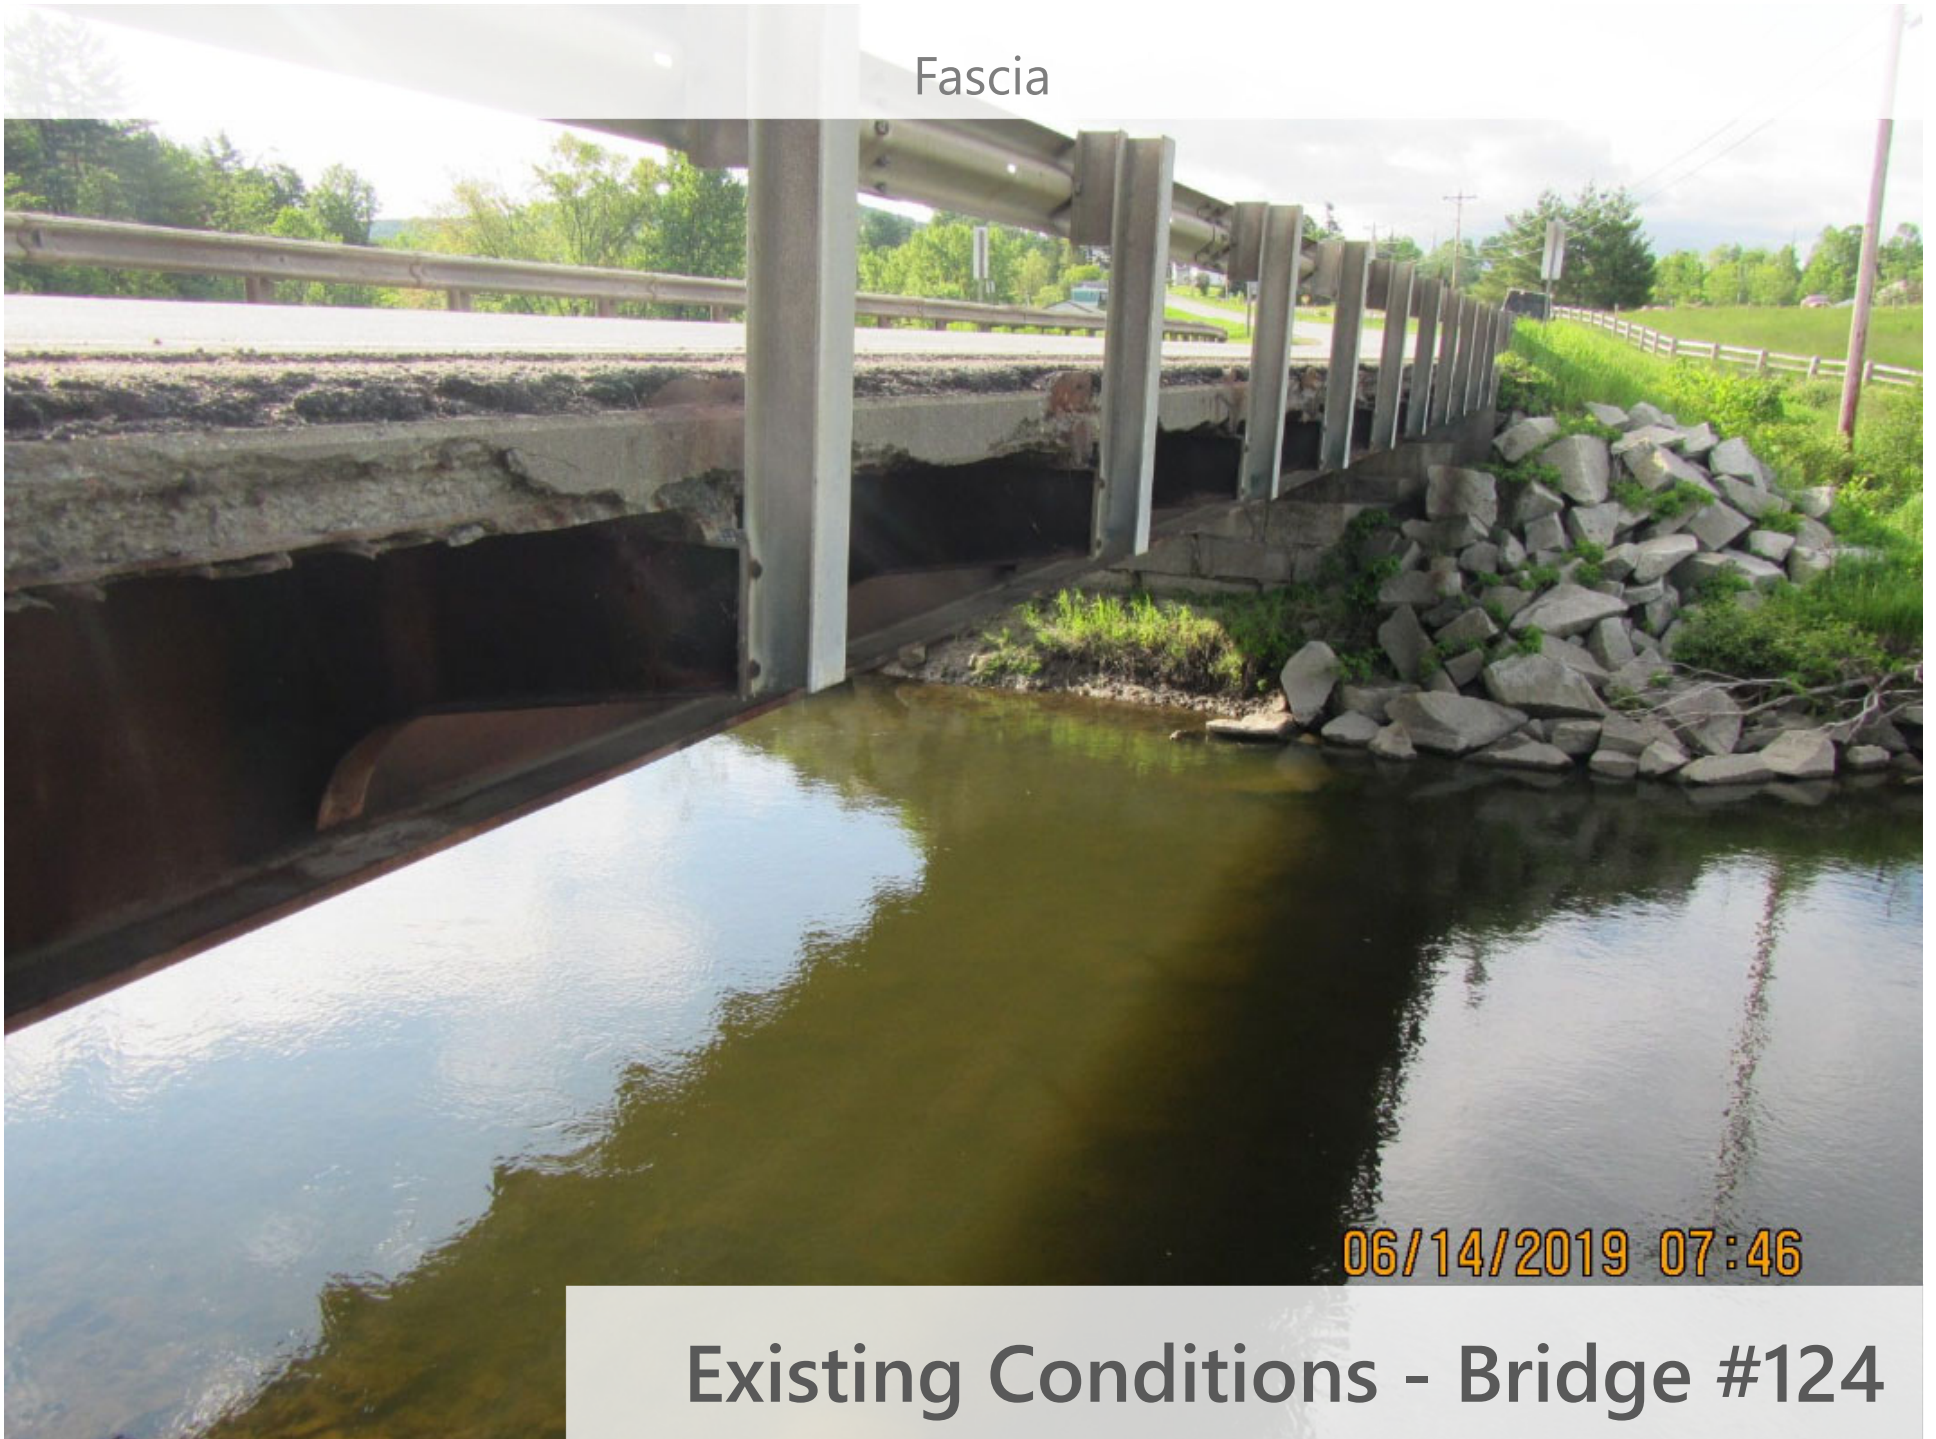
Fascia

- The reinforced concrete deck is in fair condition.
 - Multiple areas with delaminations with efflorescence leakage and saturation.
 - Minor map cracking and saturation is present in various areas around the deck.
 - Compromised membrane
 - Both the upstream and downstream fascias are in poor condition with spalling and delaminations along the entire length. Spalling has exposed longitudinal and transverse bars with rust scaling and are starting to thin.

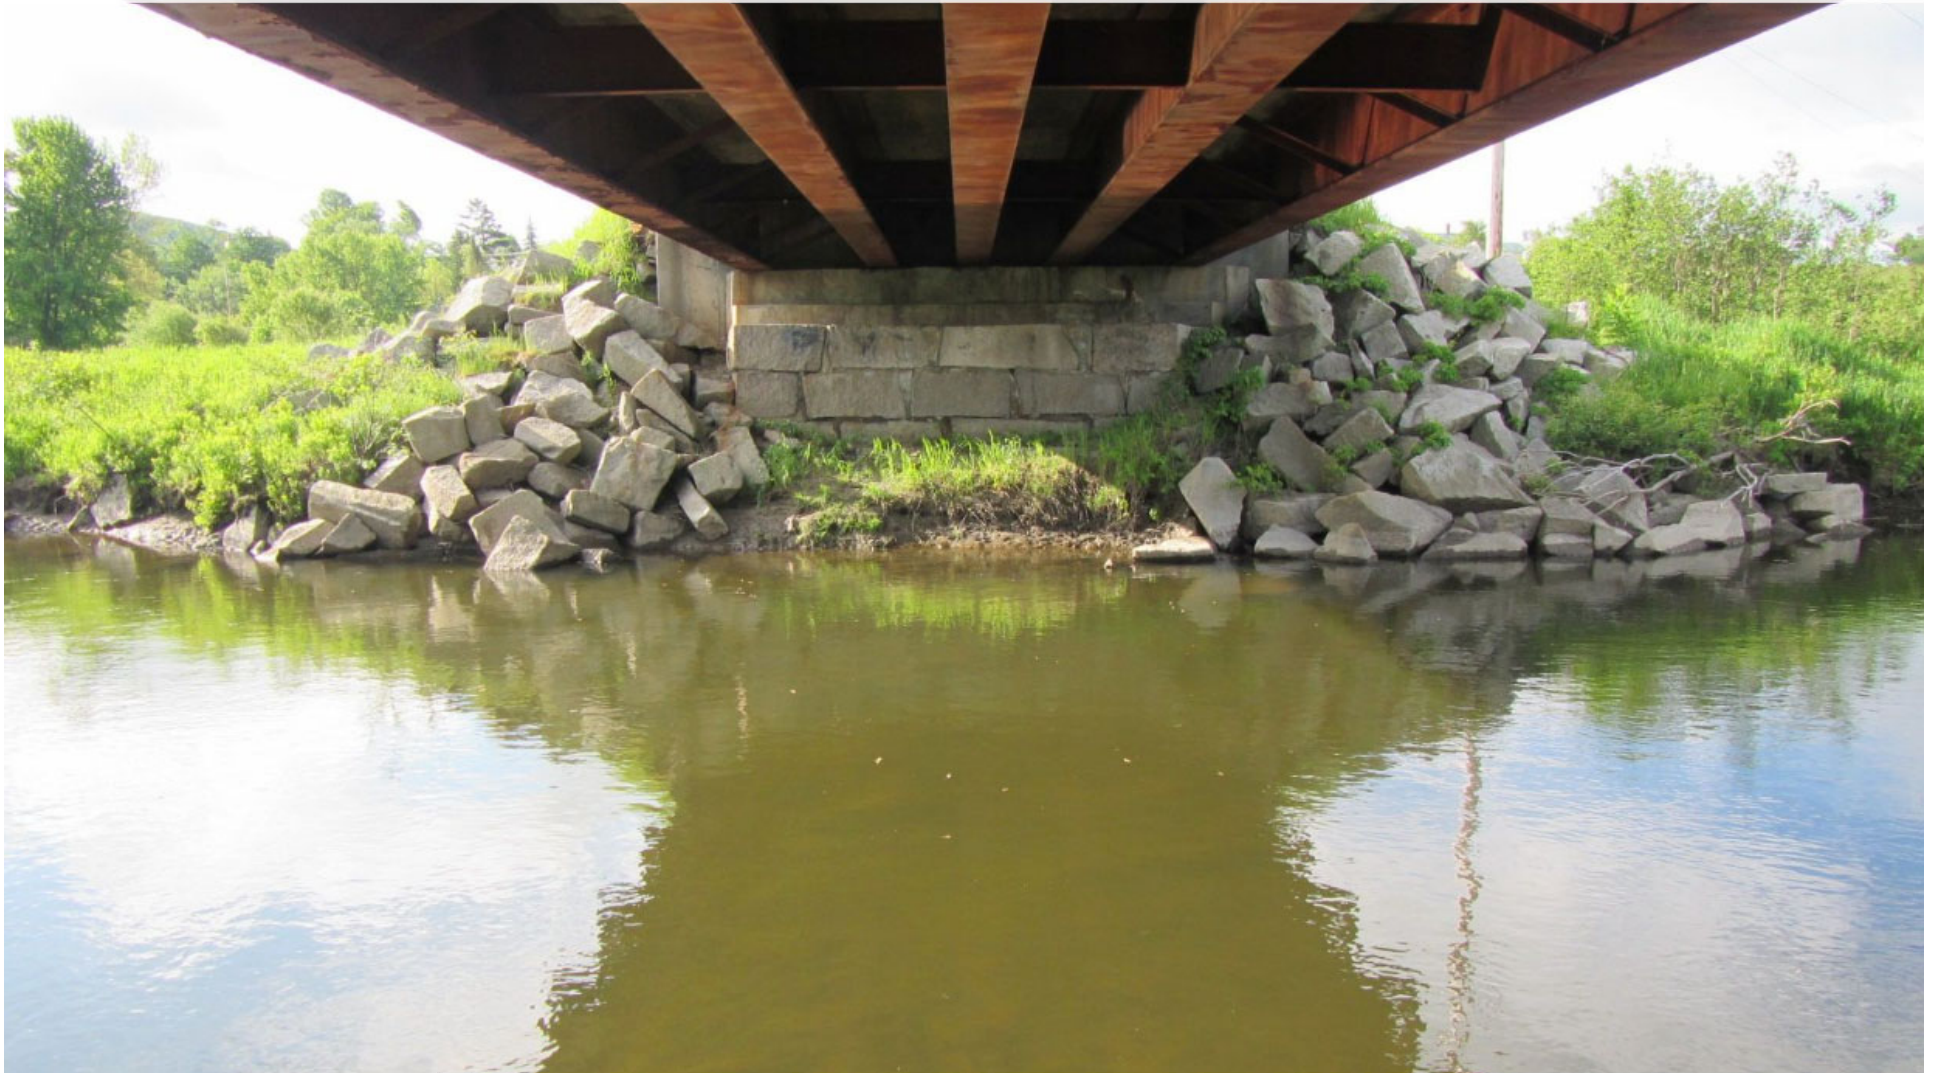
Southern Abutment

- Laid up stone blocks

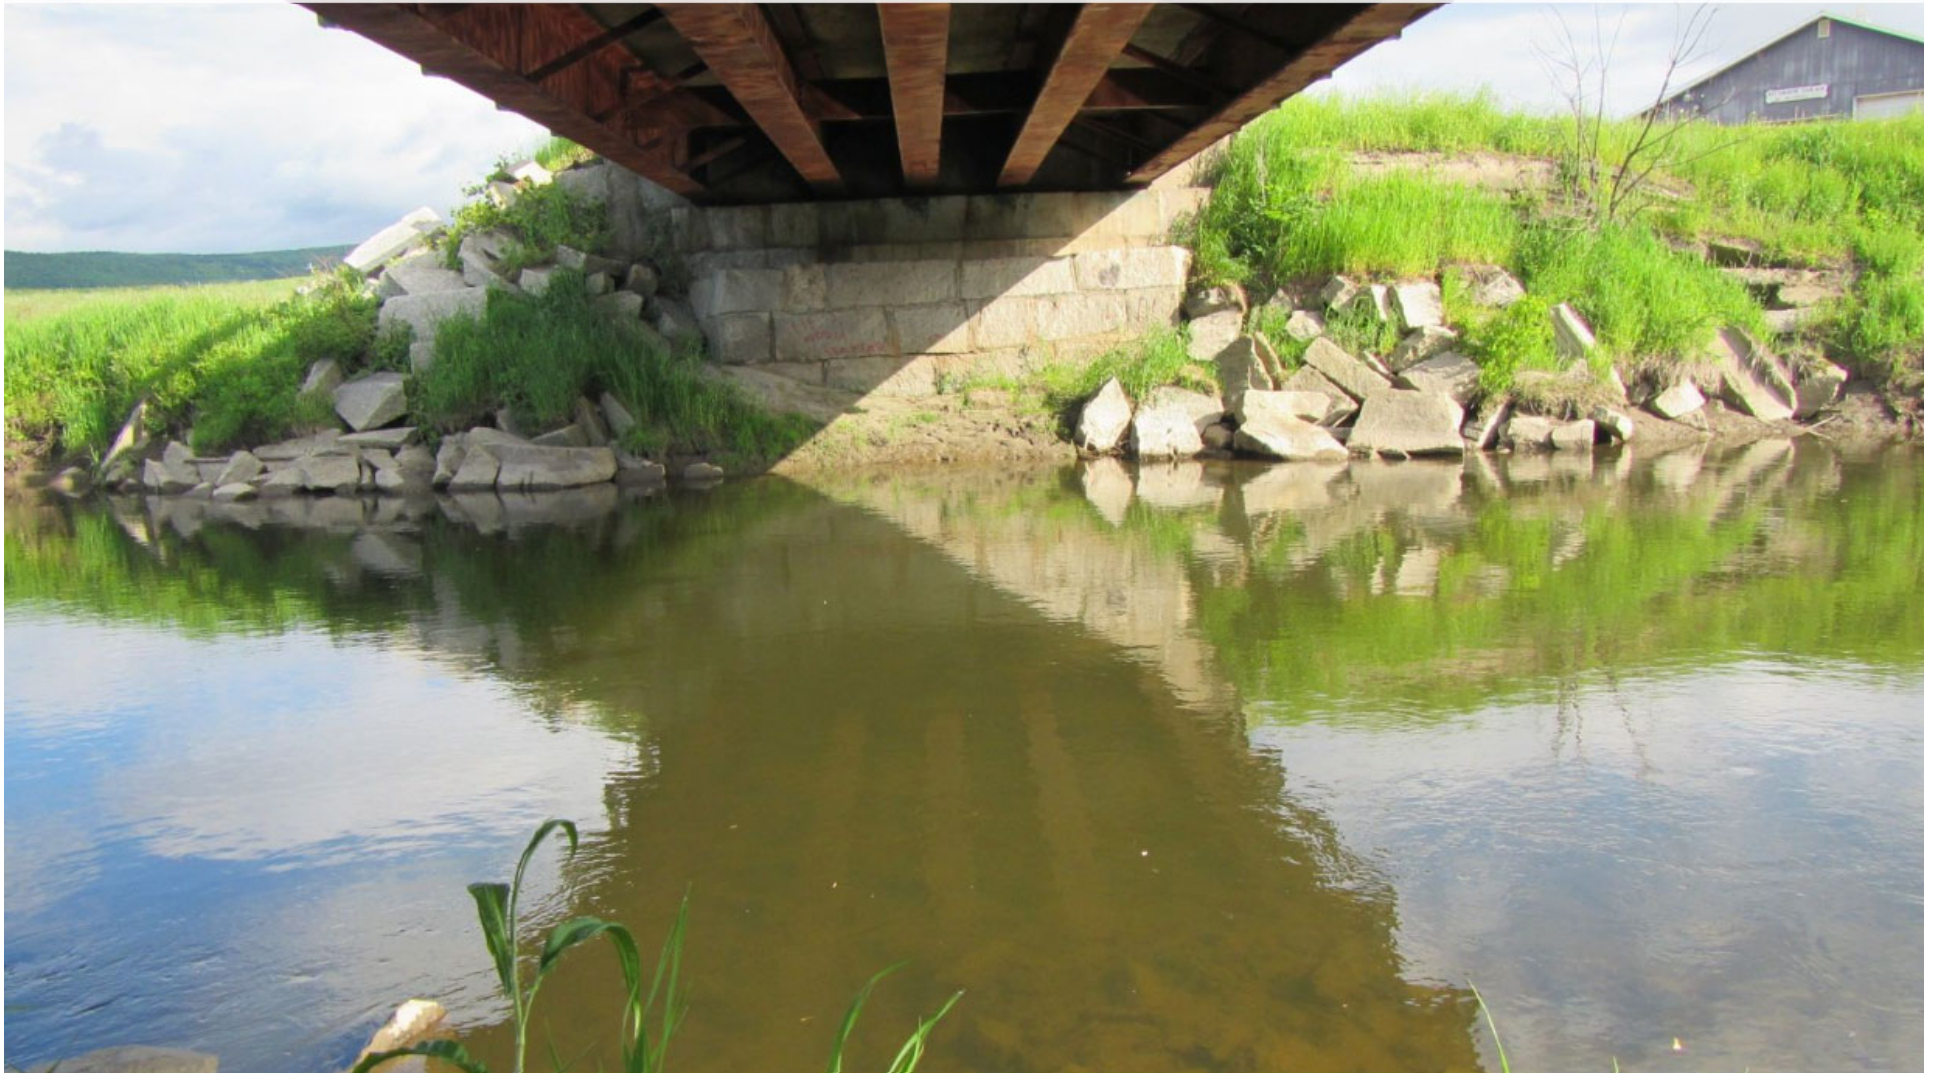
Northern Abutment

- Laid up stone blocks

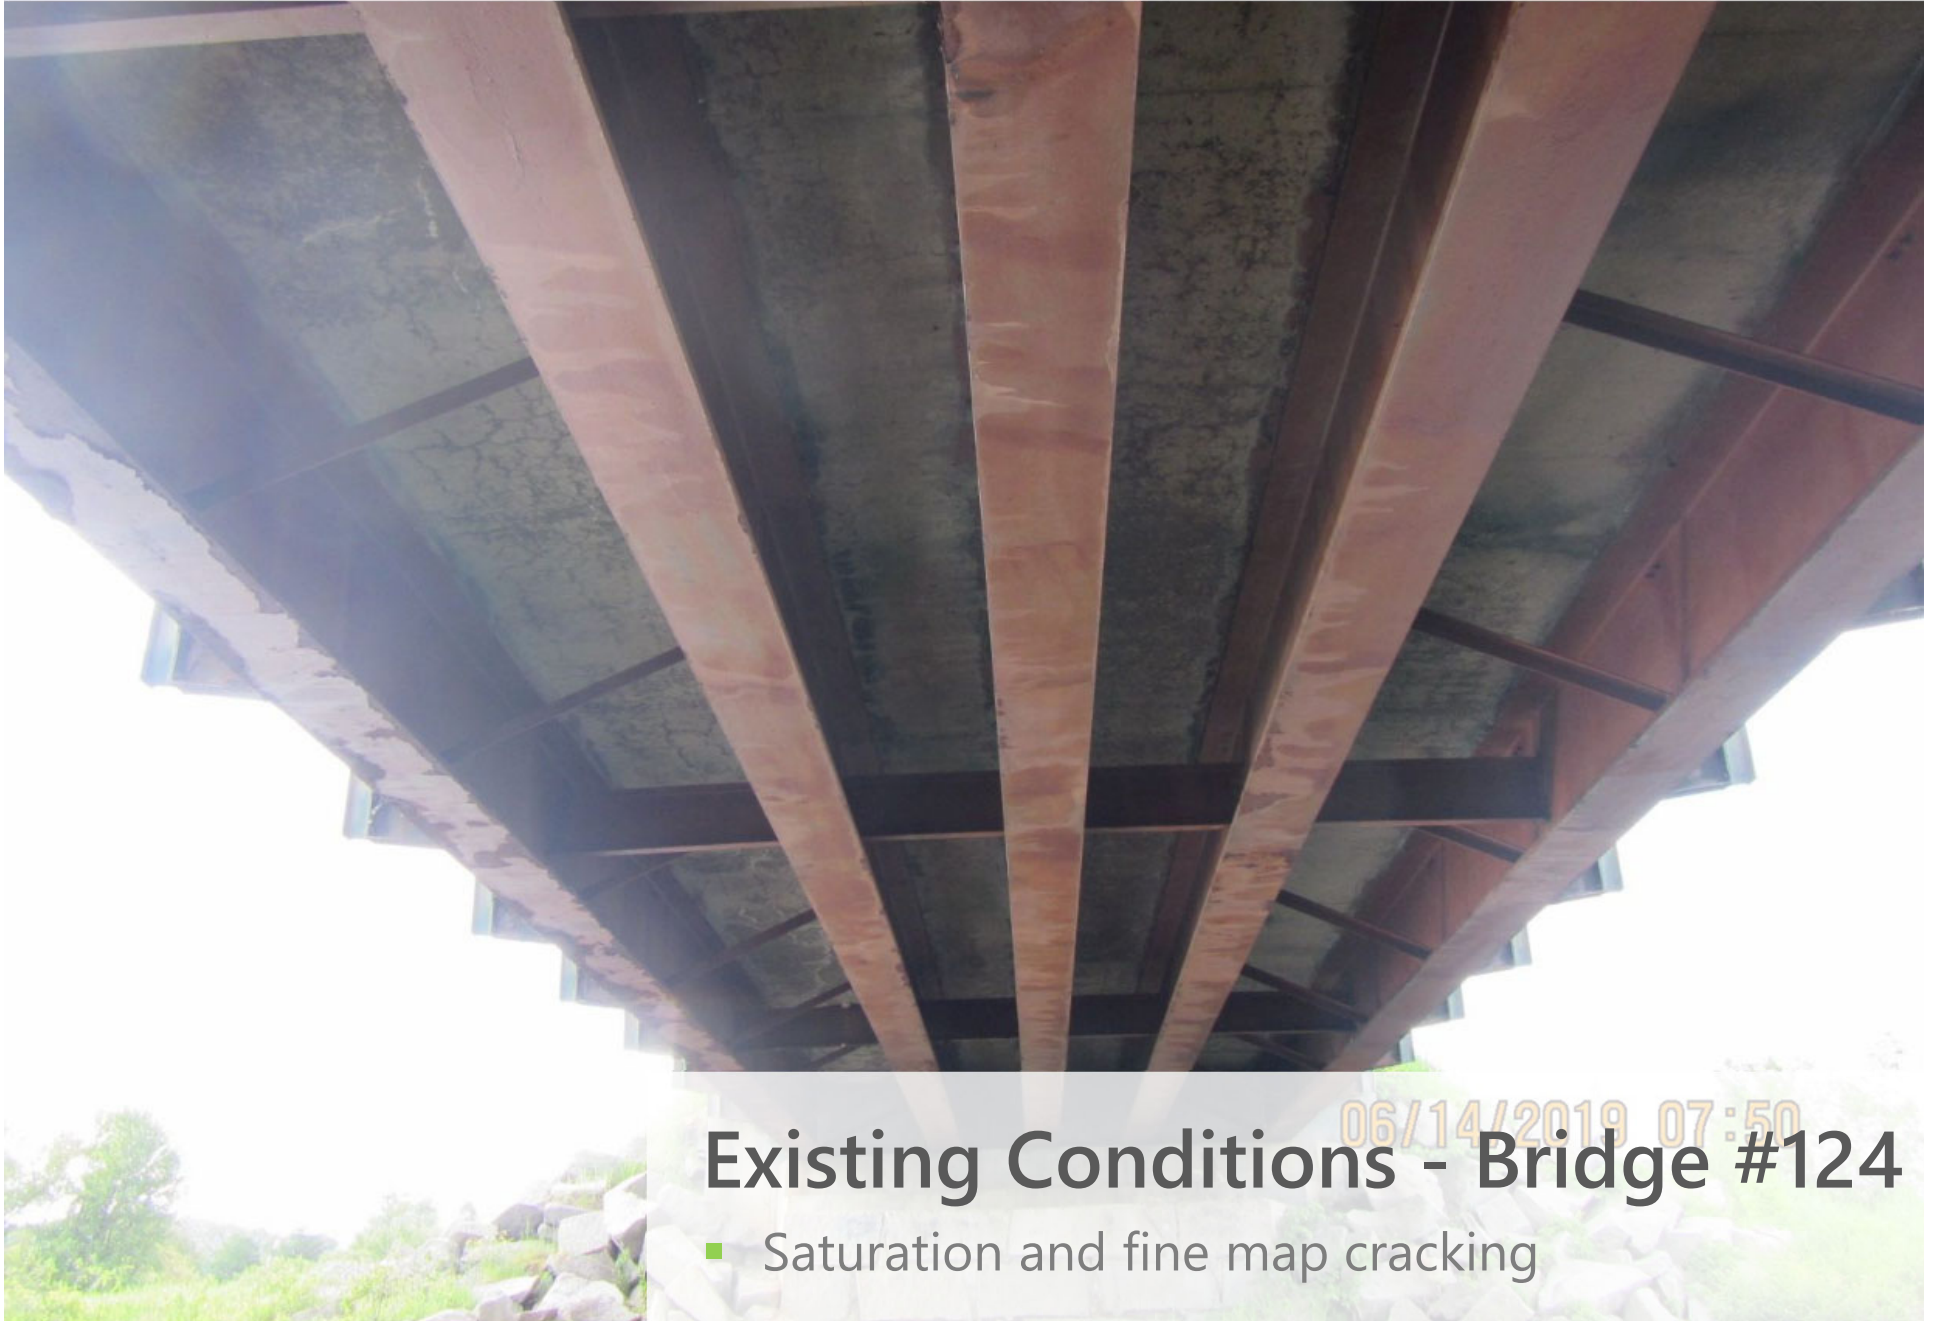
Underside of Deck

- Saturation and fine map cracking

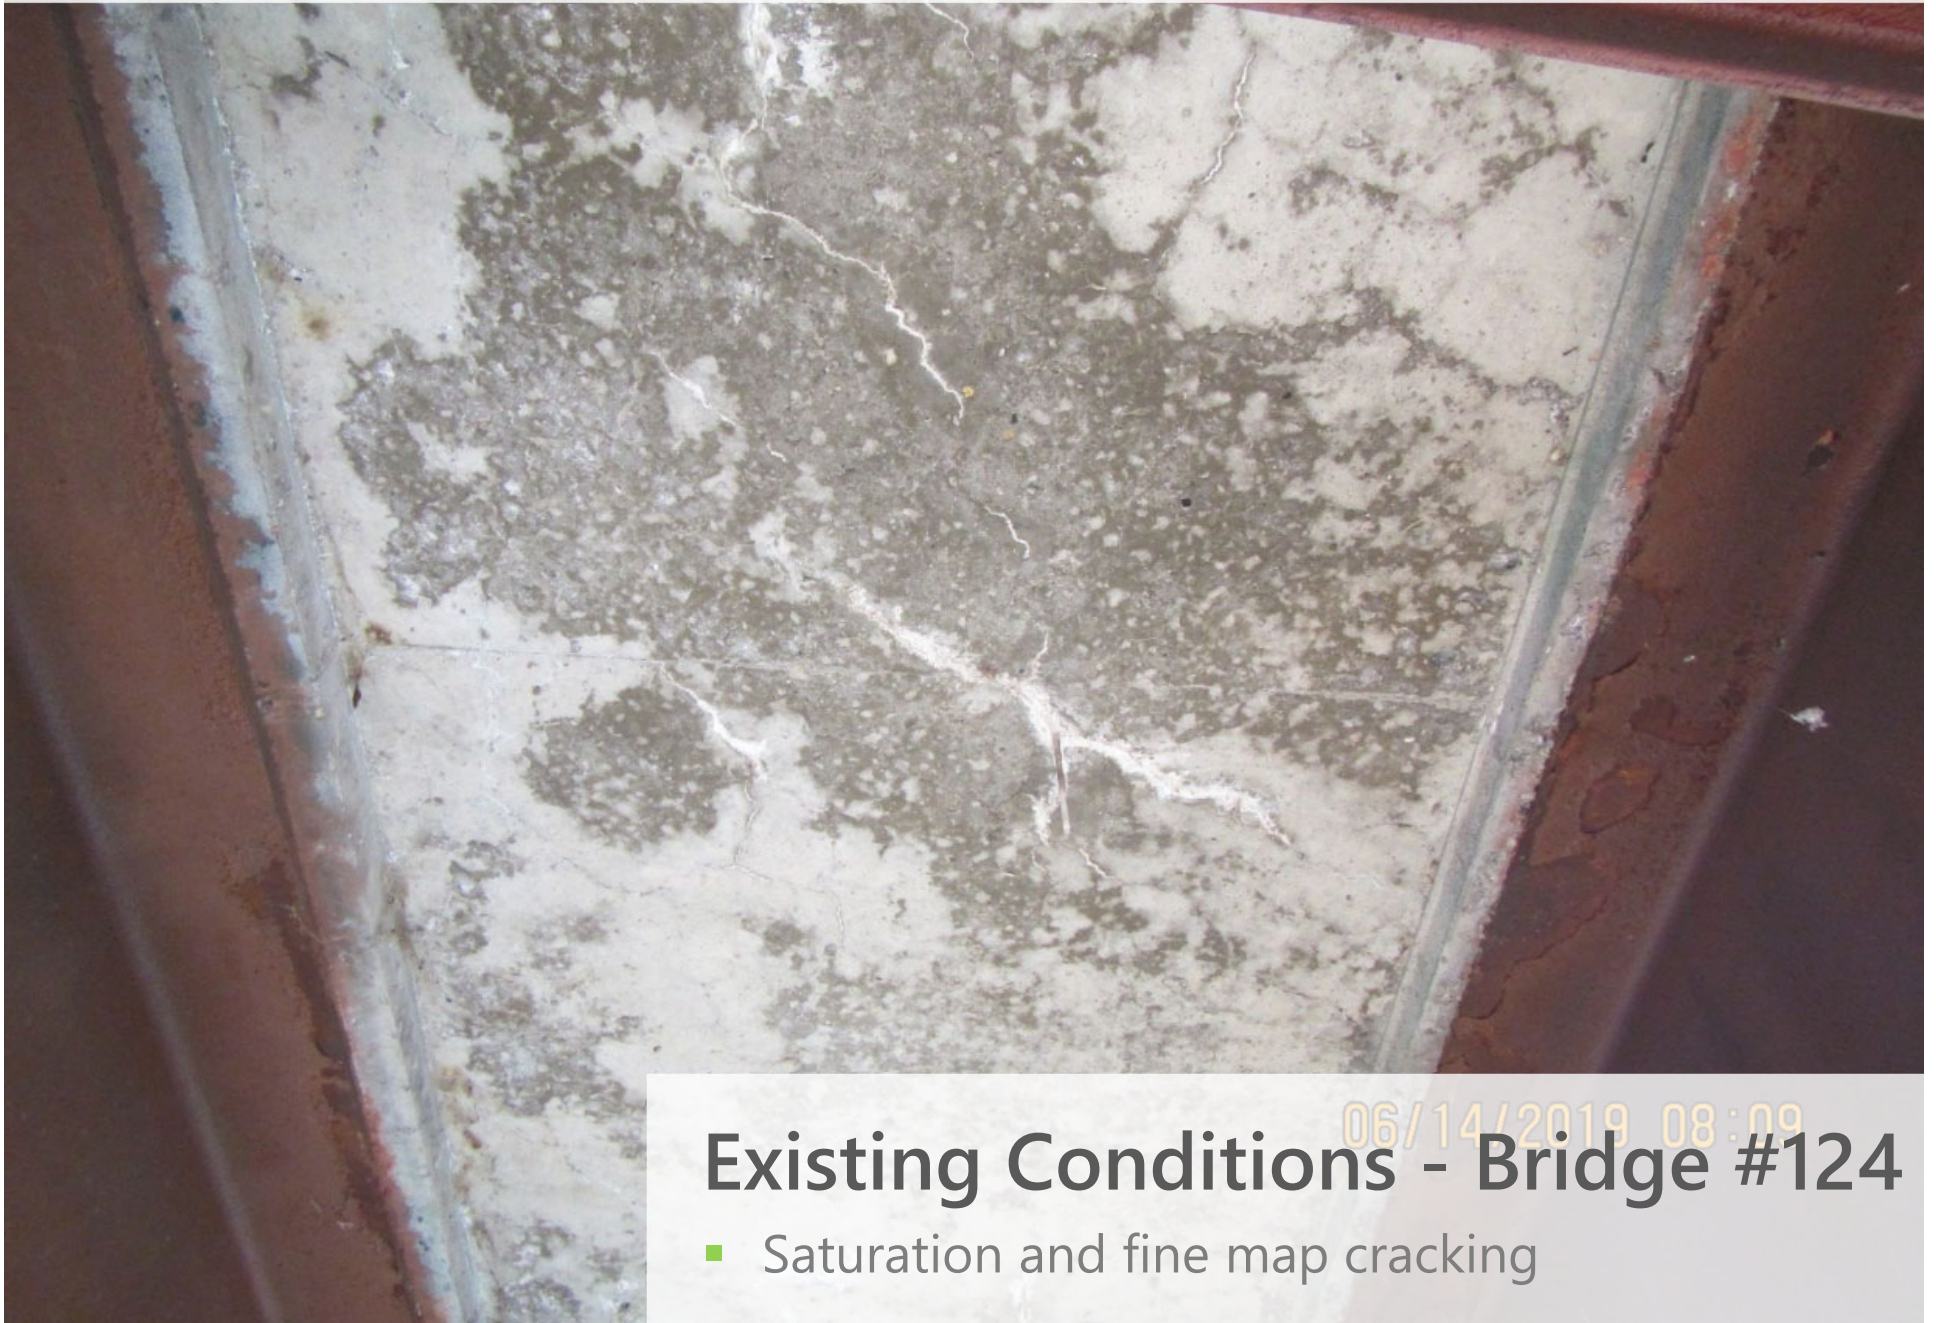
Underside of Deck

- Saturation and fine map cracking

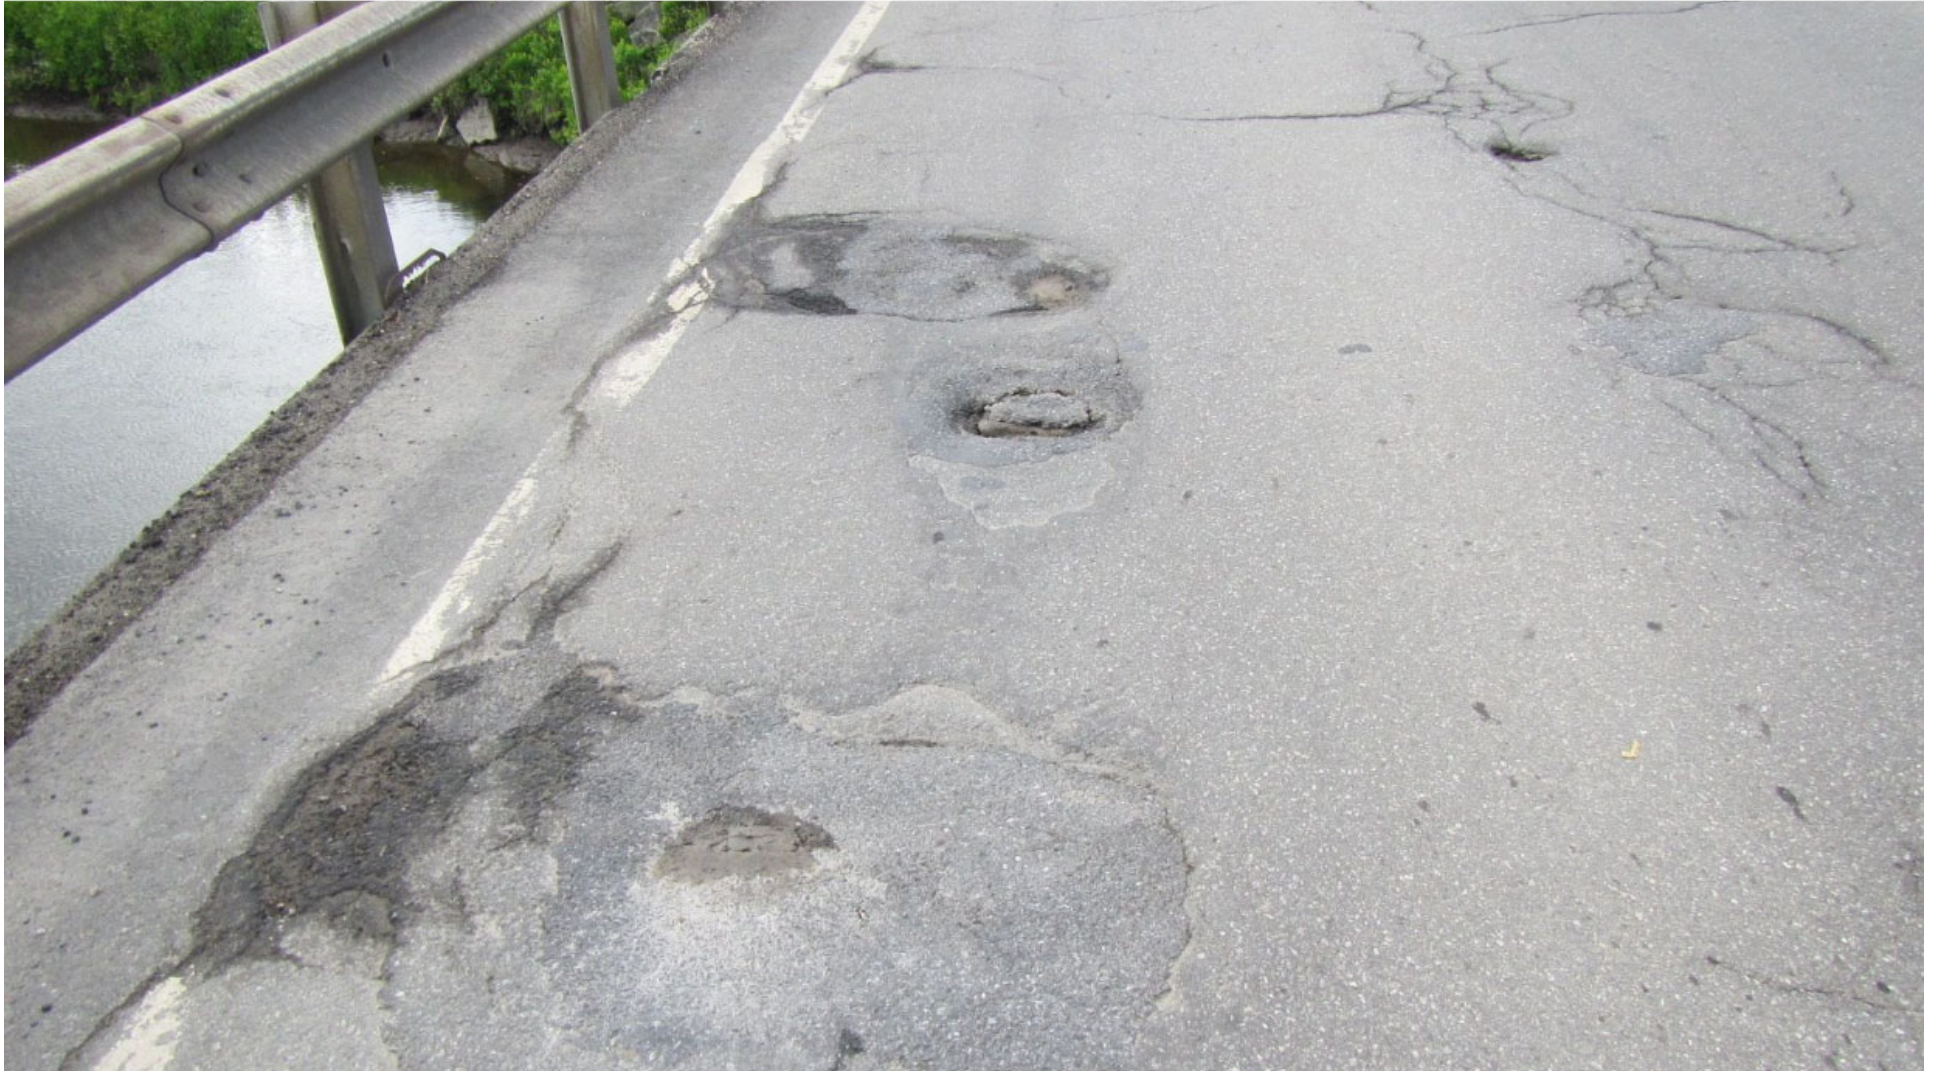
Wearing Surface

- Potholes
