Fairfield STP DECK(51)
Regional Concerns Meeting
VT Route 36 – Bridge #6 over Fairfield River

February 22, 2021

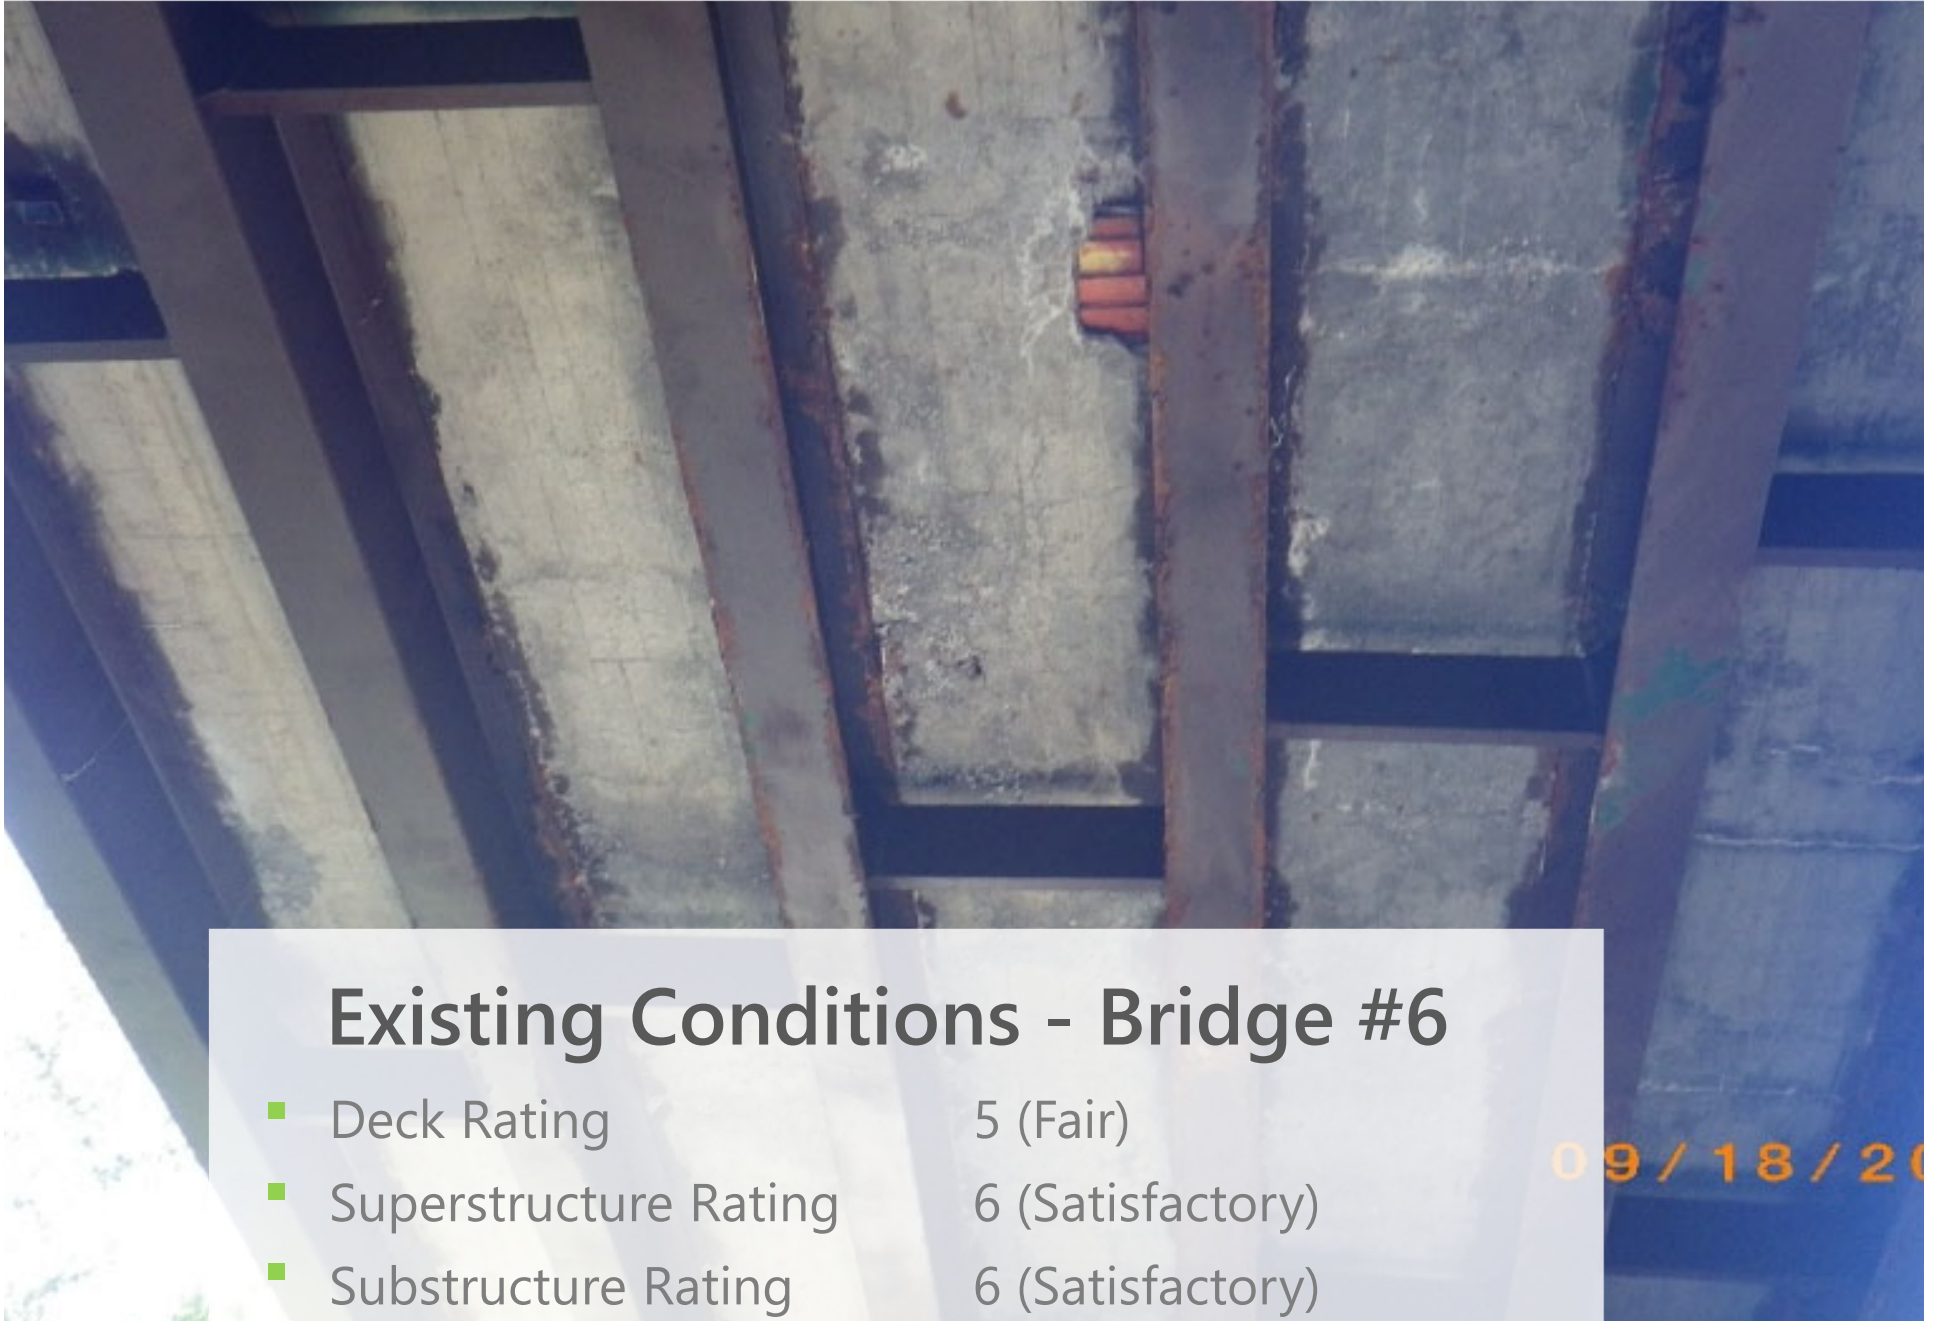
Condition Ratings

- Deck Rating 5 (Fair)
- Superstructure Rating 6 (Satisfactory)
- Substructure Rating 6 (Satisfactory)

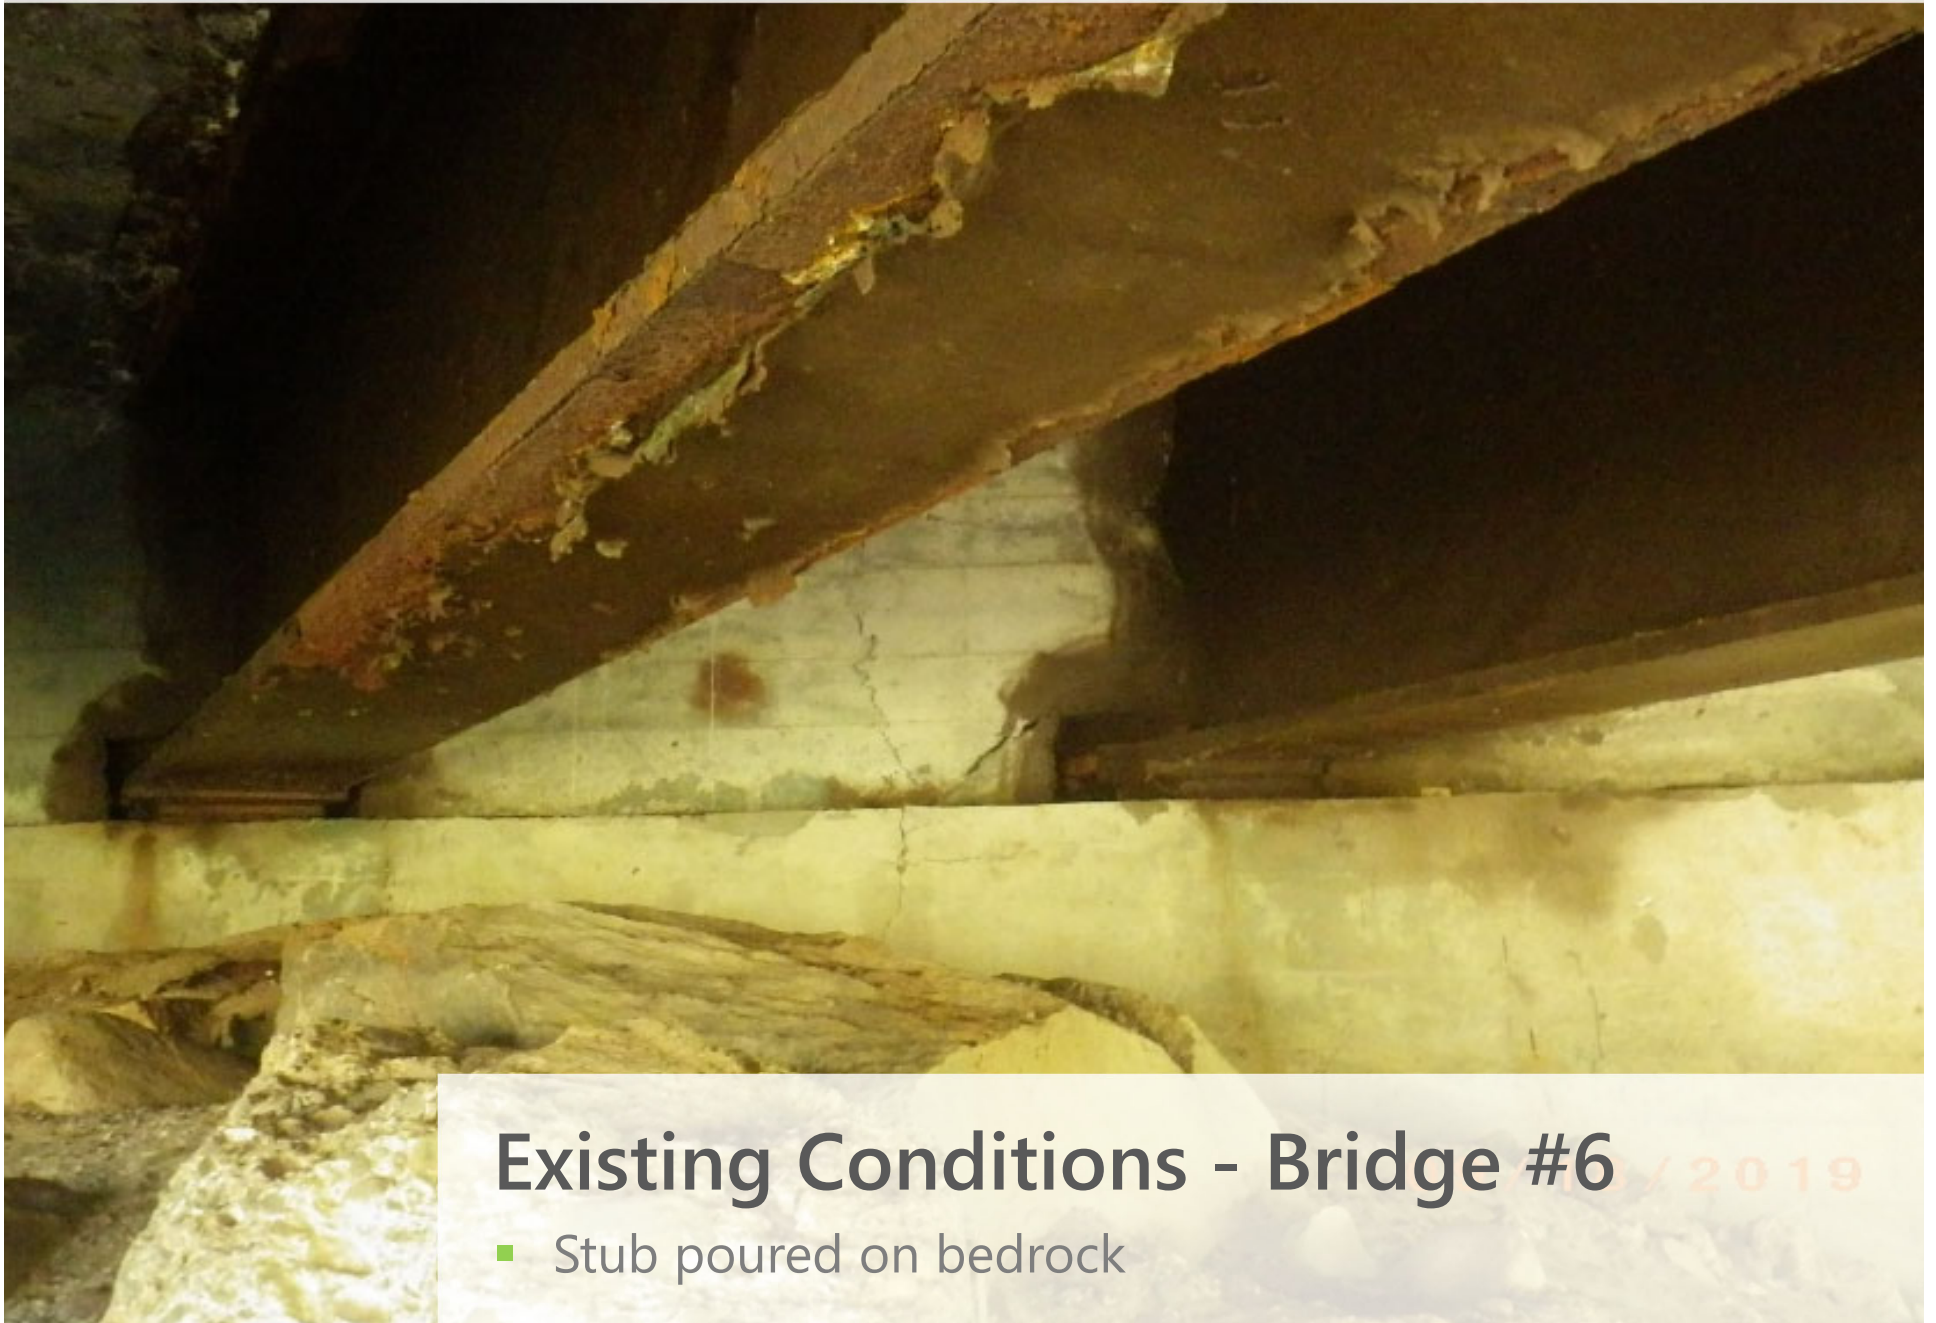
Southern Abutment

- Stub poured on bedrock

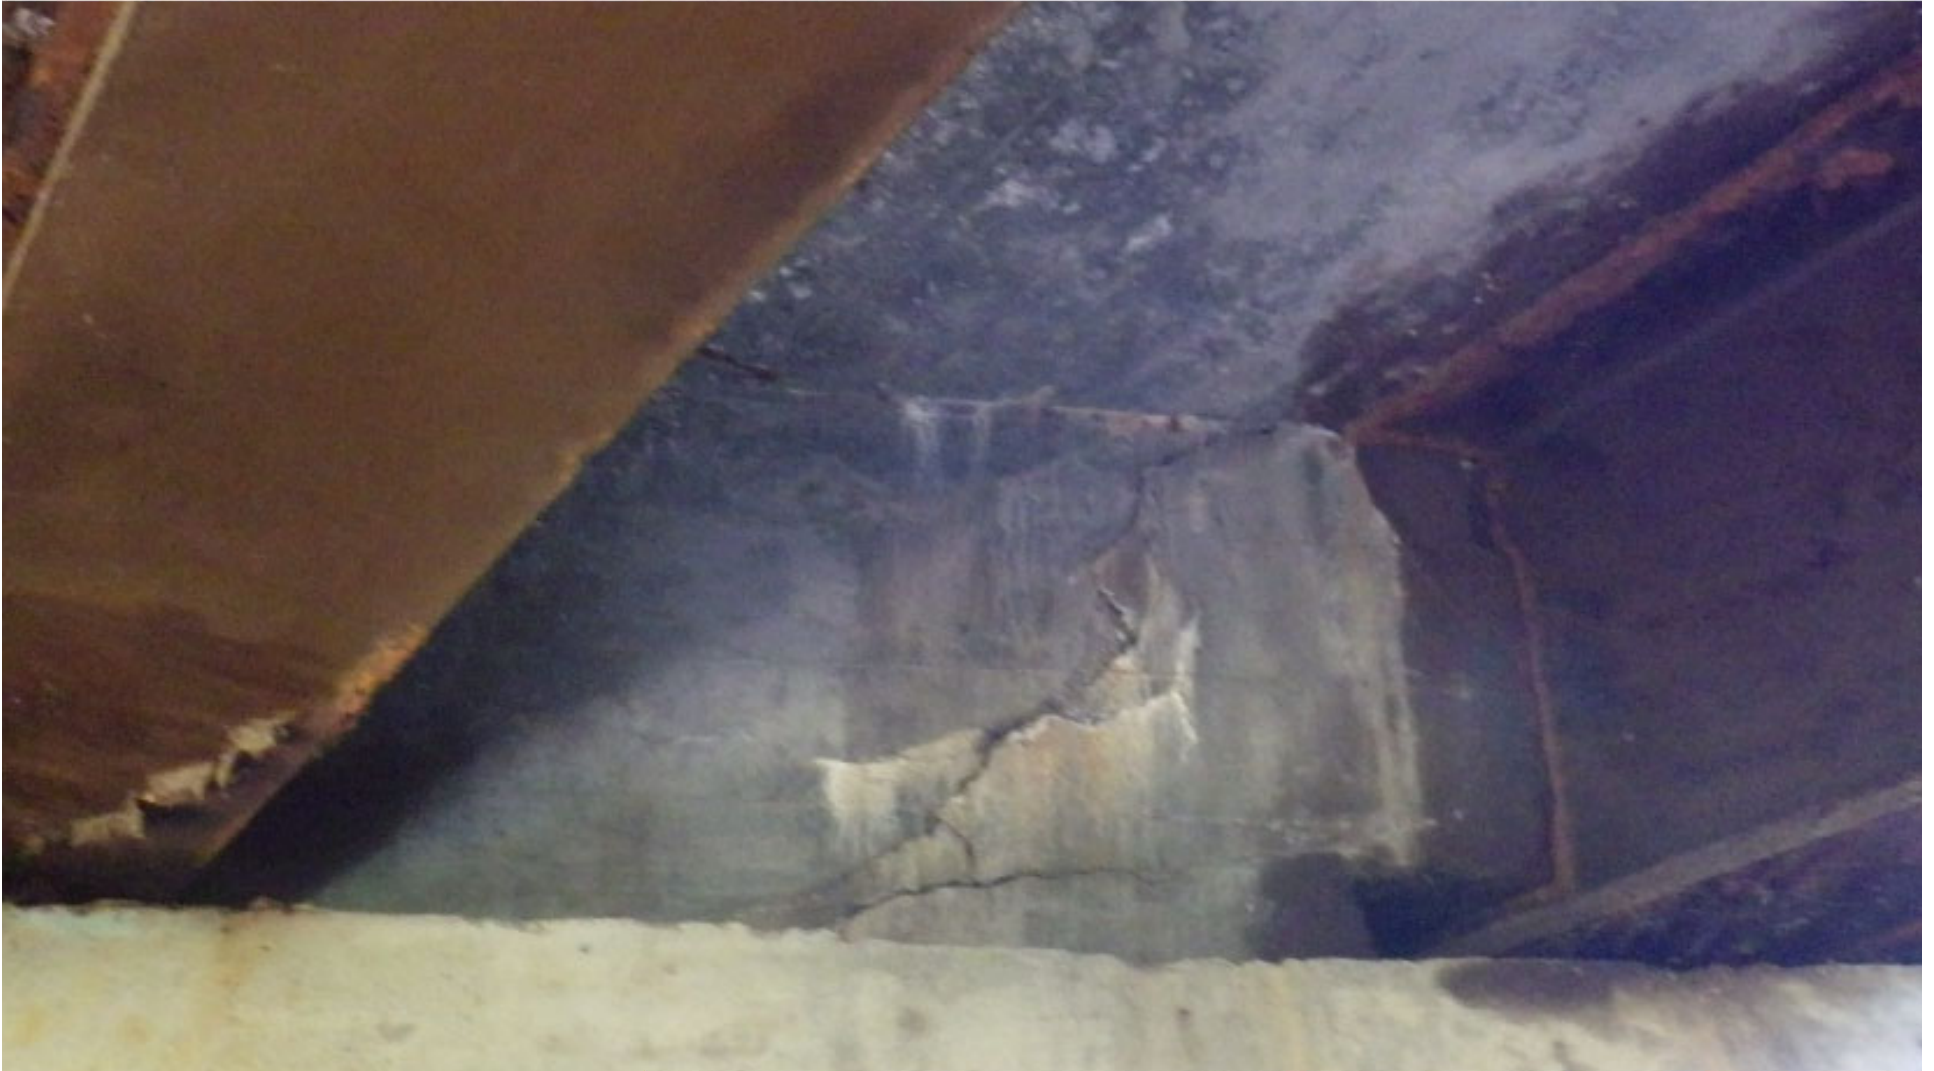
Backwall

- Cracking

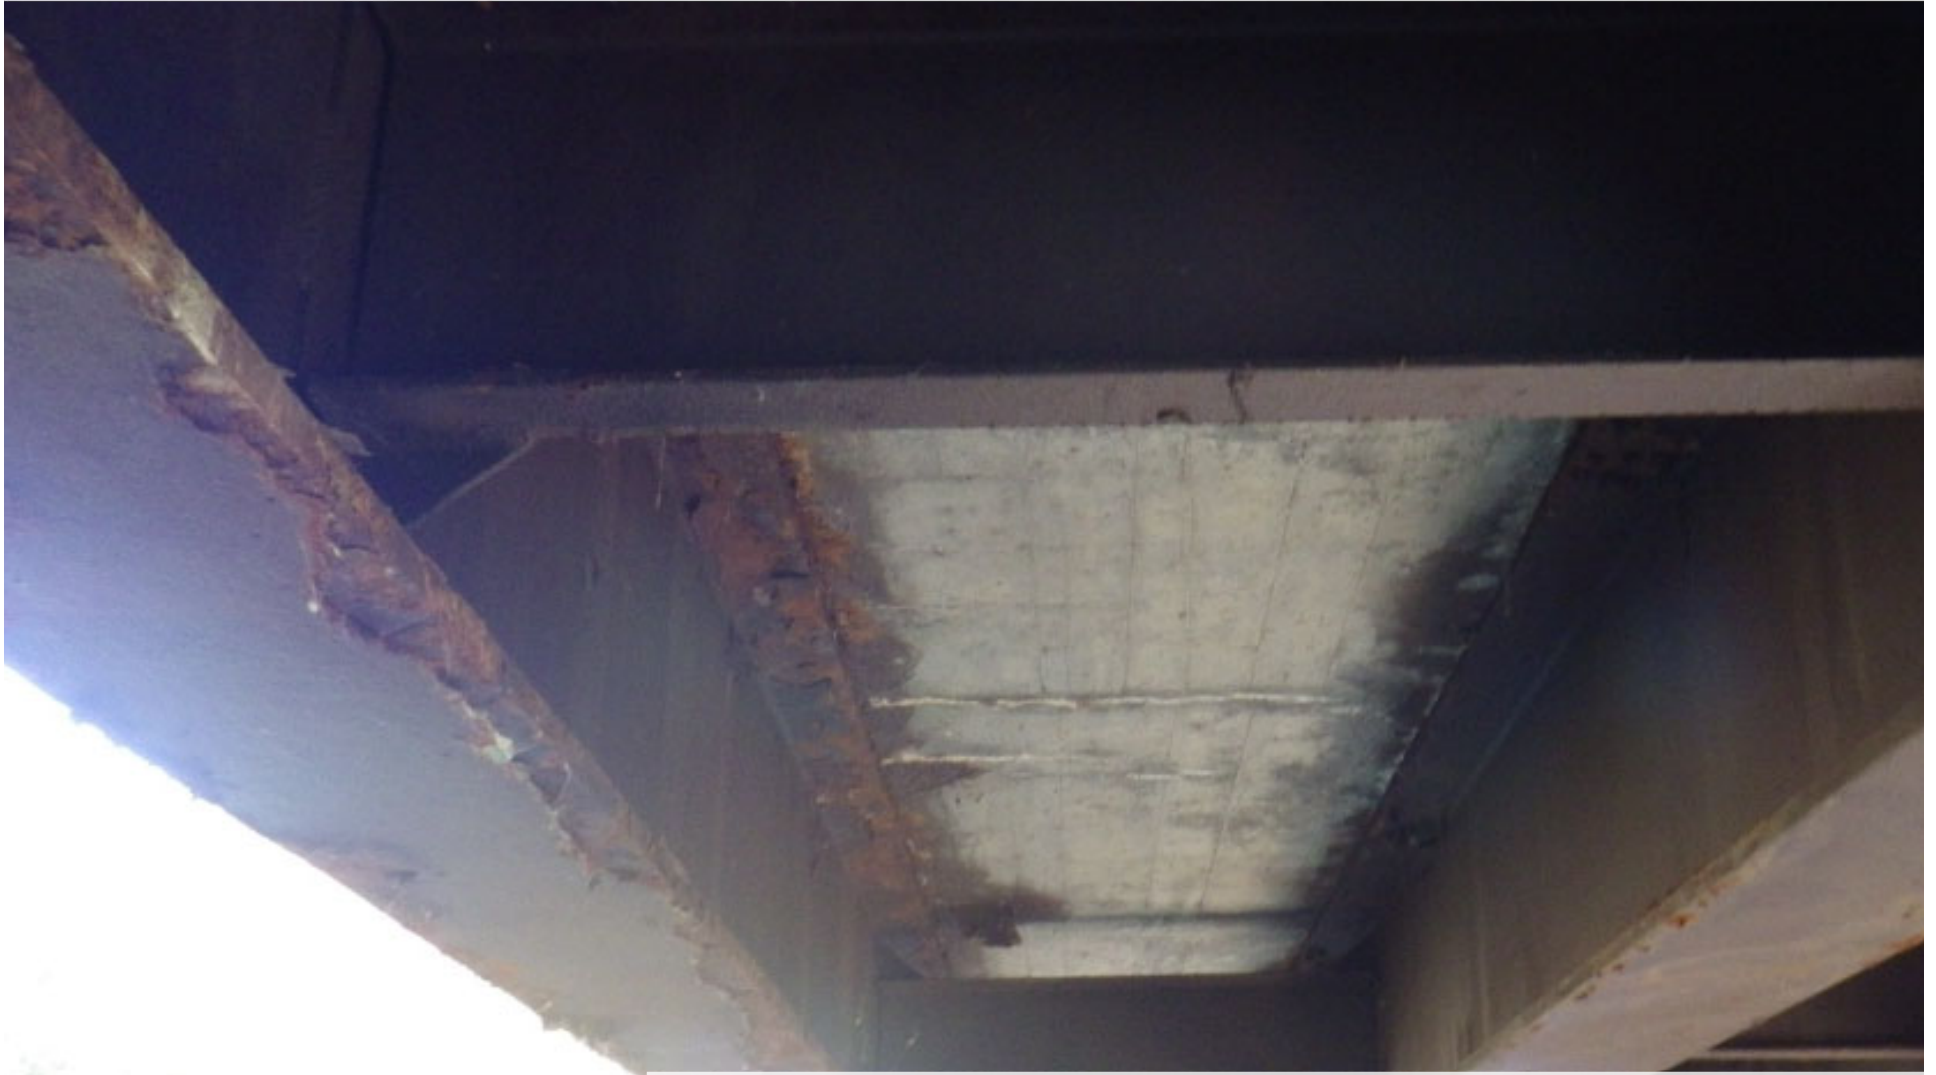
Underside of Deck

- Beams have paint peel

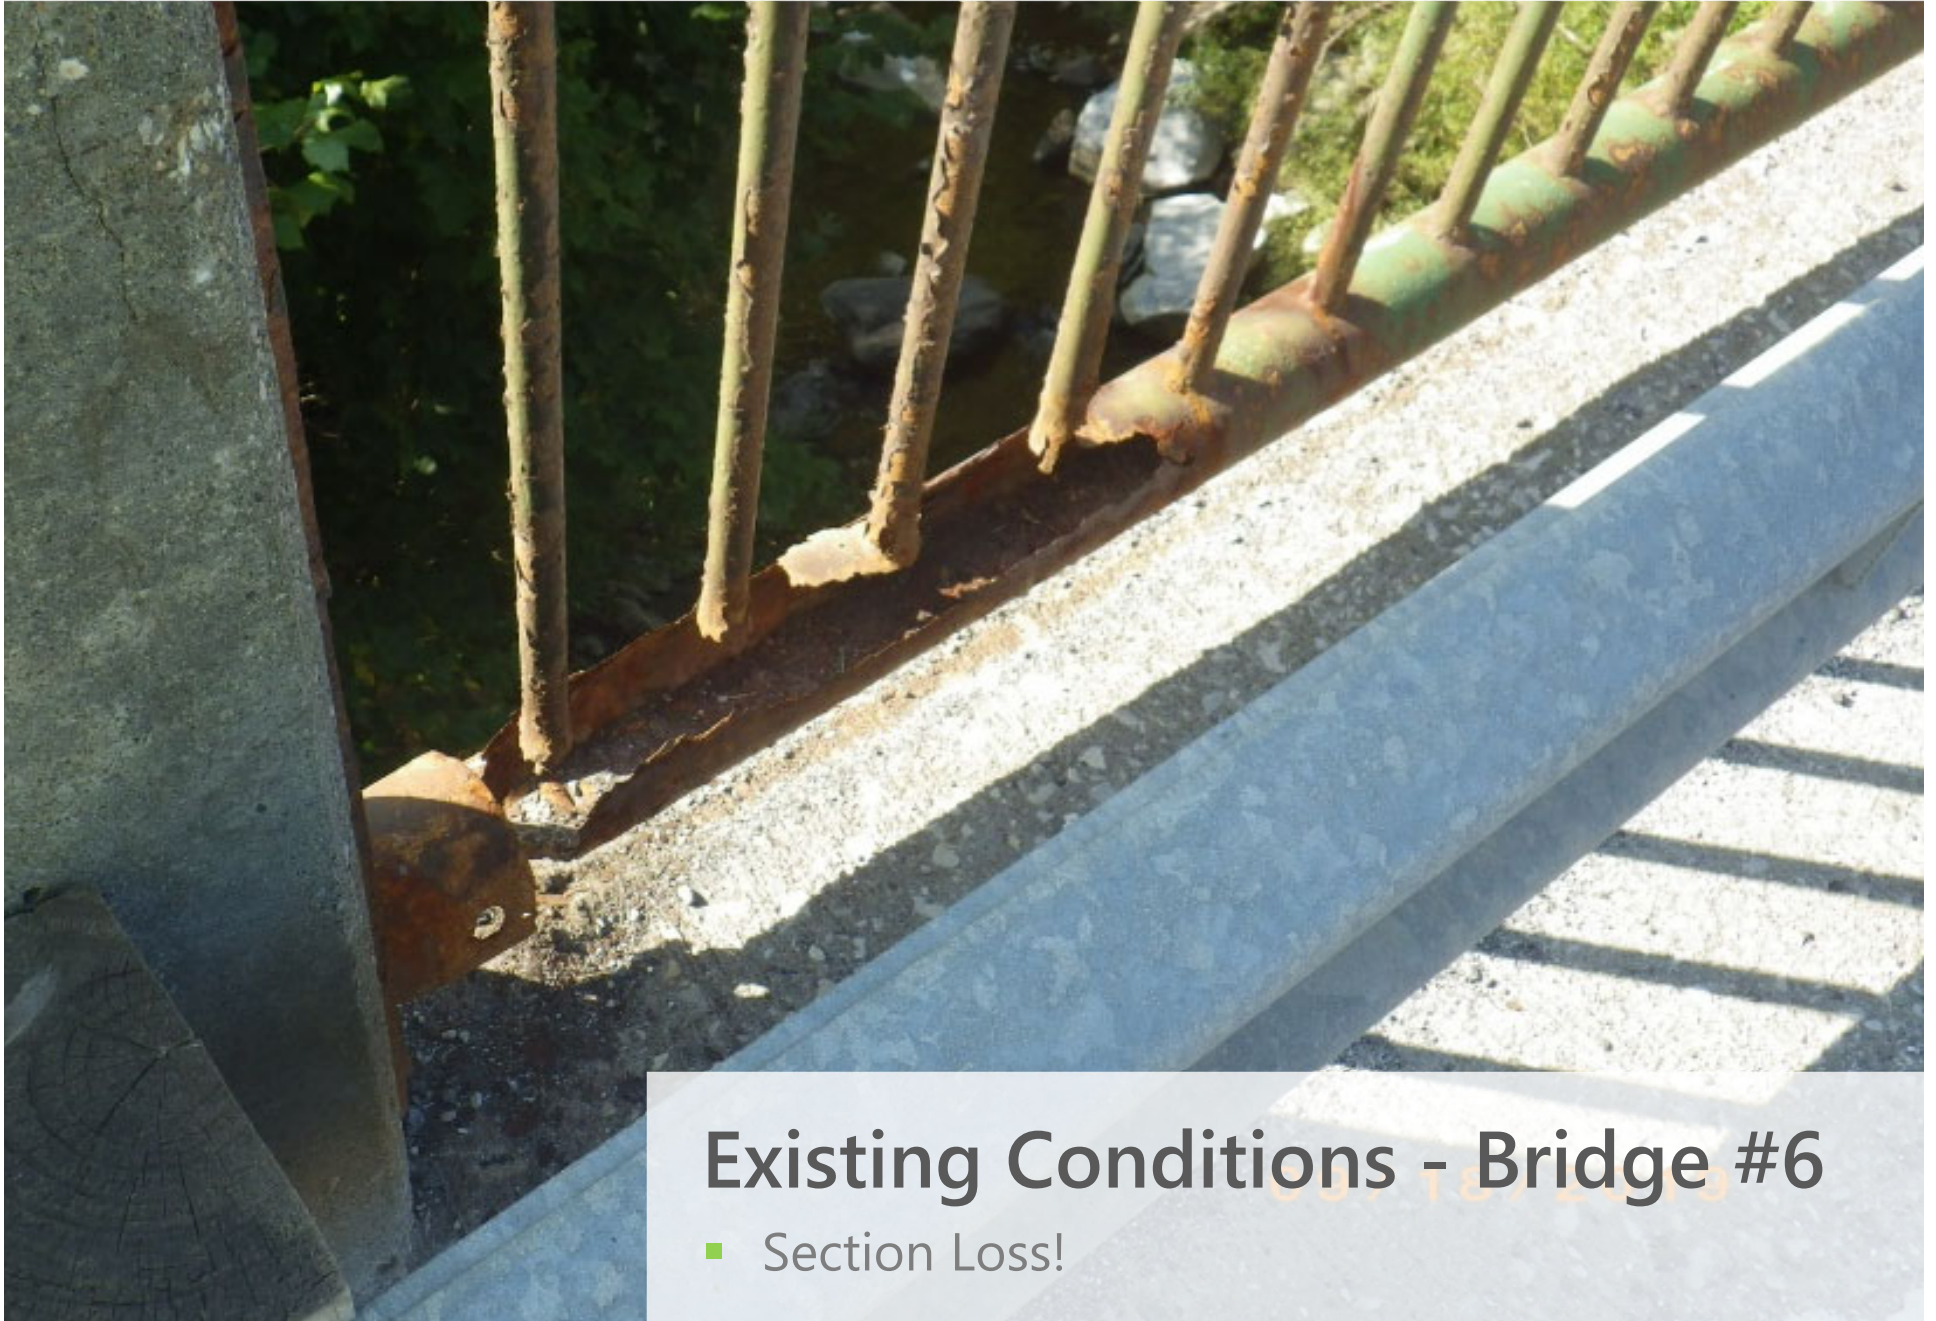
Railing

- Section Loss!
