Bridge 9
VT Route 102 over
Nulhegan River

Town of Bloomfield, VT

ALTERNATIVES PRESENTATION MEETING

Bloomfield BF 0271(21)

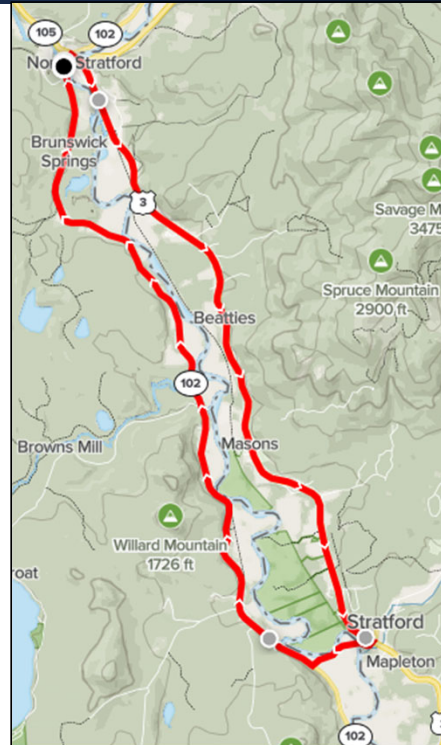
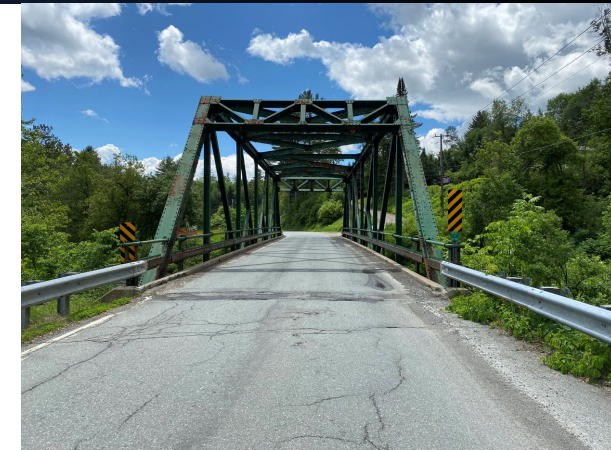
Narrow Bridge: Pedestrian, Bicycle and Snowmobile conflict

18 Mile Detour on already busy road that is Posted for 20 Tons with increased emergency response time

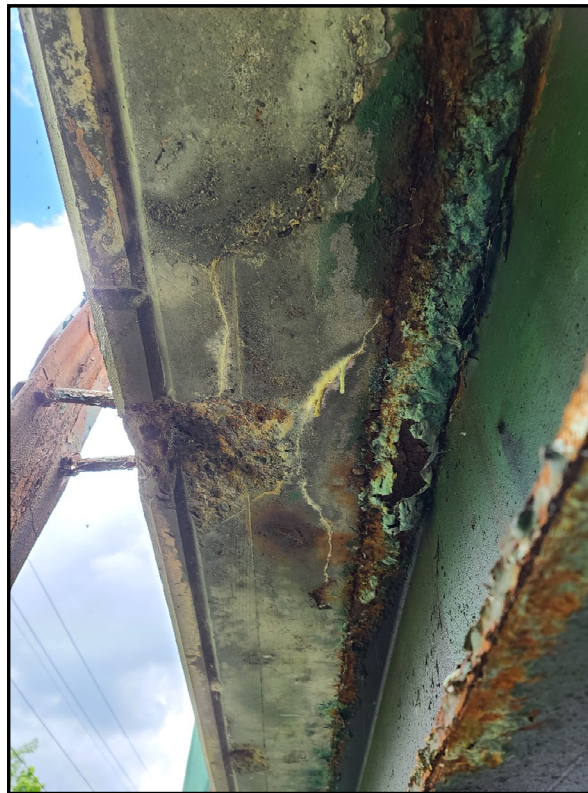
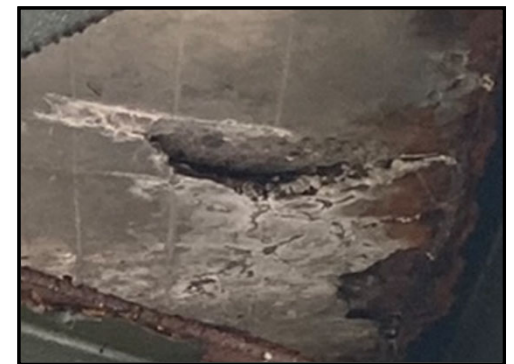
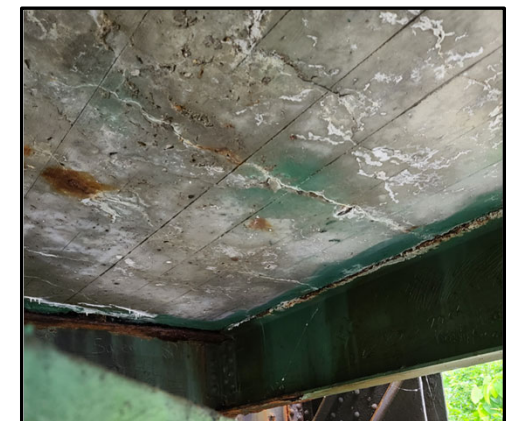
Existing Conditions – Deck (below roadway)

- Cracks and Spalls present on bottom of deck
- Marked deterioration in bridge overhangs, particularly at rail post connections

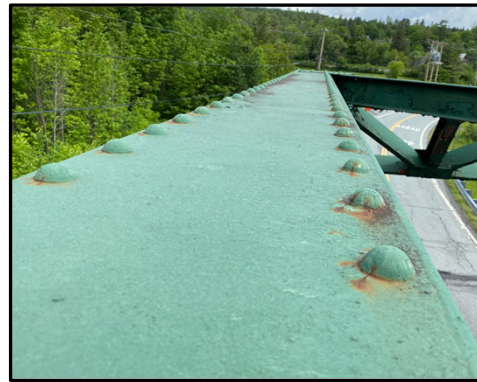
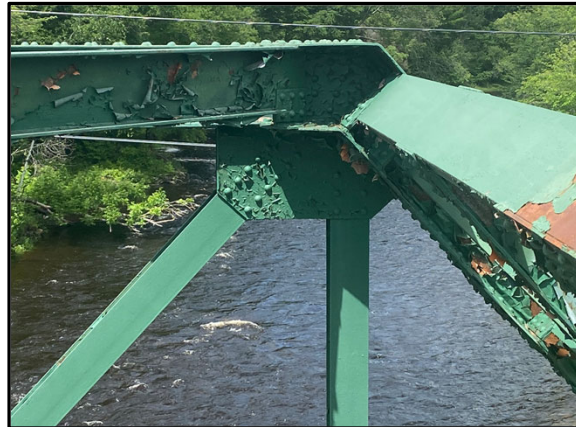
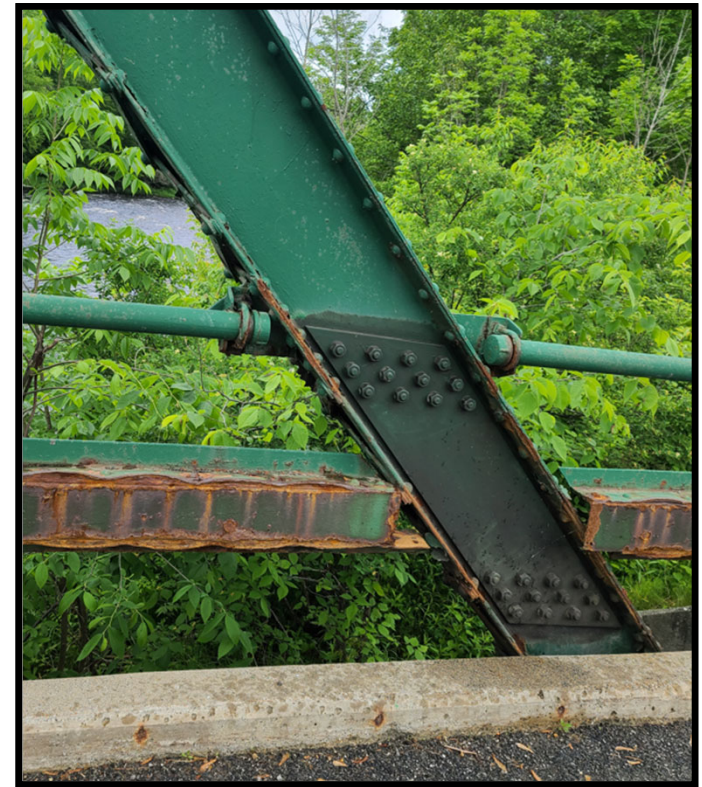
Existing Conditions – Truss (above roadway)

- Primary and secondary members are all in relatively good condition above the deck level (other than paint condition)
- Evidence of prior repairs in good condition

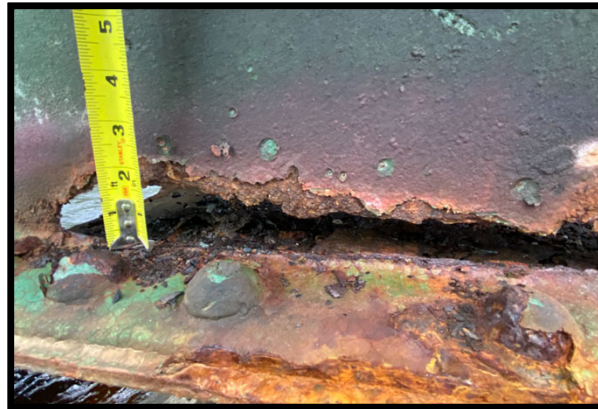
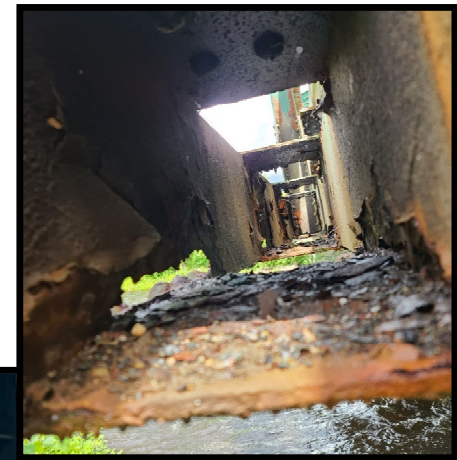
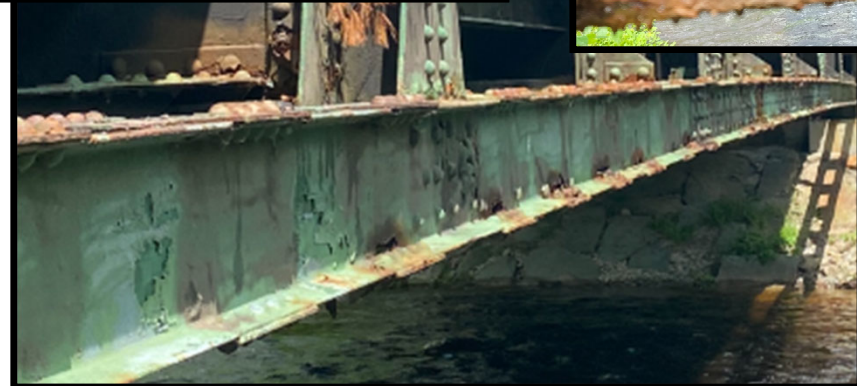
Existing Conditions – Truss (below roadway)

- Lower Chord Members Show regular regions of section loss at batten plates
- Full Truss needs to be cleaned and repainted to continue to protect the existing steel from corrosion
- Existing paint may be lead based

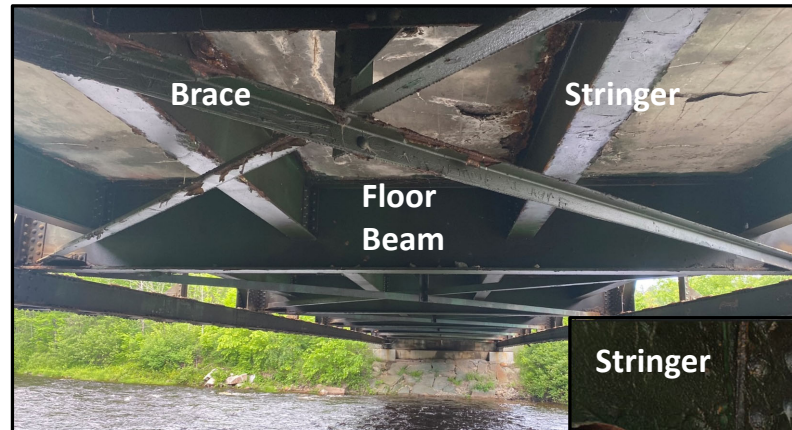
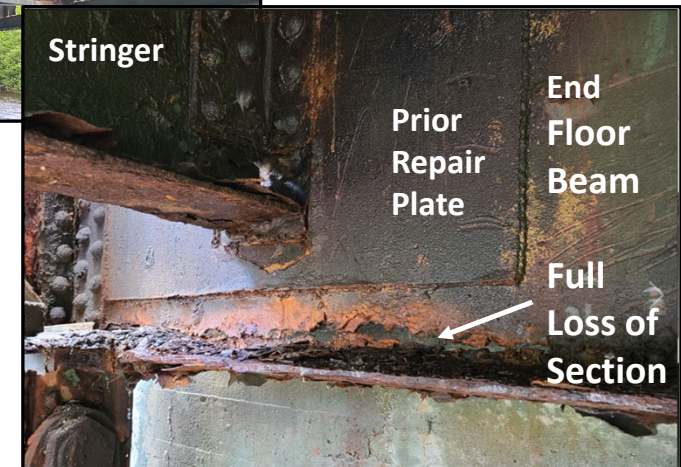
Existing Conditions – Floor System

- Severe Deterioration of All Components
- Replacement Required:
 - Stringers
 - Floor beams
 - Bracing of expansion end bay

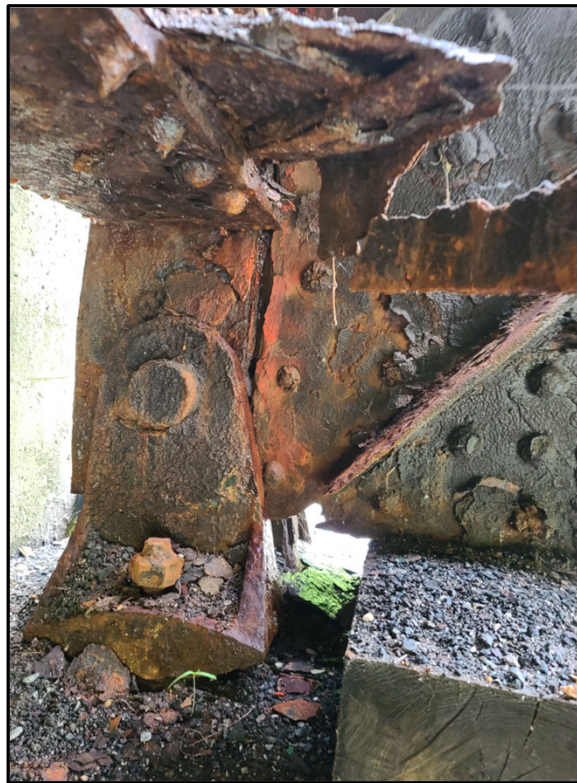
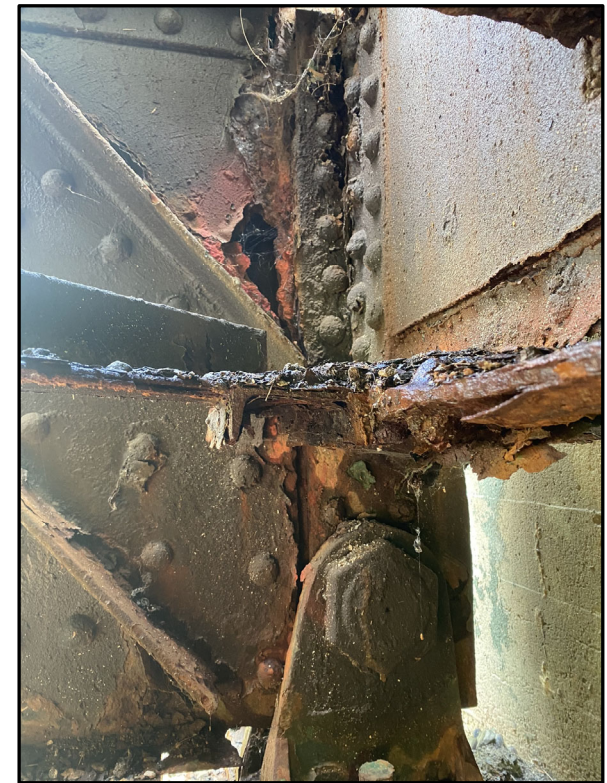
Existing Conditions – Truss (Expansion Bearings)

- Severe Deterioration of Both Bearings at Expansion End Require Replacement
- Areas of complete loss of section in connecting plates and braces
