Eden BF 029-2(15)
Regional Concerns Meeting
VT Route 100 – Bridge 220 Over Gihon River

May 10, 2022

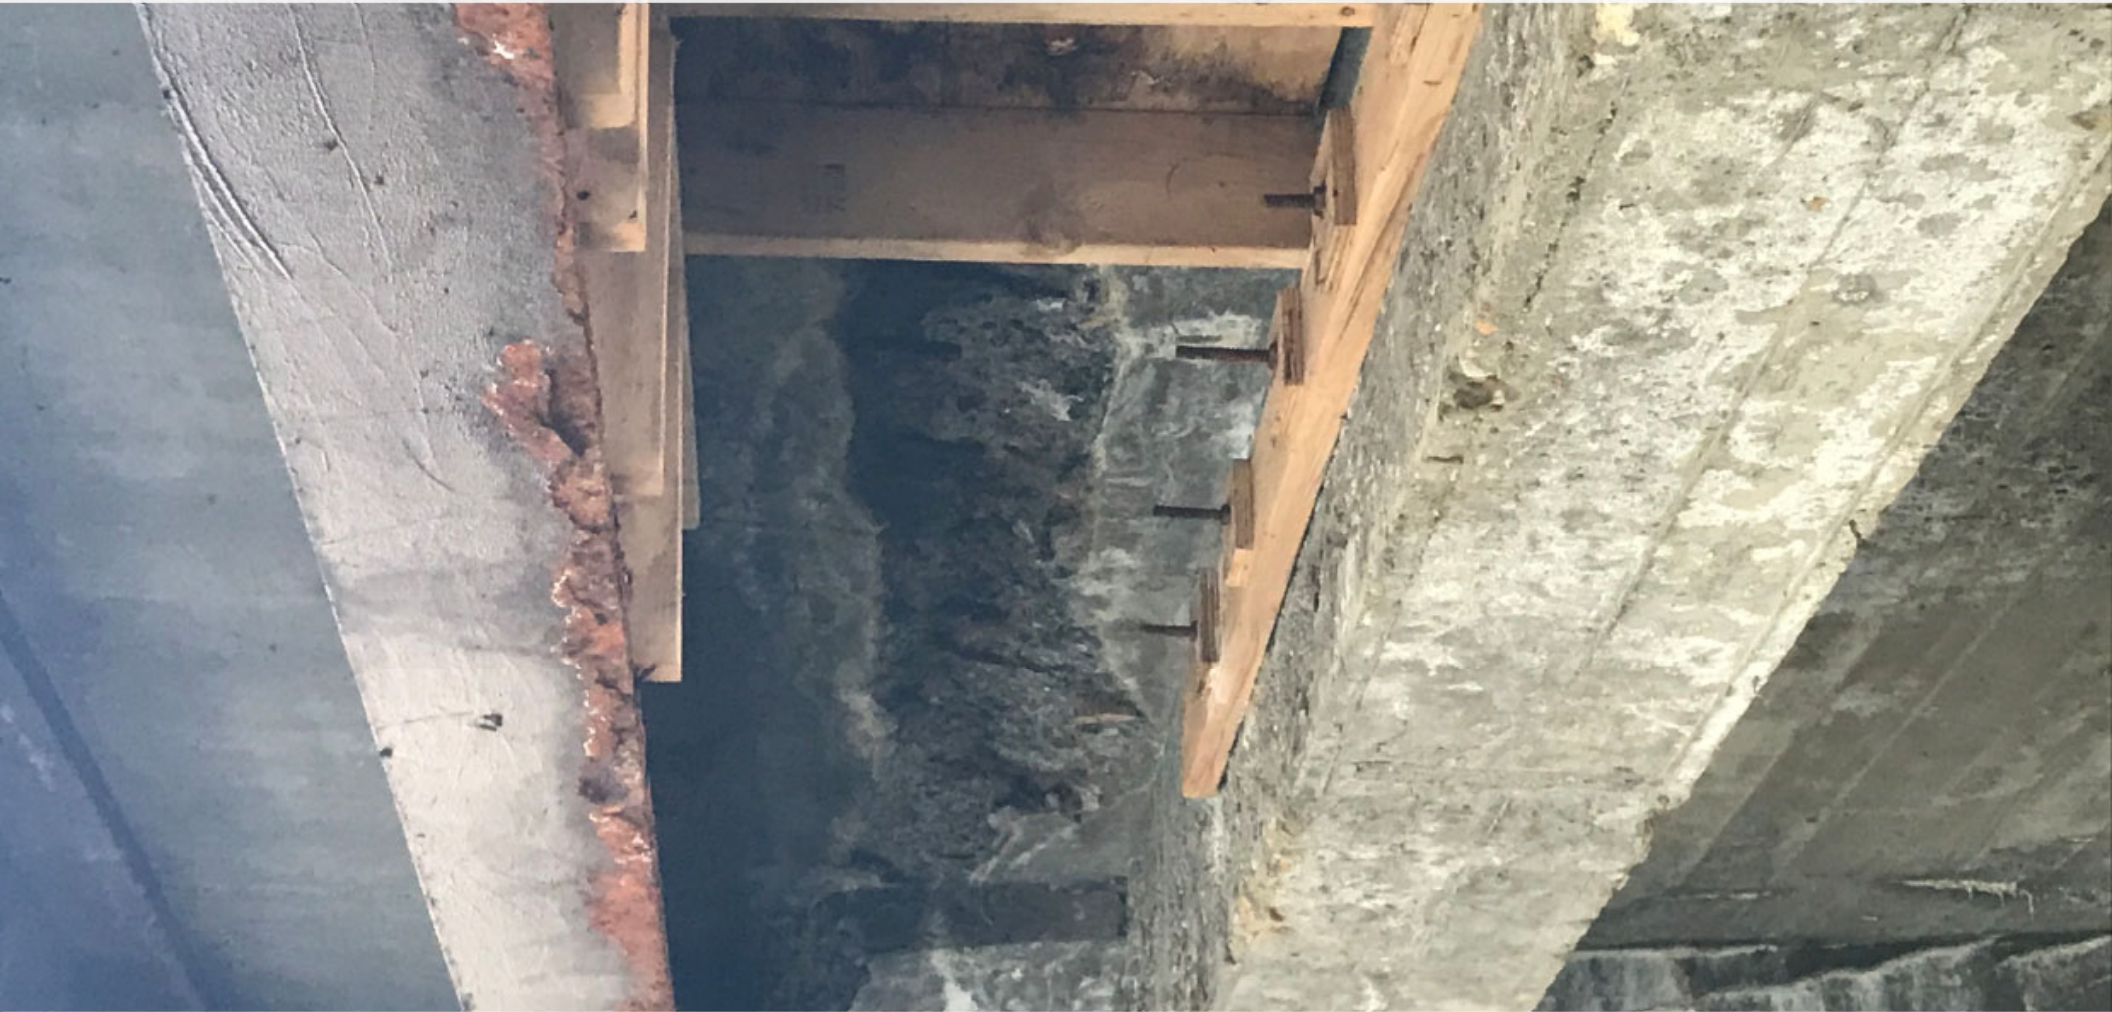
Bridge Inspection Report Ratings

- Deck Rating 4 (Poor)
- Superstructure Rating 7 (Good)
- Substructure Rating 6 (Satisfactory)

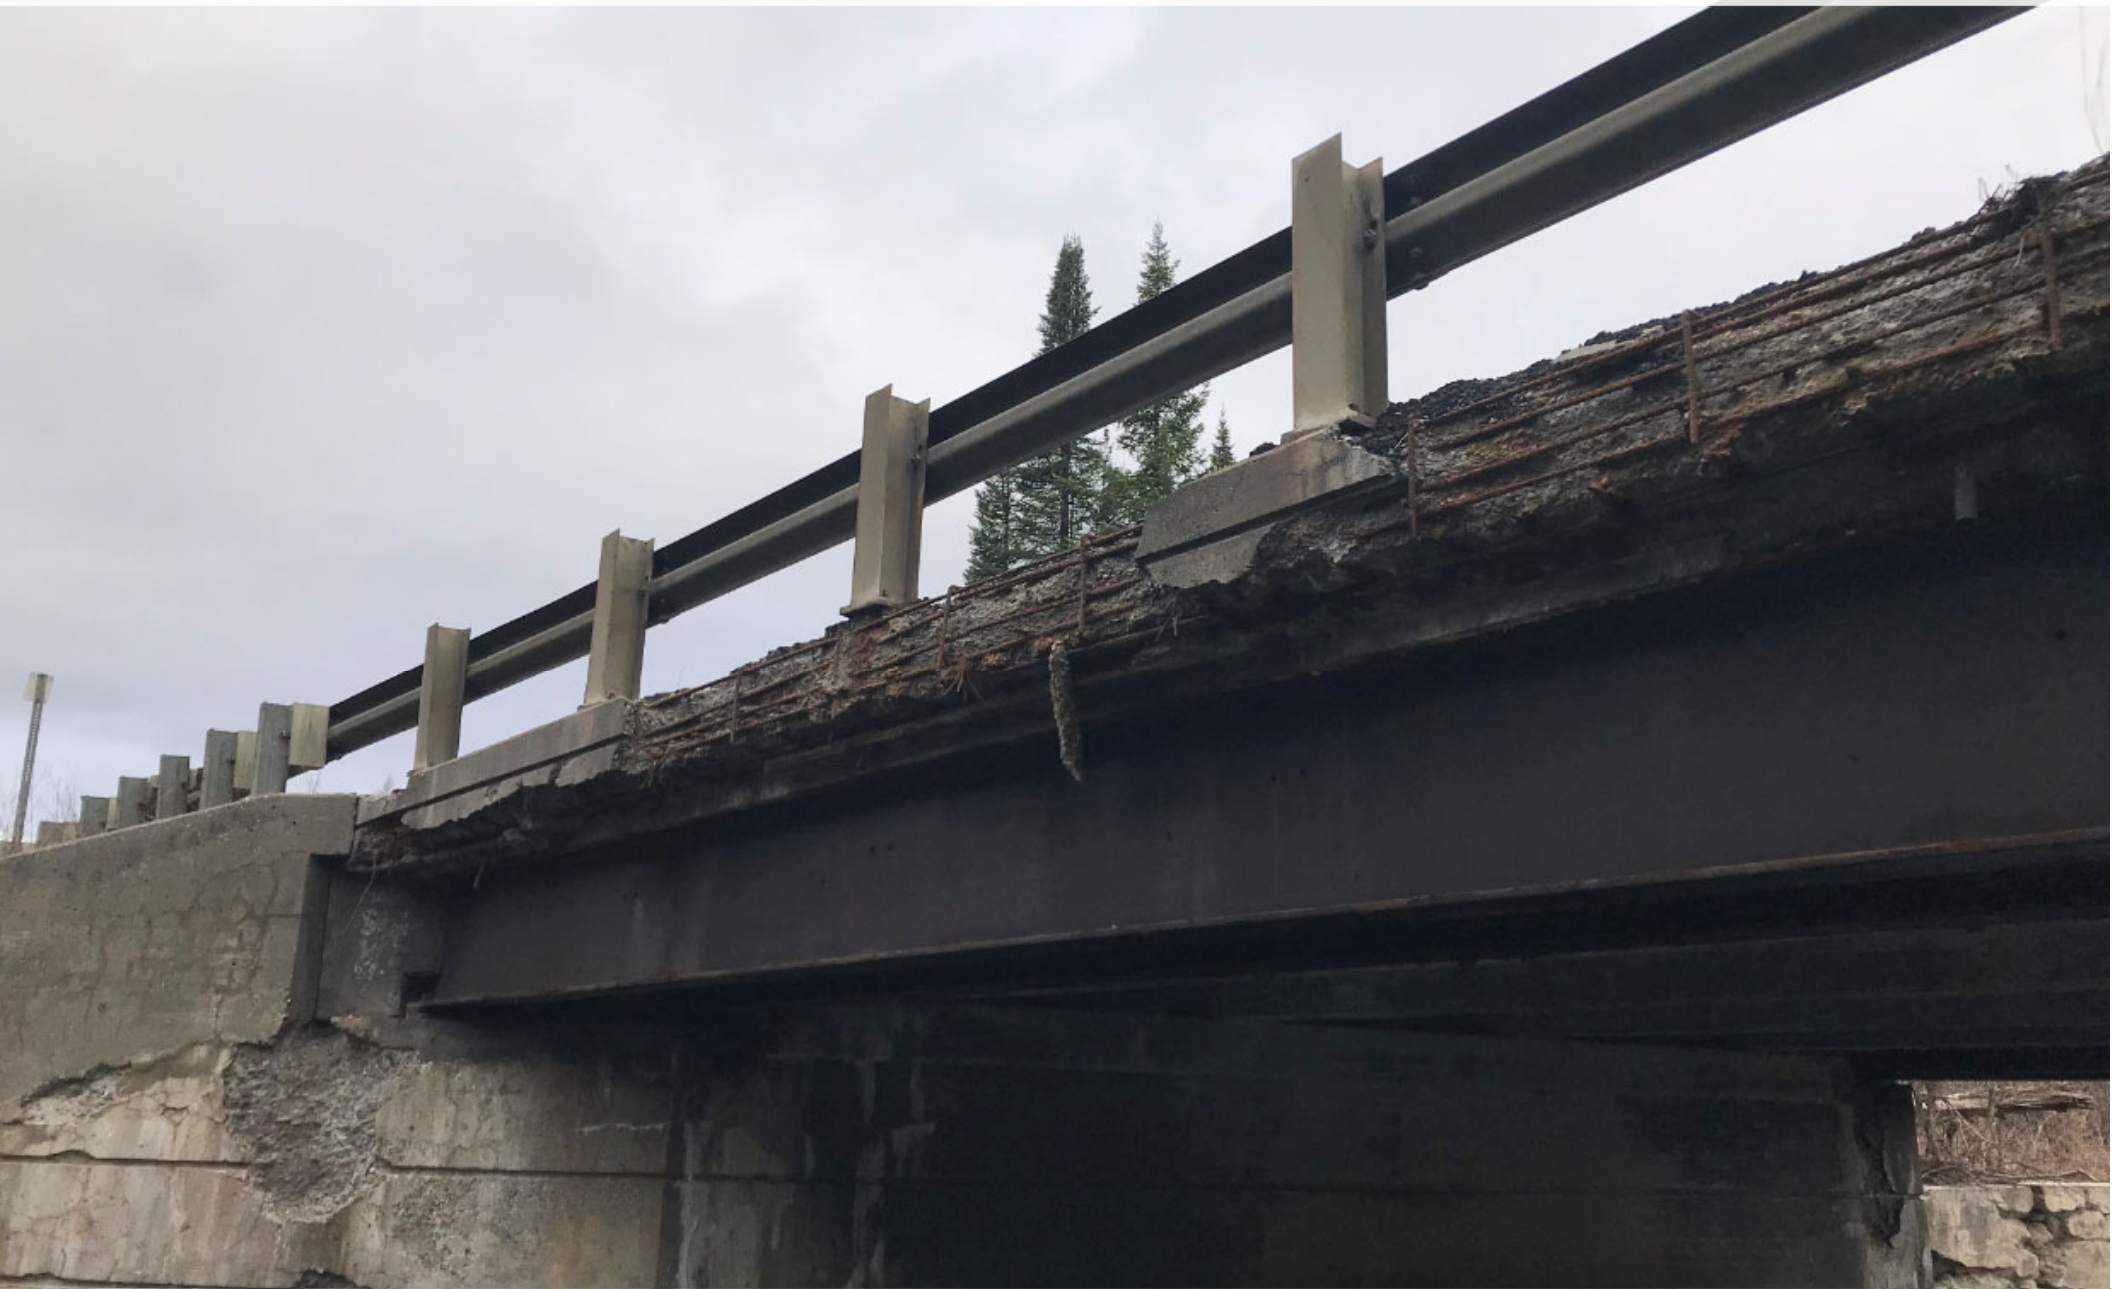
Downstream Fascia

- The reinforced concrete deck is in poor condition with heavy spalling with saturated concrete and heavily rusted steel reinforcing exposed in areas. A steel plate has been installed near the midspan with wood catch forms installed below. The downstream fascia is in poor condition with heavy concrete spalling.
- The lower portions of both abutments have minor abrasion present. The wingwalls are only in fair condition with map cracking with efflorescence leakage and areas of heavy concrete scaling exposing areas of steel reinforcing.
- The existing bridge width is slightly narrow for the roadway classification and traffic volumes and does not provide adequate shoulder space for shared use.
- The bridge does not meet the minimum hydraulics standard or bank full width requirements.

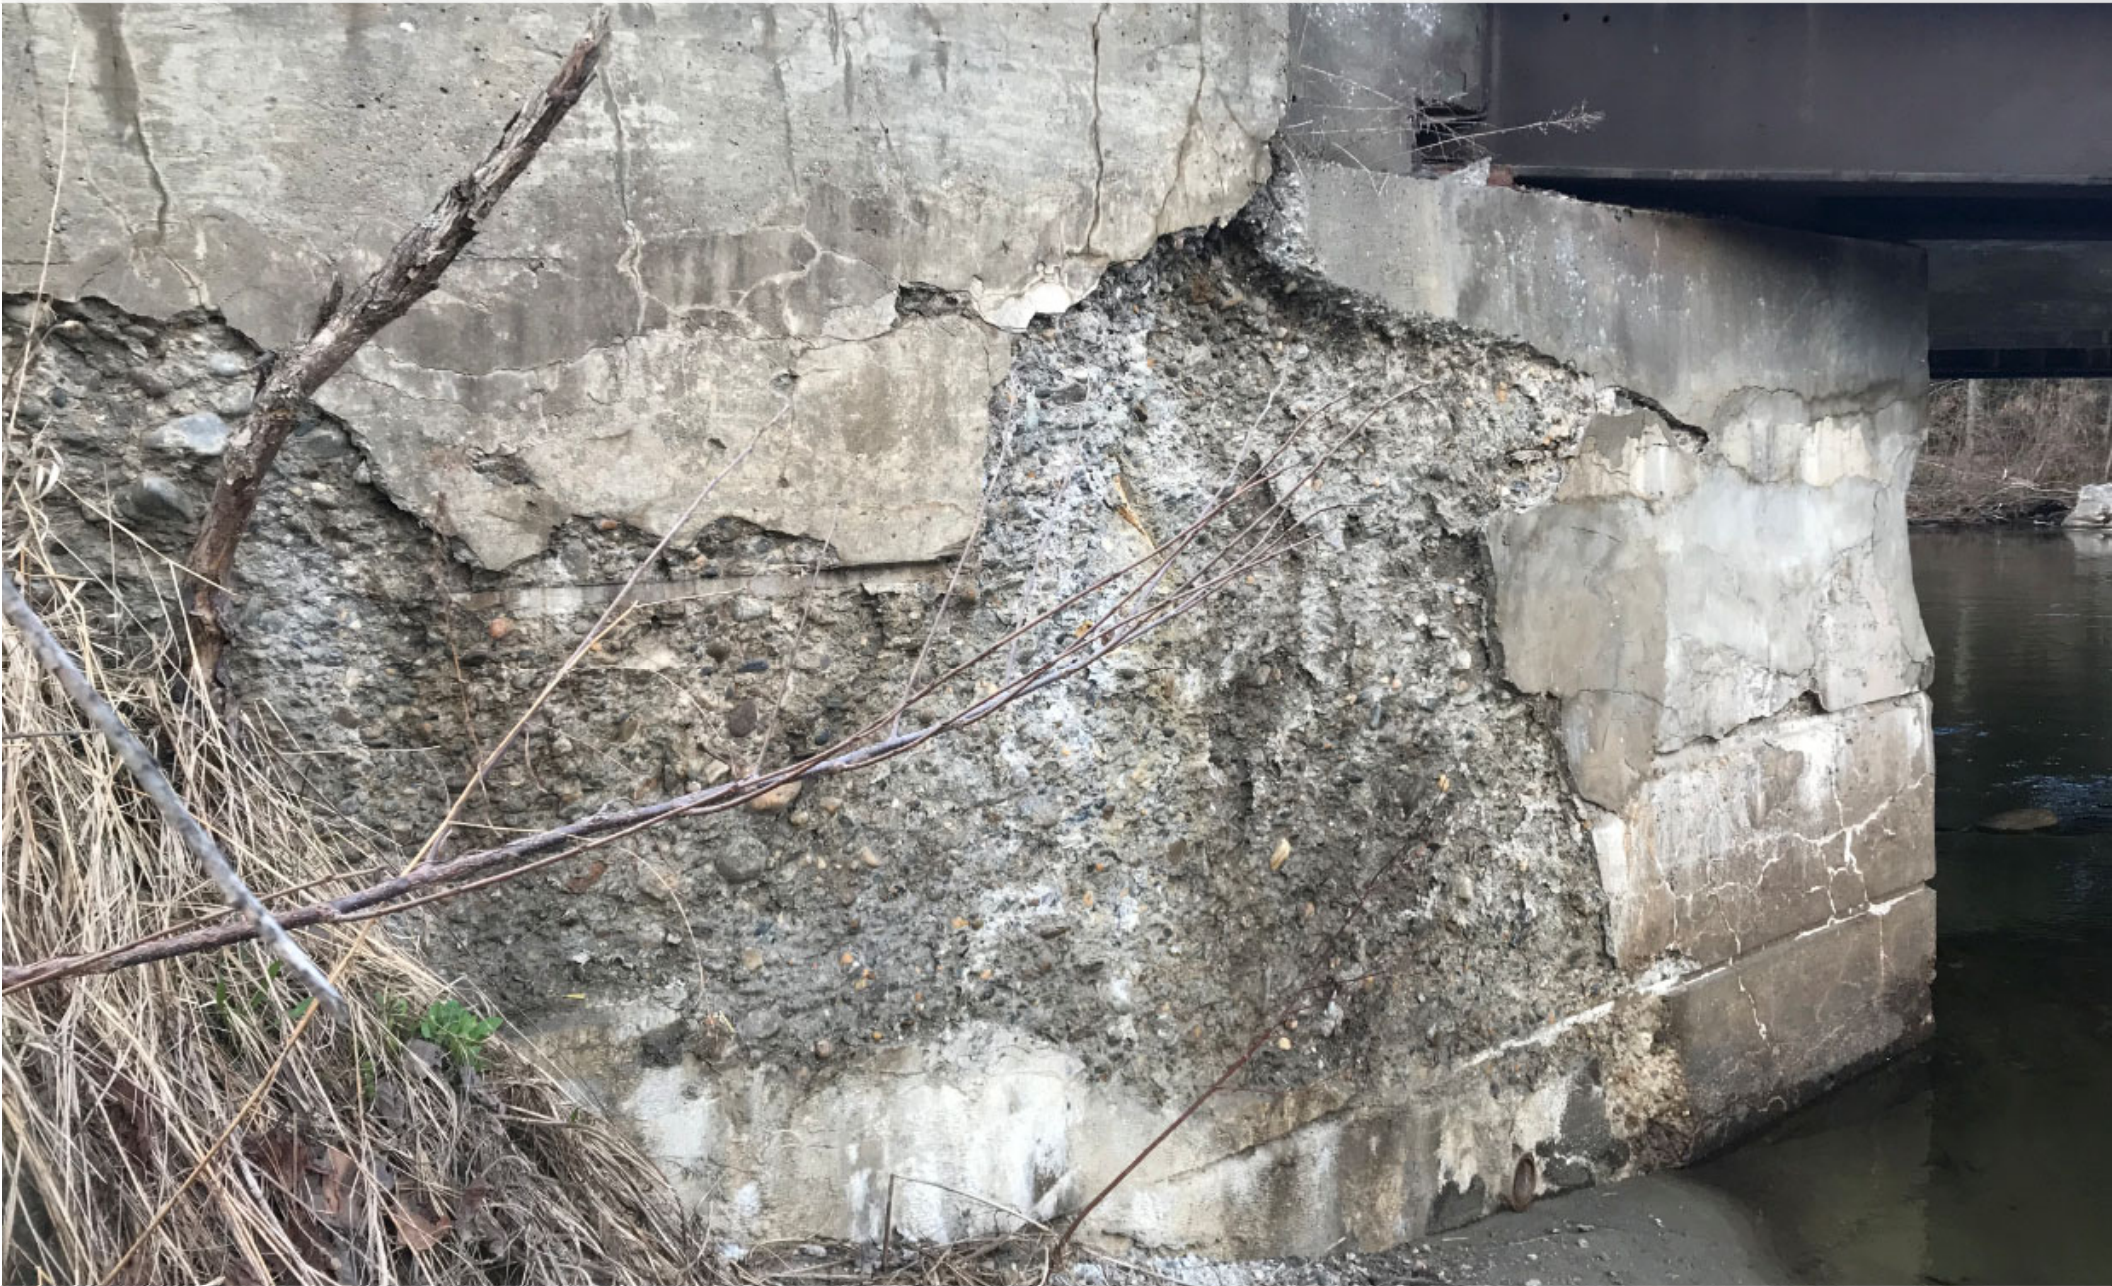
Wingwall Deterioration
