Norton BF 0321(21) Public Informational Meeting VT ROUTE 114, BRIDGE 41 OVER NUMBER FIVE BROOK

April 9, 2024

Existing Site Conditions – Bridge #41

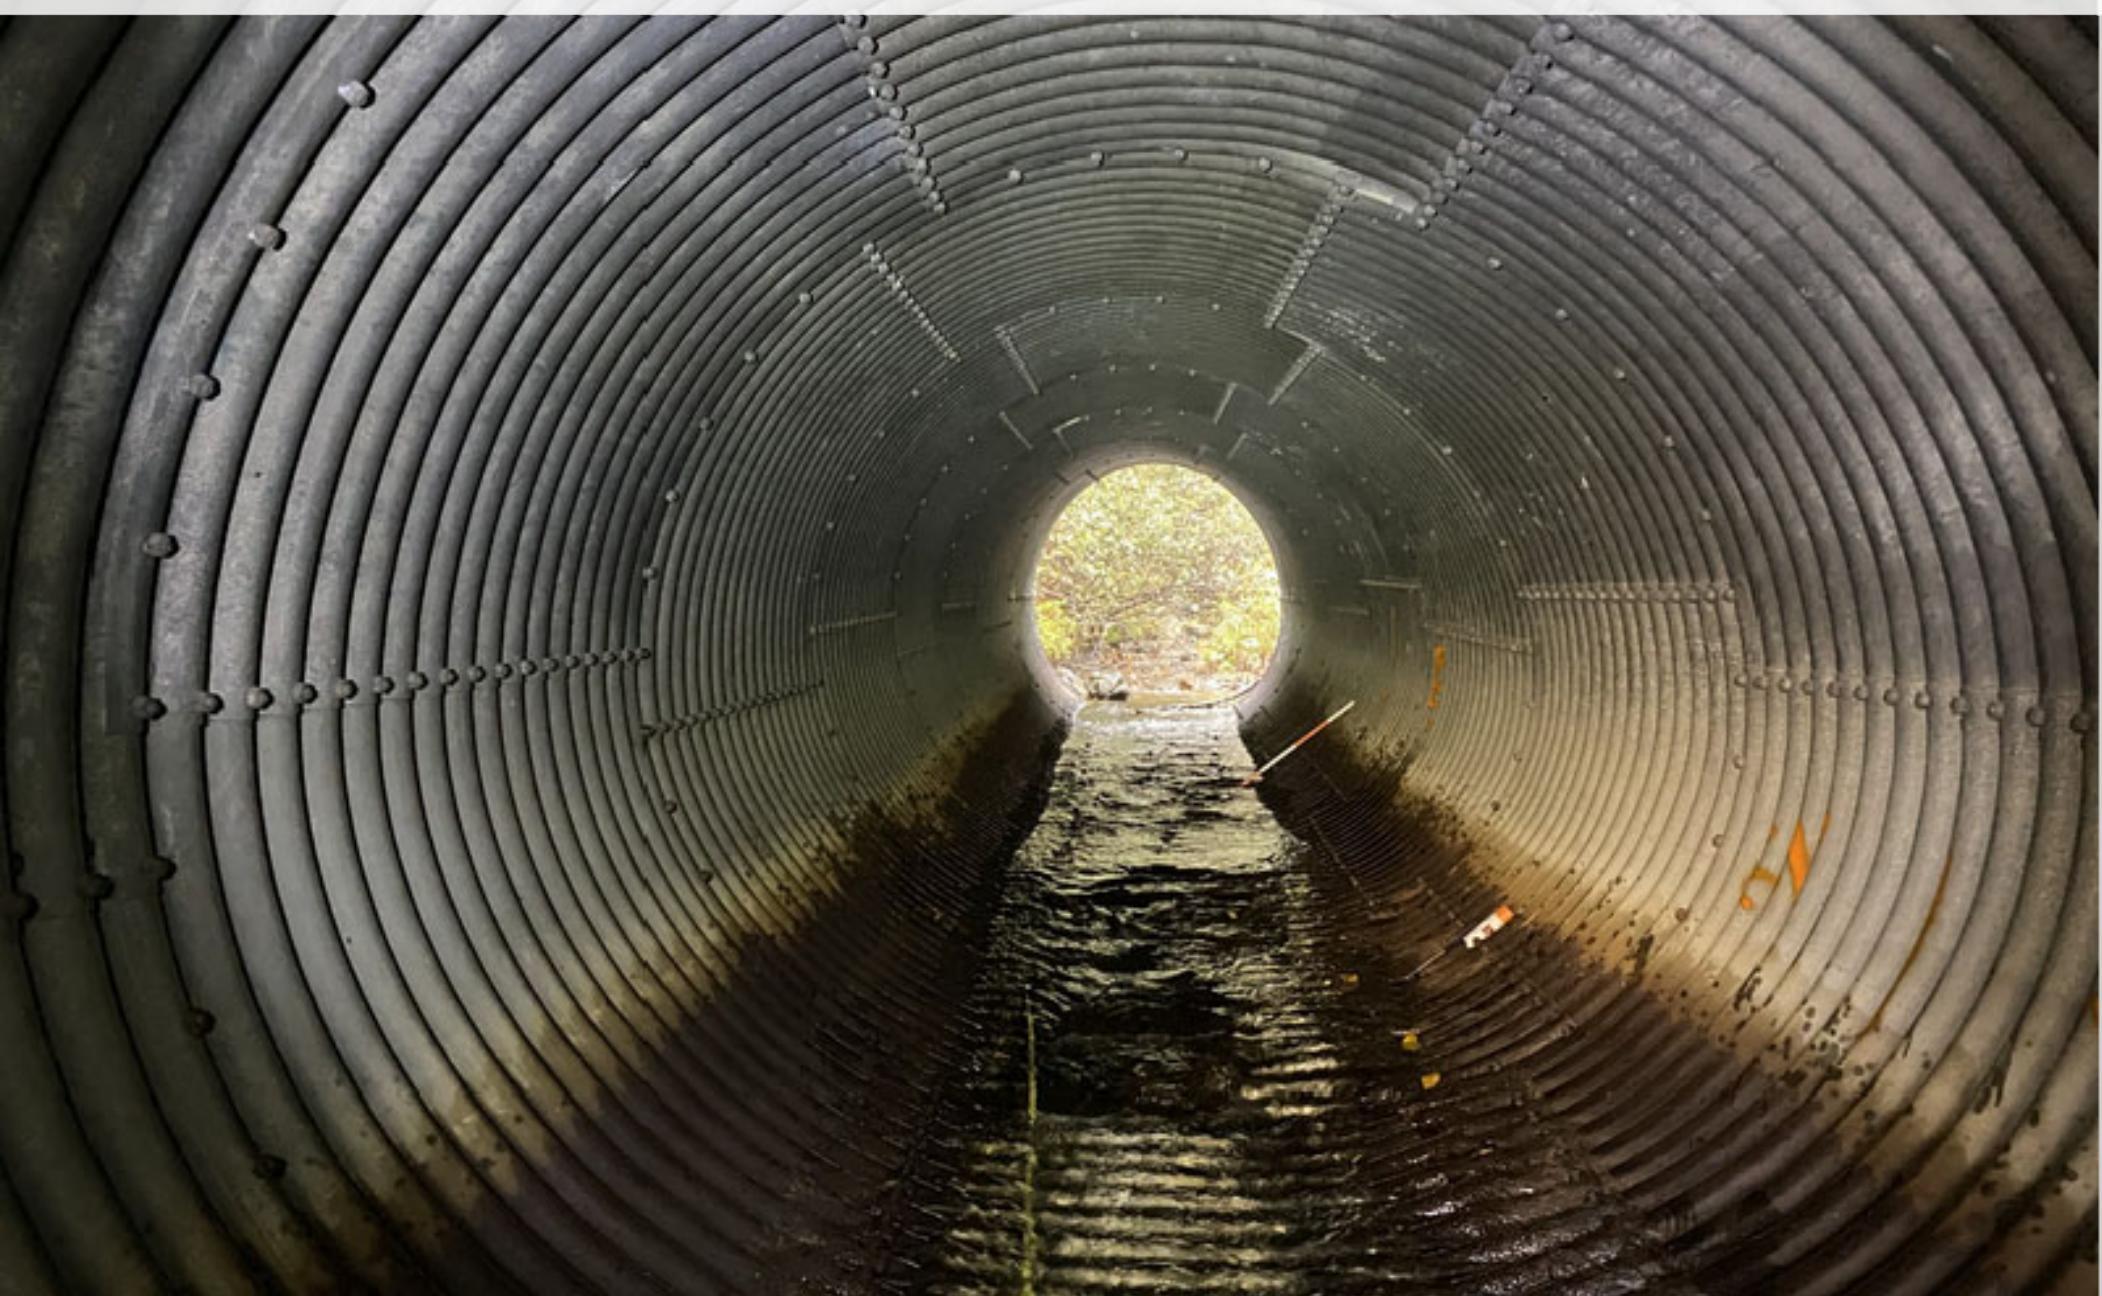
Barrel – Deformation

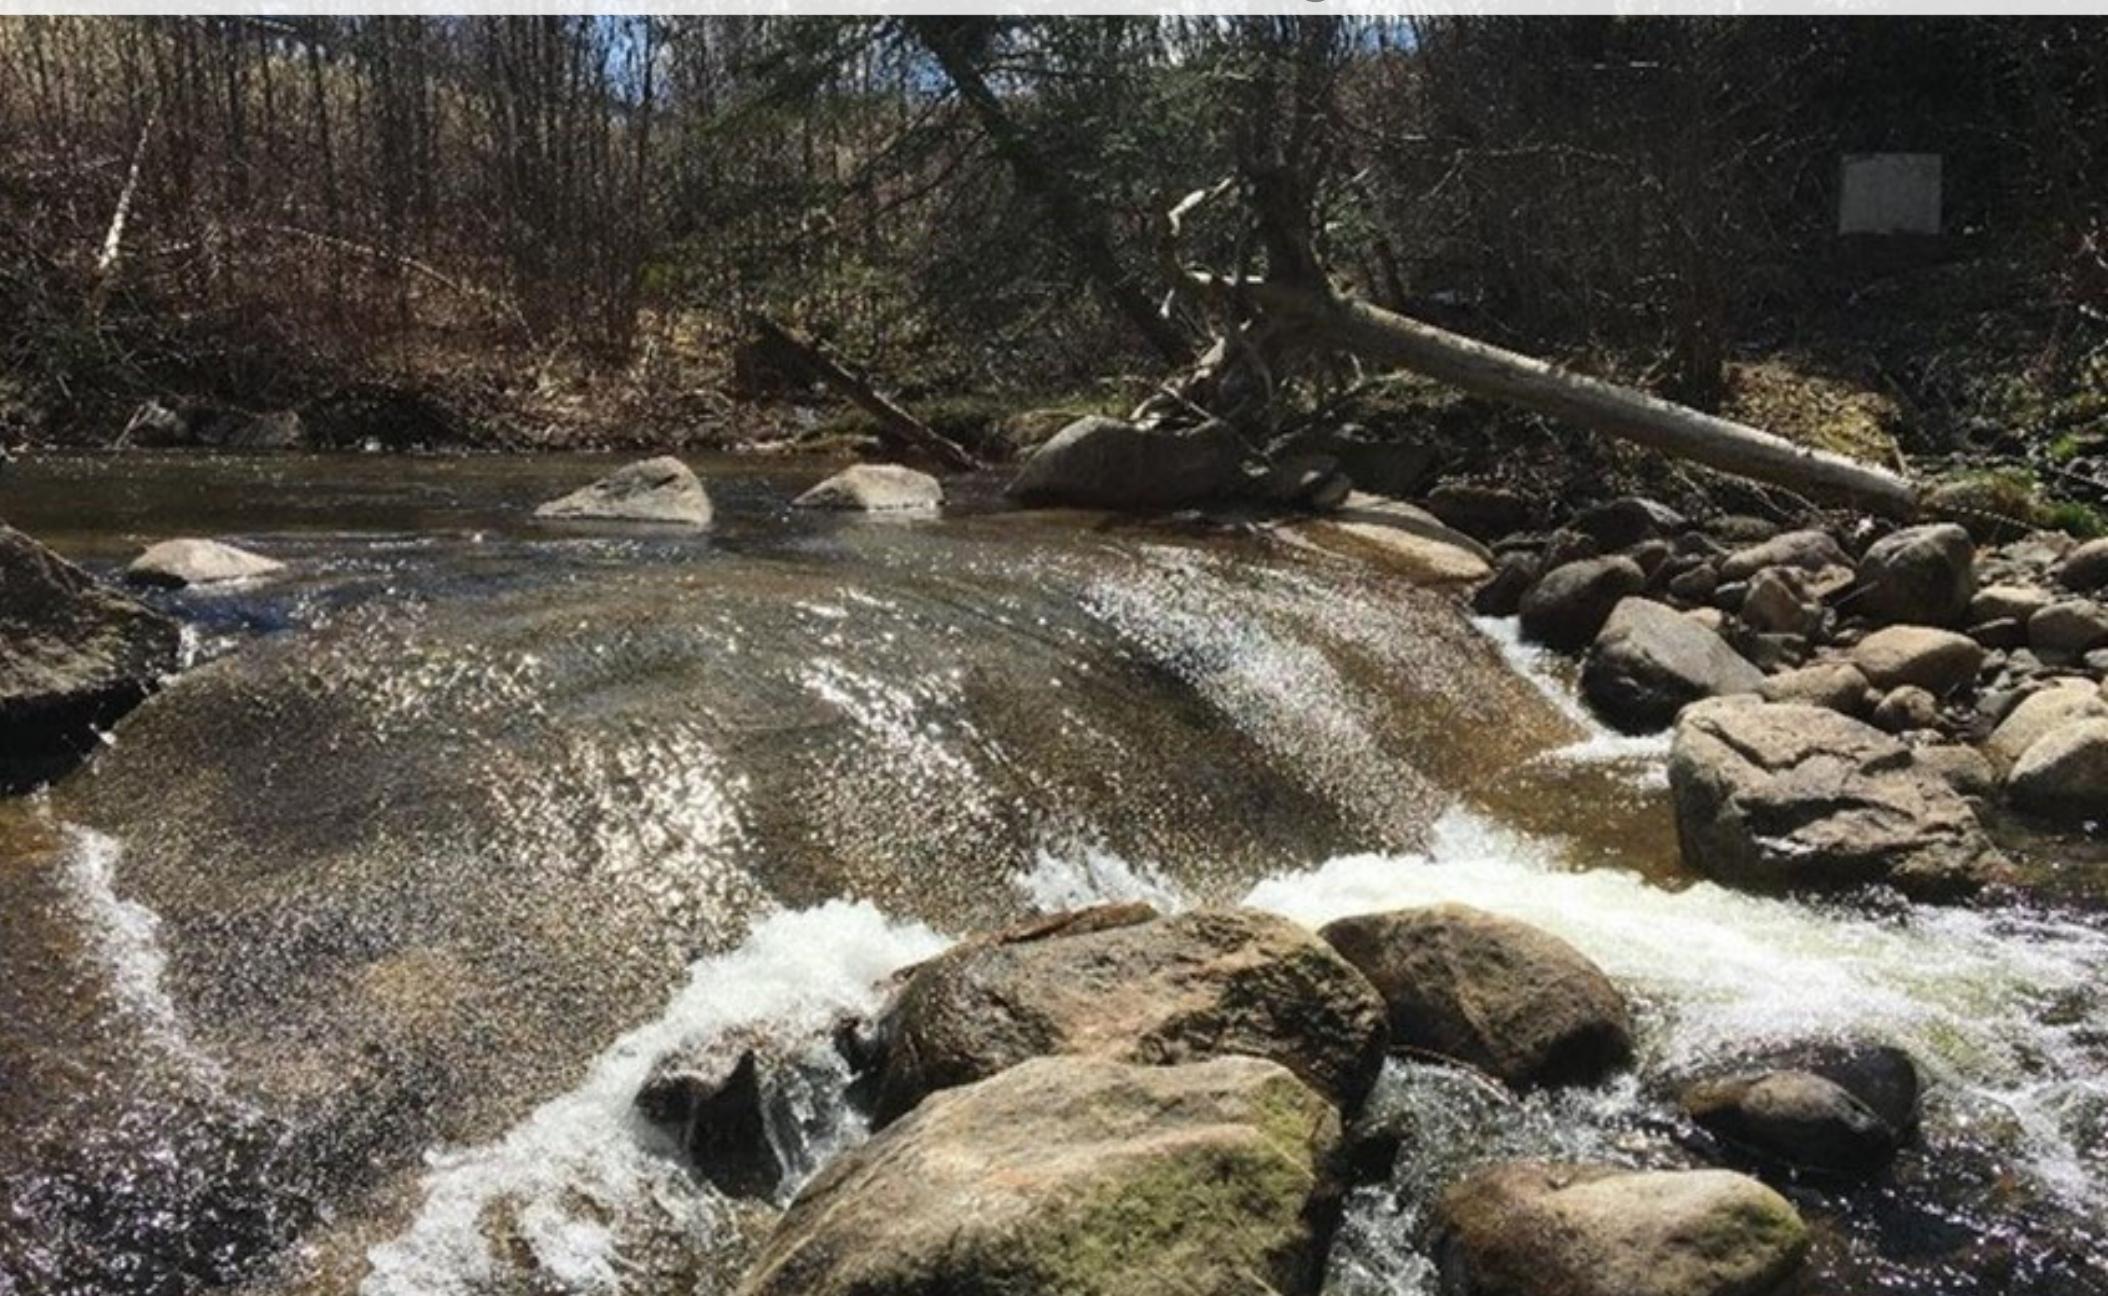
Scour Hole "Sill" is Visible Ledge at Outlet

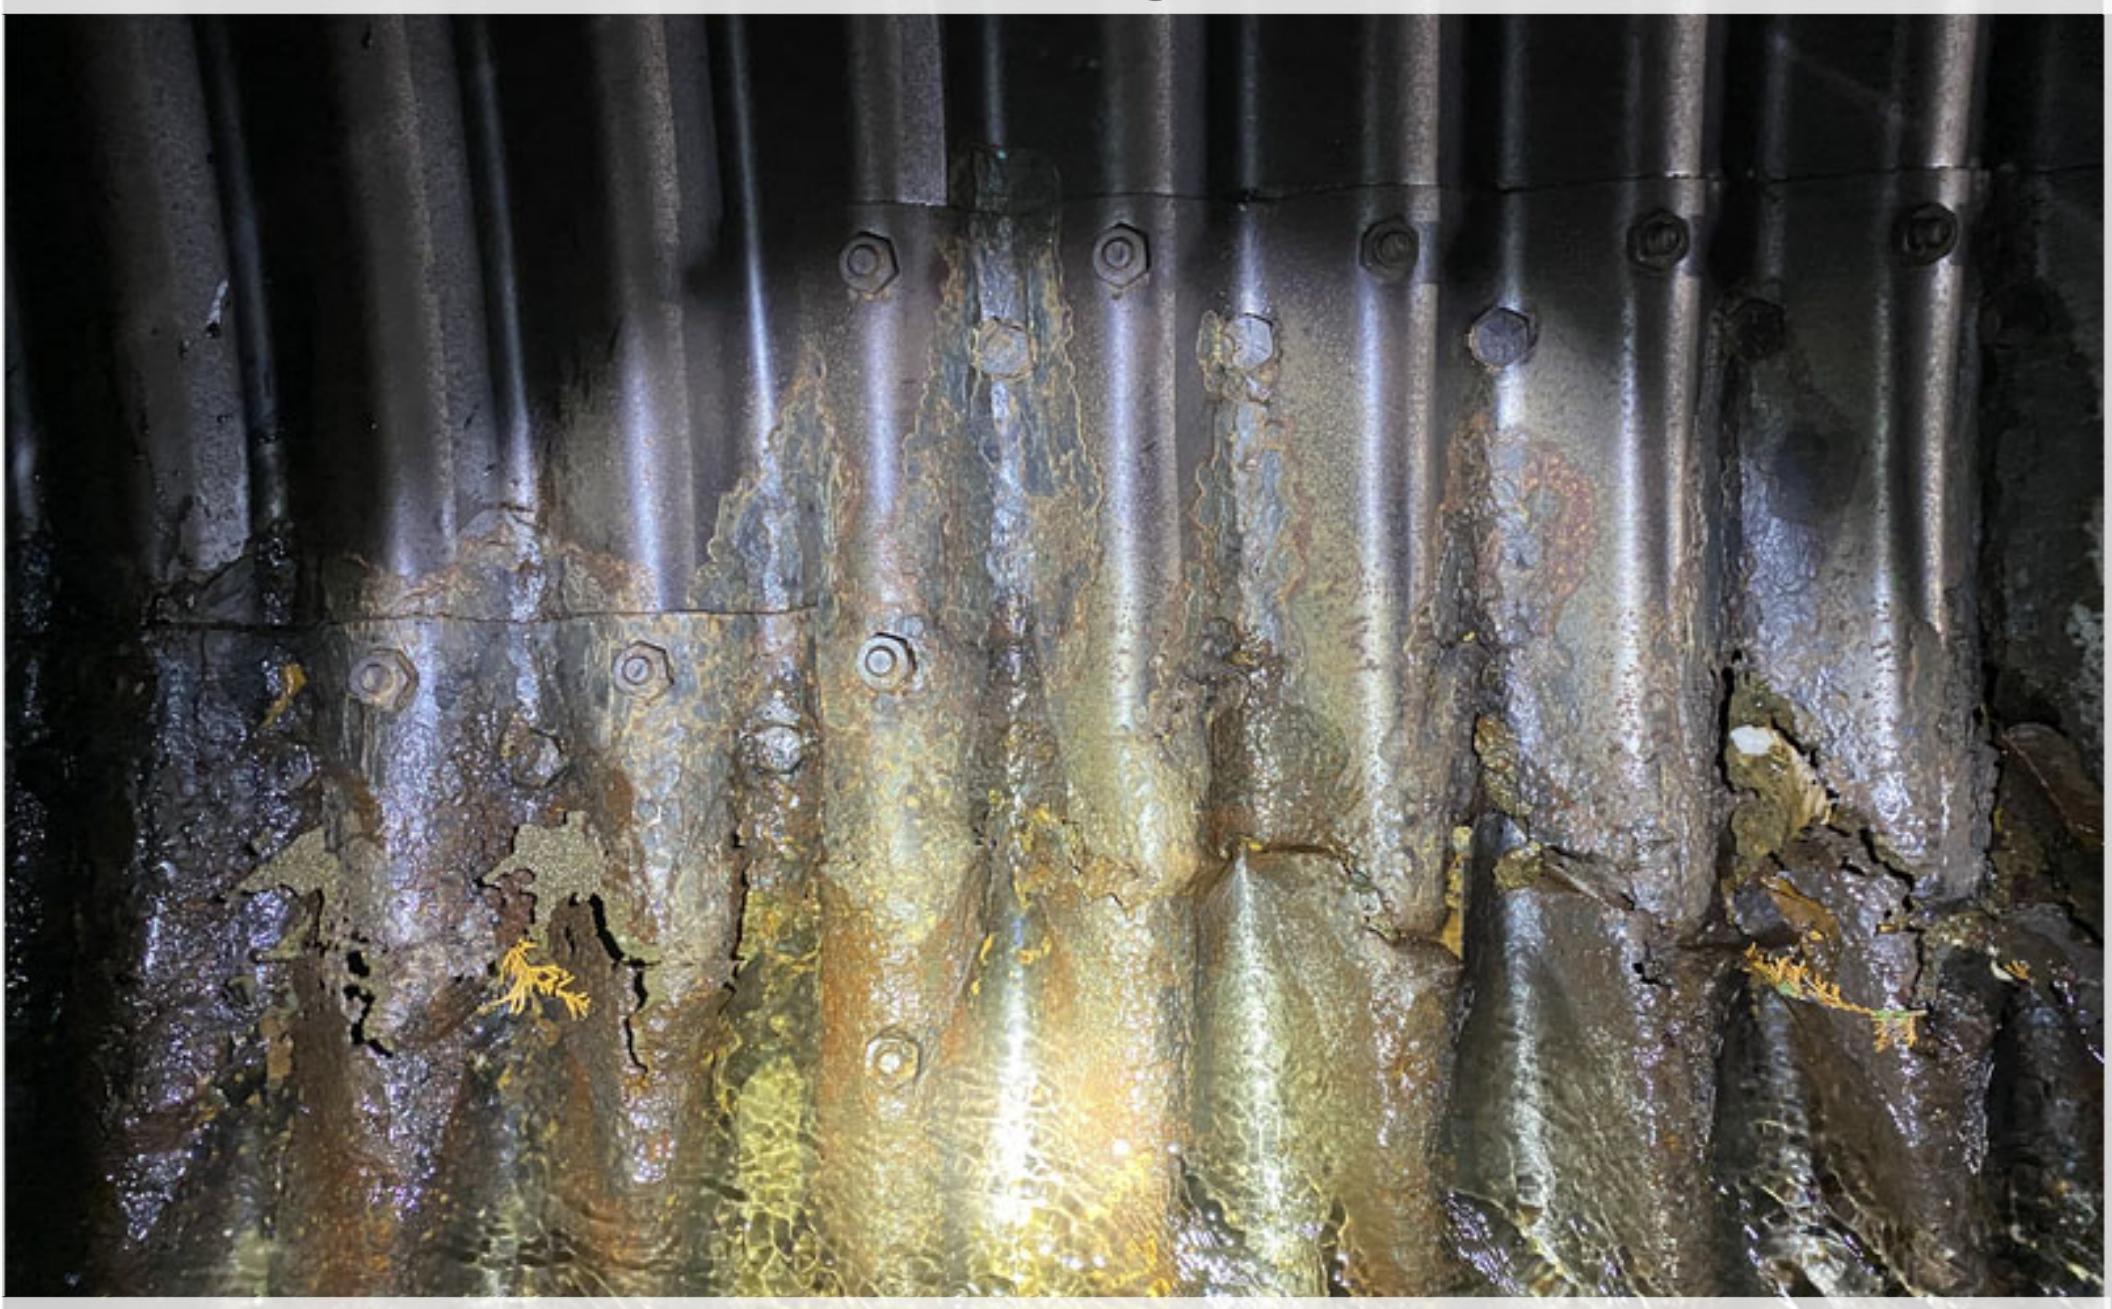
Perforations/Crushing on Side Panel

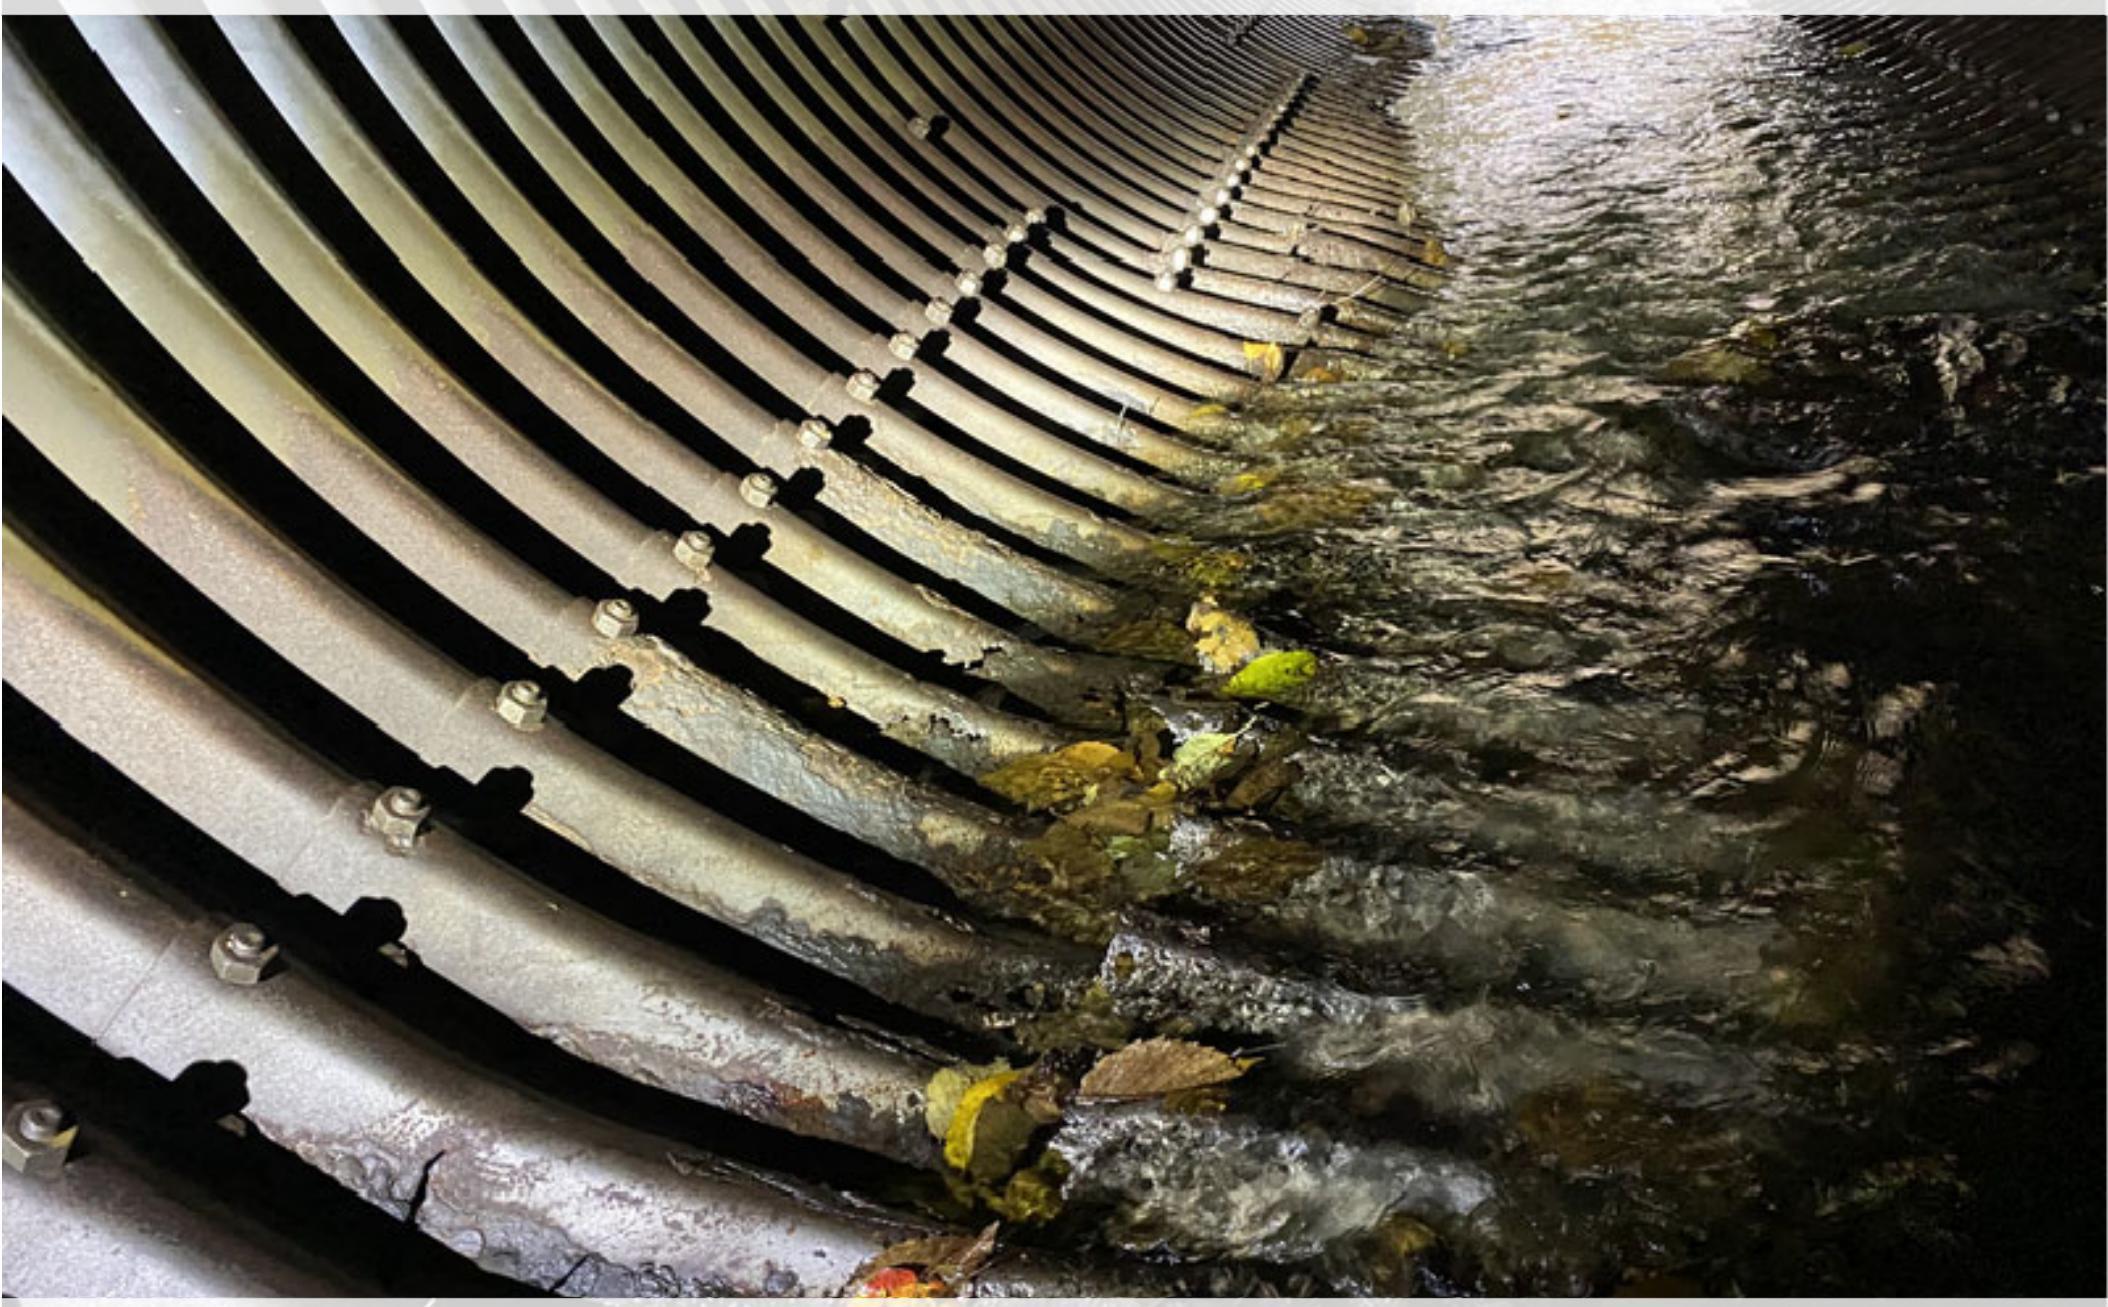
Perforated Invert
