STATE OF VERMONT AGENCY OF TRANSPORTATION

Scoping Report

FOR Rutland City BF 3000(24)

TOWN HIGHWAY 8 (RIVER ST), BRIDGE 27 OVER VERMONT RAILWAY (VTR) -General Merritt A. Edson Memorial Bridge-

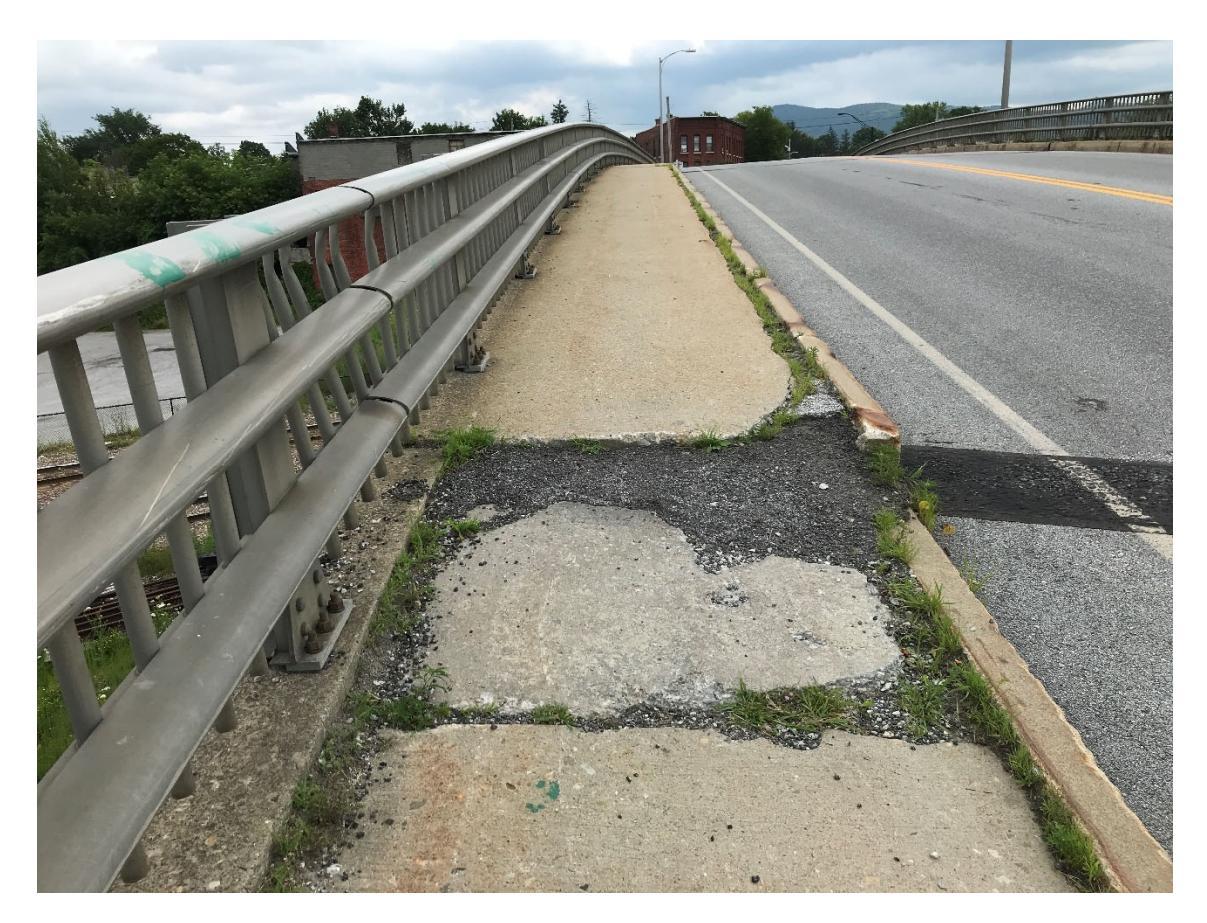
Sidewalk and Guardrail.

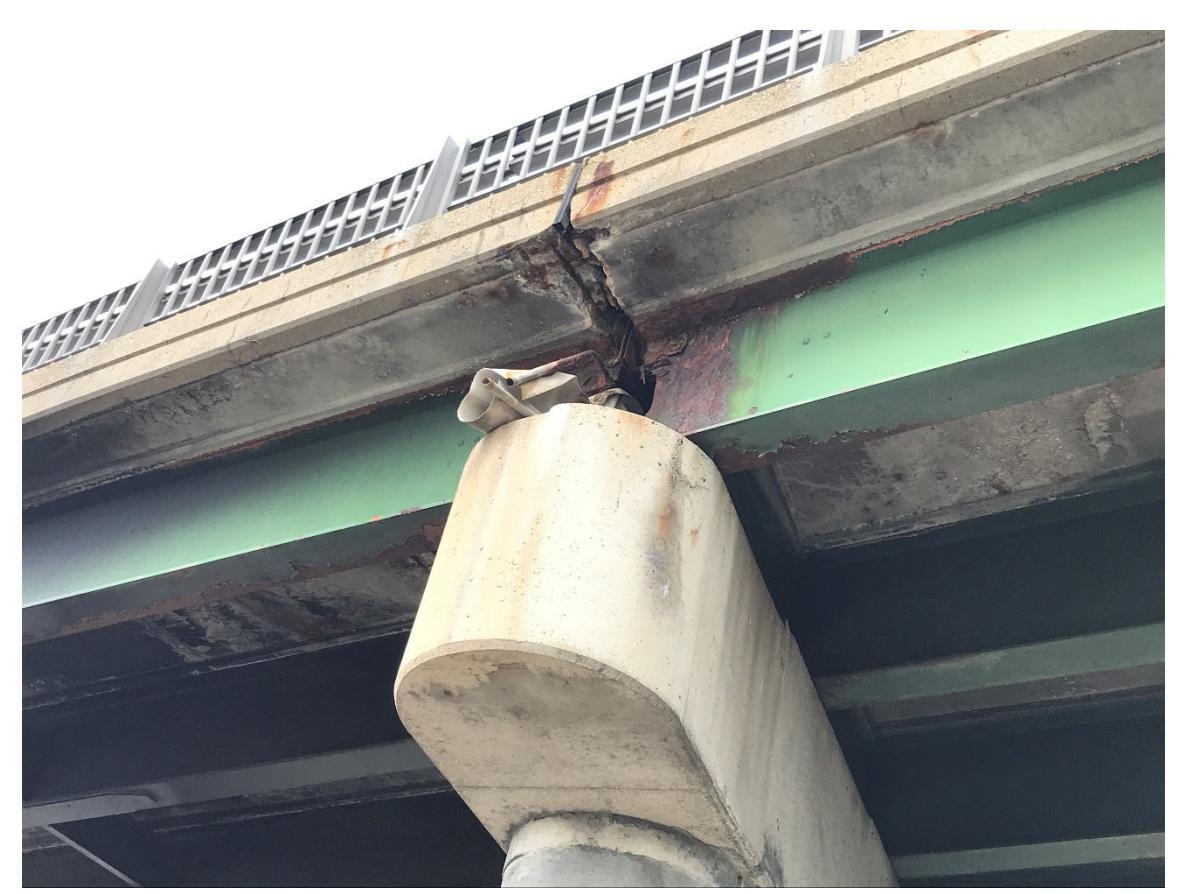
Joint & Beam

- There are areas of water damage to the steel beams at the joints. The beams should be inspected, cleaned, and a new protective coating applied as needed.
- Bearings should be inspected and cleaned as needed.
- The wingwalls, piers, and abutments are in good condition, with only minor cracking and efflorescence present. The pier caps were rehabbed previously and are in good condition. Currently no repairs are needed. Silane should be applied to all exposed substructure concrete as part of the project as a protective measure.
- A new deck with the typical section of 4'-11'-11'-4' with a 5' sidewalk would be constructed. With additional work to match the new deck and sidewalk into the existing off bridge travel surfaces.

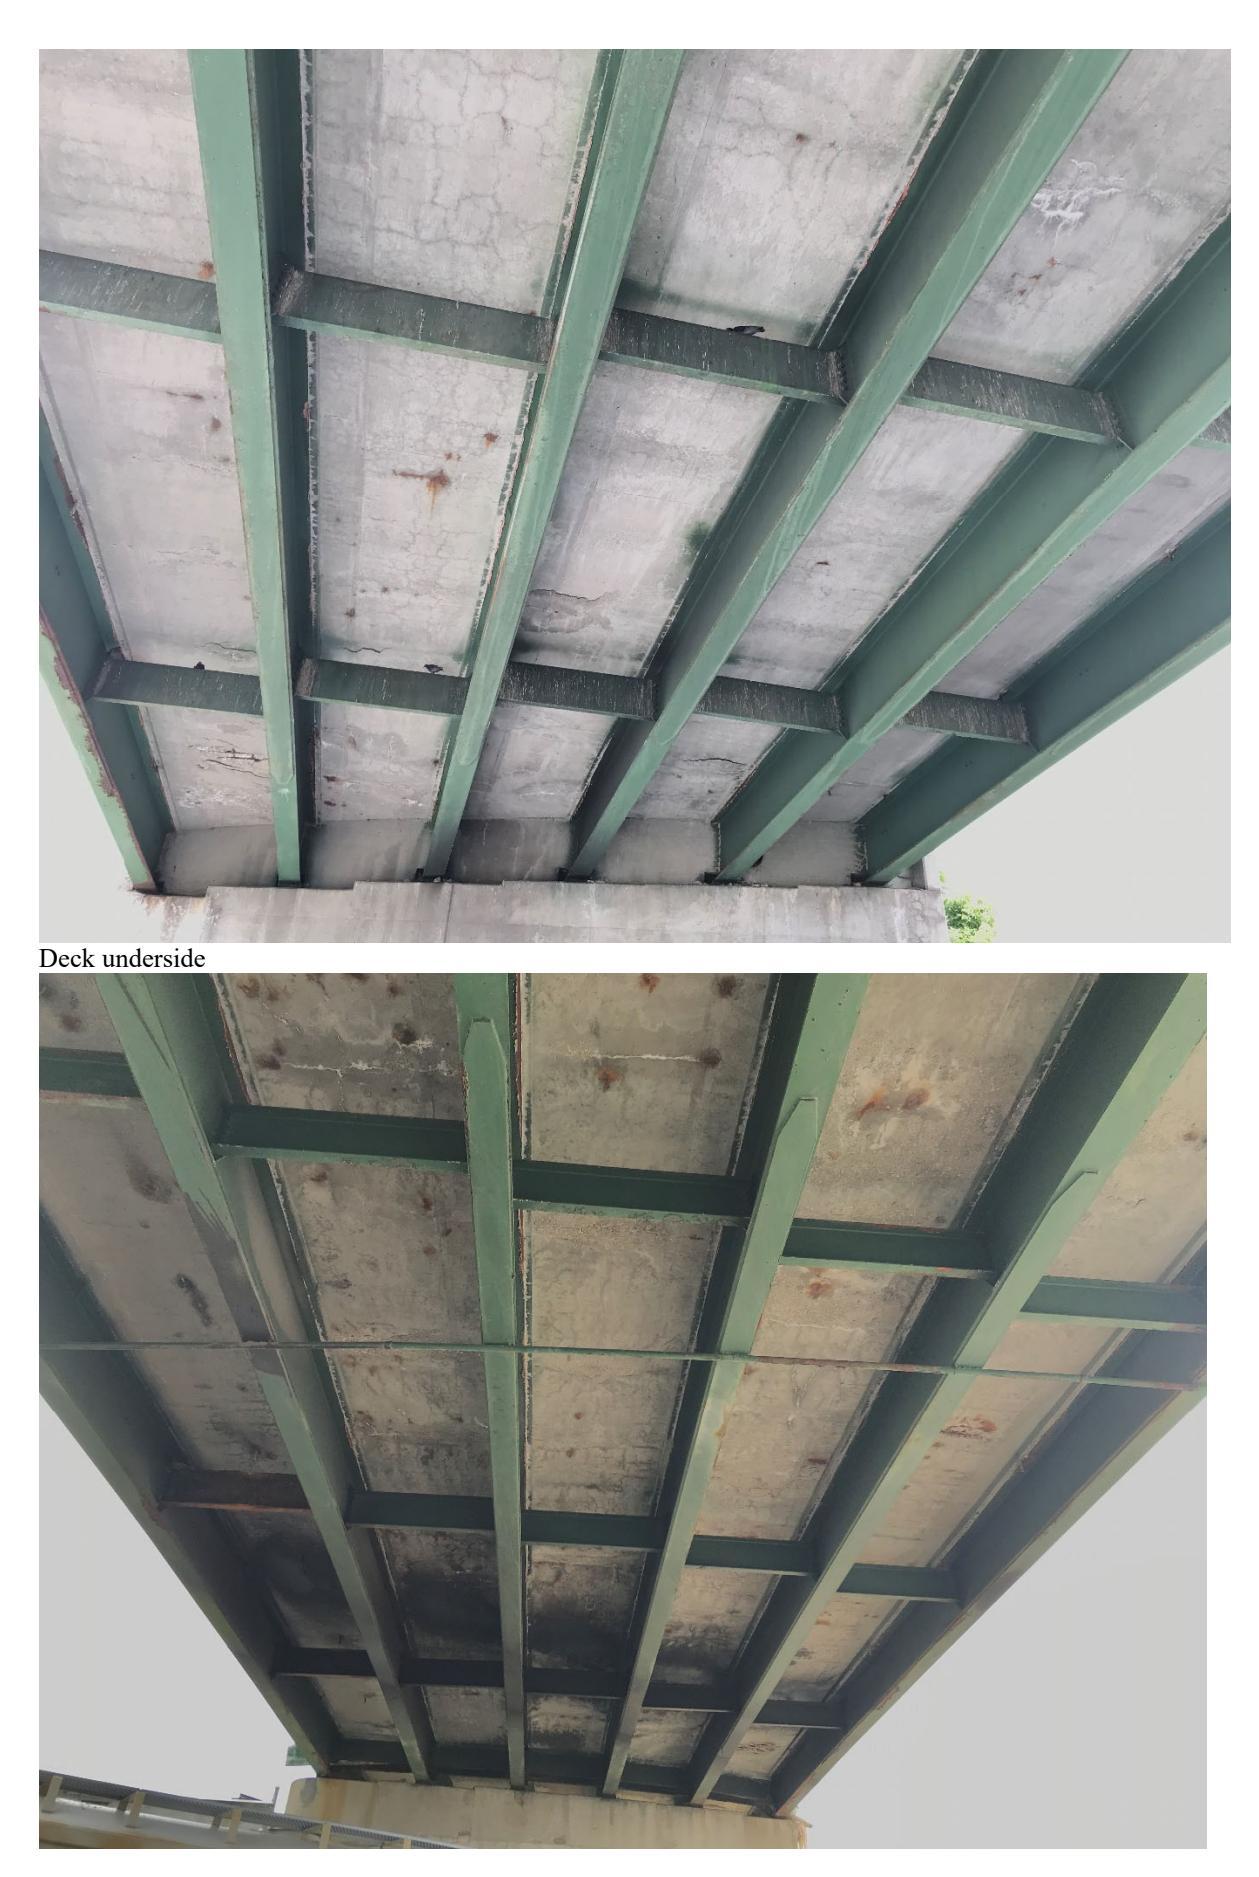
Deck Underside

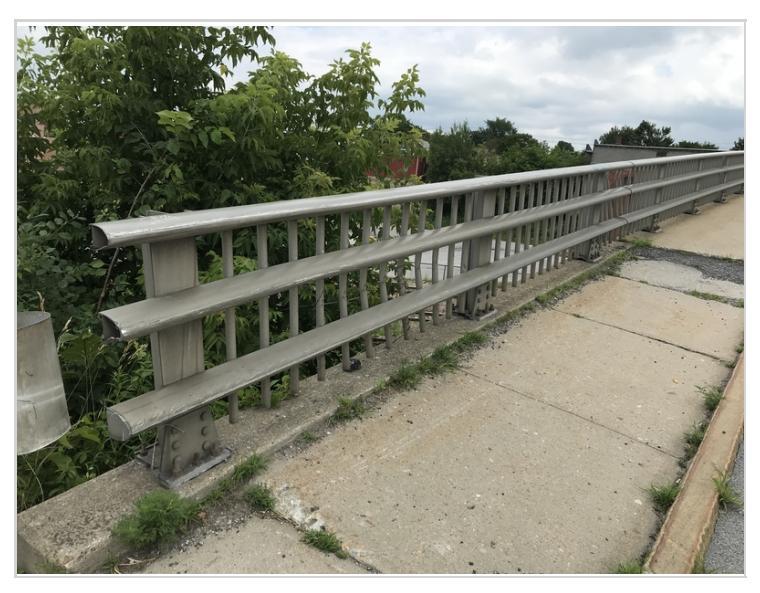
North rail damage West approach

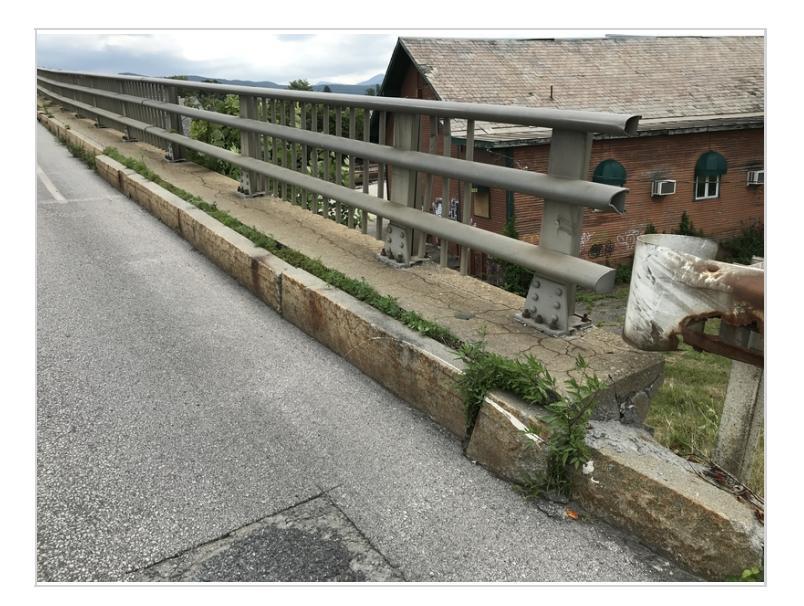
South rail damage,missing ballasters & displaced curbing at West approach
