STATE OF VERMONT AGENCY OF TRANSPORTATION

Scoping Report

Swanton BF 036-1(16) VT ROUTE 78, BRIDGE 6 OVER MISSISQUOI RIVER

March 10, 2025 Revised May 30, 2025

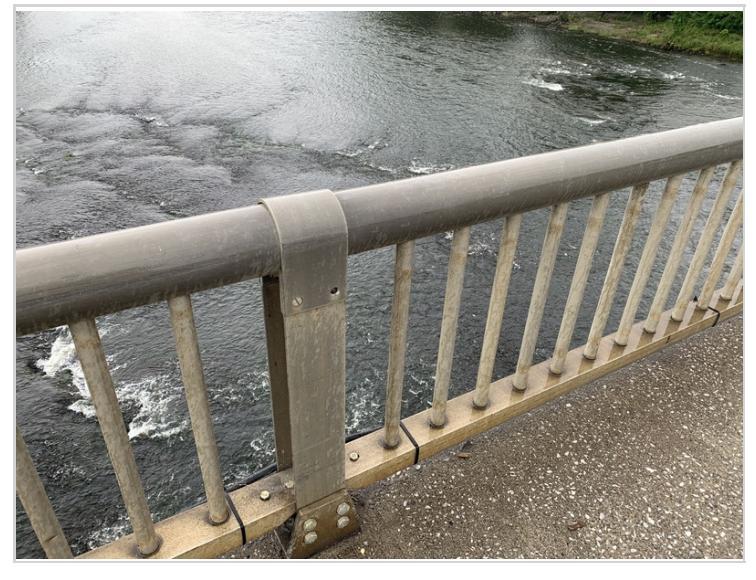
Downstream near pier 1 rail spindles

Missing bolt in the rail hoop

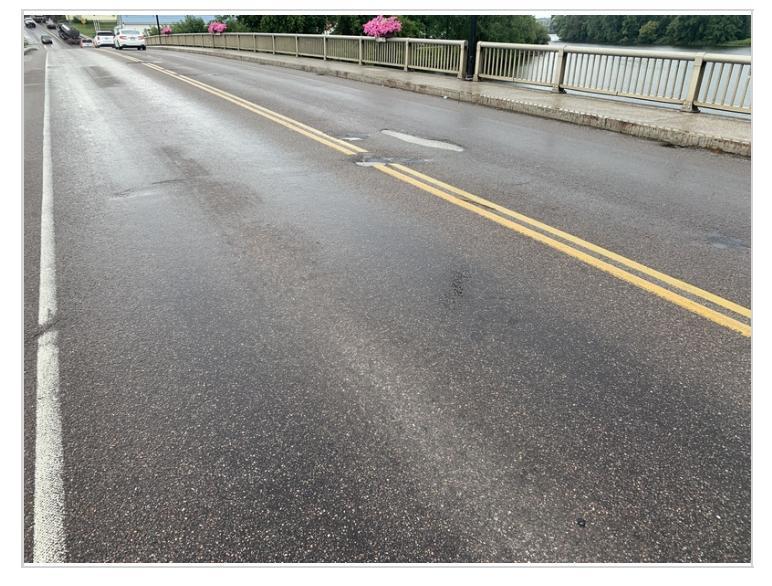
Potholes in wearing surface

Exposed deck

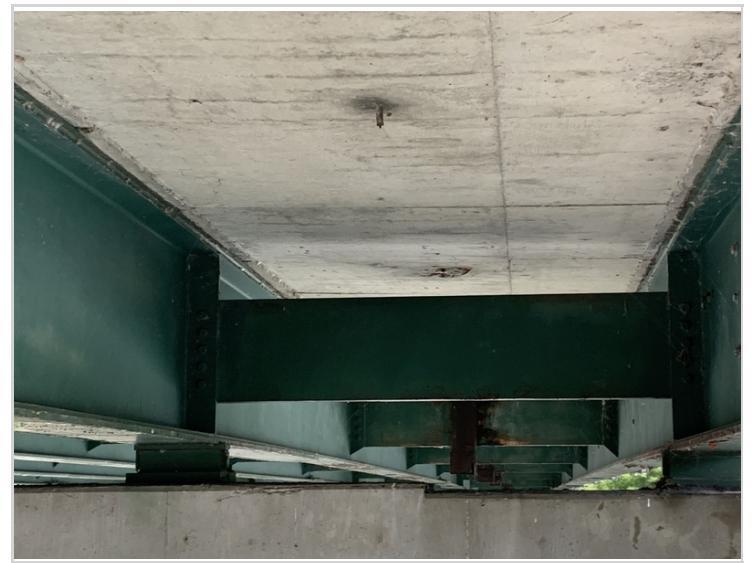
Beam 6 looking east

Saturation and minor spalling around deck weep tubes

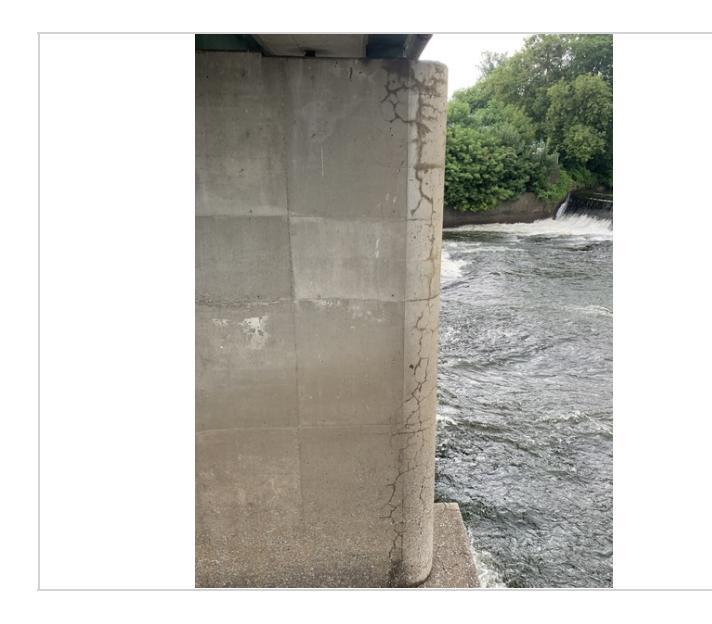
Upstream pier 2 nose cracking

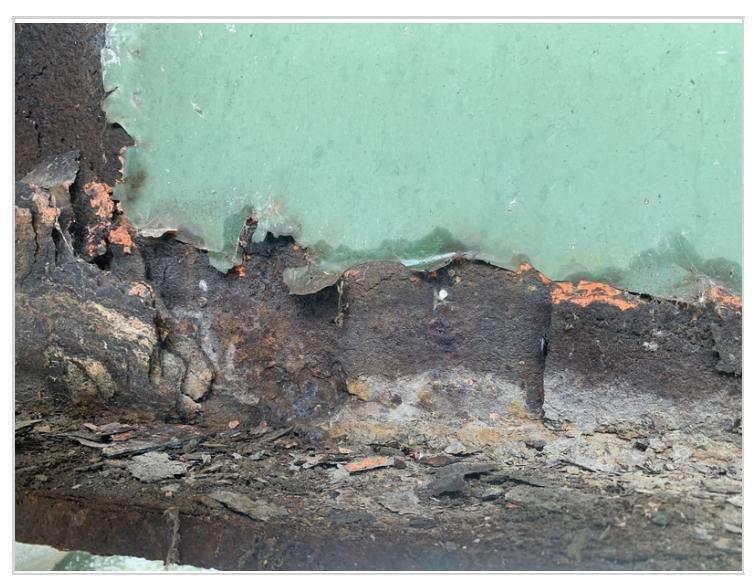
Section loss beam 1

Heavy rust scale beam 1

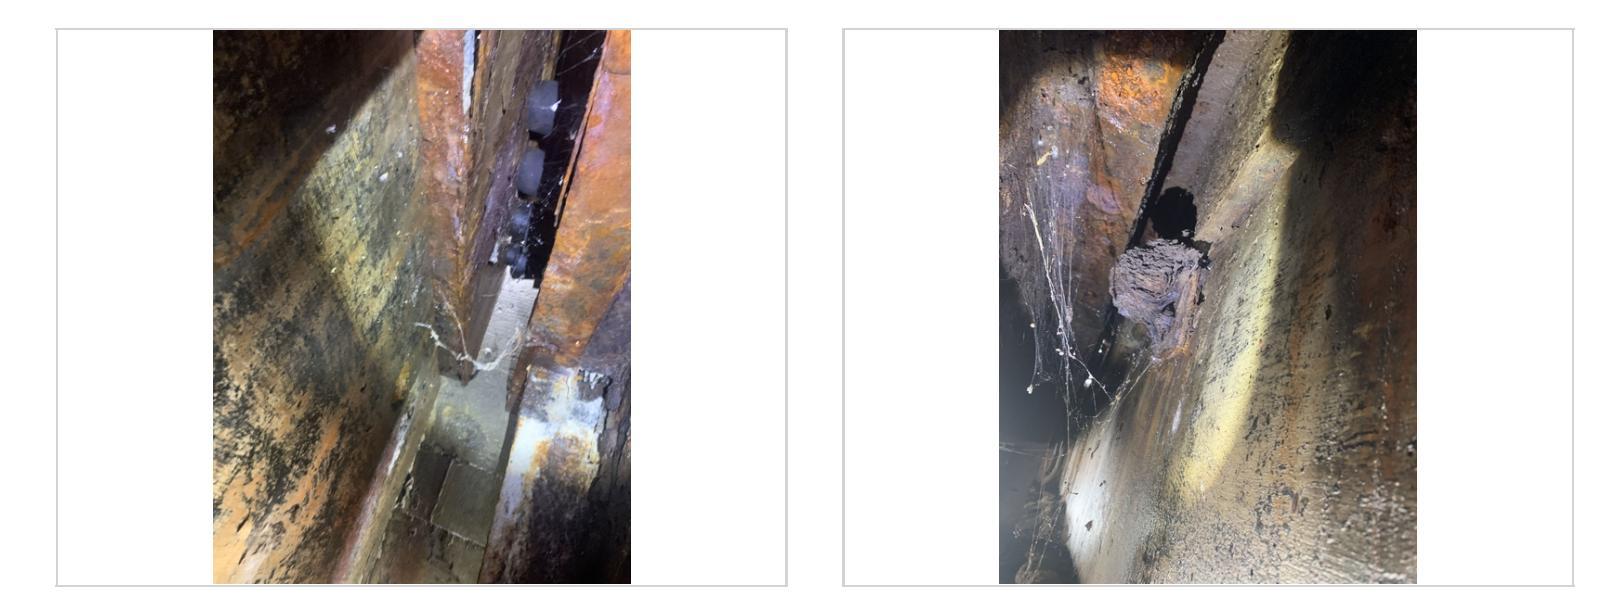
corroded bracket abutment 1 joint

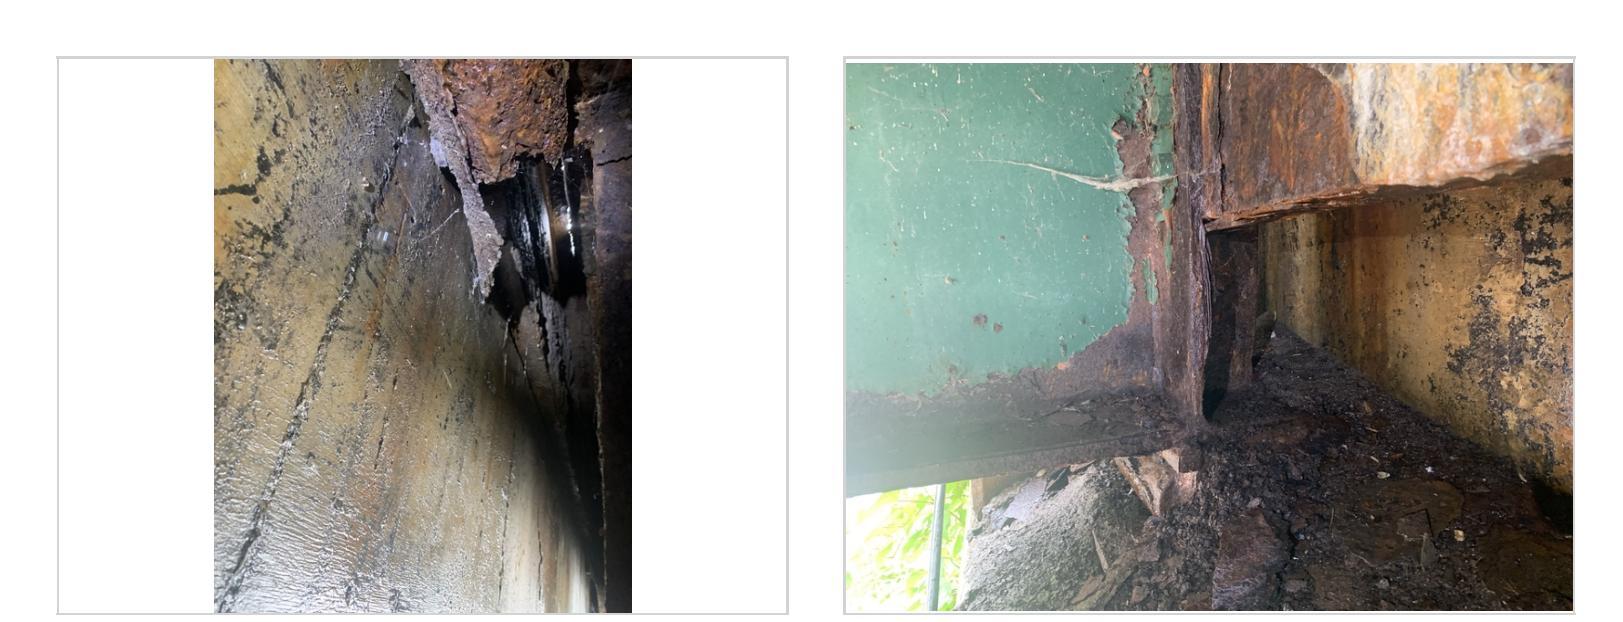
beam 1 debris

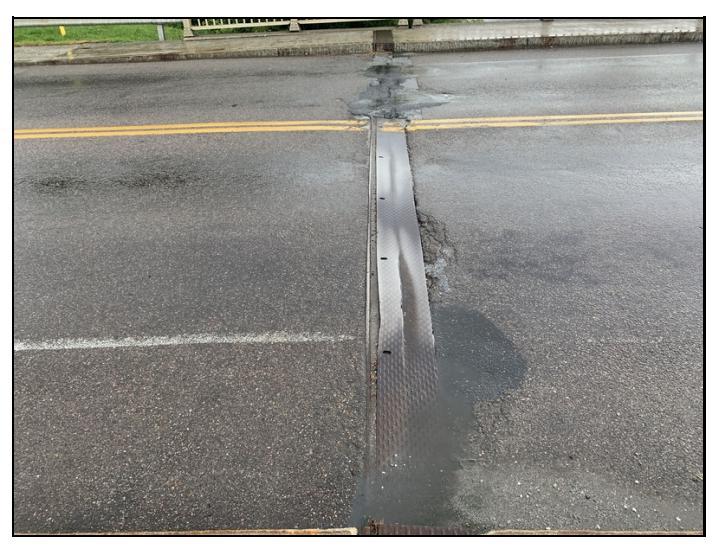
Abutment 2 joint

Joints have had some temporary repair work done to plug holes that have developed in the roadway.

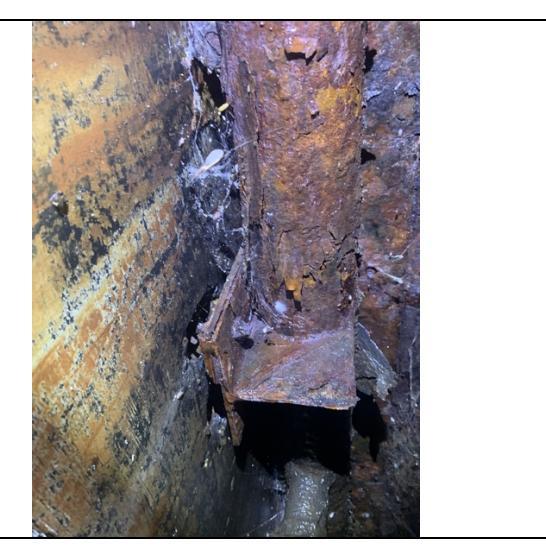
drain trough failed from corrosion

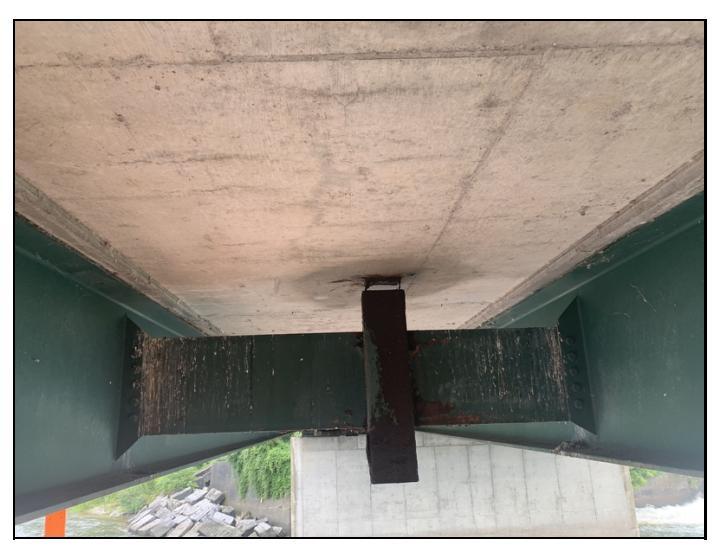
Typically drain

Deck drains along both the upstream and downstream sides have been previously repaired however have full perimeter perforations present at the deck soffit and continue to allow leakage to structure below and should be replaced.

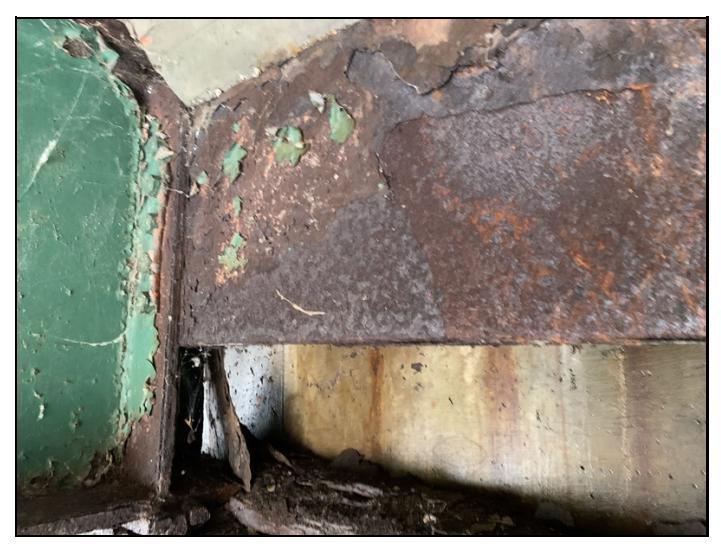
End diaphragm's abutment 1

Failed Joints over both abutments have allowed continuous leakage to structure below which has progressed steel corrosion that has minor to to moderate rust scaling and is in need of cleaning and painting. Beam #1 throughout also has built up rust scaling along the outer lower flange and should be cleaned and painted to prevent further corrosion.
