Local Concerns Meeting

Windsor BF 0113(88)

Bridge 55

US 5 over Mill Brook

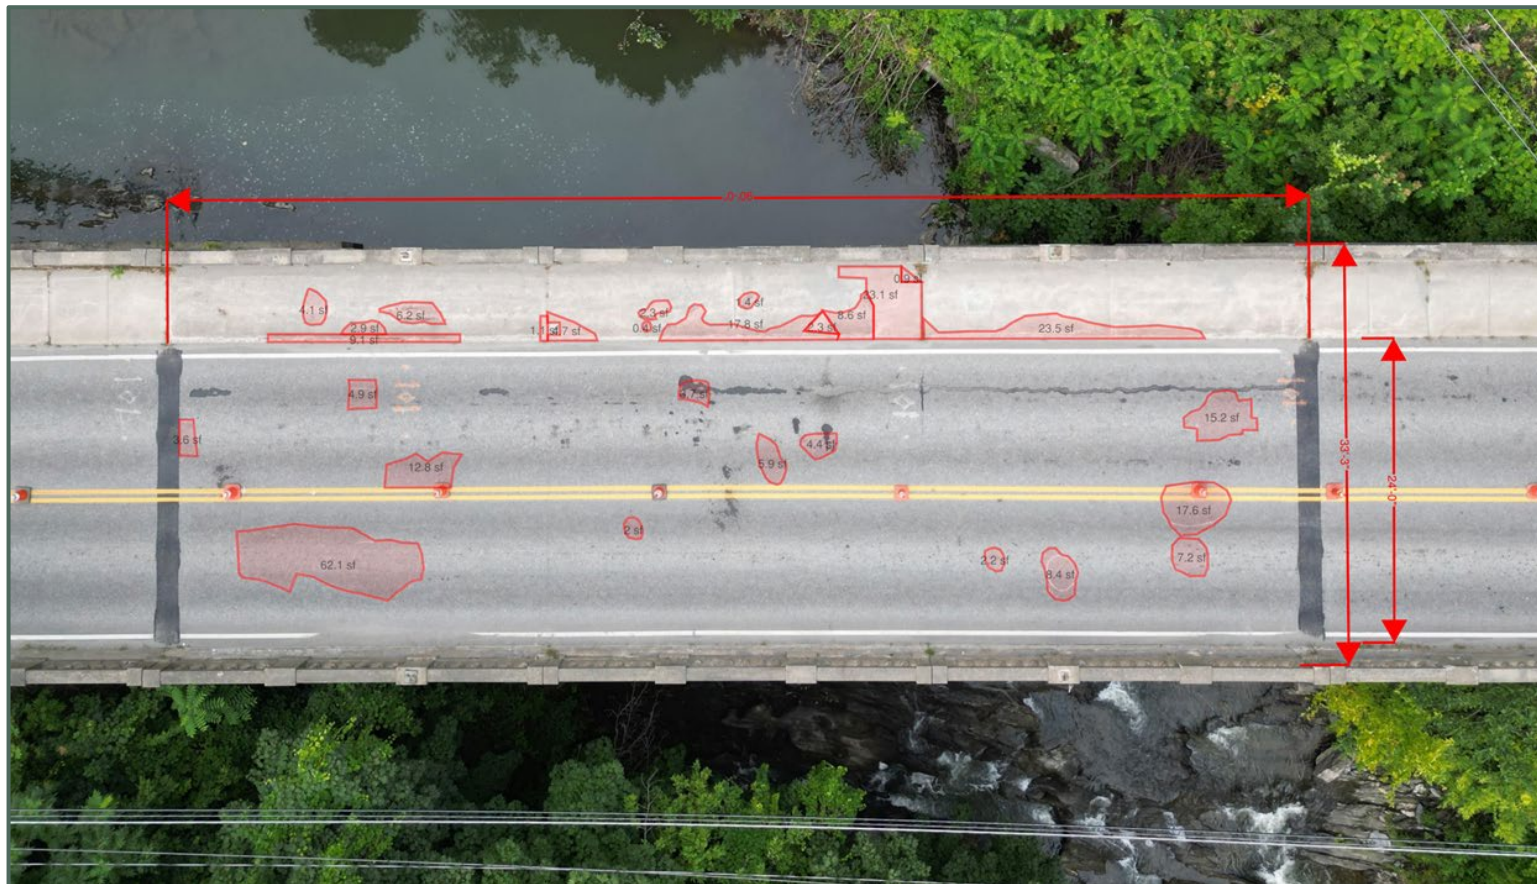
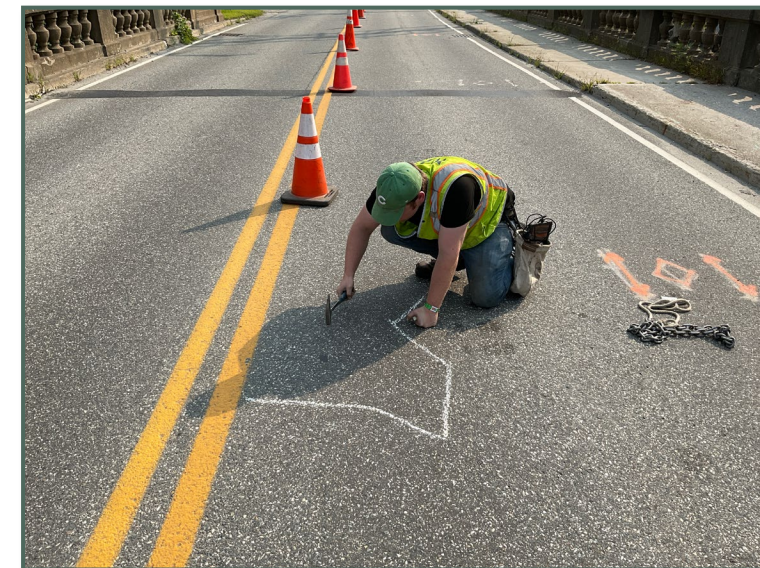
Existing Conditions - Roadway Condition

- Top Surface of Deck Soundings

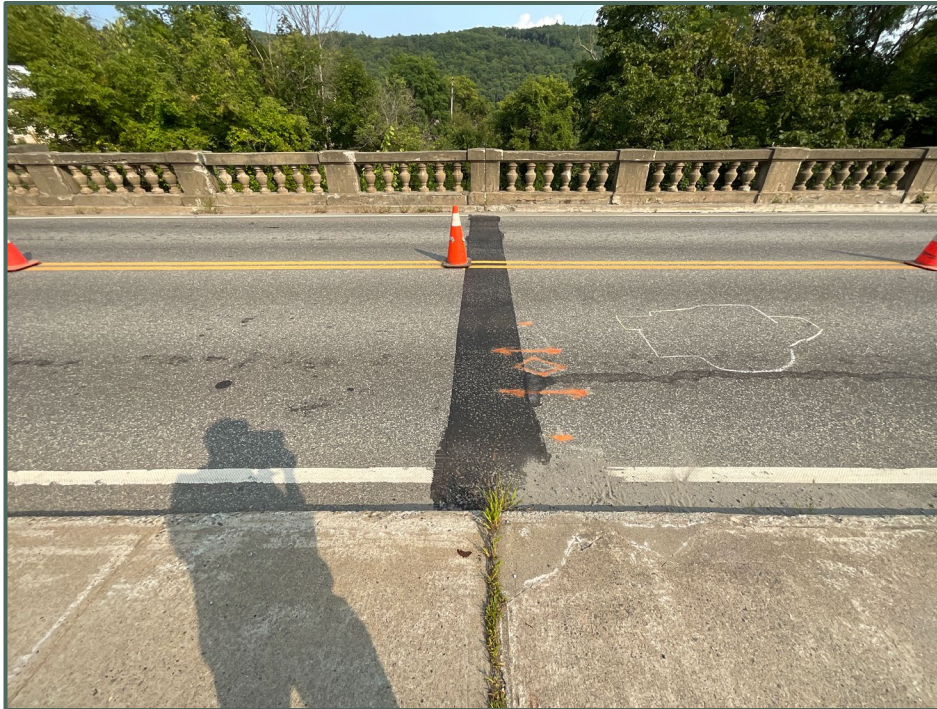
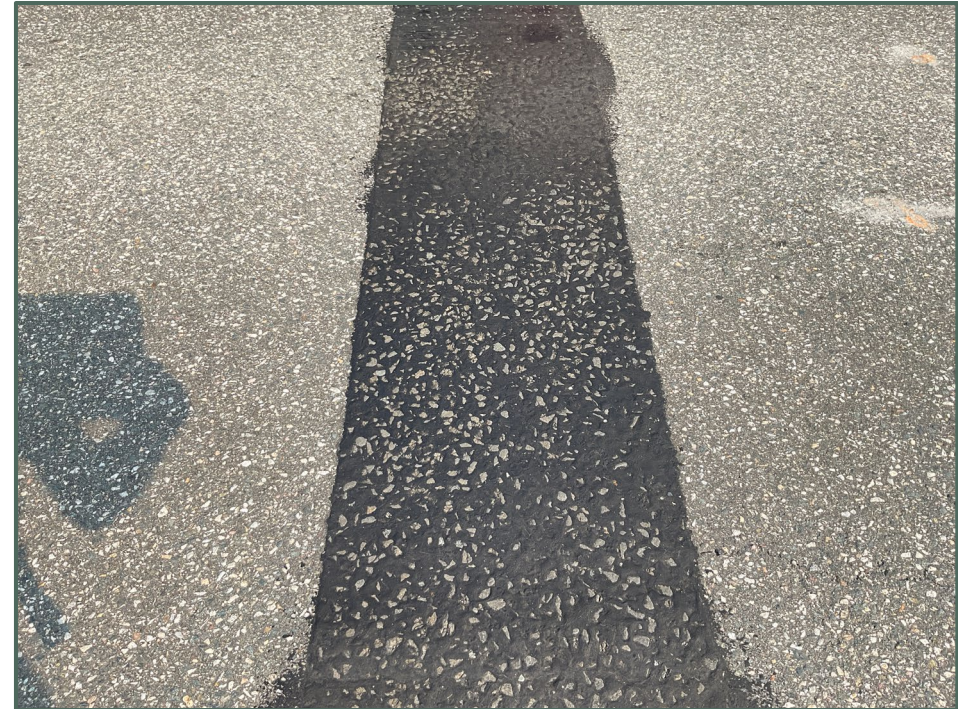
Existing Conditions – Bridge Joints

- Asphaltic Plug Joints Visual Inspection
- Over the years, road salts have been allowed to penetrate concrete elements below

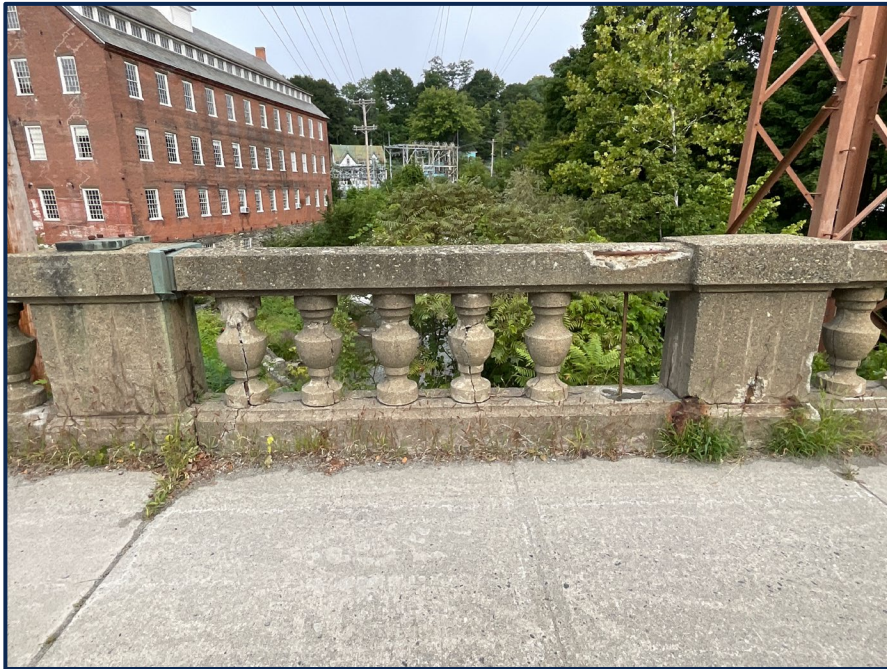
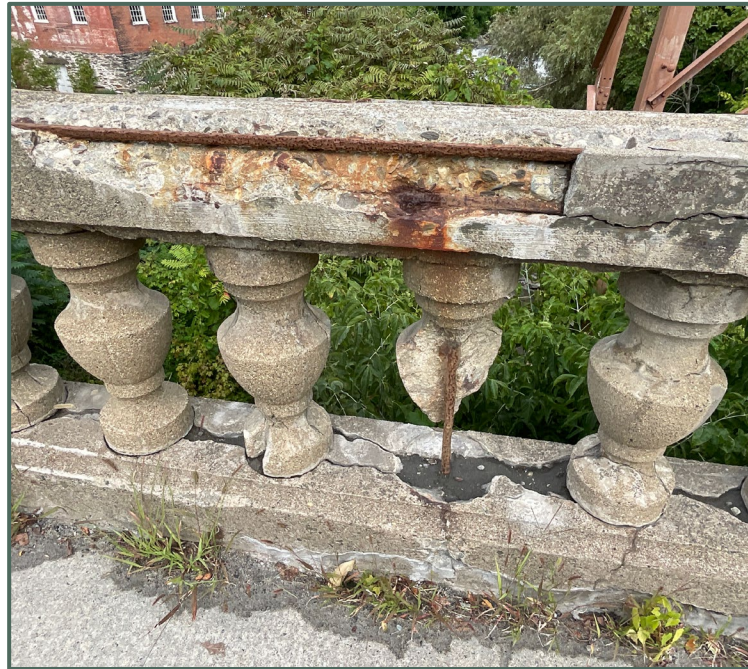
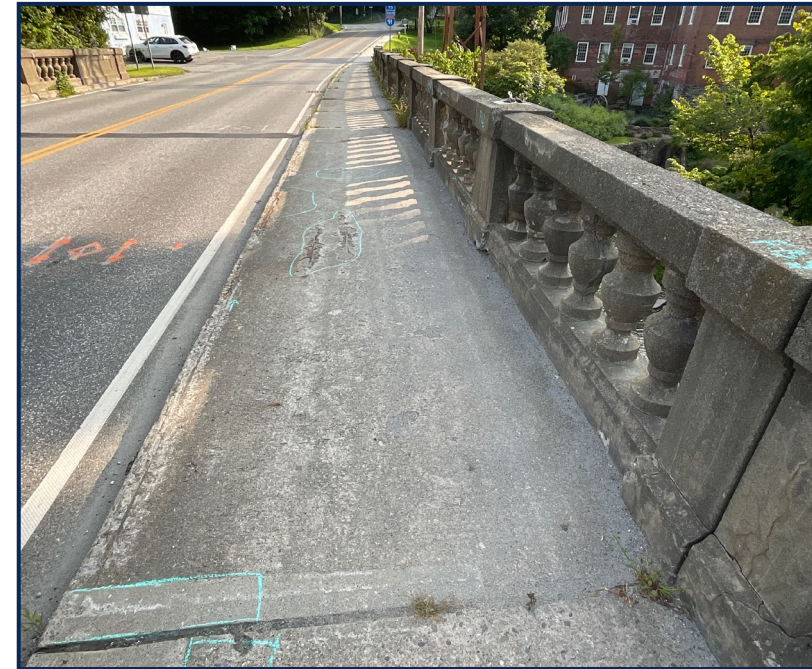
Existing Conditions - Curbs, Sidewalk, and Railing

- Shallow curb/sidewalk with spalling
- The original railing is substandard, with concrete deterioration present

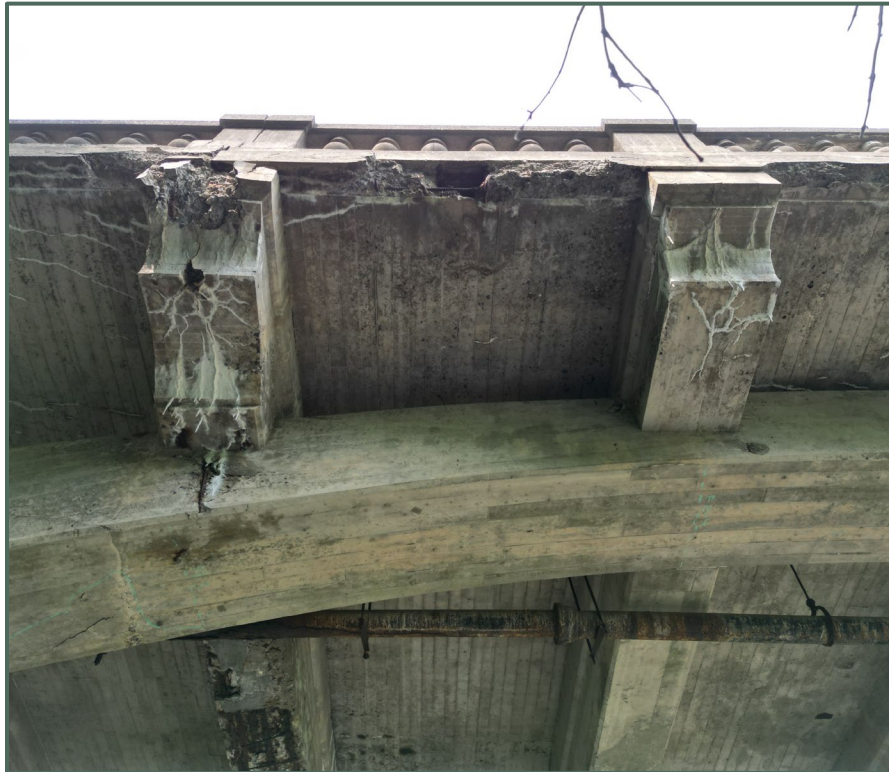
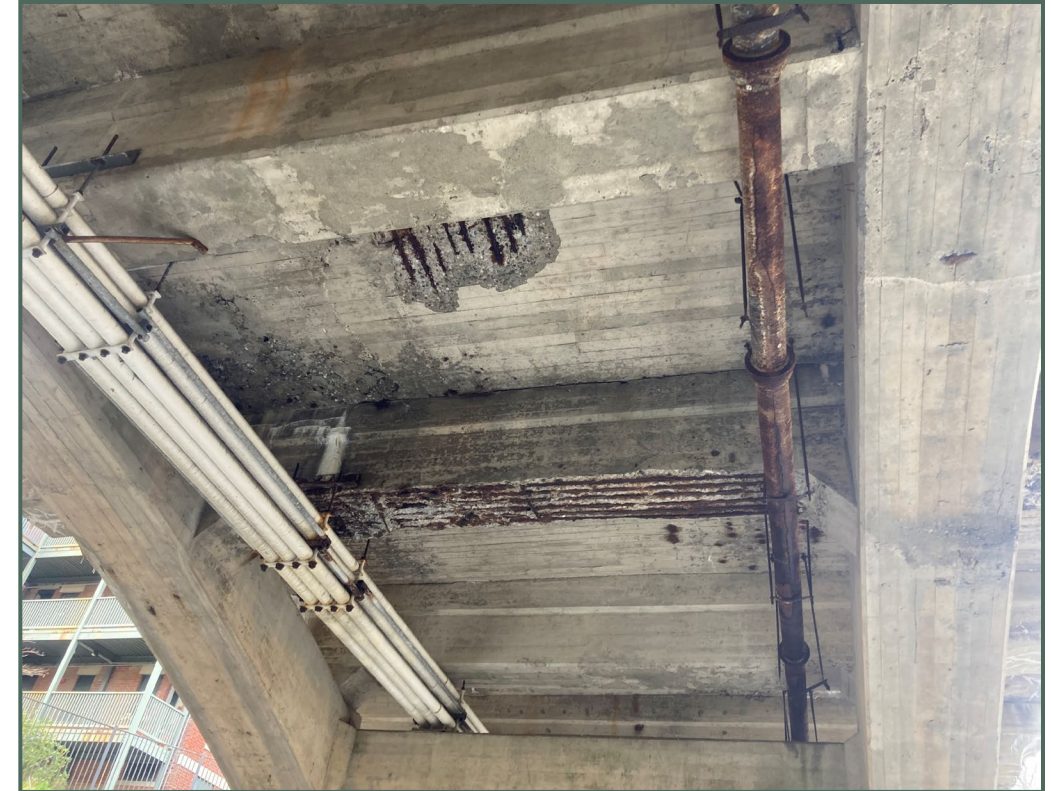
Existing Conditions – Deck (Underside)

- Spalls present, predominately adjacent to deck joints
- Marked deterioration in bridge overhangs
- Heavy chloride content

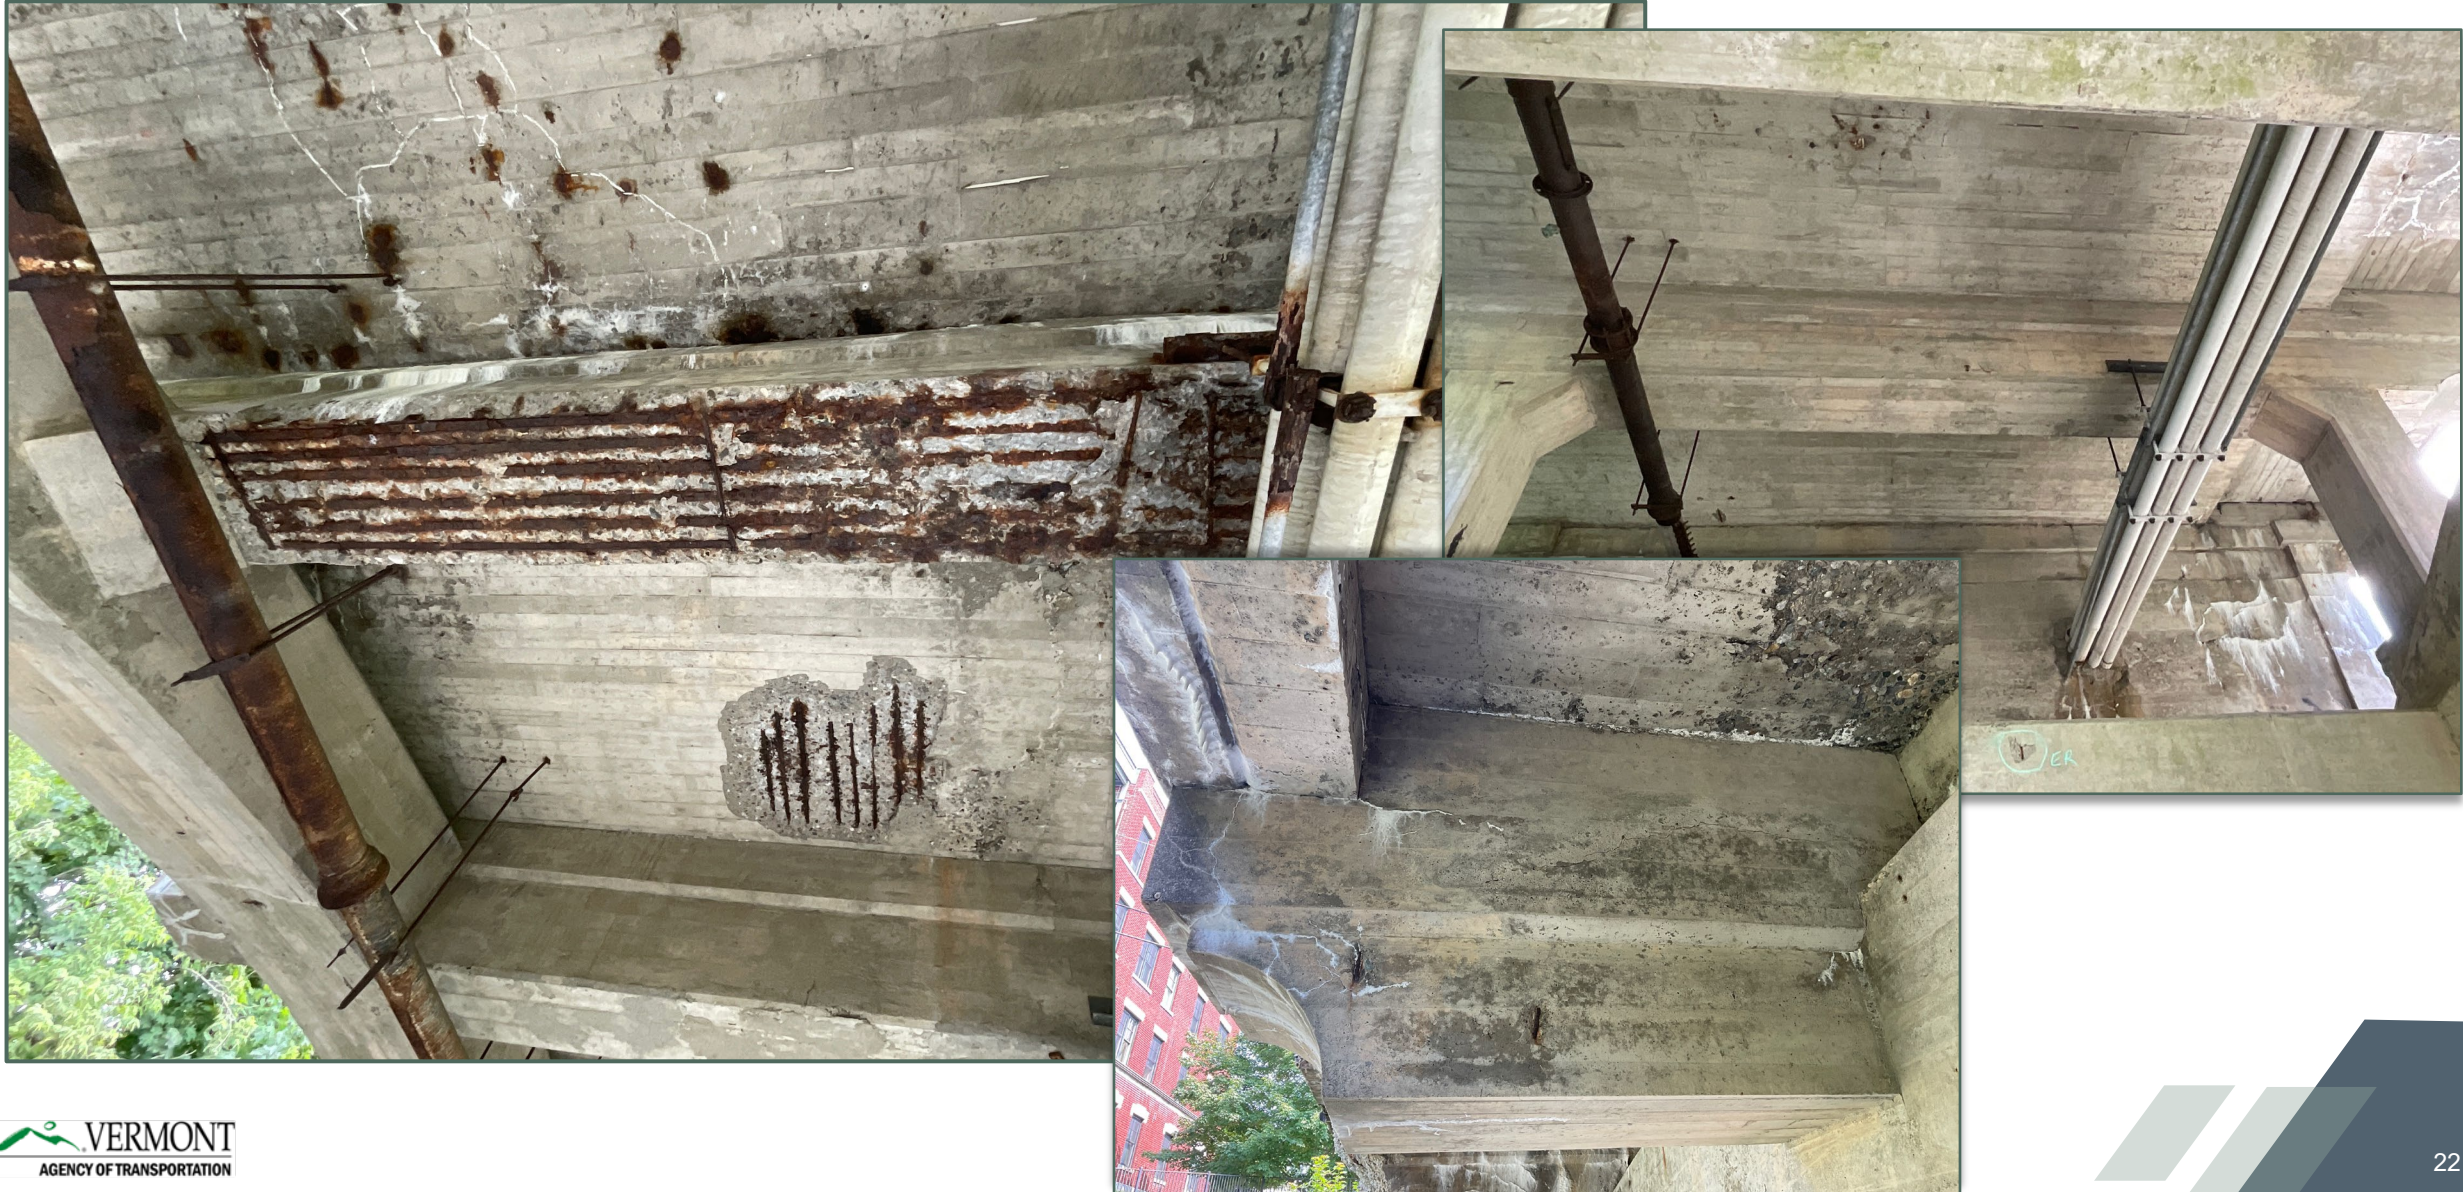
Existing Conditions – Floor Beams

- Several members do not meet HL-93 Design loading
 - Deck, floorbeams, some locations in the arches
 - Not unexpected for historic bridges
- The deck and some floorbeams do not meet legal, SHV or EV loading
 - These members should be replaced
- Alternatives evaluation will consider the capacity of the existing members that are to remain

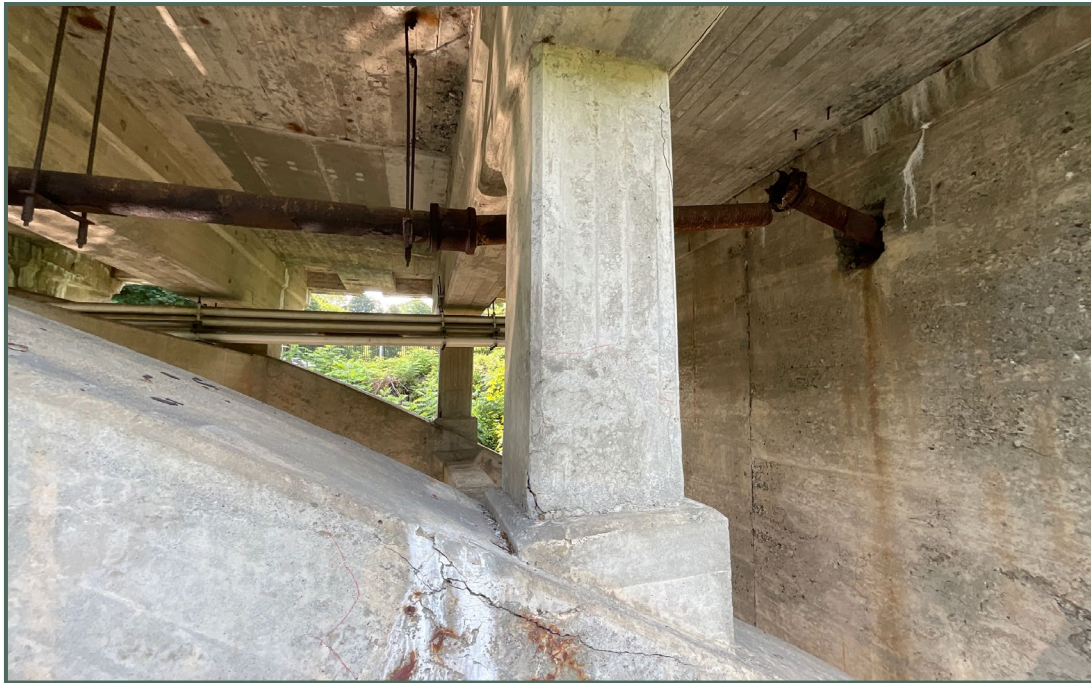
Existing Conditions – Spandrel Columns

- Small, localized areas of deterioration
- Low corrosion activity

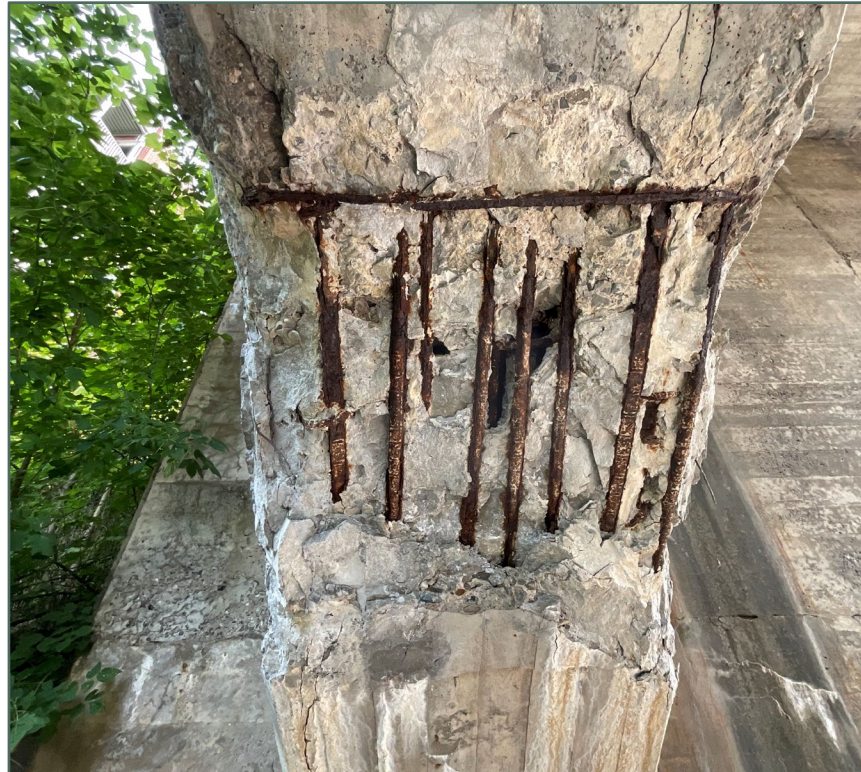
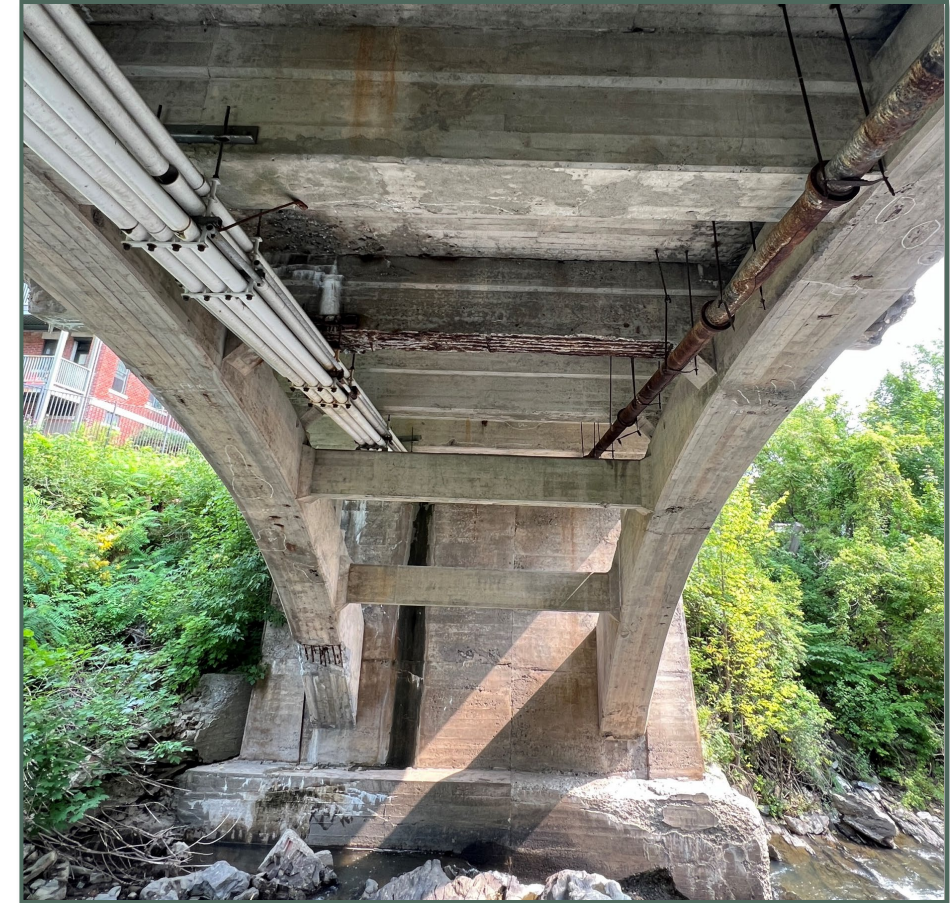
Existing Conditions – Arch Ribs

- Deteriorated locations in outer thirds of the arch ribs
- Larger areas of delamination on the arch undersides
- Evidence of corrosion and minor freeze-thaw damage
