# Essex-Jericho Culvert Bundle Public Informational Meeting

March 18, 2024

- ESSEX TOWN STP CULV(148) 23B688, Bridge 11 on VT Route 289
- ESSEX TOWN STP CULV(149) 23B689, Bridge 2 on VT Route 15
- JERICHO STP CULV(150) 23B690, Bridge 6A on VT Route 15
- ESSEX TOWN NH CULV(151) 23B691, Bridge 17-A on VT Route 289

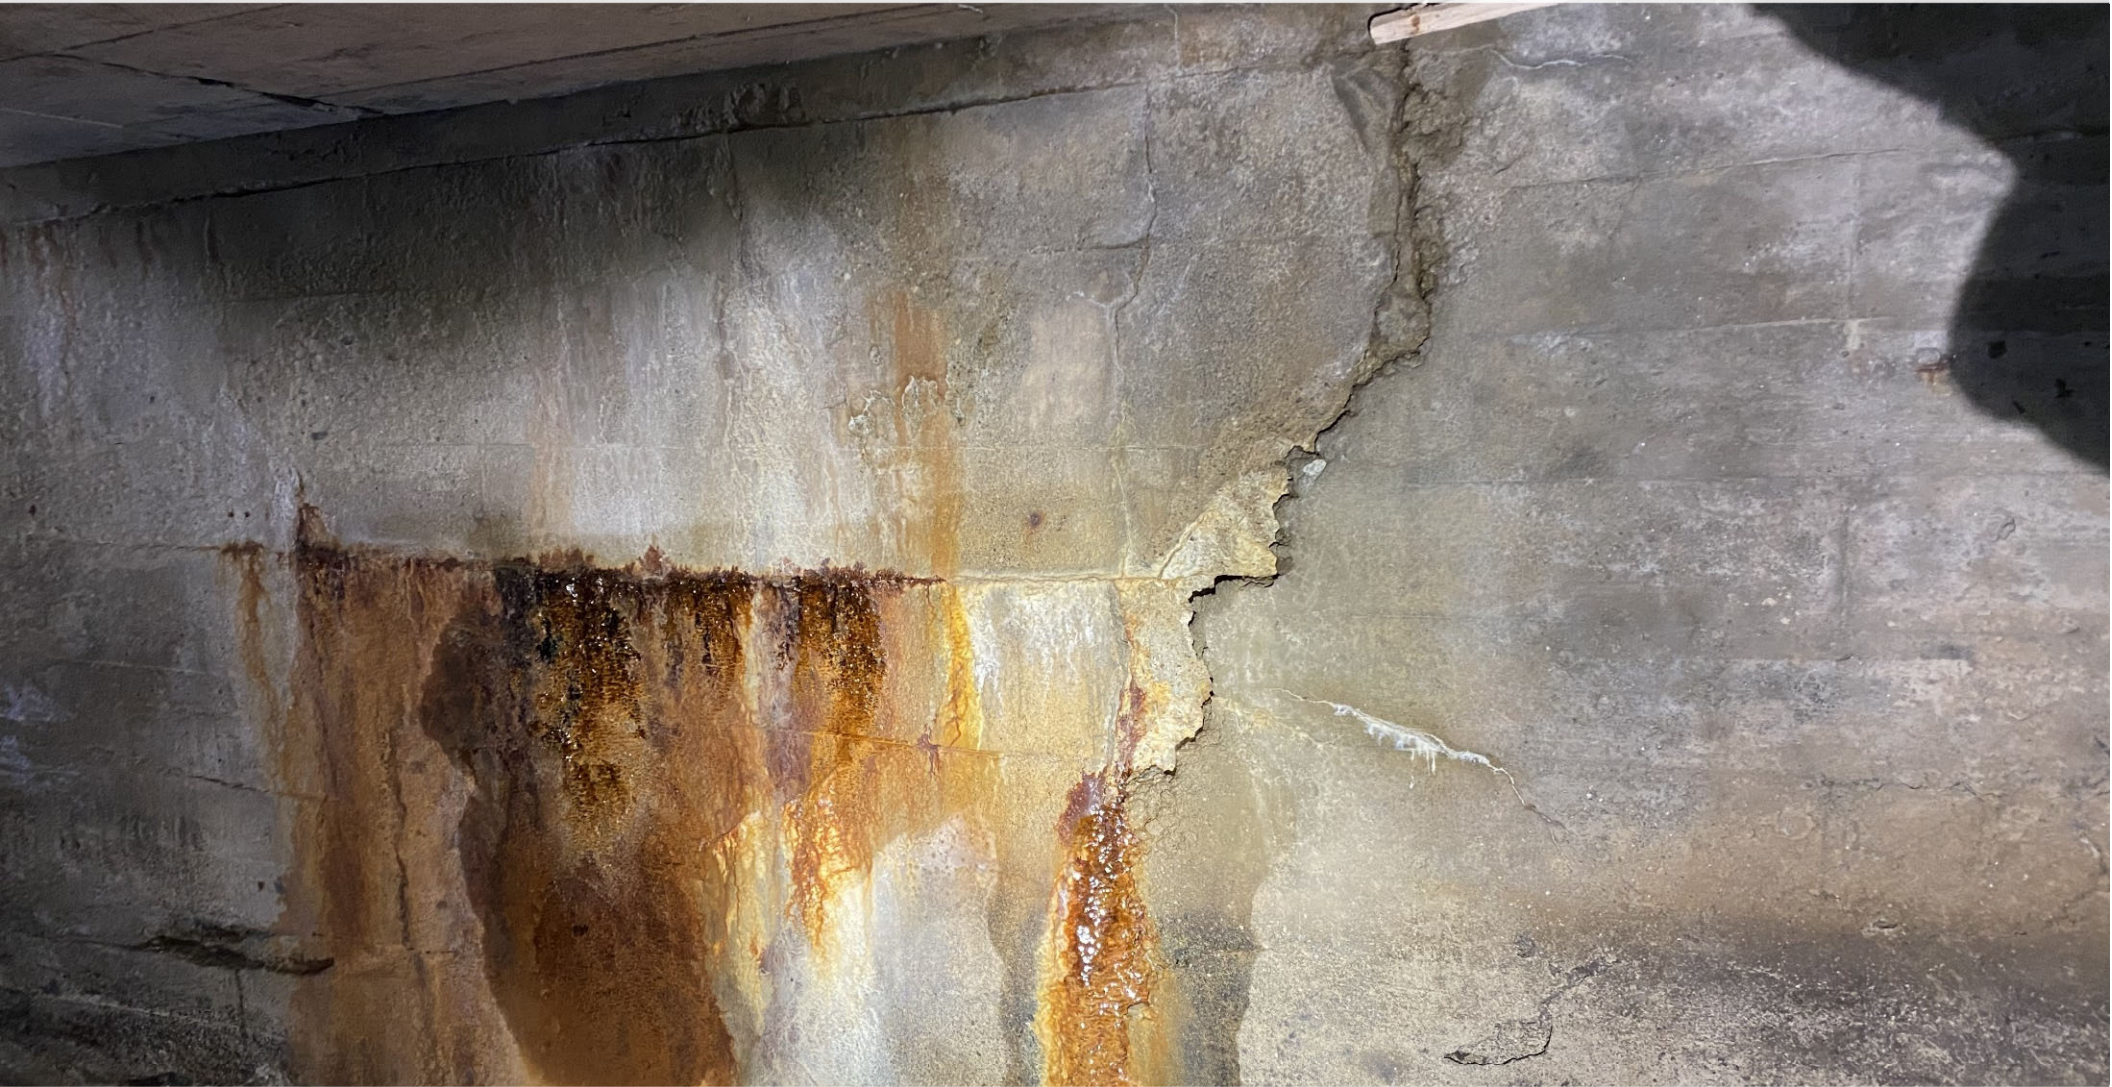
# Bridge Inspection Report Ratings

- The culvert is in poor condition. The box has (2) full perimeter cracks, heavy efflorescence leakage, rust staining, and heavy saturation. Timber bracing was placed between the midspan and upstream end to prevent further spalling and settlement in the roadway. Spalling and delaminations are present along cold joints and there is a large full depth hole at the upstream cold joint.
- The existing culvert does not meet the measured bank full width of Indian Brook.
- VT Route 15 has substandard shoulder widths along the VT Route 15 corridor through the project area.

- Culvert Rating 4 (Poor)
- Channel Rating 7 (Good)

- Replace the existing culvert with a new 3-sided or 4-sided Precast Concrete Buried Structure
  - Traffic will be maintained via phased construction and/or an offsite detour, or a combination of the two in order to keep the corridor partially open during construction to be determined in design
  - Impacts to utilities, environmental resources and cultural resources will be minimized by not constructing a temporary bridge
  - Proposed 12' span, 75' long precast concrete box or frame (on-alignment)
  - Proposed 12' span meets the minimum hydraulic standards and bank full width conditions
  - New culvert length designed to meet minimum roadway width standards
  - 75-year Design life

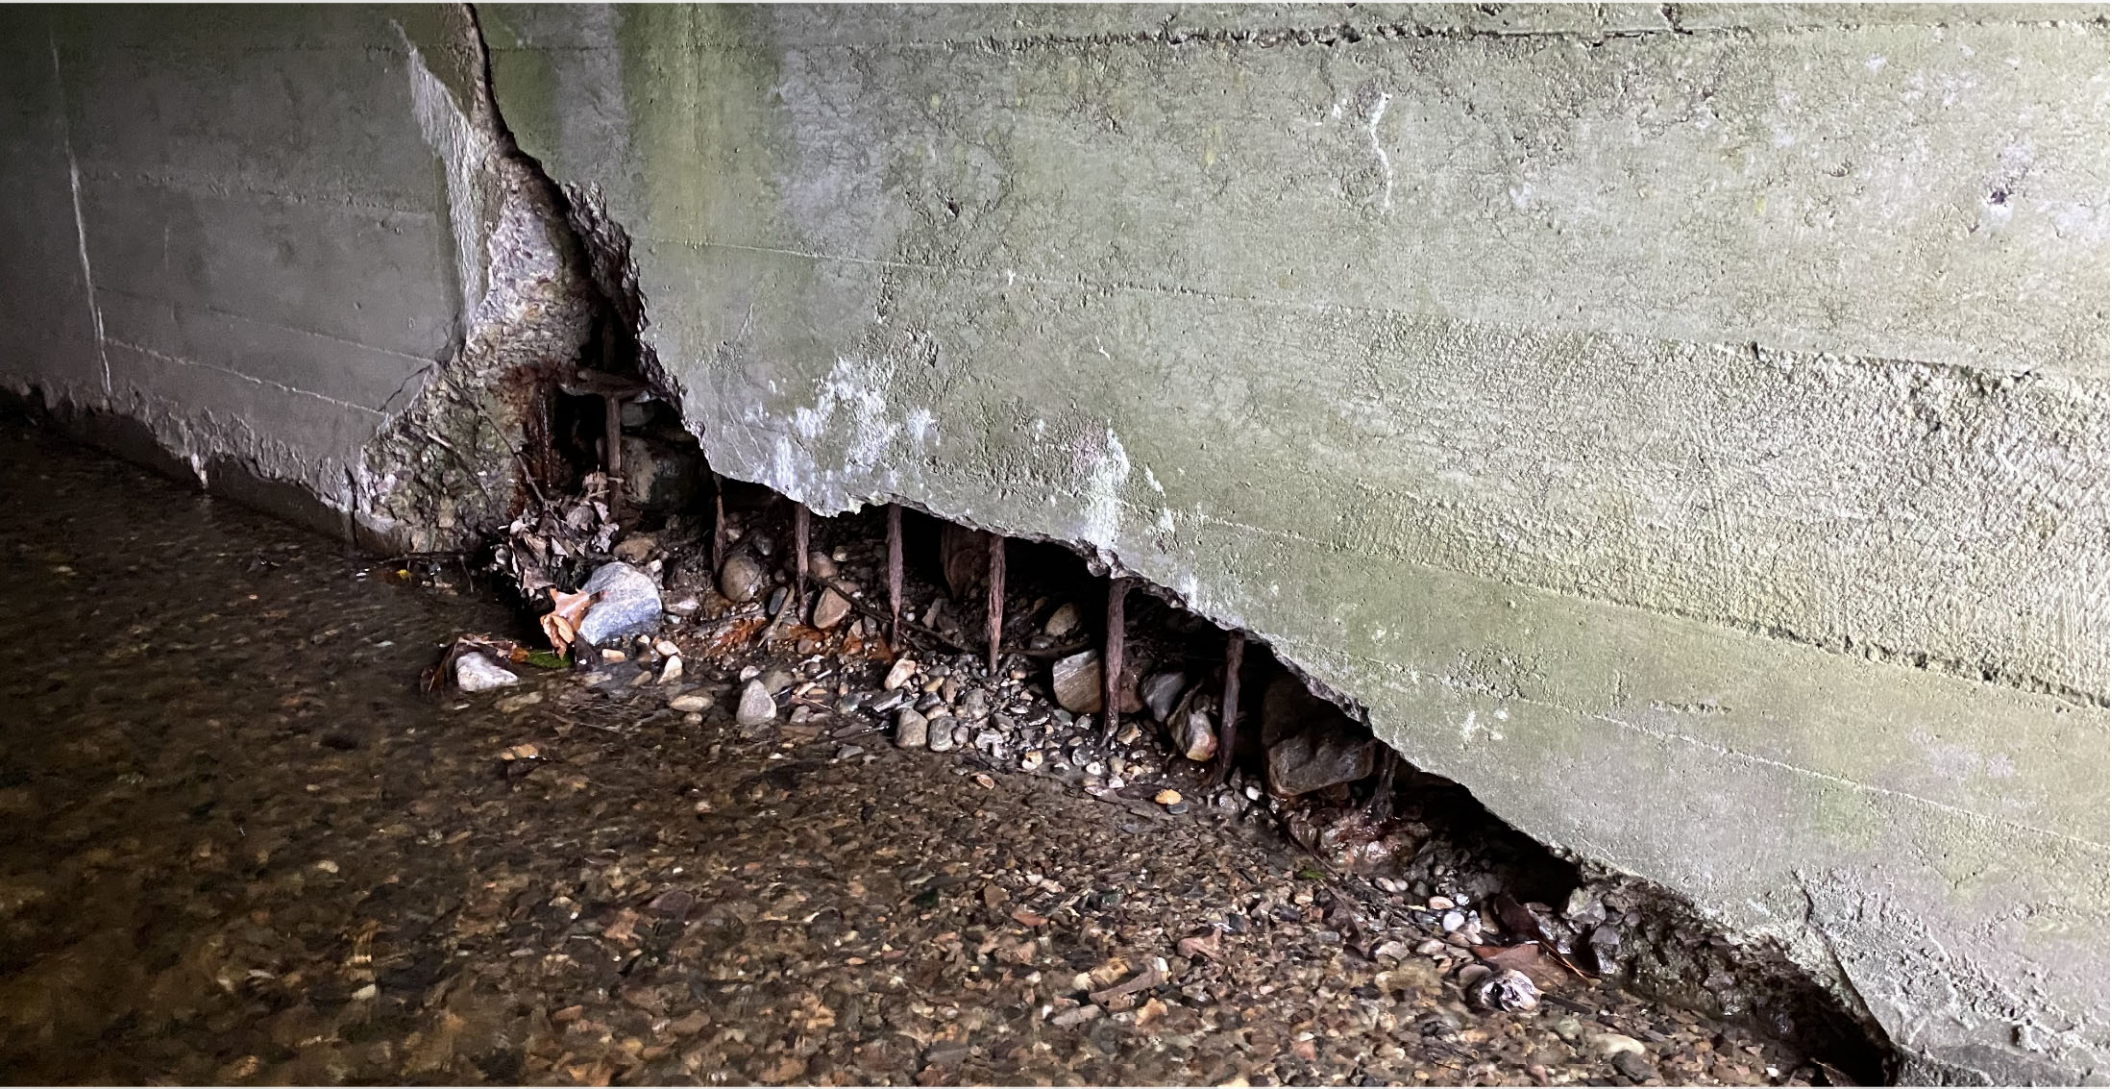
# Bridge Inspection Report Ratings

- The culvert is in poor condition. There are holes exposing backfill and thinning rebar, moderate cracking throughout sidewalls, southwest wingwall failed
- The existing culvert meets the measured minimum 6' bankfull width and VTrans hydraulic standards.
- The lane and shoulder widths along VT Route 2A through the project area do not meet the minimum standards of 11' travel lanes, 5' shoulders.
- The Existing structure is comprised of three different structures connected and directing flow under TH-24, NEC RR, and VT-2A:
  1. TH-24: two 3.5-ft x 5-ft cast-in-place concrete boxes
  2. NEC railroad: laid up stone box ~12-ft x 6-ft with 4-ft wide column (overall dimensions of two 4-ft x 6-ft boxes)
  3. **VT-2A: 6-ft x 6-ft concrete box (Bridge #11)**

- Culvert Rating 4 (Poor)
- Channel Rating 5 (Fair)

- Rehabilitate the existing culvert with Class III concrete repair and slope stabilization work while maintaining traffic on the existing culvert with temporary lane closures as needed.
  - Class III concrete repair and slope stabilization work including new wingwalls and headwall, and armoring side slopes
  - Minimum hydraulic standard and bank full width conditions will be met
  - Temporary lane or shoulder closures as needed in order to mobilize/demobilize construction equipment or manage truck traffic
  - Extends the life of the structure an additional 30 years

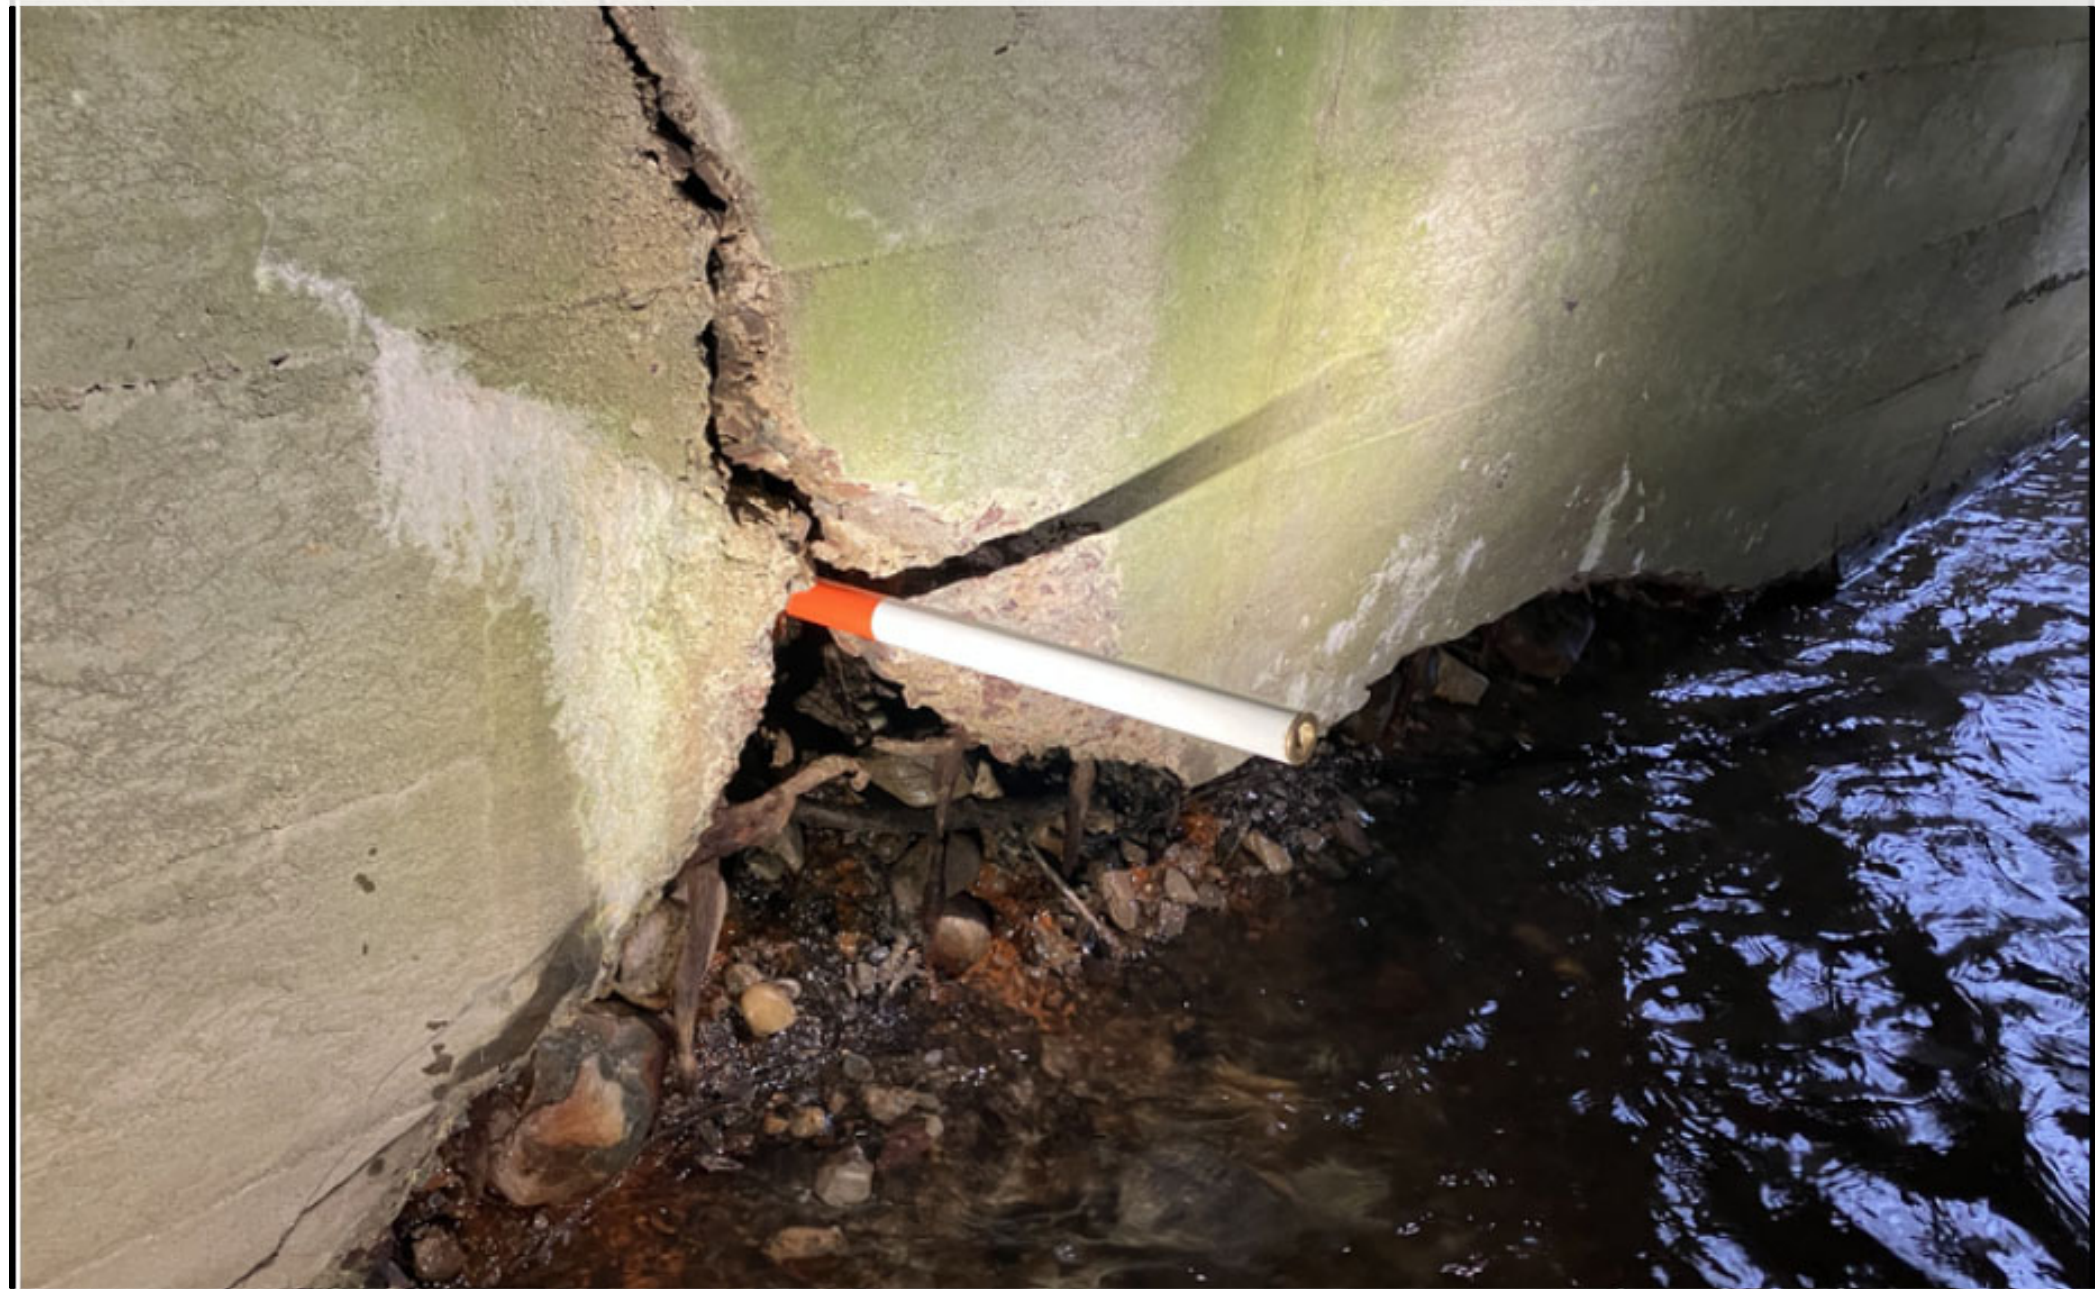
3ft of Backfill Sediment Loss in Spalled Area

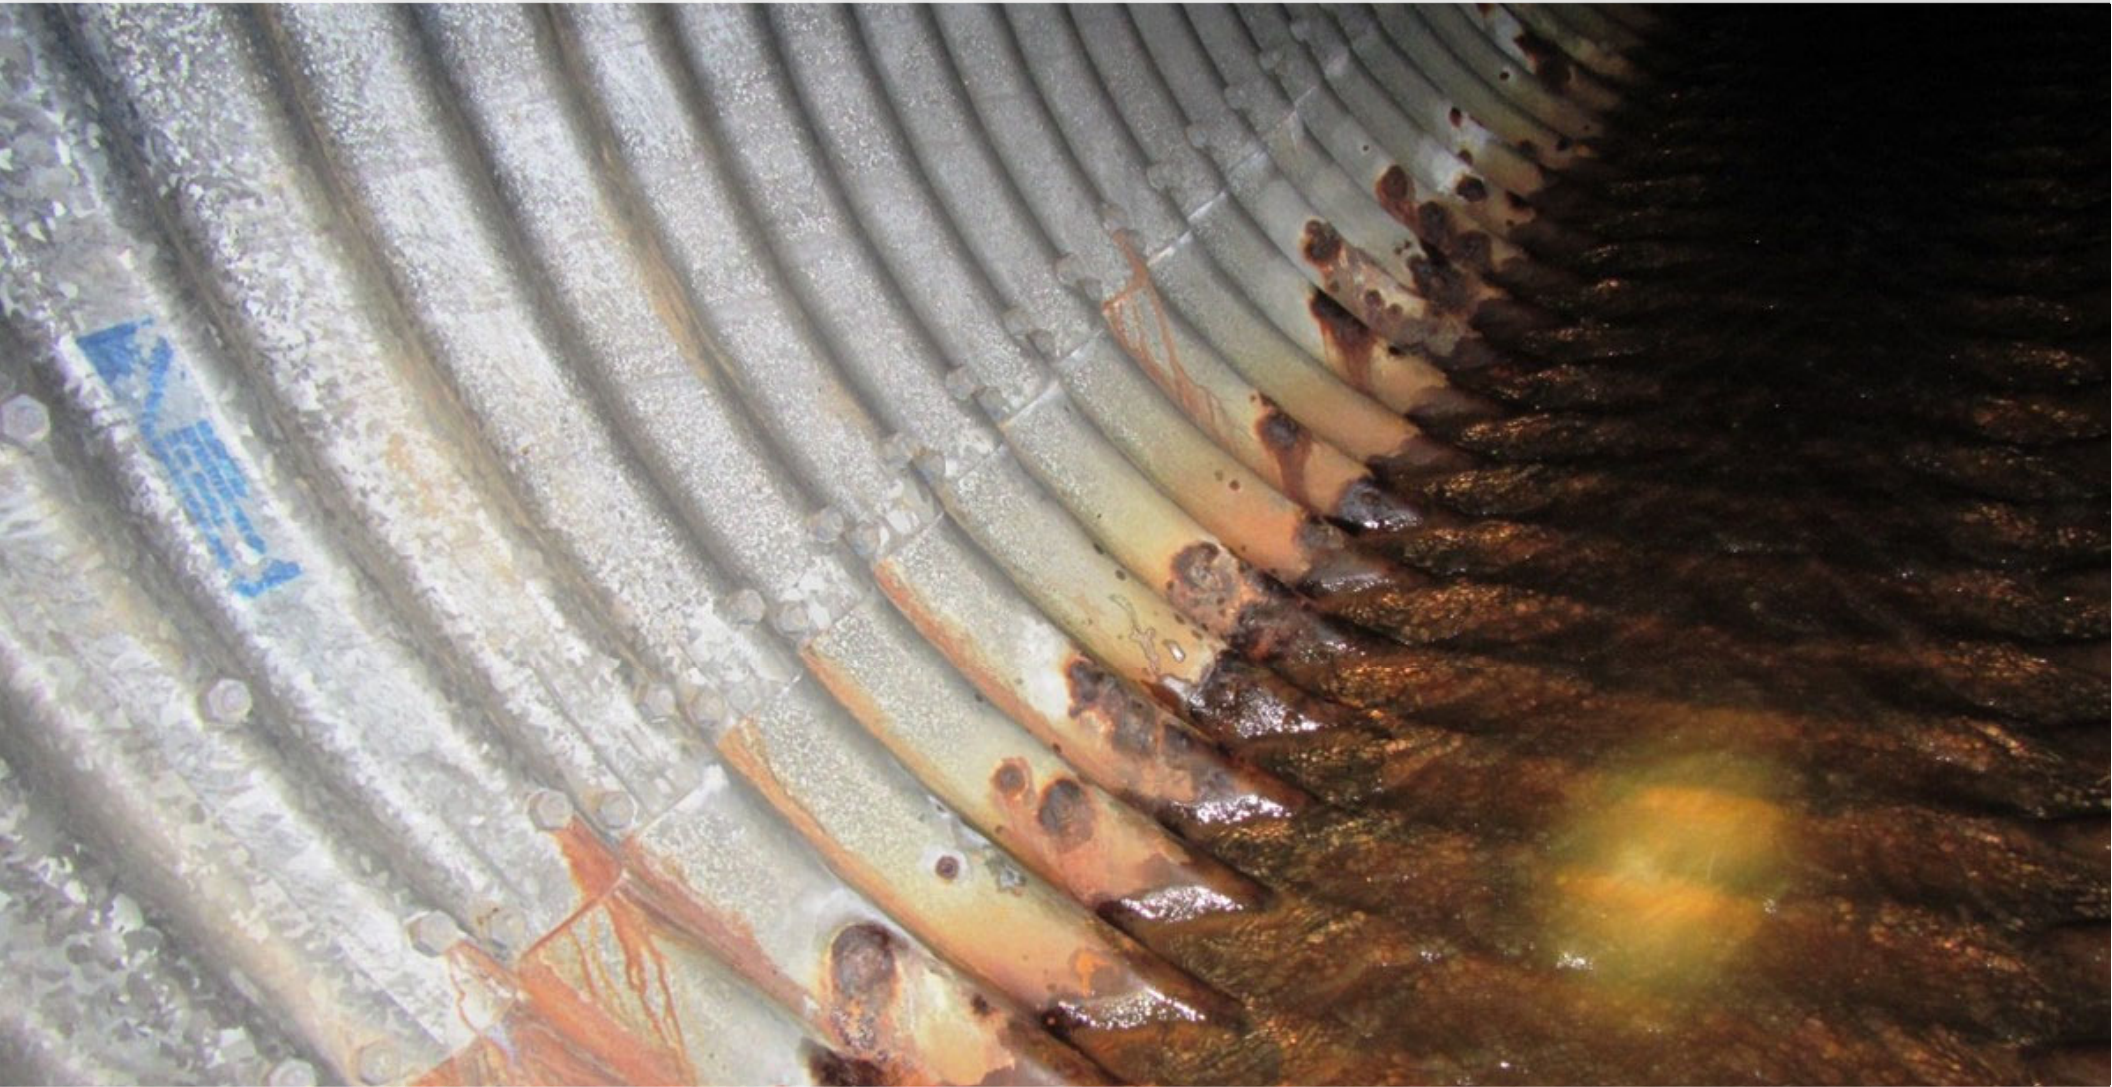
# Bridge Inspection Report Ratings

- The culvert is in fair condition. There are perforations throughout the entire invert and some areas are rusted through. The pipe shape is still in good condition with no distortion.
- On average there is over 60' of fill over this 565' long structure. Traditional open-cut replacement methods would significantly impact traffic
- The existing culvert exceeds the measured minimum 2'-4' bankfull width and meets VTrans hydraulic standards.
- The lane and shoulder widths along VT 289 through the project area meets the minimum roadway geometry standards.

- Culvert Rating 5 (Fair)
- Channel Rating 7 (Good)

- Rehabilitate the existing culvert with a slip liner or concrete invert while maintaining traffic on the existing culvert
  - Possible temporary lane or shoulder closures for mobilizing construction equipment and managing truck traffic
  - Meets Minimum hydraulic standard and bank full width
  - 8'/12'/12'/8' roadway typical meets minimum standard width
  - Extends the life of the structure an additional 50 years
