# Essex-Jericho Culvert Bundle Public Informational Meeting

March 21, 2024

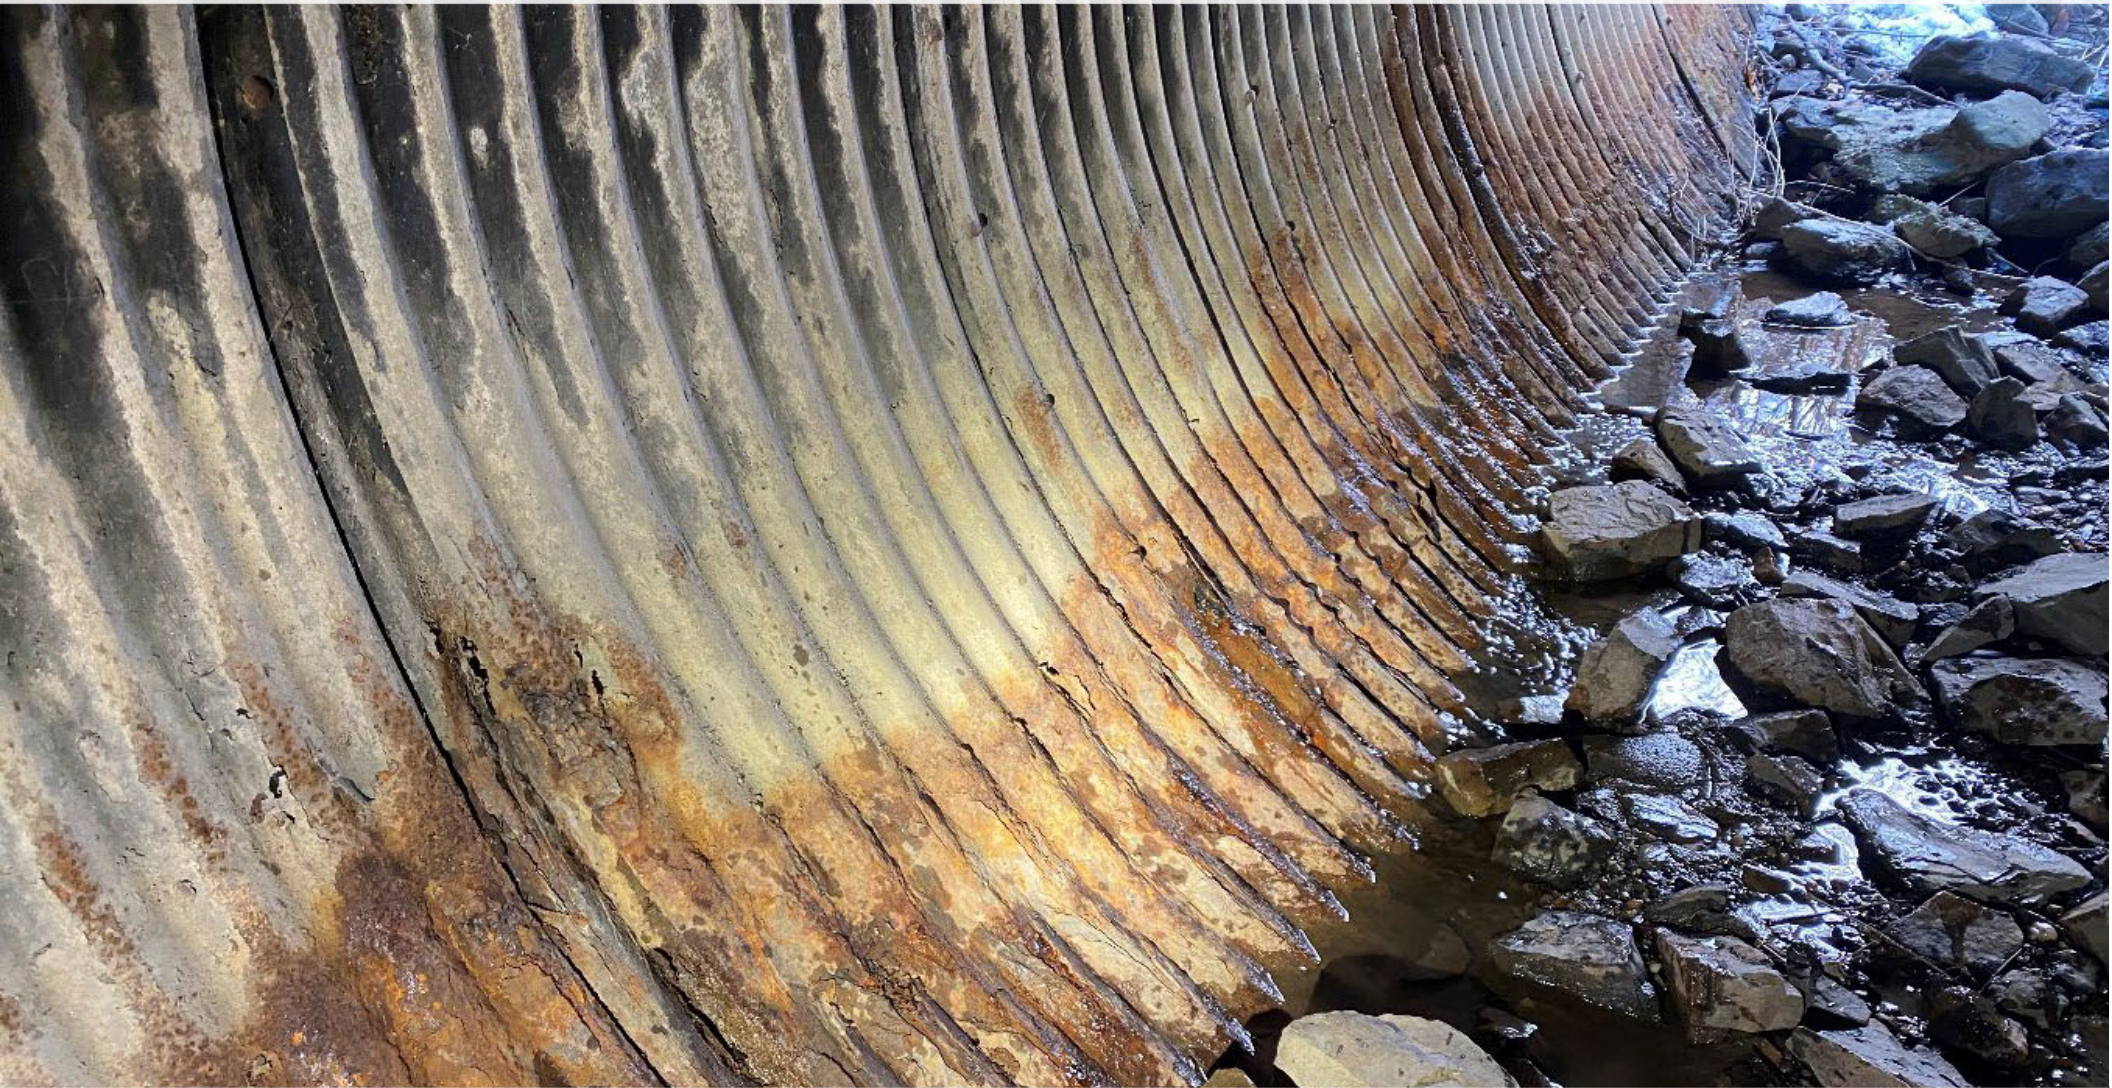
- The culvert is in poor condition. There is heavy rust scaling and pitting which has led to small perforations along the haunches in the first half of the barrel. Moderate distortion throughout the pipe has allowed for small gaps along connection joints leading to minor piping. The invert is covered with gravel, and is in poor condition.
- The existing culvert meets VTrans hydraulics standards and meets bankfull width.
- VT Route 15 has substandard shoulder widths along the VT Route 15 corridor through the project area.

- Culvert Rating 4 (Poor)
- Channel Rating 7 (Good)

- Rehabilitate the existing culvert with a Round Pipe Slip Liner system while maintaining traffic on the existing culvert
  - Minimum 4-foot inside diameter slip liner system
  - Minimum hydraulic standards will be met
  - Substandard shoulder widths along the VT Route 15 corridor through the project area
  - Extends the life of the structure an additional 50 years
  - Possible temporary lane or shoulder closures for mobilizing construction equipment and managing truck traffic

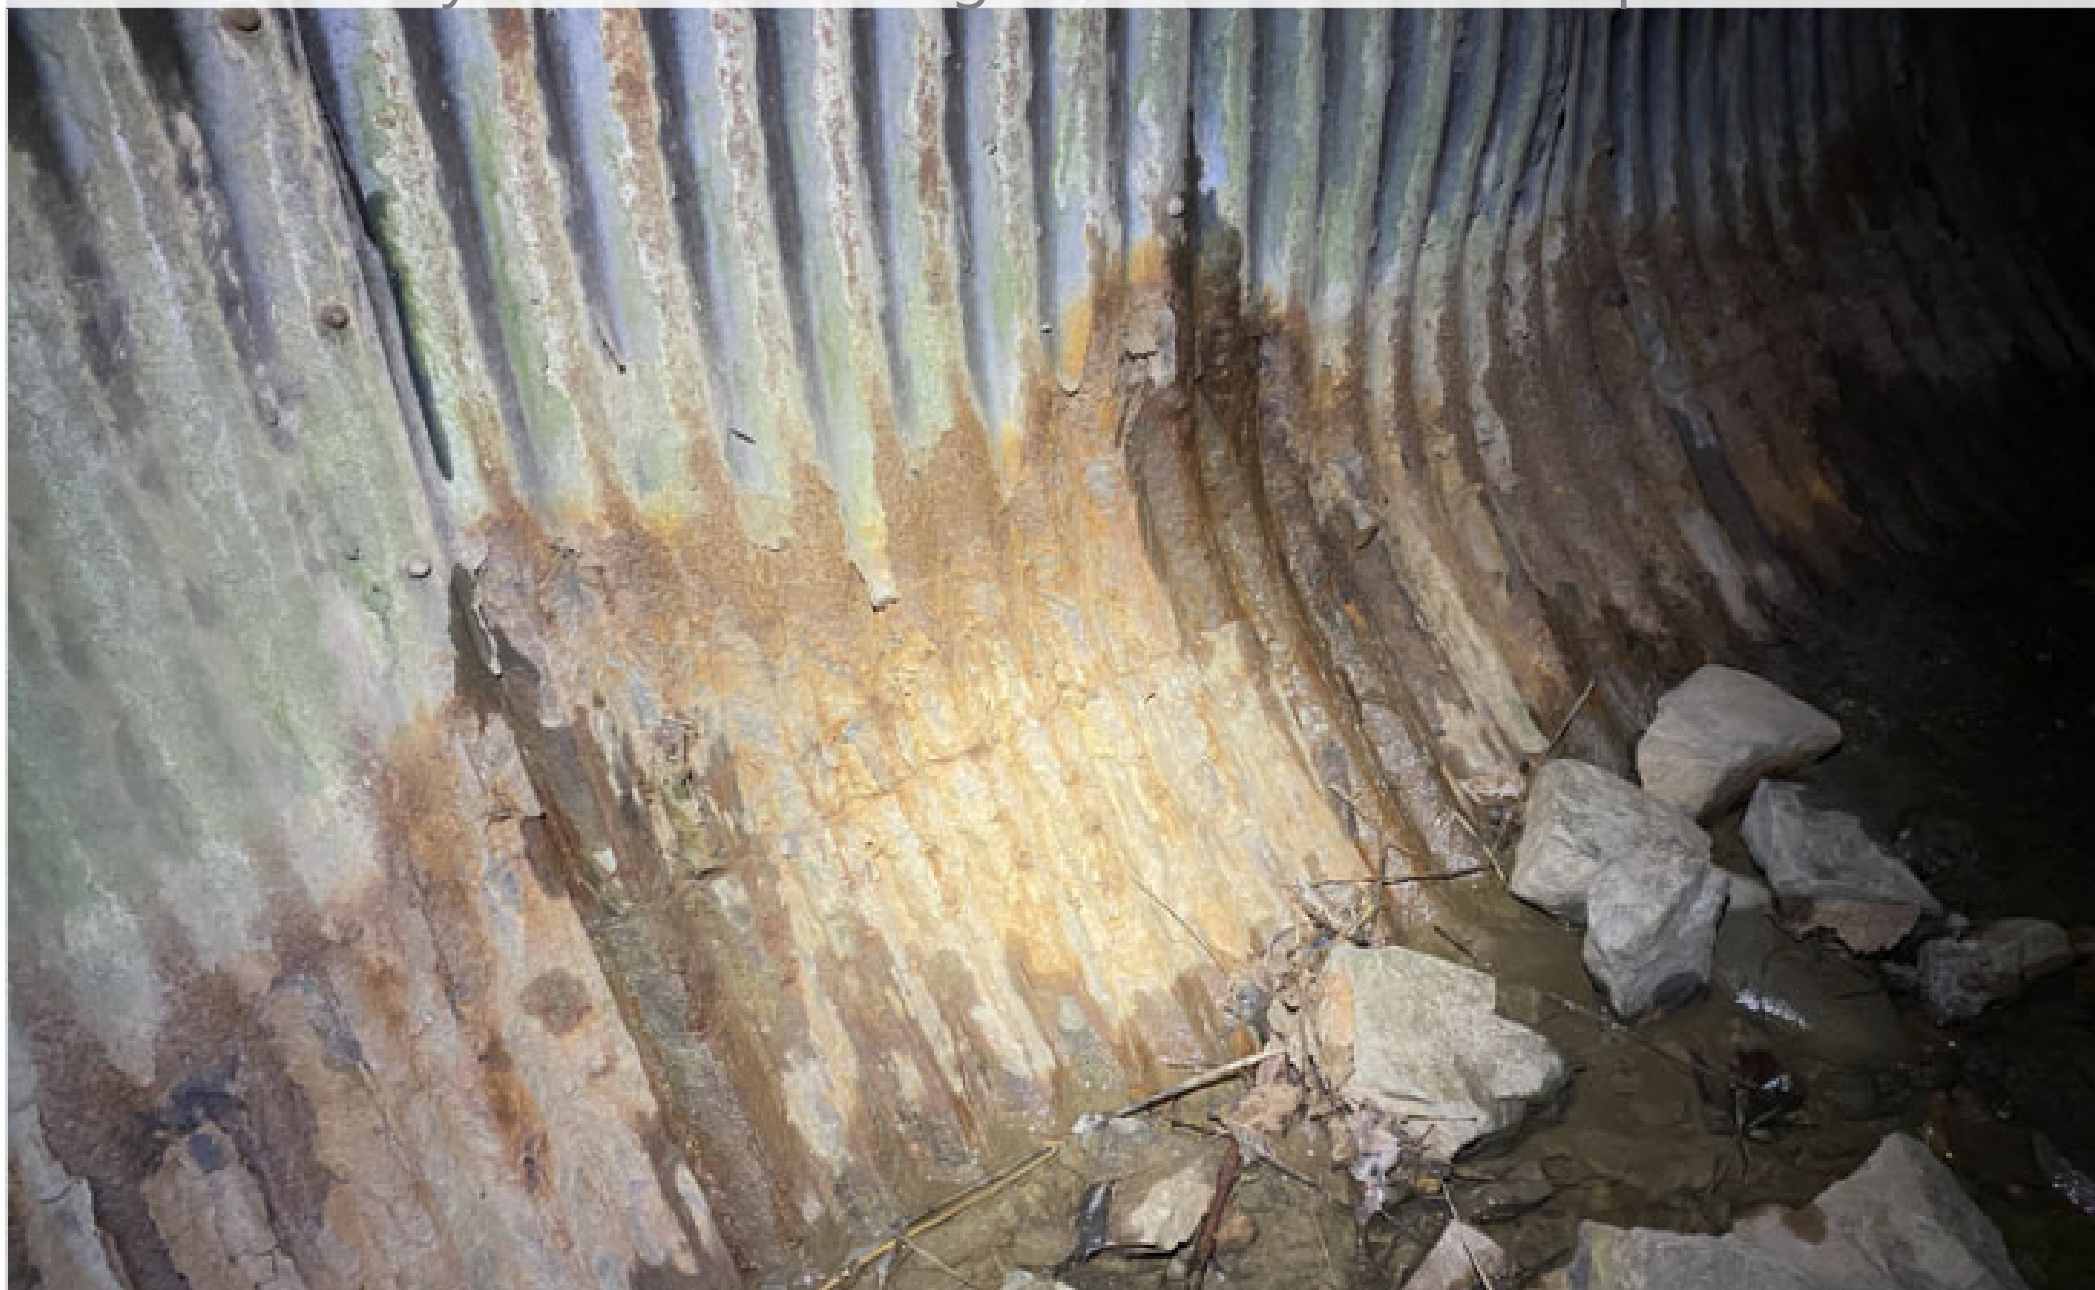
Heavy Corrosion along Eastern Wall near Upstream

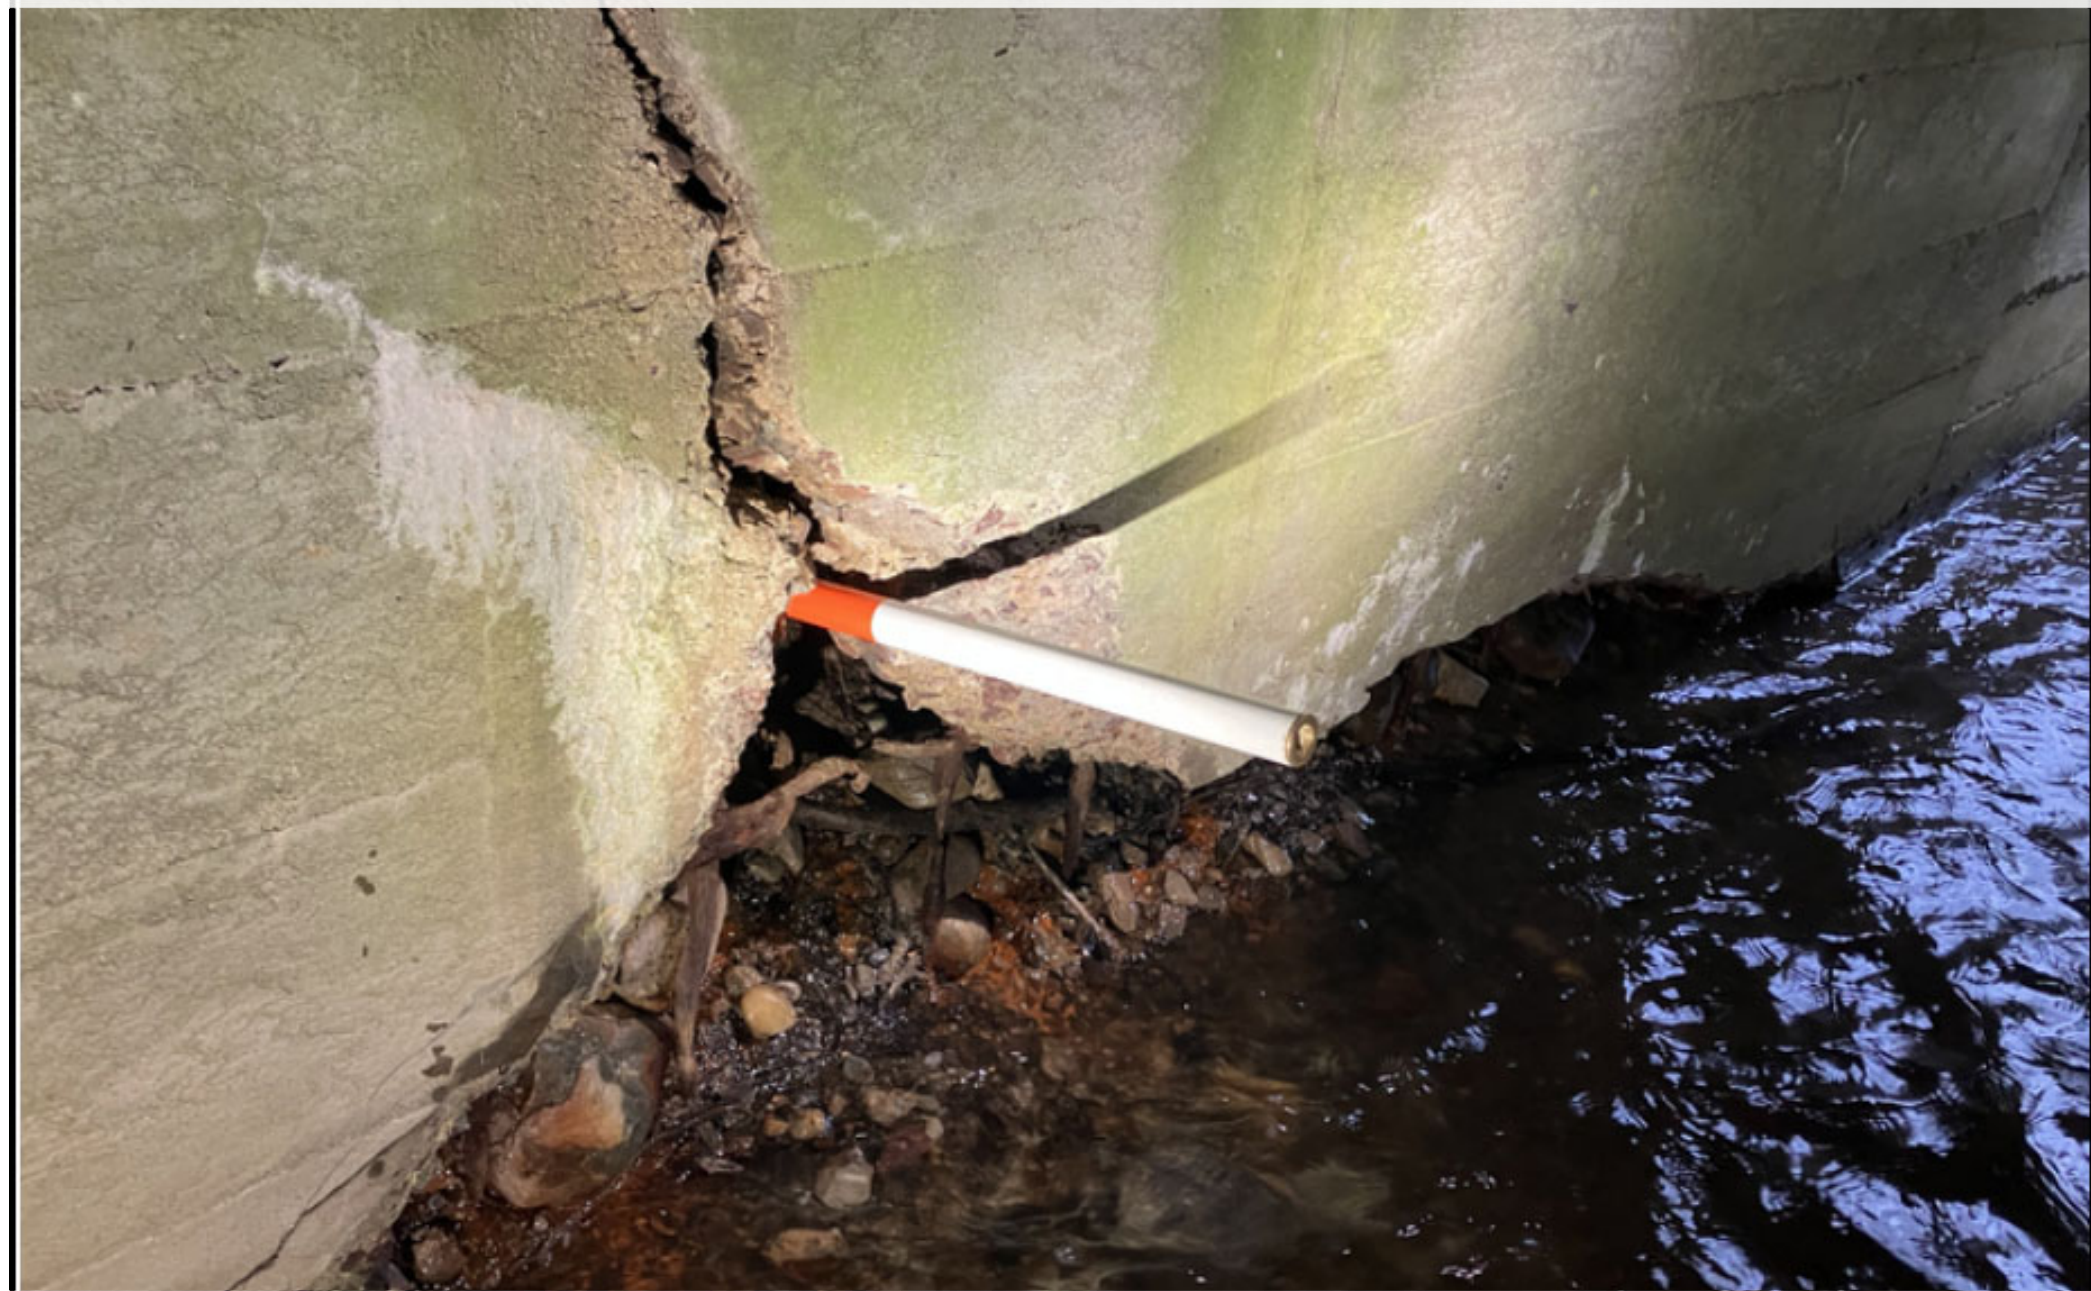
3ft of Backfill Sediment Loss in Spalled Area

- Rehabilitate the existing culvert with Class III concrete repair and slope stabilization work while maintaining traffic on the existing culvert with temporary lane closures as needed.
  - Class III concrete repair and slope stabilization work including new wingwalls and headwall, and armoring side slopes
  - Minimum hydraulic standard and bank full width conditions will be met
  - Temporary lane or shoulder closures as needed in order to mobilize/demobilize construction equipment or manage truck traffic
  - Extends the life of the structure an additional 30 years
