WE12 - Worcester Elmore VT Route 12 Public Informational Meeting VT Route 12 - Worcester Bridges #84, 87, & 89

February 1, 2021

Worcester BF 0241(59) VT Route 12– Bridge #84 over the North Branch of Winooski River

Worcester BF 0241(56) VT Route 12 – Bridge #87 over Hardwood Brook

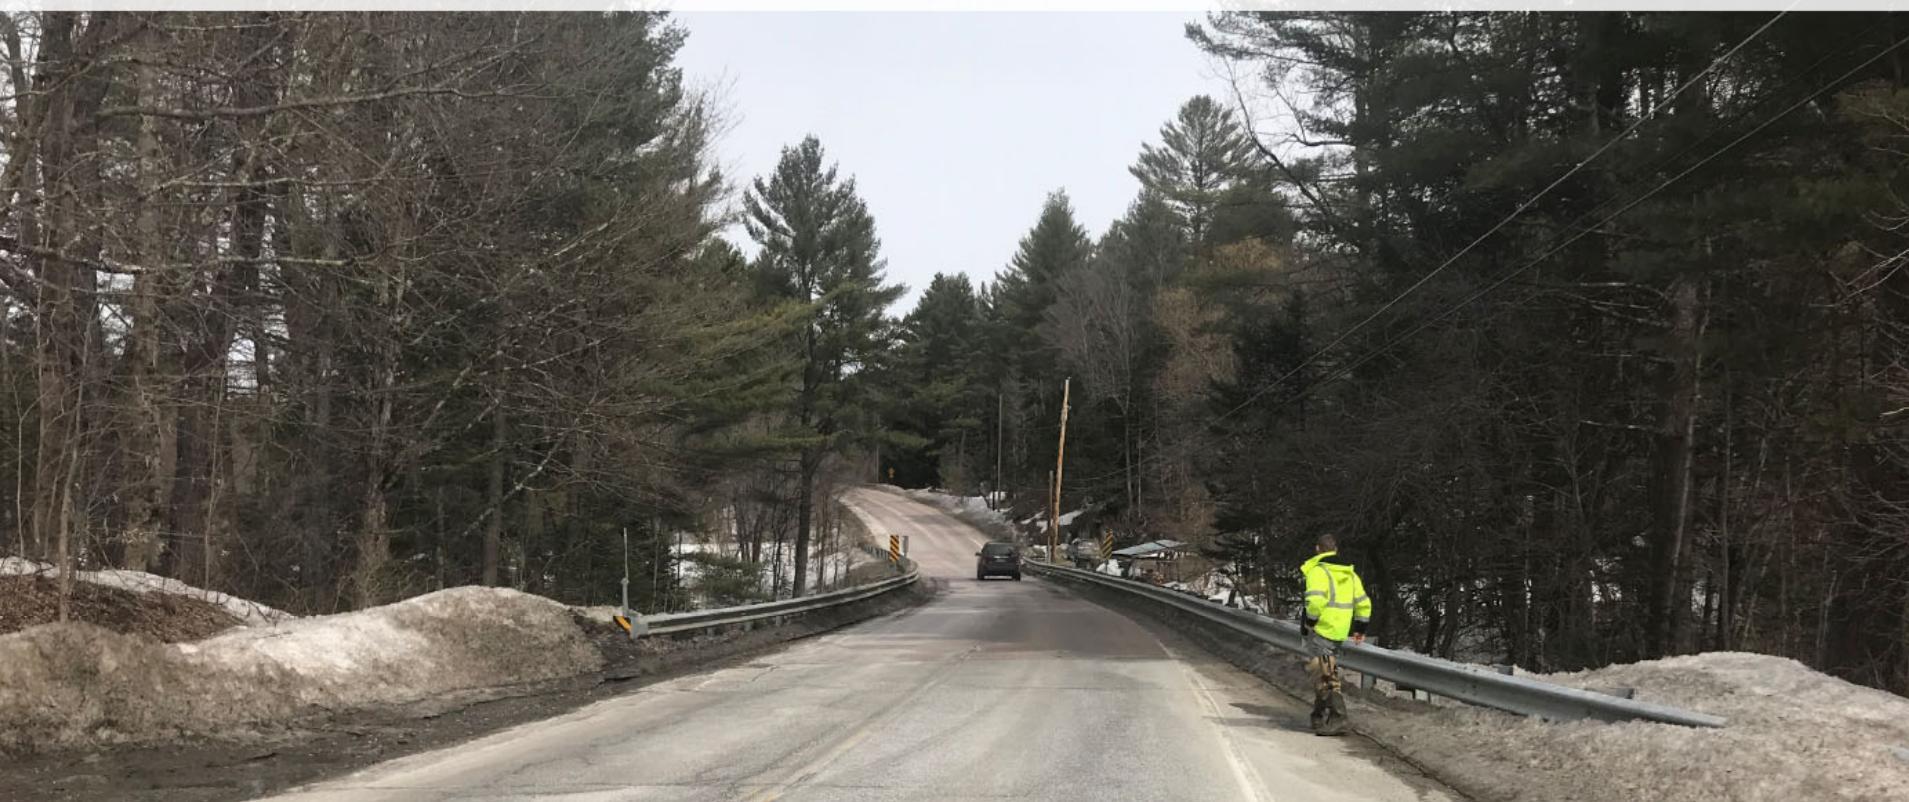
Looking North over Bridge 84

- Roadway Classification Major Collector
- Bridge Type Single Span Rolled Beam Bridge
- Bridge Length 84 feet
- Ownership State of Vermont
- Constructed in 1936

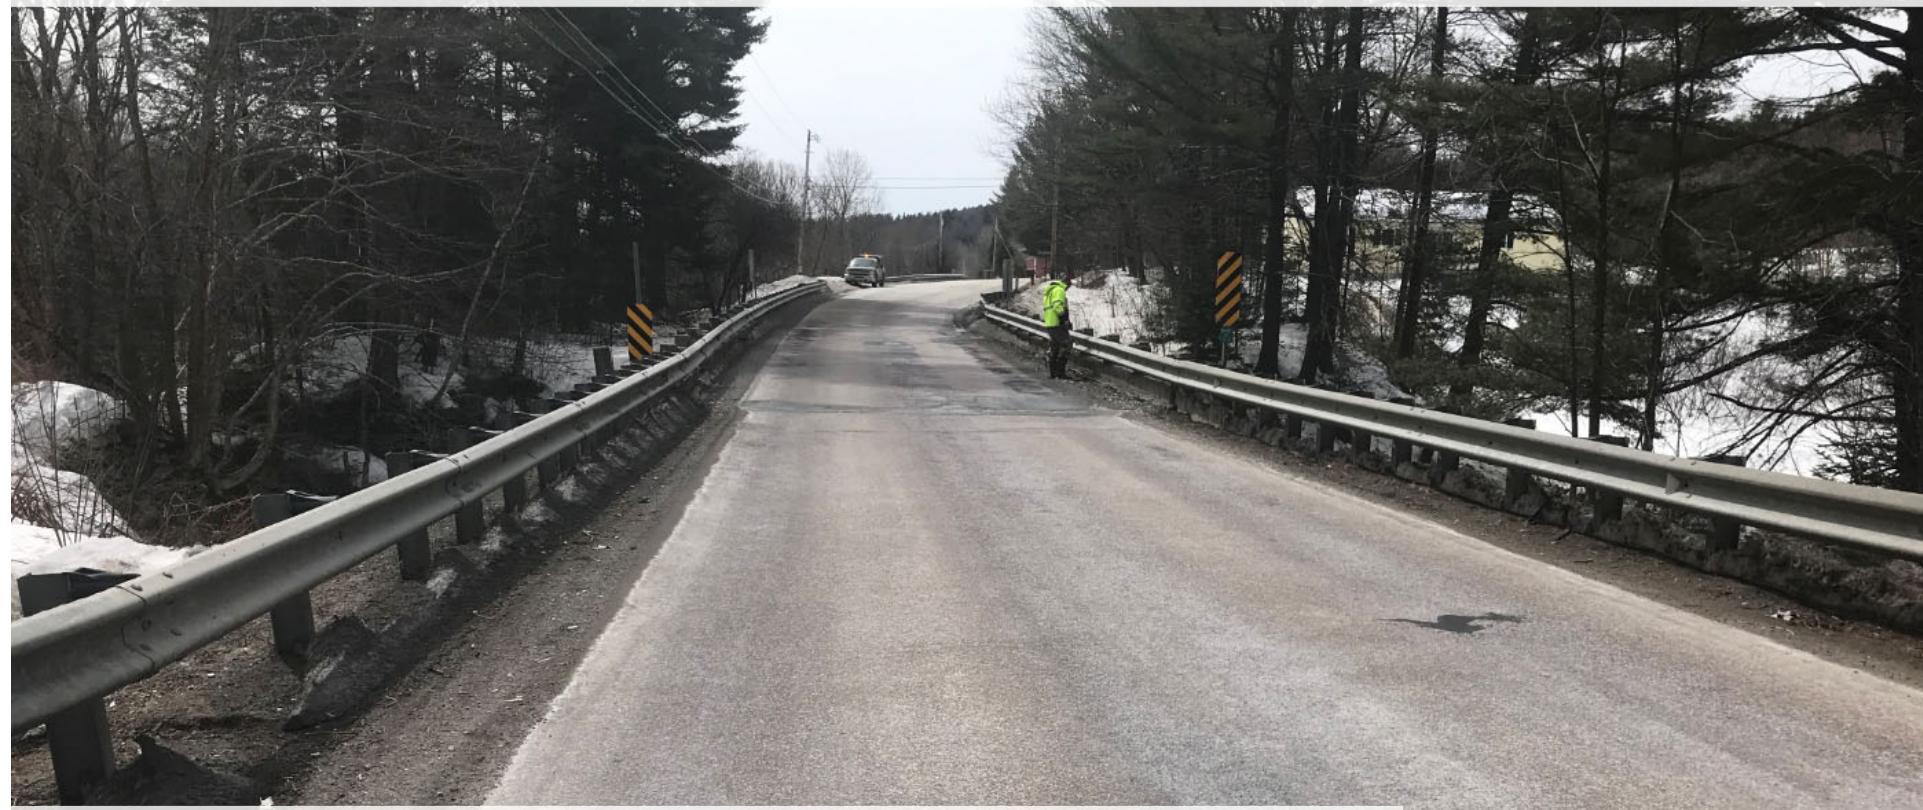
Looking South over Bridge 84

- Aerial Utilities
- Narrow Bridge
 - Existing Typical Section: 10'/0'
 - Standard Typical: 10'/4'
 - Corridor Typical: 11'/4'

- The deck is in poor condition.
 - widespread rust staining, concrete scaling, saturation leakage and efflorescence leakage.
 - Localized large spalls
 - Multiple patches, potholes, depressions and cracking in wearing surface above
- The superstructure is in satisfactory condition
 - Rolled beams paint failure with paint starting to peel, flake and bubble.
- The substructures are in satisfactory condition
 - Backwalls have areas of concrete scaling with heavy efflorescence leakage present
 - The southern abutment has a full height vertical crack.
- VT Route 12 through the project area and over the bridge is substandard in width by 8 feet.

- Full Bridge Replacement
 - Substructures founded on exposed bedrock
 - Minimum 66' clearspan per hydraulics recommendation
 - Approximate 90' span
 - Widen to 11'/4' typical to match the corridor
 - Paved width is widened by 10'
 - 75-year design life

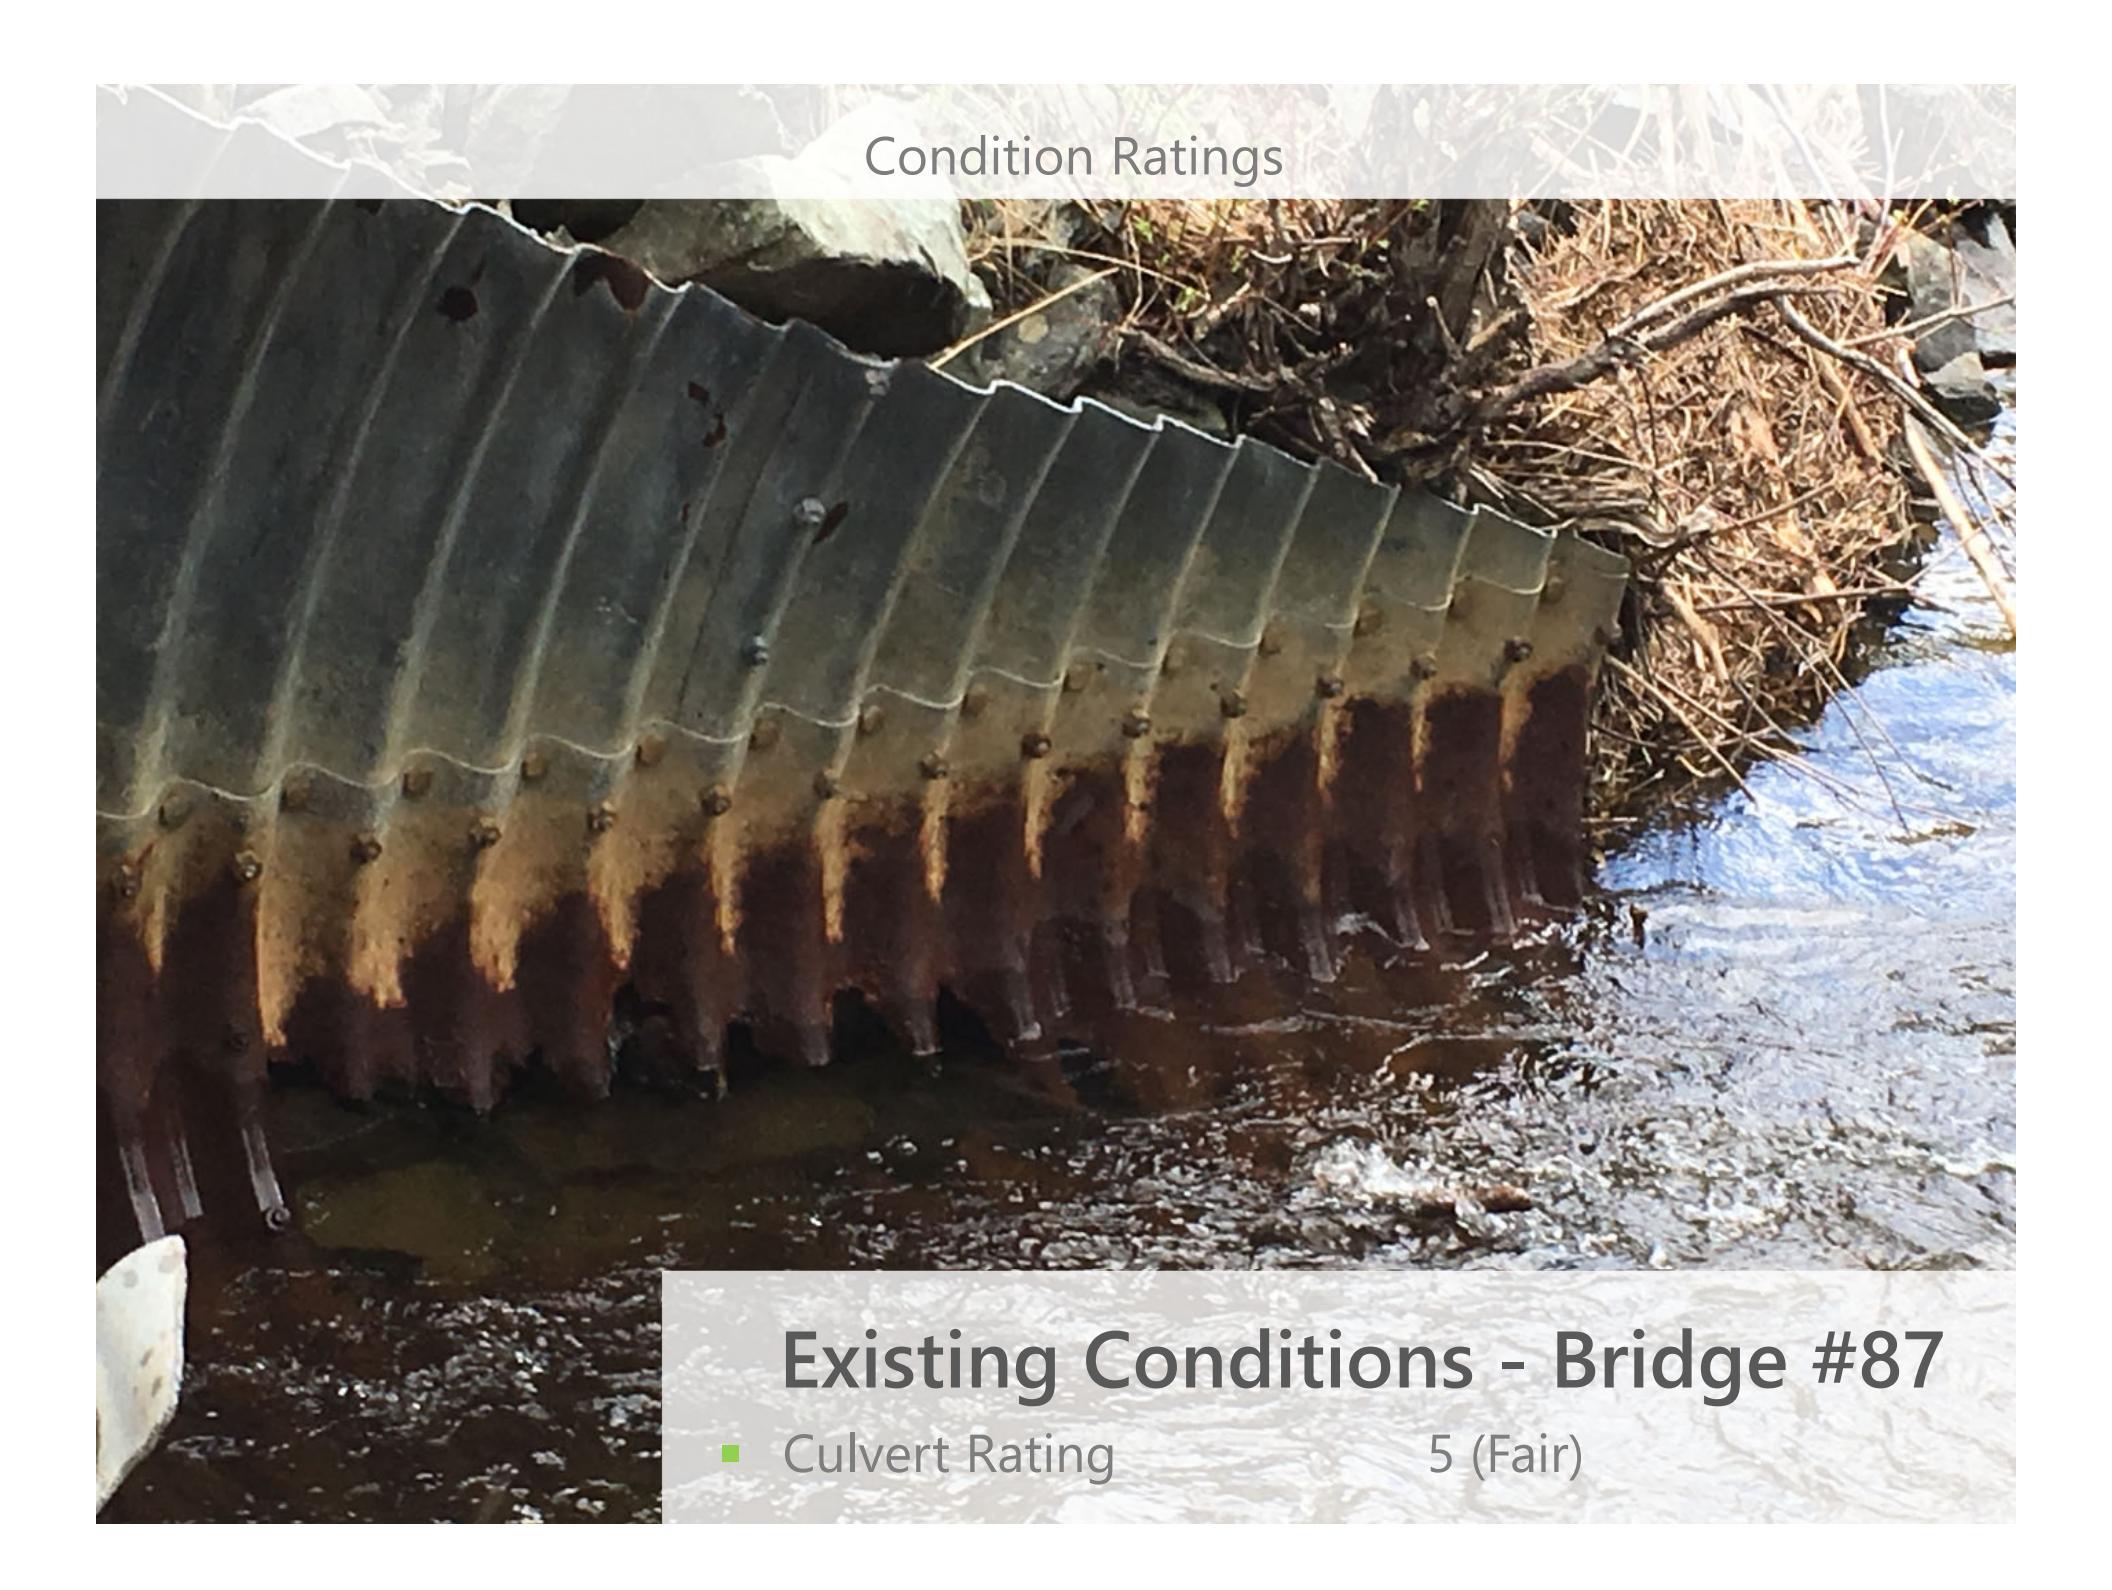
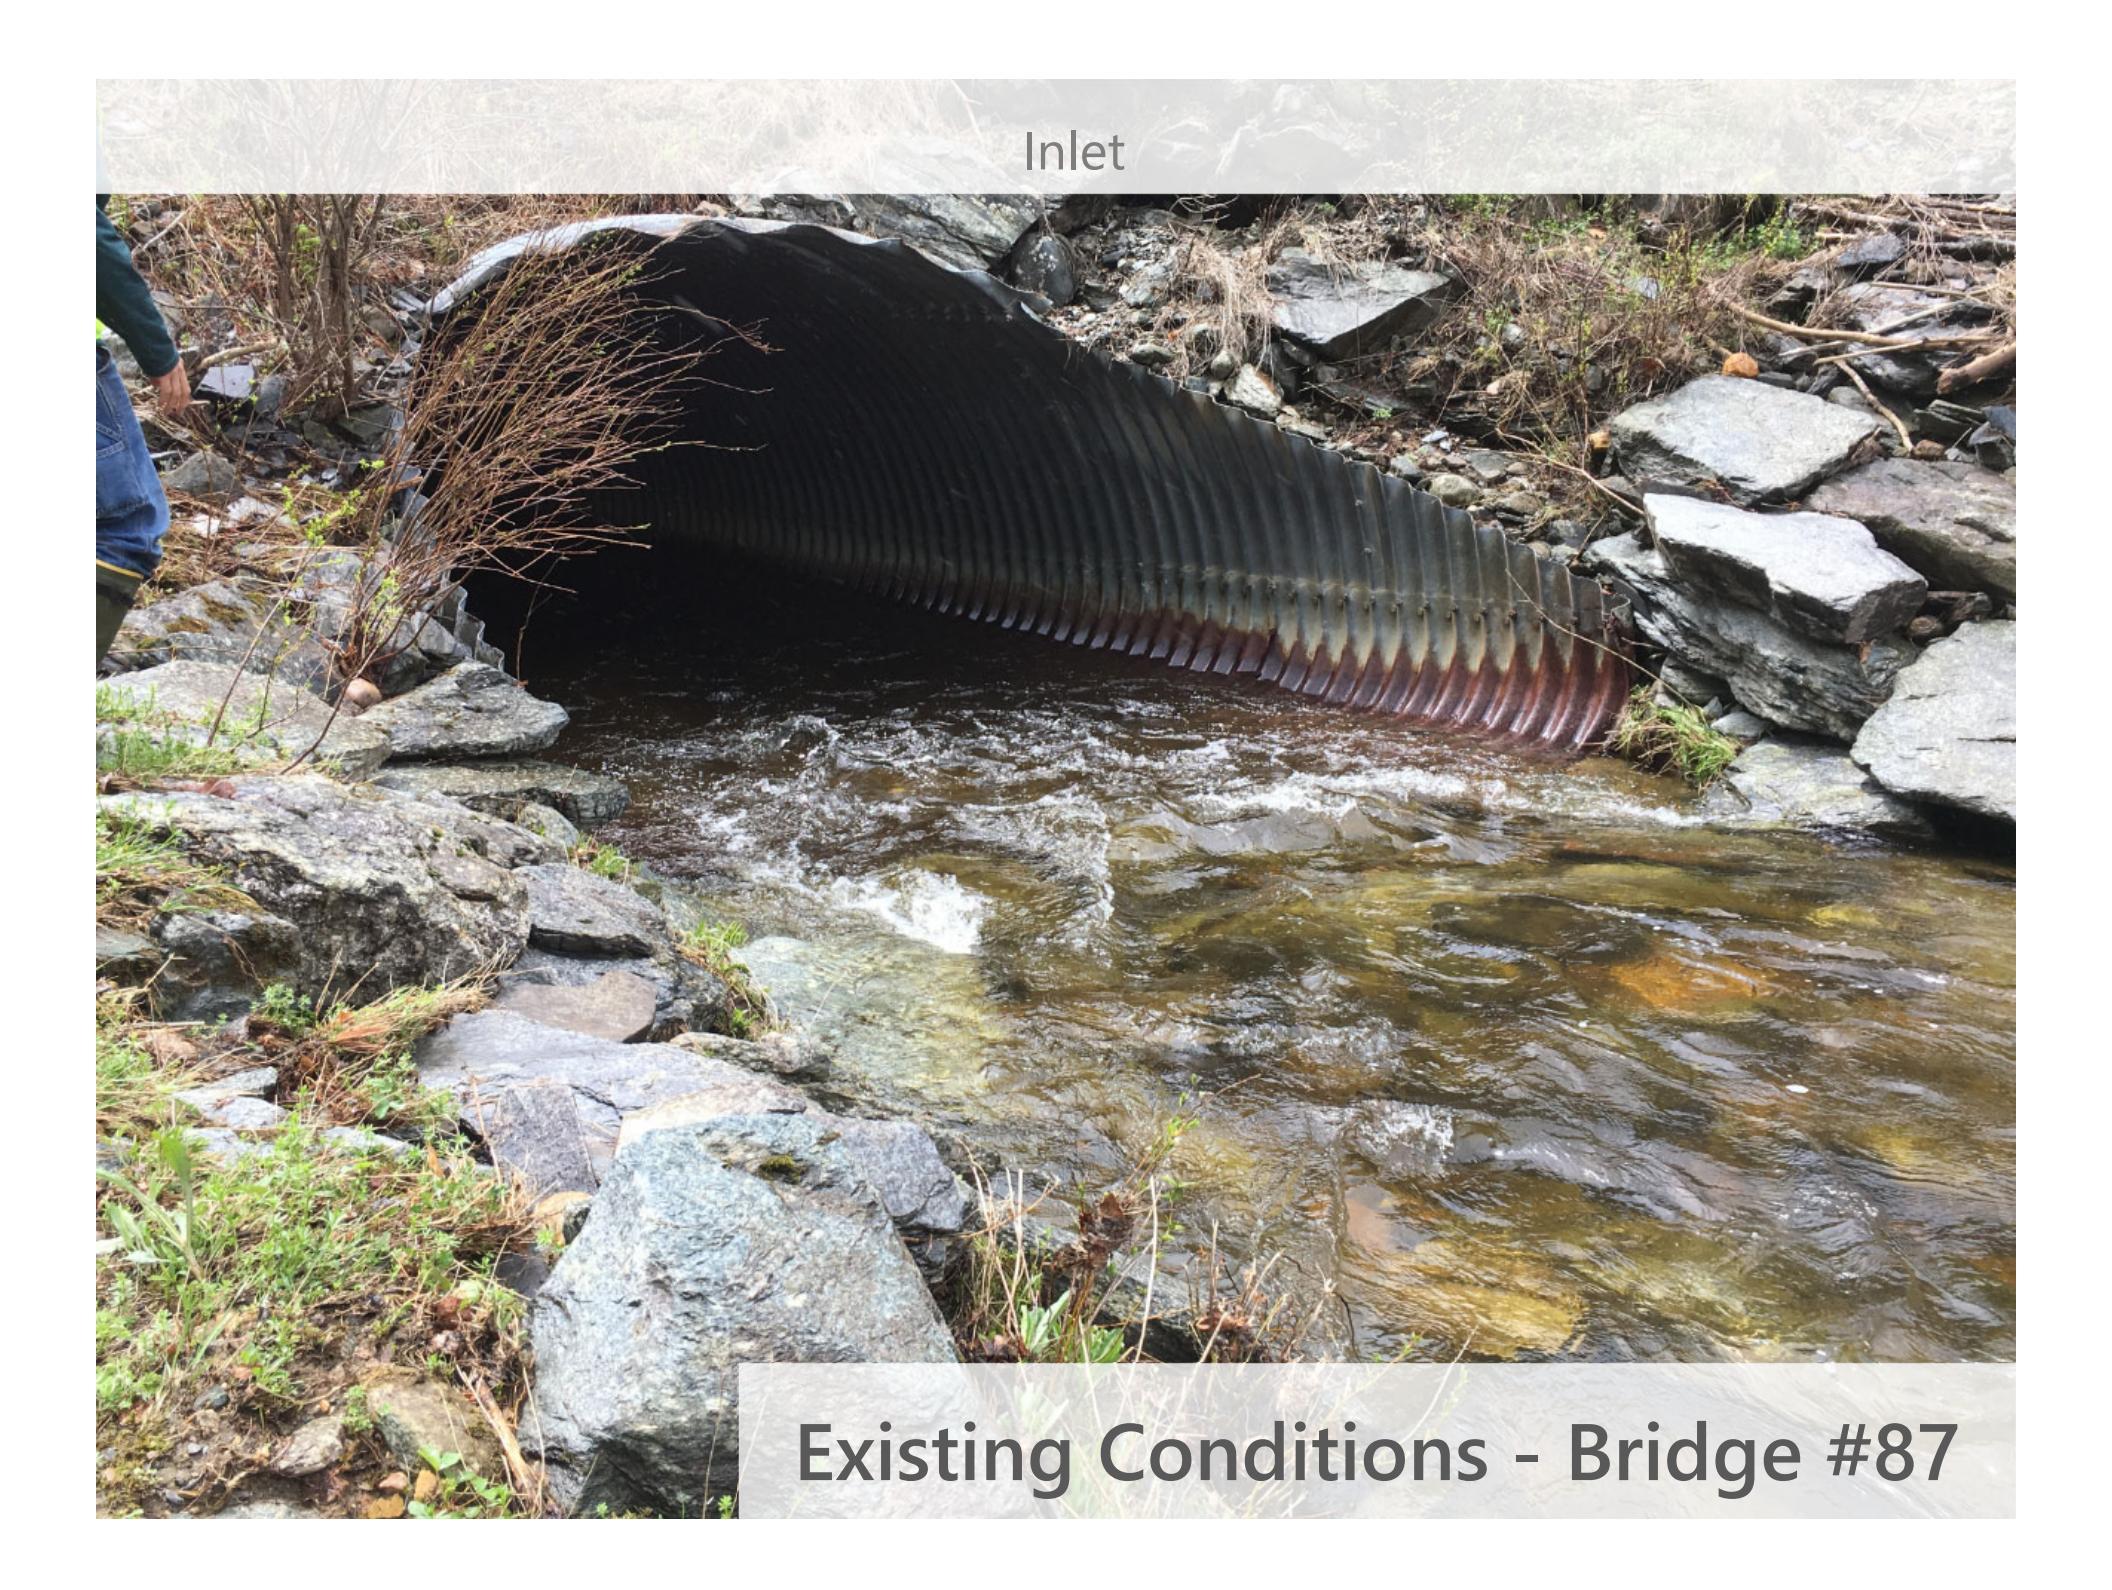
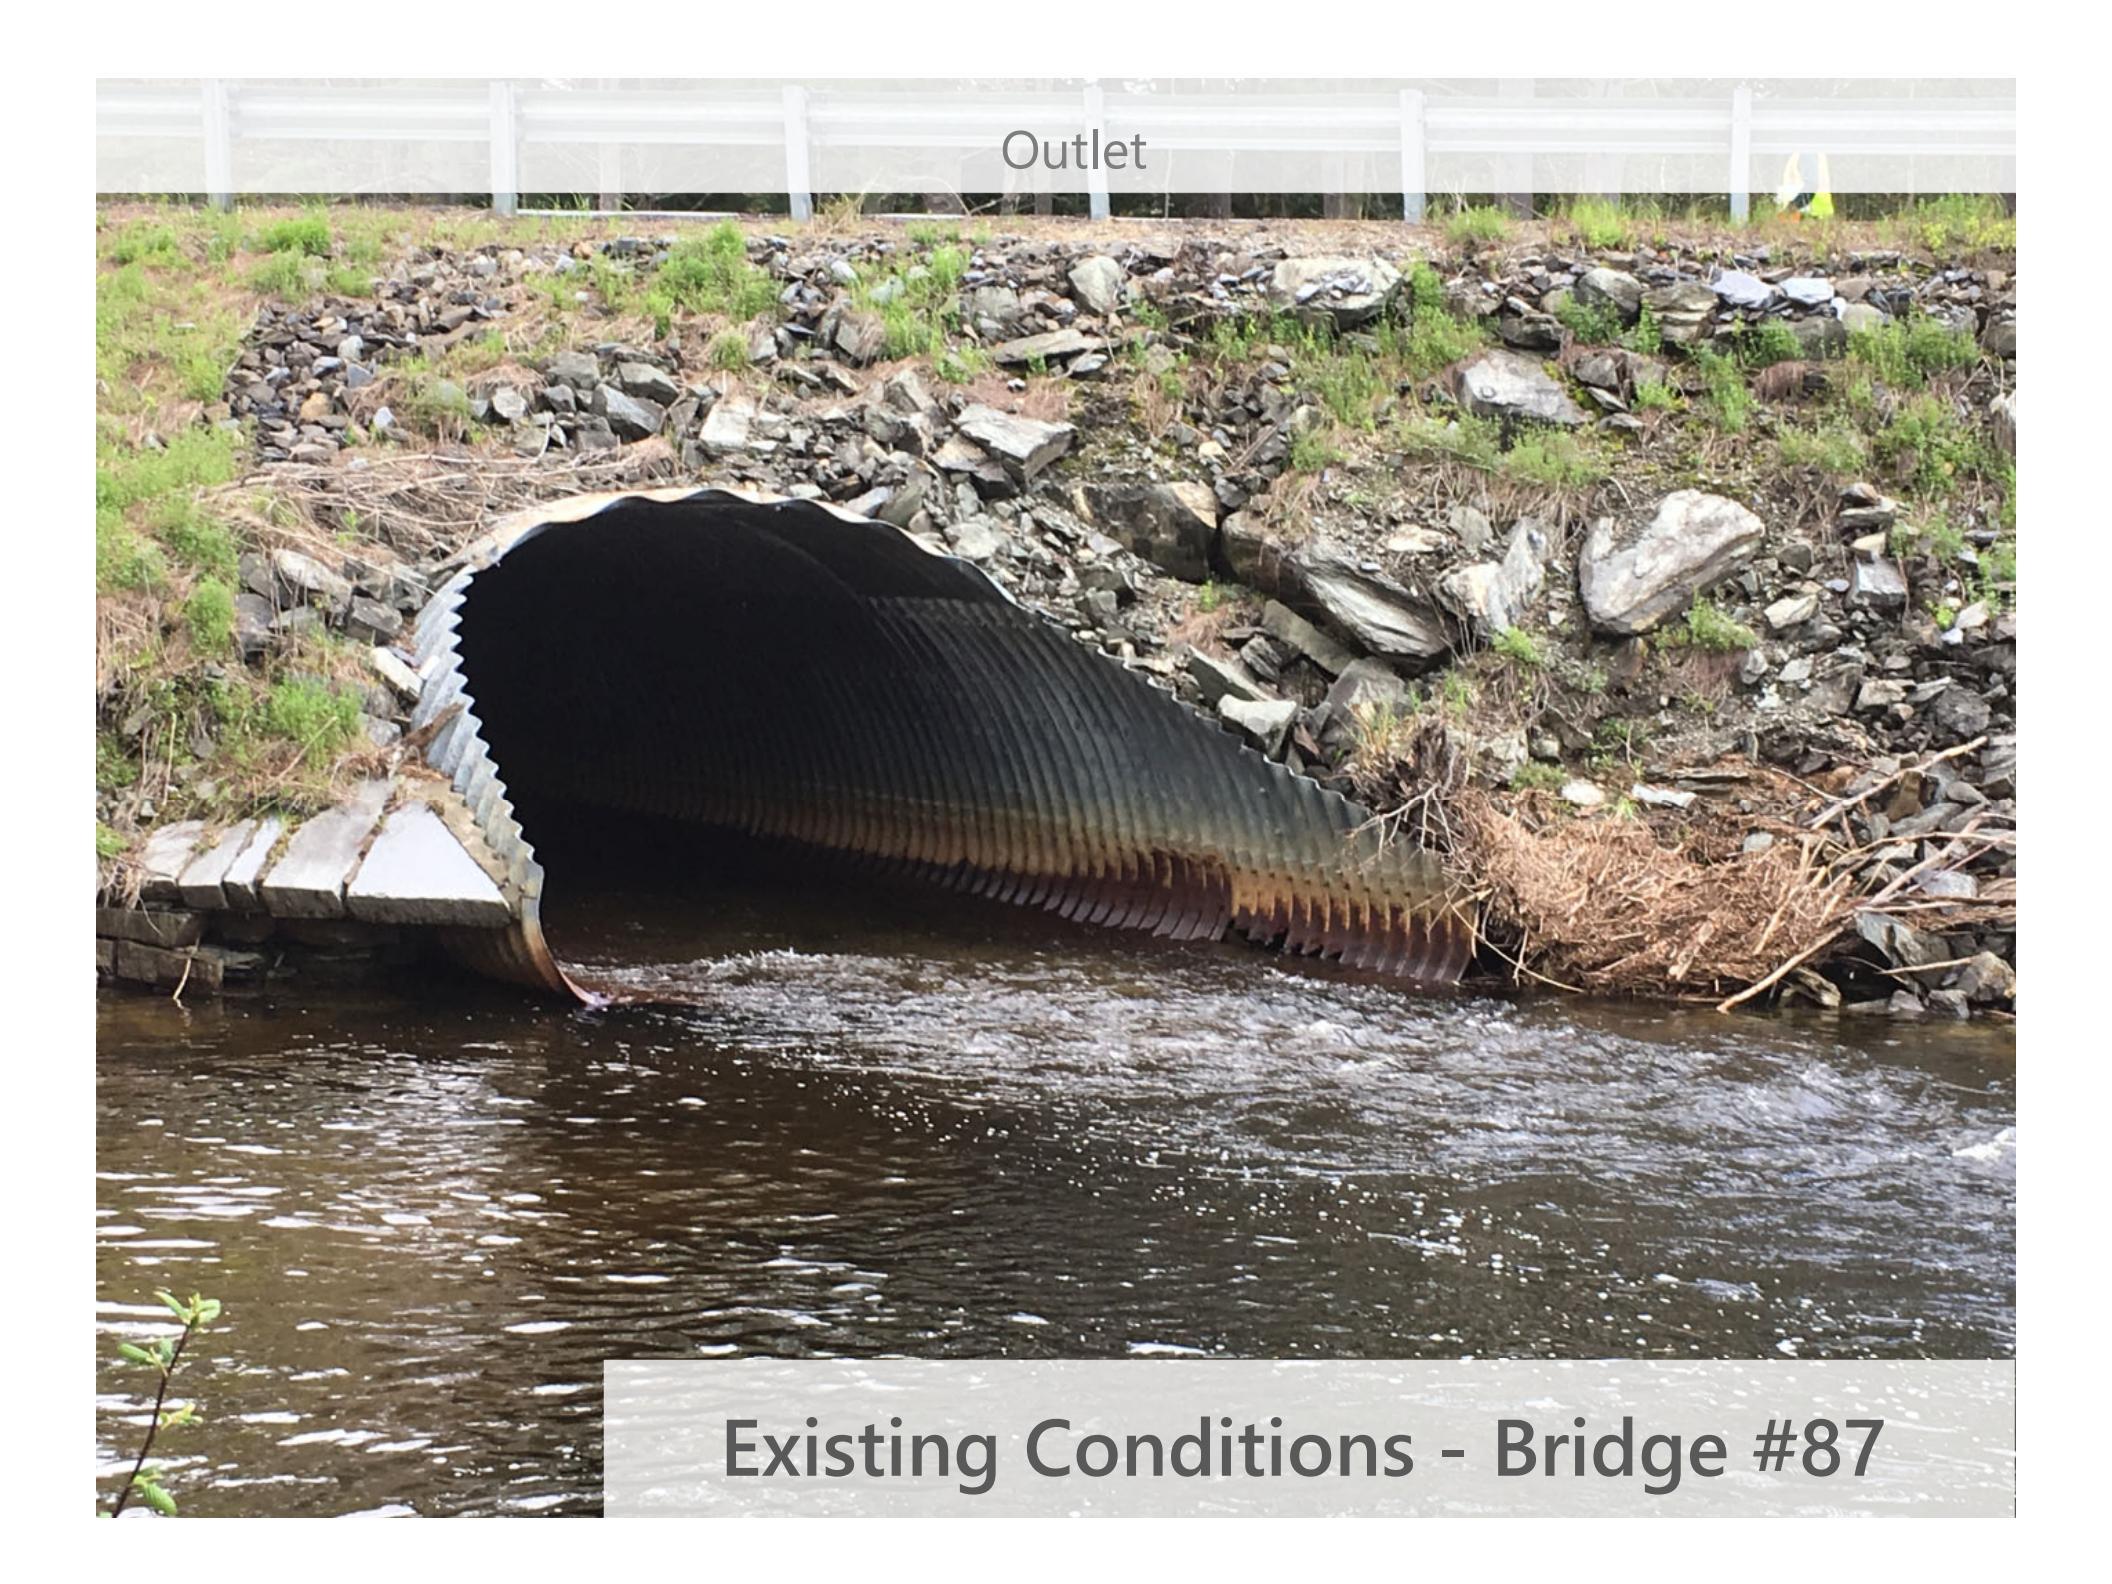
- The culvert is in fair condition
 - Barrel: On the outlet end, there is a large hole at the water line.
 - Invert: The invert of the culvert has deep pitting and heavy rust scaling in random spots. It is expected that holes will start to form in the near future.
- The existing culvert does not meet the calculated or measured bank full width. There is a large scour hole at the outlet, indicative of an undersized structure.

- Culvert Replacement with a New Buried Structure
 - Precast Concrete Box
 - Contingent on borings
 - Minimum 19' x 10' box with Type E3 Stone
 - 19' x 7' waterway opening
 - 87' Culvert Length
 - 11'/4' typical to match existing conditions
 - Exceeds the 11'/3' standard typical section
 - 75-year design life

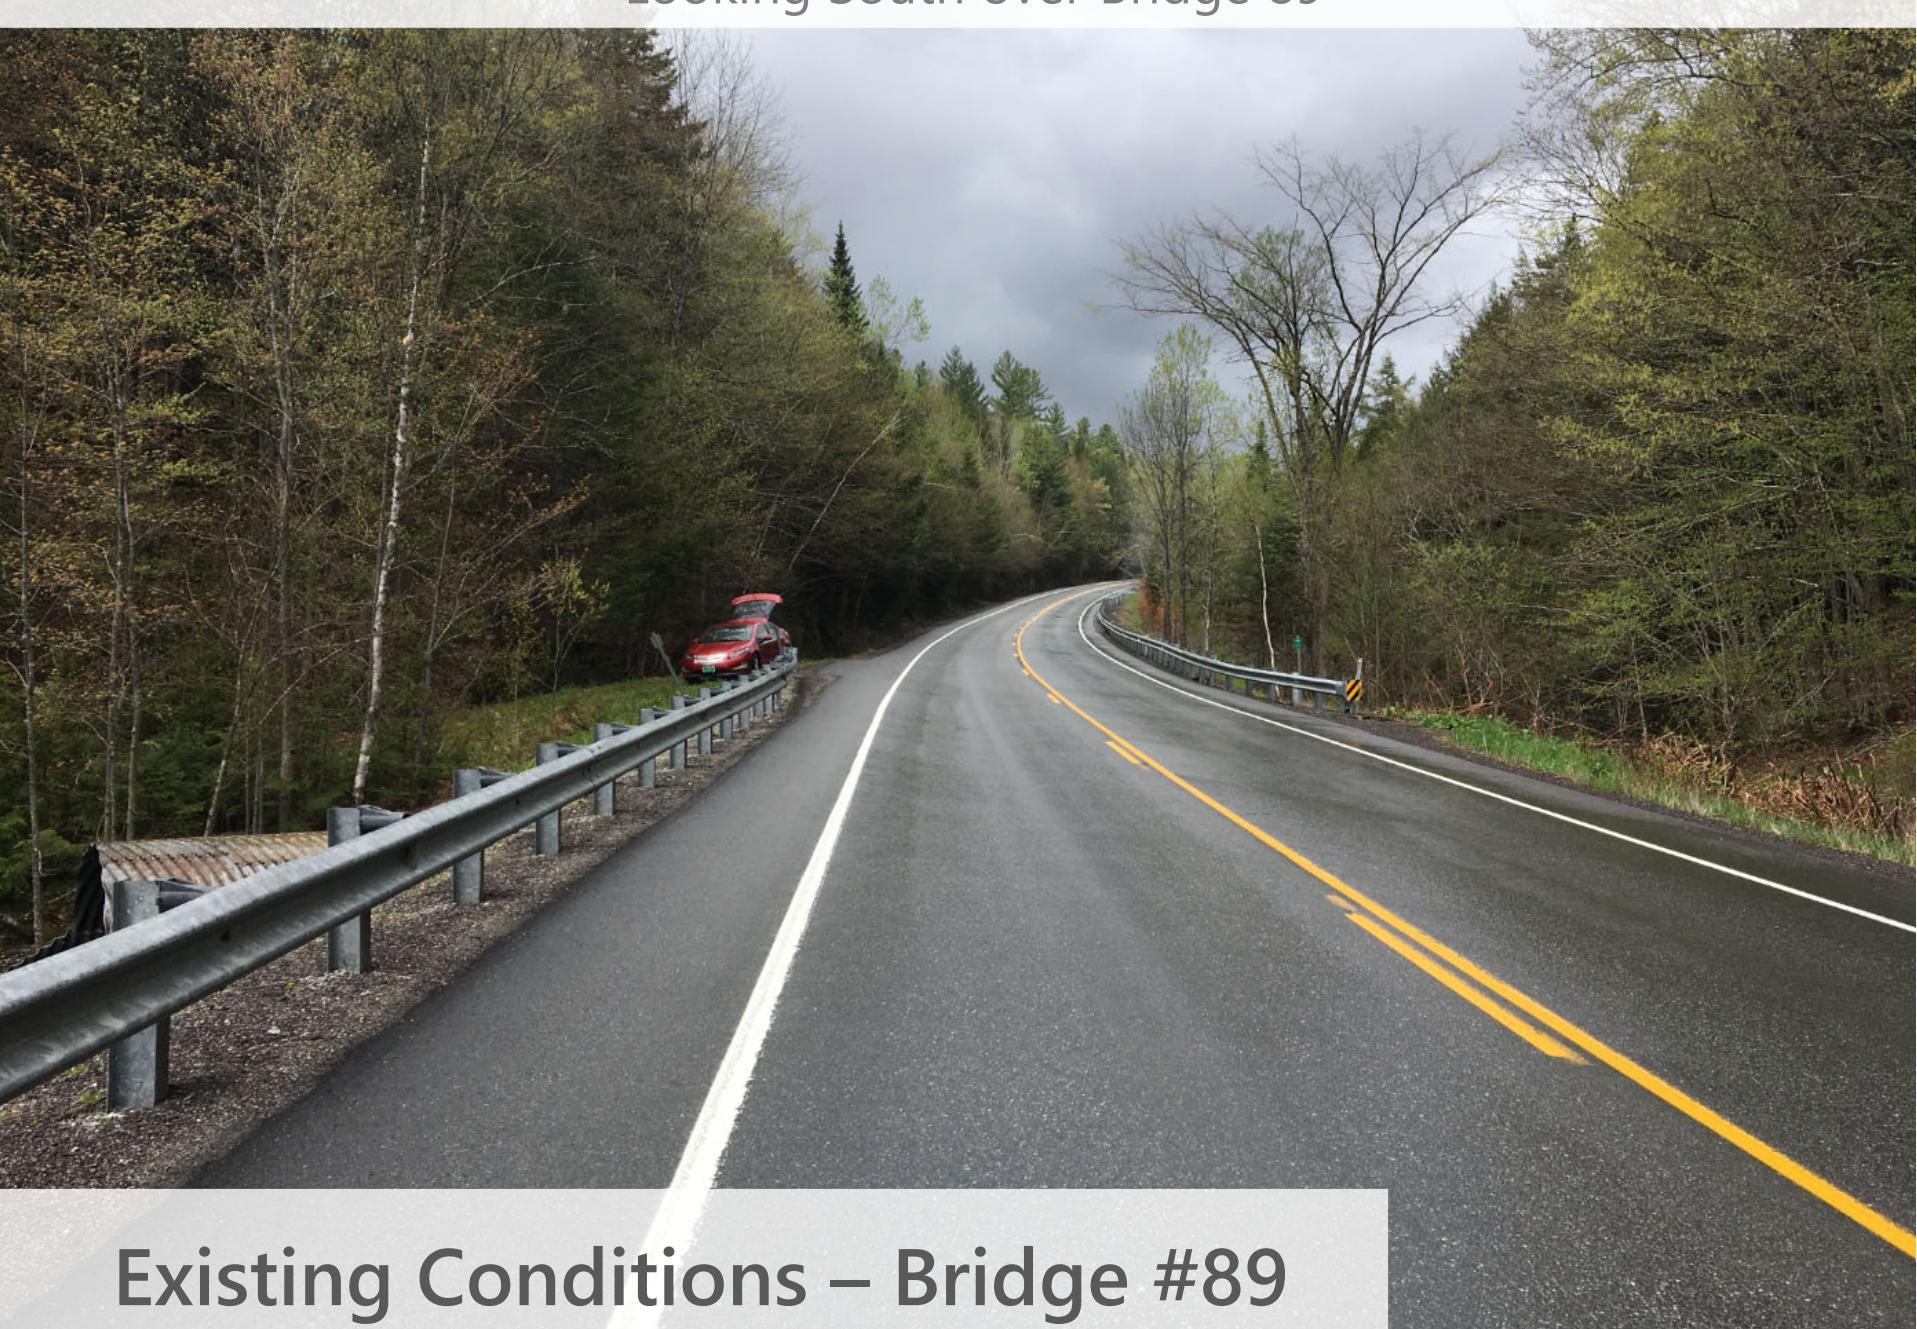
Looking South over Bridge 89

- The culvert is in fair condition
 - The invert has some holes and undermining has started at the outlet.
- The existing culvert does not meet the calculated or measured bank full width.

- Culvert Replacement with a New Bridge
 - Structure type contingent on borings
 - Approximate 100' Span
 - 11'/4' typical to match existing conditions
 - Exceeds the 11'/3' standard typical section
 - 75-year design life

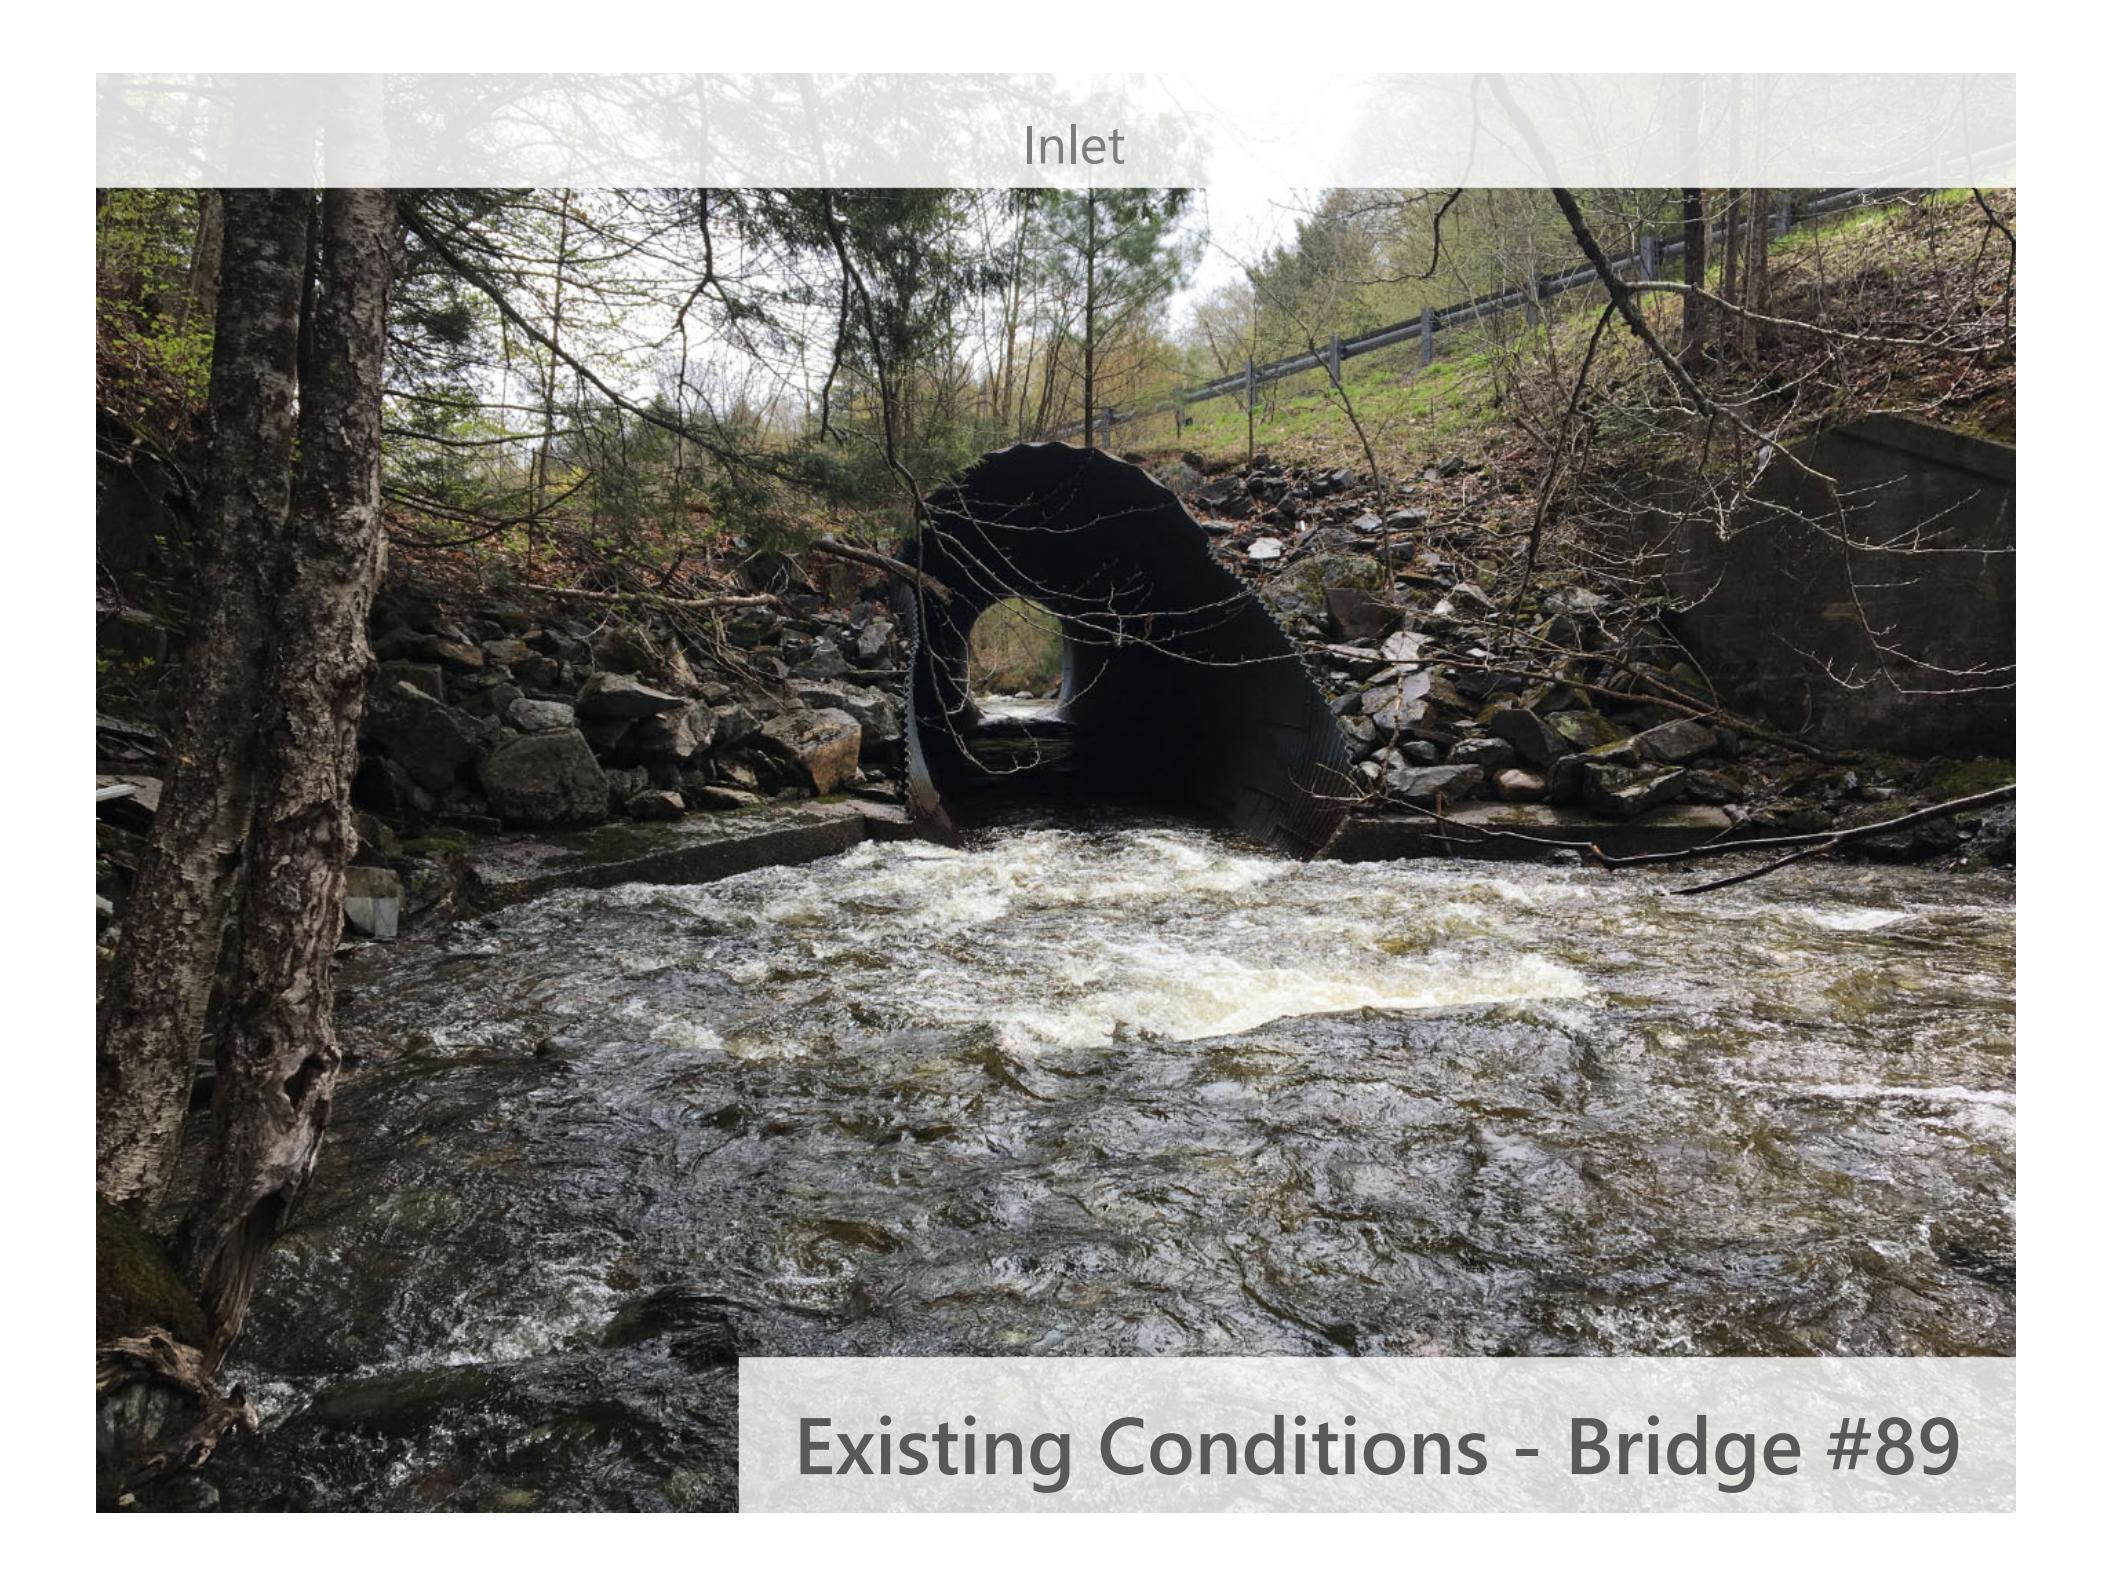
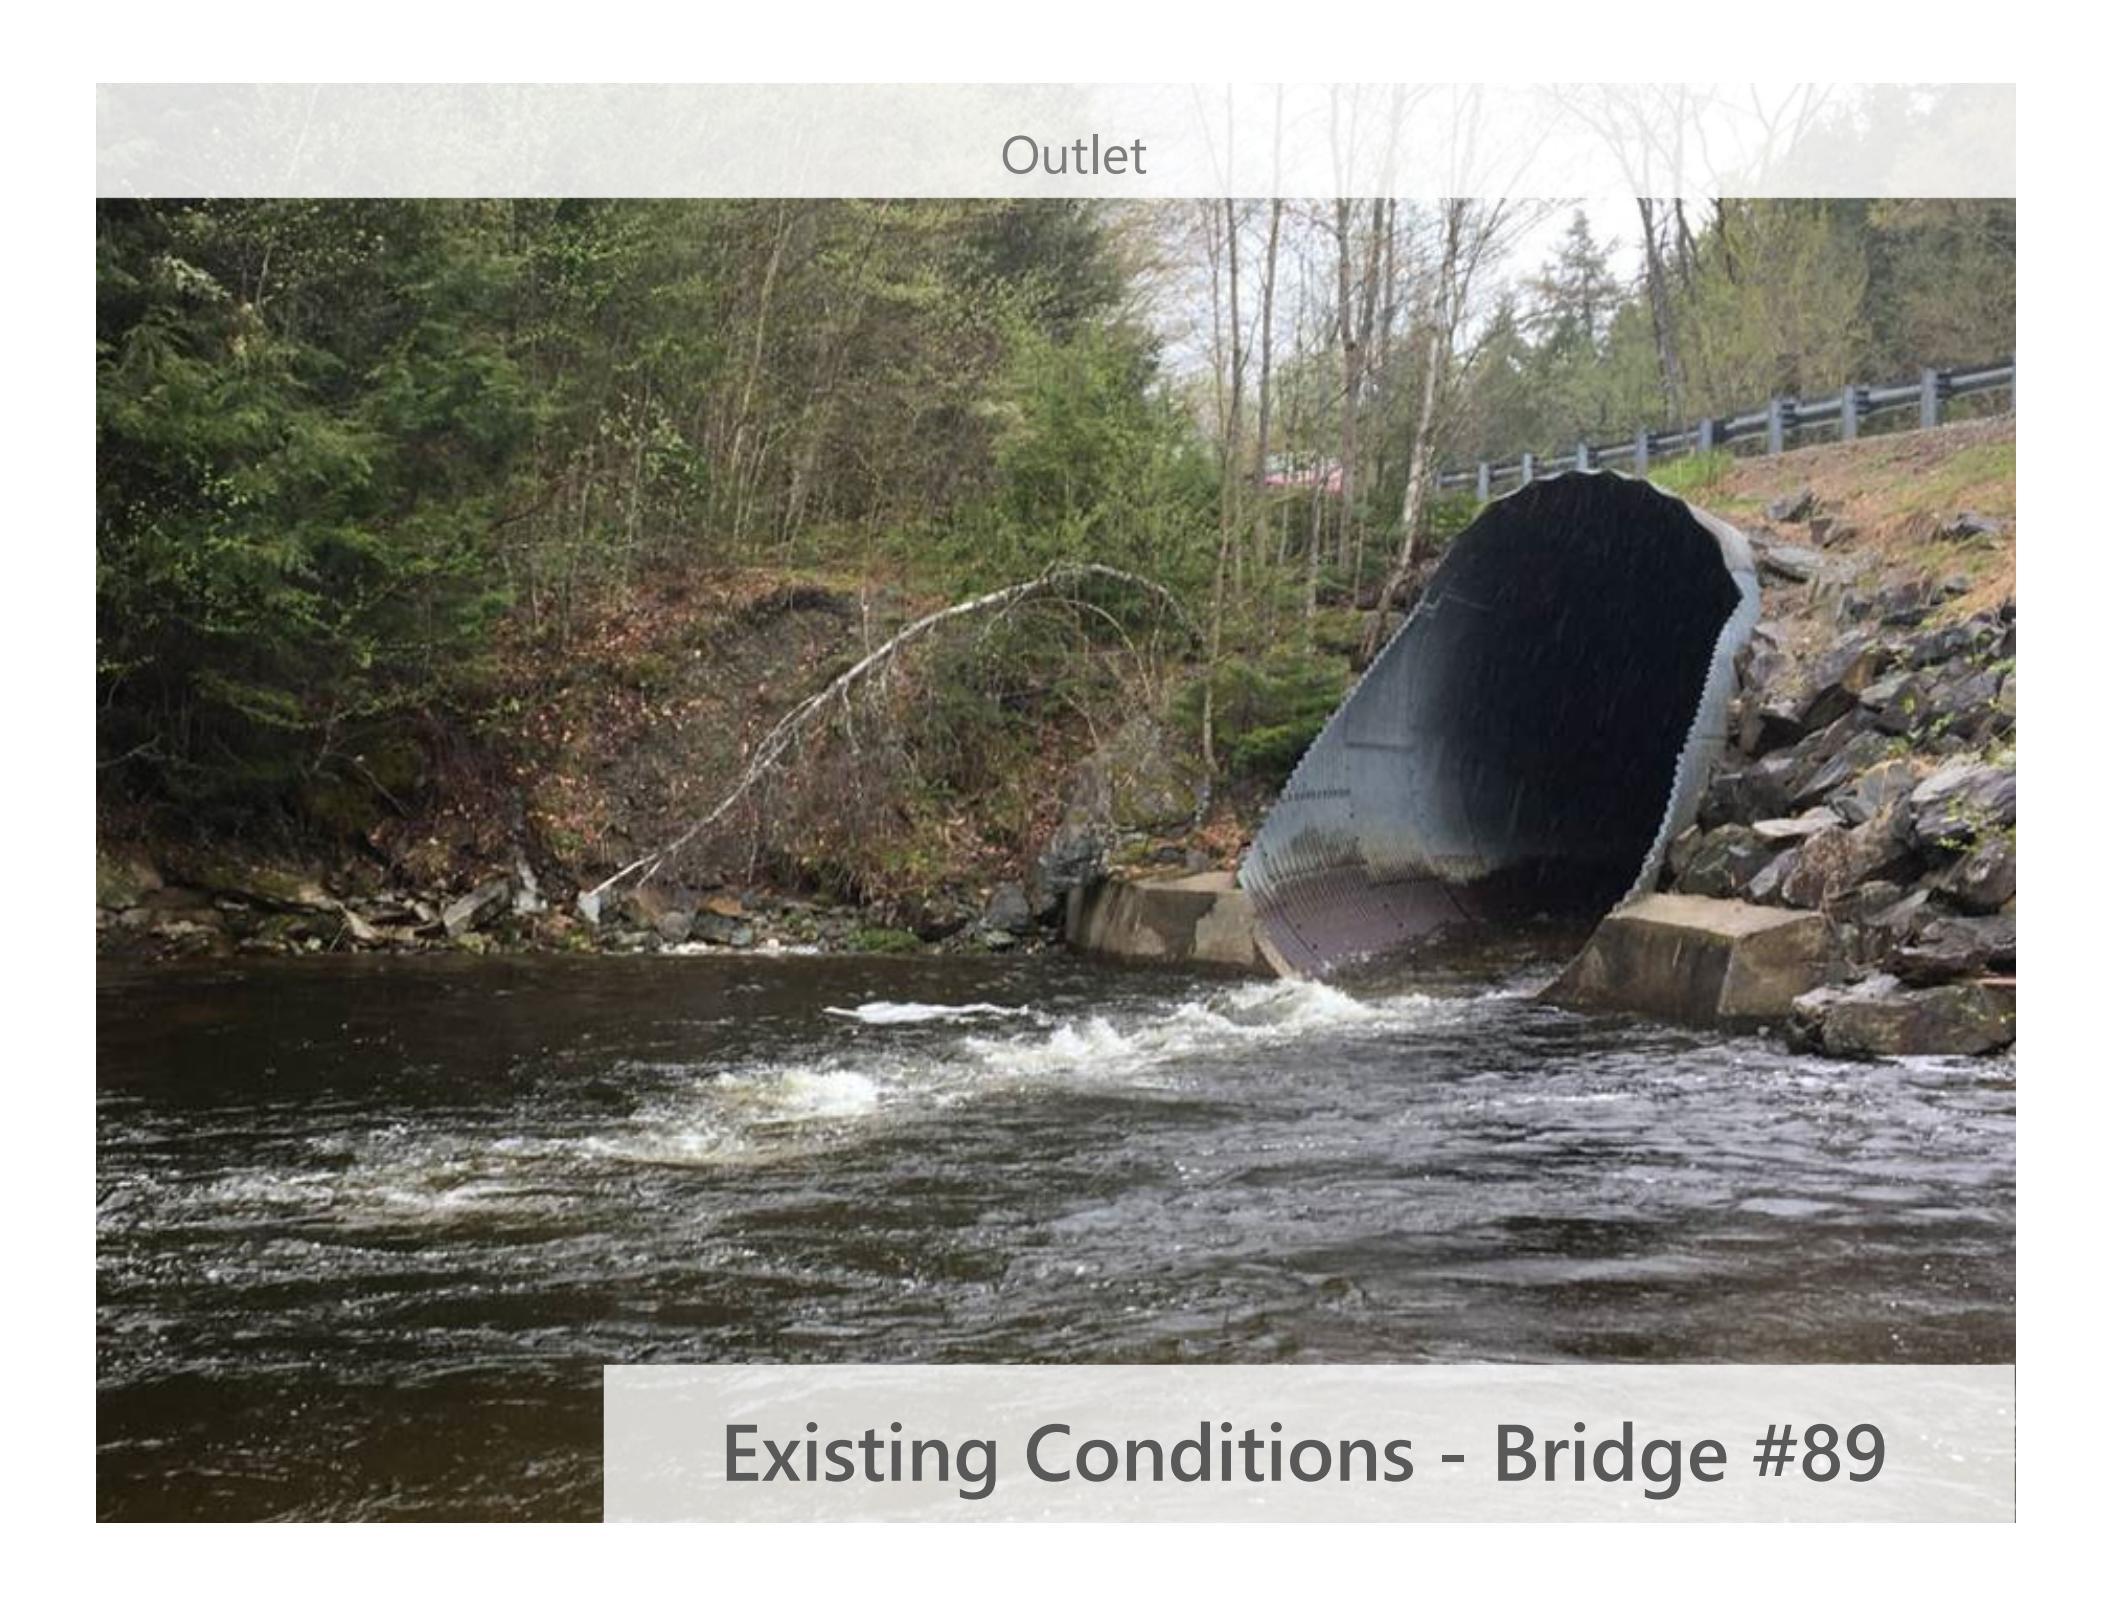
5 (Fair)

Culvert Rating
