FY17 Vermont Better Roads Grant Application

Project Name: York Hill, West Hill, Gove Hill

Lincoln, Vermont Road and Culvert Inventory-2015

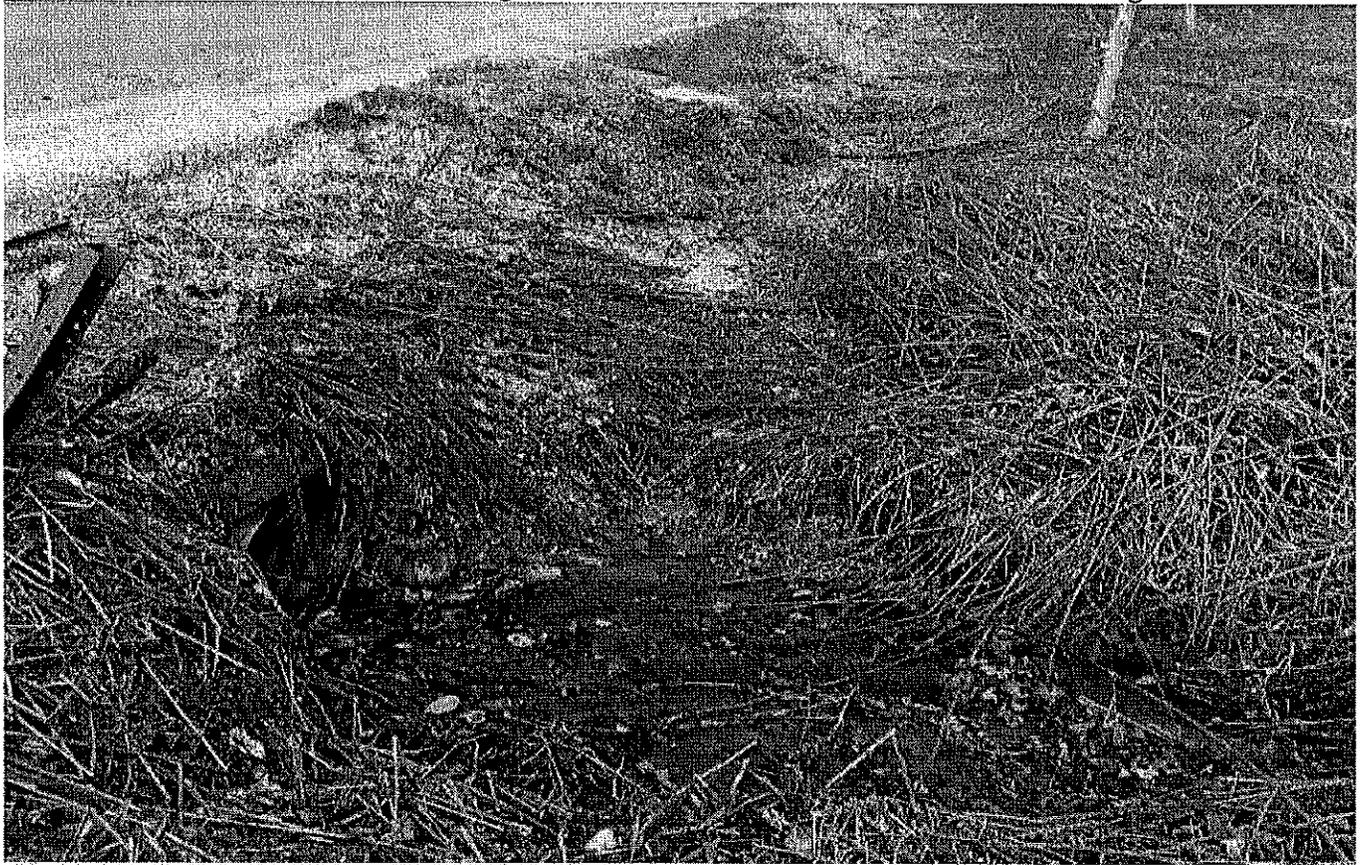
Invert feed ditch

The invert side shows some of the eroding material settled in the ditch-line and scattered along the shoulder.

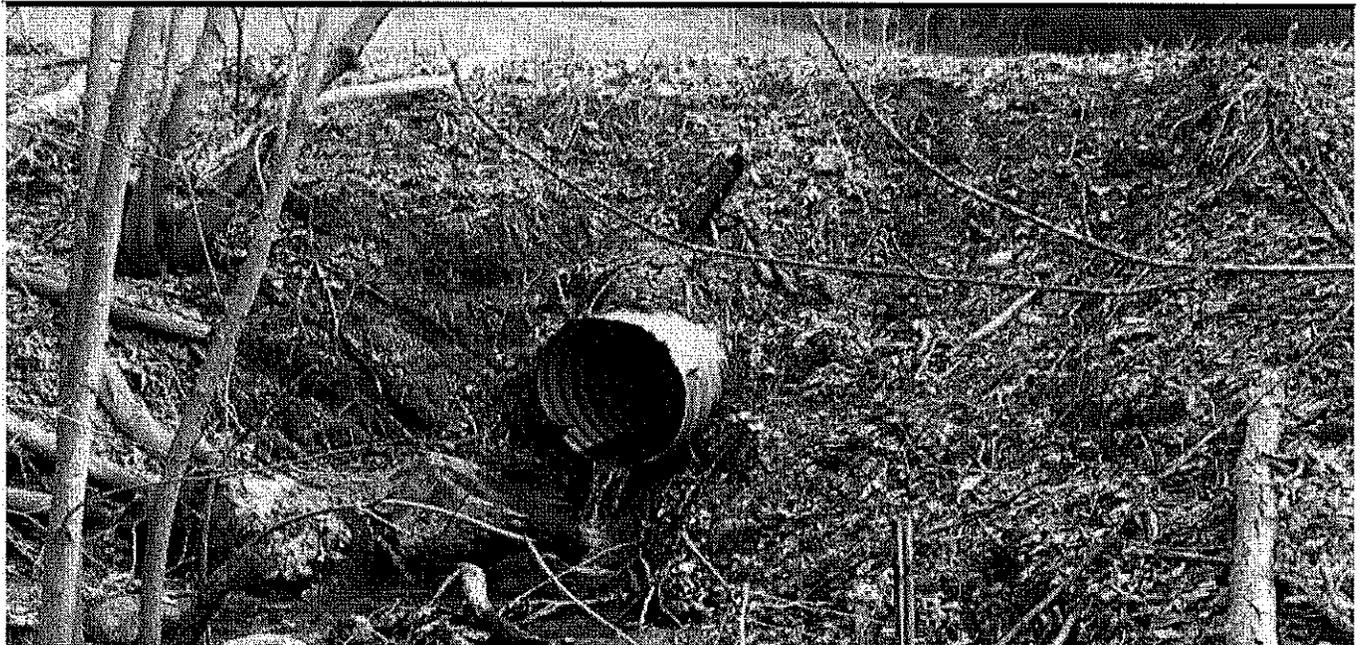
An additional photo of the outflow side shows some need for bank stabilization:

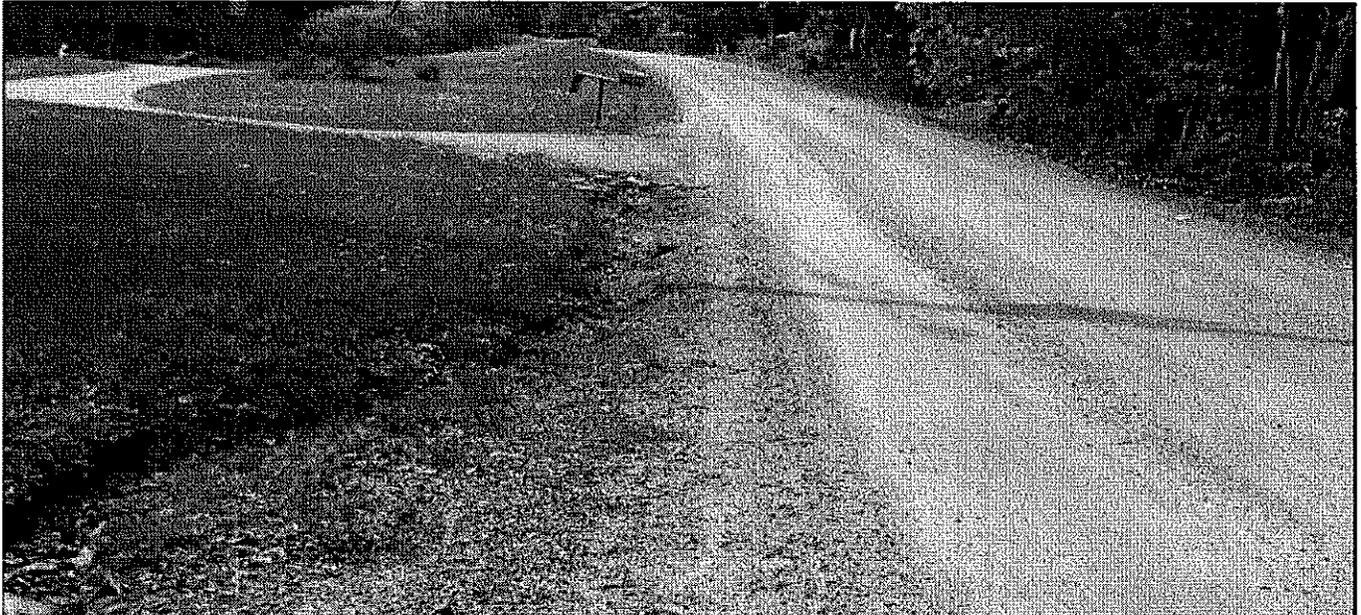
In the **picture below**, this residential property is located on the river side of the road. At the top of the hill, a good deal of water is crossing the road into the front yard above this driveway. The drive culvert is too small. Water coming through the culvert is cutting an erosion ditch that turns and goes out to the slope carrying run-off toward the river. The river is visible from the top of the slope. Some erosion is occurring above the mailbox and has the potential of plugging the undersized culvert which could lead to failure. This could create much more significant erosion of the driveway and the road.

This project will address these erosion cuts by removing road base along this edge, filling gaps in the large stone with a bed of smaller stone, covering the smaller stone with fabric, and then replacing the road gravel and leaving a strip of clear stone as a border between the road and the large rock. Also, some work will be done along the shoulder to encourage water to shed from the road before reaching this low point in the road. These minor improvements will help with the ongoing erosion that has been frequently occurring since this bank was stabilized.

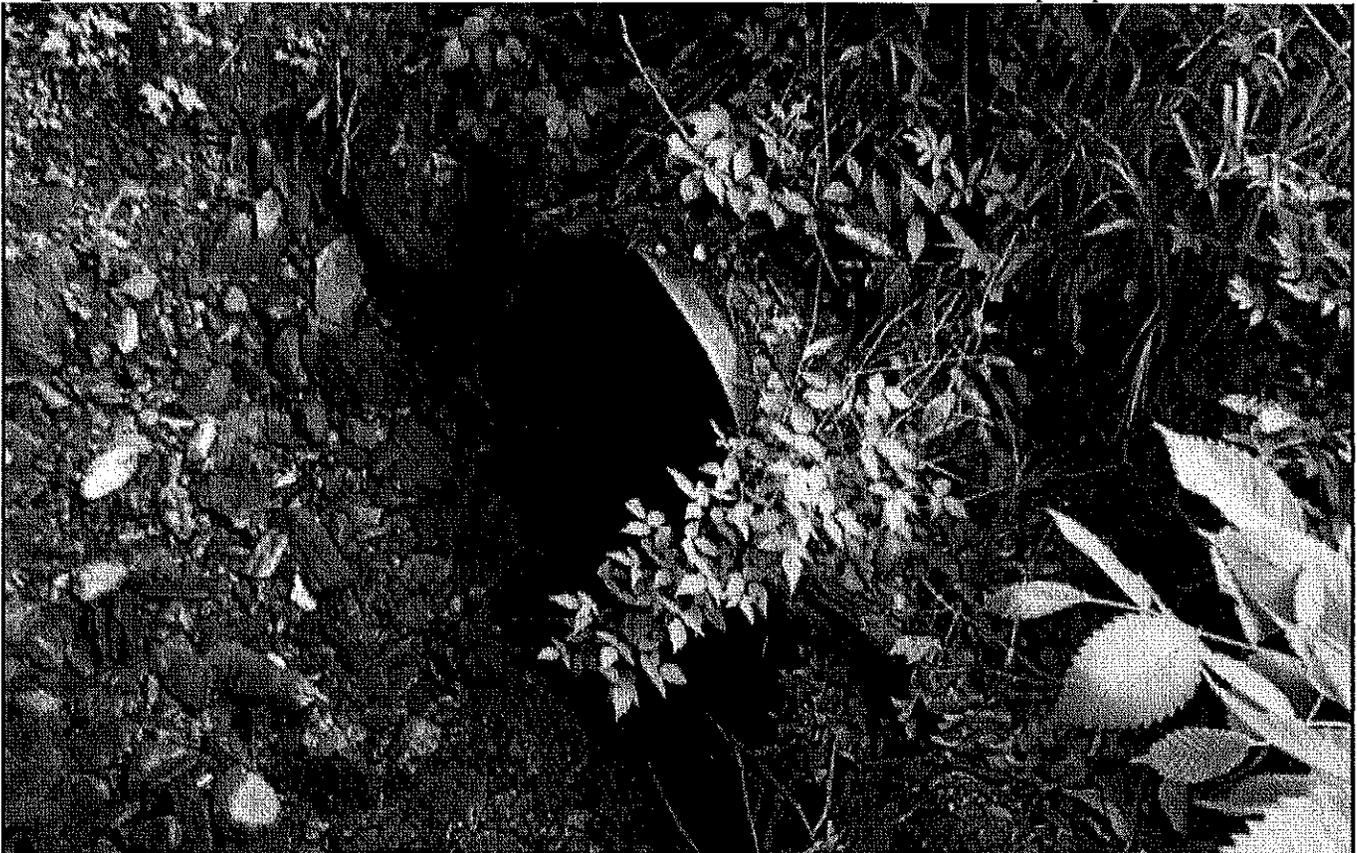
In addition to fixing minor erosion currently occurring, additional work is needed to address the original flooding problems. This culvert crossing (uphill from aforementioned location) accommodates a very small branch stream that flows under the road and eventually connects with the larger branch discussed on the previous page. This 36 round culvert is adequate most of the time as the stream flows at a trickle except during storm events or spring run-off. However, this culvert is installed in such a way that it can be easily plugged by debris and sediment. The culvert sets down in a bowl-like area and surrounding banks are loose gravely material. The culvert should be upsized using and an arch style culvert to give it more width and minimal height. The culvert should have a headwall and banks should be well armored with Rip Rap material.

In addition to this culverts deficits, it appears that ditching between the two culverts was likely a contributing factor to the volume of water going into the road. This project will improve the width and depth of ditching and provide stone lining between the two culverts and on the upper side of the uphill culvert. The ditching improvements between the culverts will increase the amount of overflow contained within the ditch-line while improvements to this culvert will reduce the chance of an overflow occurring.

The culvert will be replaced to correct potential problems and ditching coming into this culvert will be stone lined for approximately 100 feet. The invert and outflow areas will have some Rip-Rap installed.

- Replace 18 inch metal culvert with 18 inch High Performance Plastic Culvert resetting to a proper depth
- Install 120 feet of stone lined ditch
- Add Rip Rap to invert and outflow areas

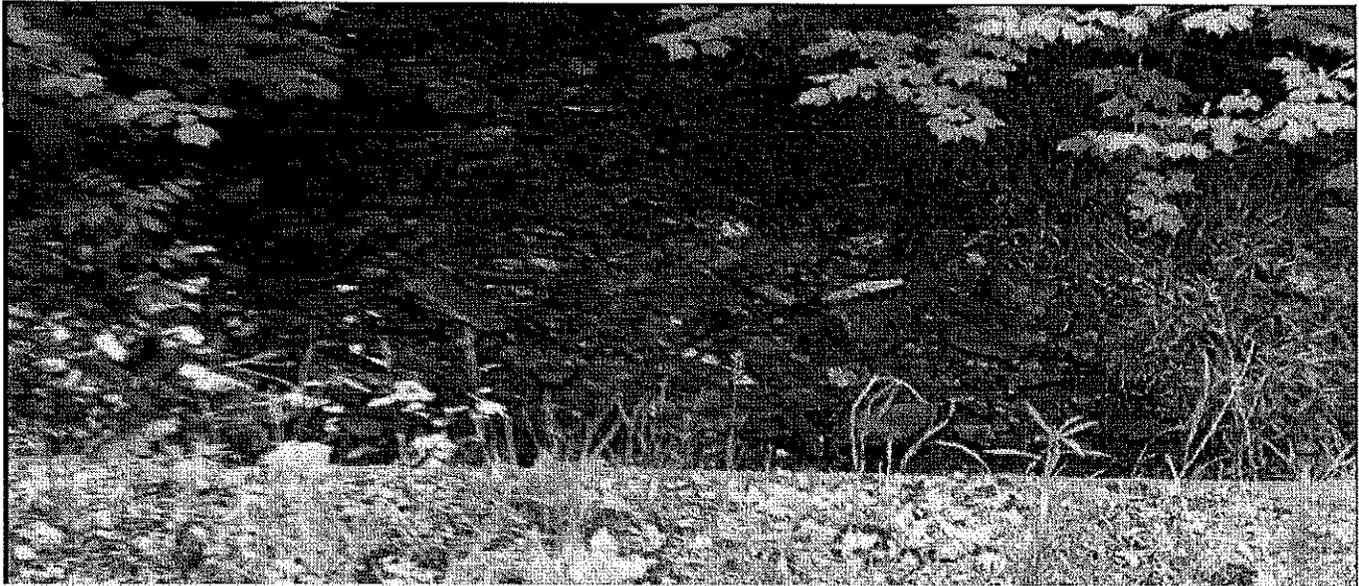
44.109510. 73.014129.

This photo shows the branch stream that the cross culvert flows into.

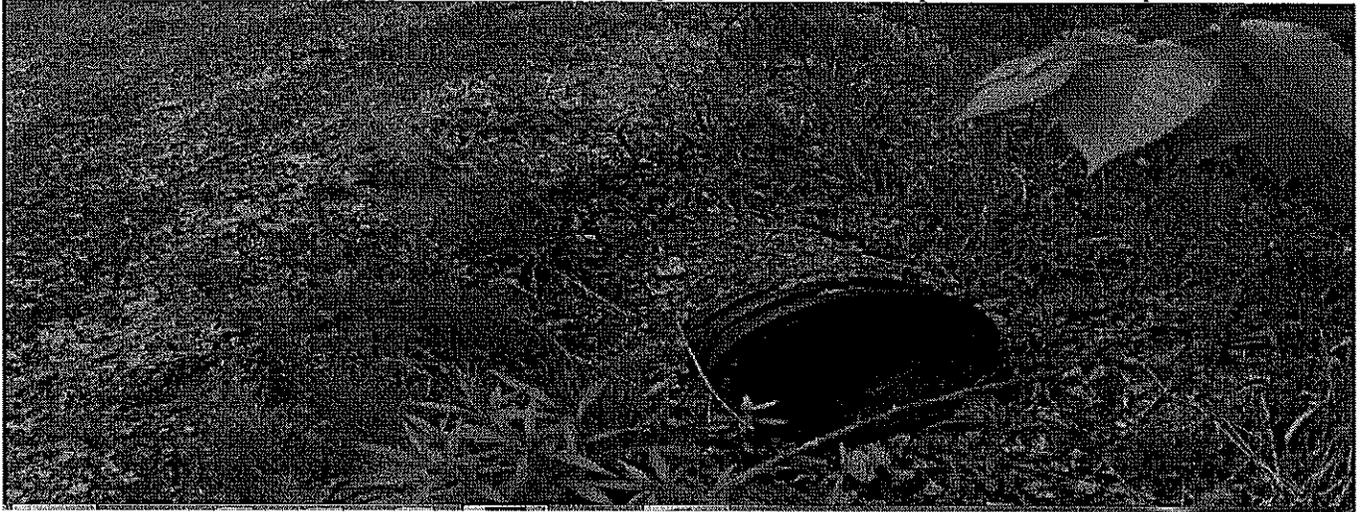
This culvert outflow (below) is at the base of York Hill a little into the intersection radius. It is both too shallow and too short. During storms, water flows from this outflow and back into the road just downhill. This culvert needs to be removed and may not be needed if ditching and other culvert improvements are implemented.

The culvert is causing erosion in the road below the outflow

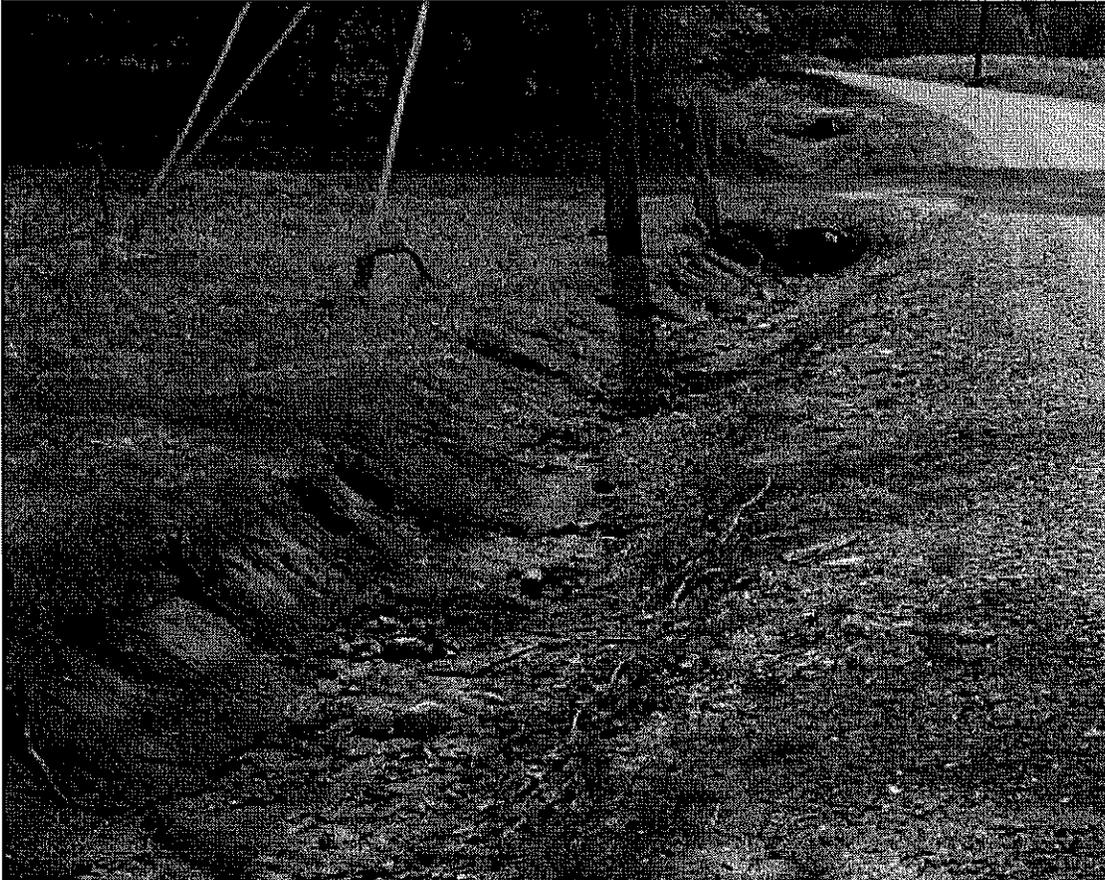
The ditching on Gove Hill is consistently poor for the entire length of the Gove Hill Road and needs improvement. The ditching photos are from both the first 1300 ft. section that parallels the branch stream and last 1200 feet that meets with the Blacktop just prior to the New Haven River. There is a need to improve ditching on both sides of the road in the first 1300 feet. The second section is mostly on one side of the road except for one location where three drive culverts need upsizing and resetting (see photo below).

Two culverts appear in the picture but there are three total that have some problems. The ditching will be stone lined between the culverts. The culverts are now very short, too shallow, and too close to the road. Two culvert replacements and one reset are included in the estimate for this project.

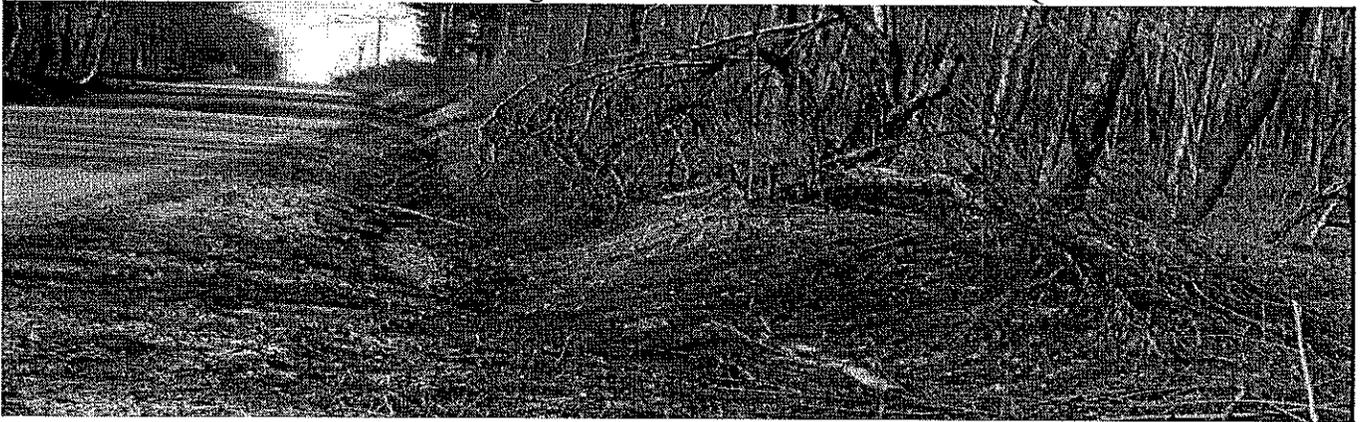
The **photo above** shows the roadside ditch that follows down the stream side of Quaker Street. In the foreground the ditch is turning toward the stream.

- Install 1000 feet of stone line ditching on the stream side of the road and install a turnout with splash area at the base of the gravel road portion of the hill.
- Install 800 feet of stone lined ditch on the opposite side of the road
- Replace two driveway access culverts
- Replace access culvert for private road (Bull Run) and fix ditch approaches to roadside ditch
- Improve the branch stream crossing locate 2/3 of the way up the hill (mailbox # 1045). Install a new culvert with concrete headwall per State of Vermont consultation (estimating 48 inch arch culvert)
- Consider relocating/resetting multiple drive accesses at address 1199. Add stone sump areas

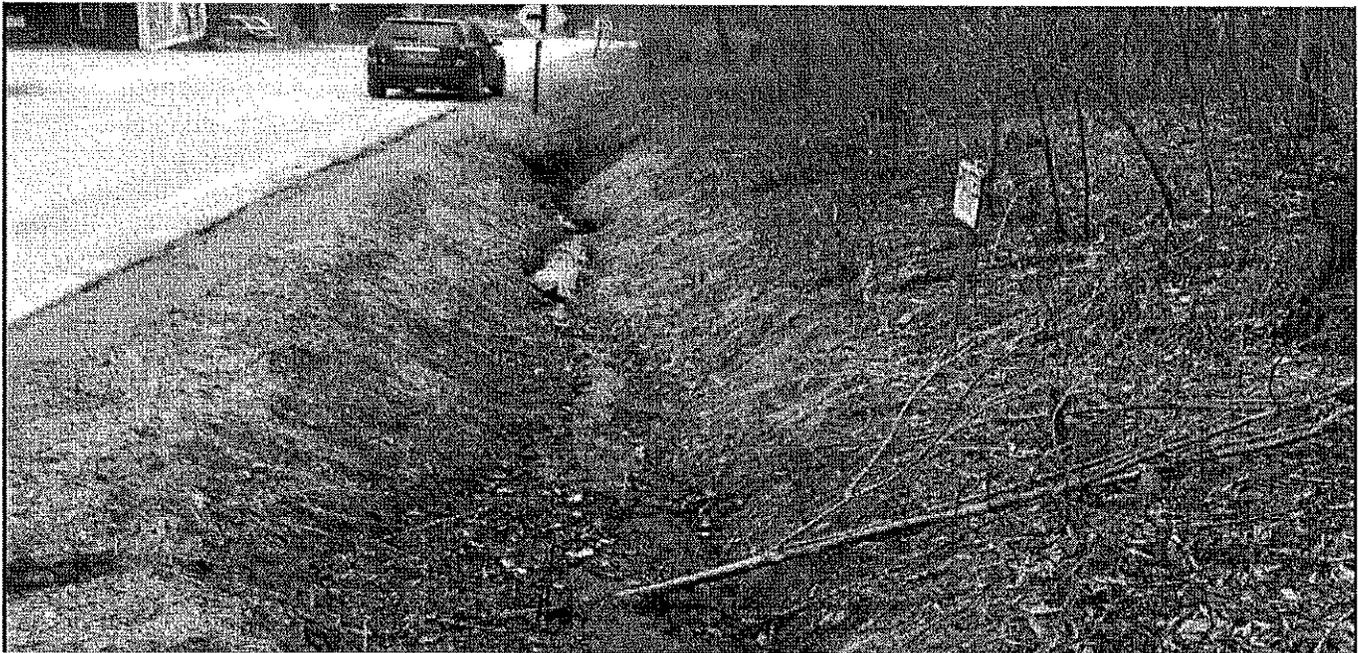
The culvert does not protrude from the bank. The end is inside the grass under the road shoulder. Road gravel is constantly running off into this stream.

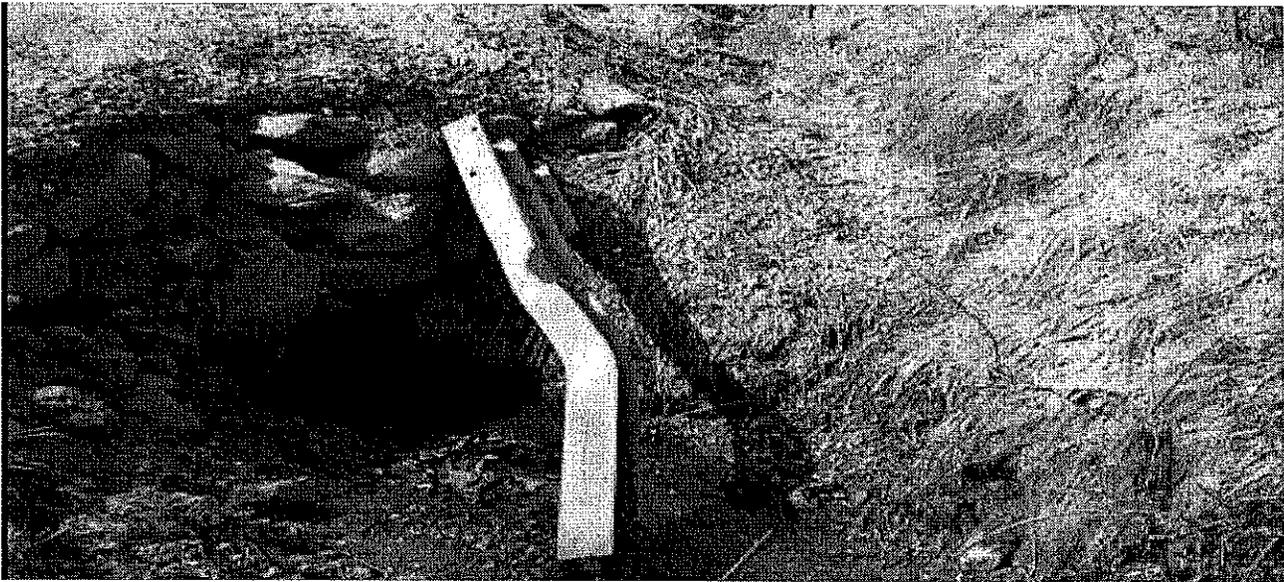
The picture **below** shows cross culvert outflow area. Water in the foreground is from the Quaker Street roadside ditch and is flowing into the stream.

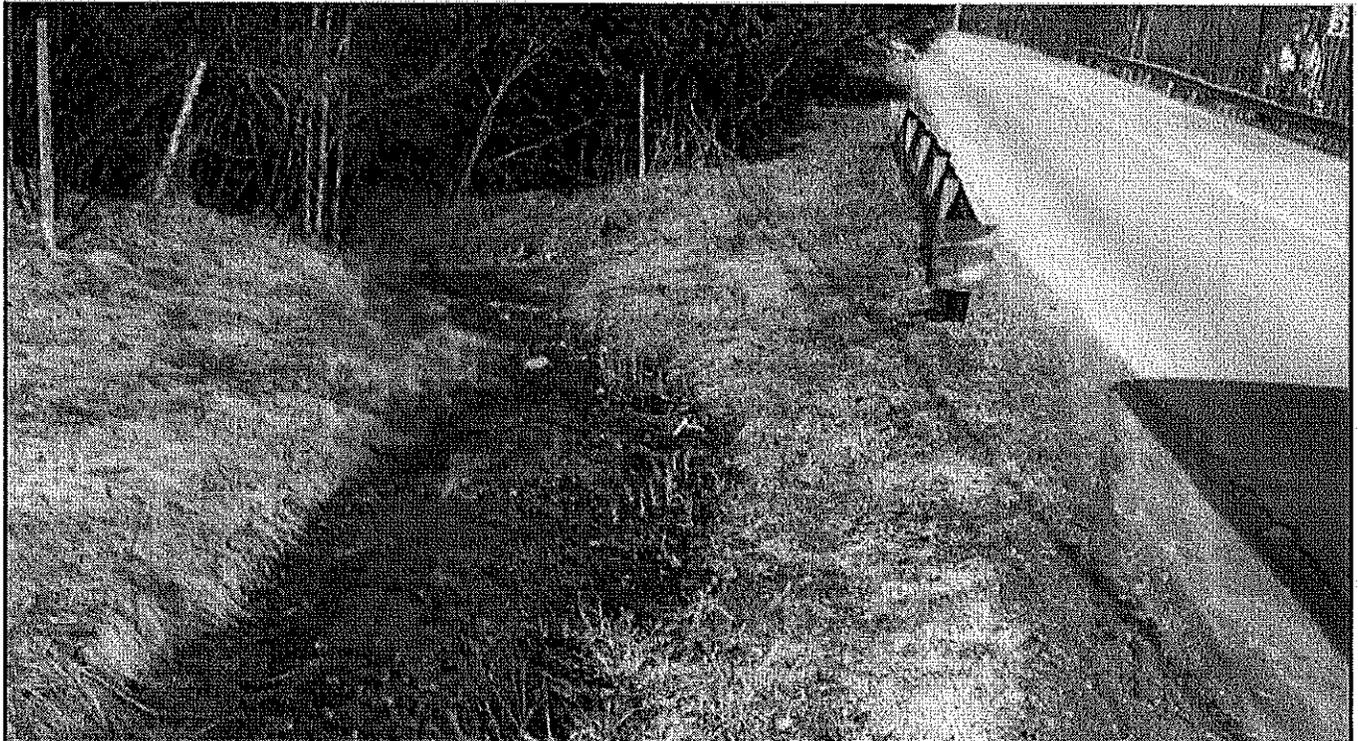
In the photo below, water from the cross culvert is flowing to the stream. The distance from culvert to stream is less 100 feet.

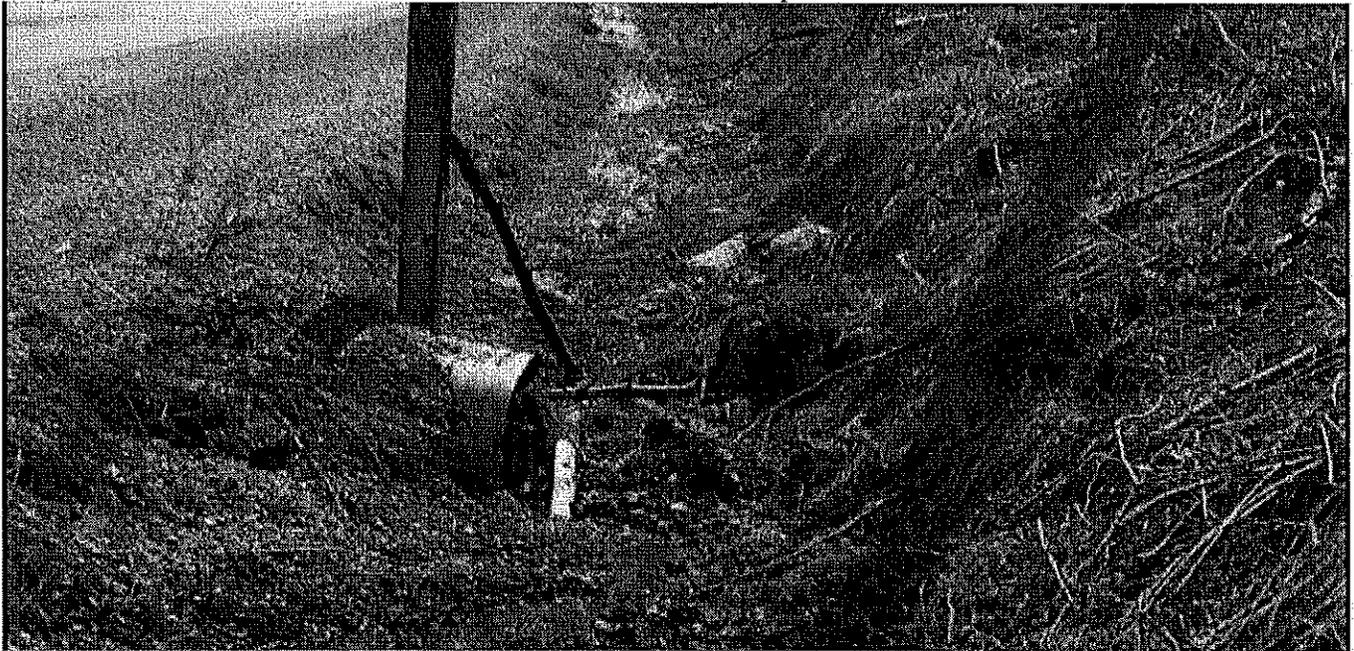
The picture below shows the culvert that is in the area of the steep bank.

The cross culvert above goes under the road and empties directly to the stream bank. The sump is inadequate and the approach needs stone in both directions. One side needs bank stabilization for about 175 feet. The other side is flatter and can simply be stoned line for 90 feet.

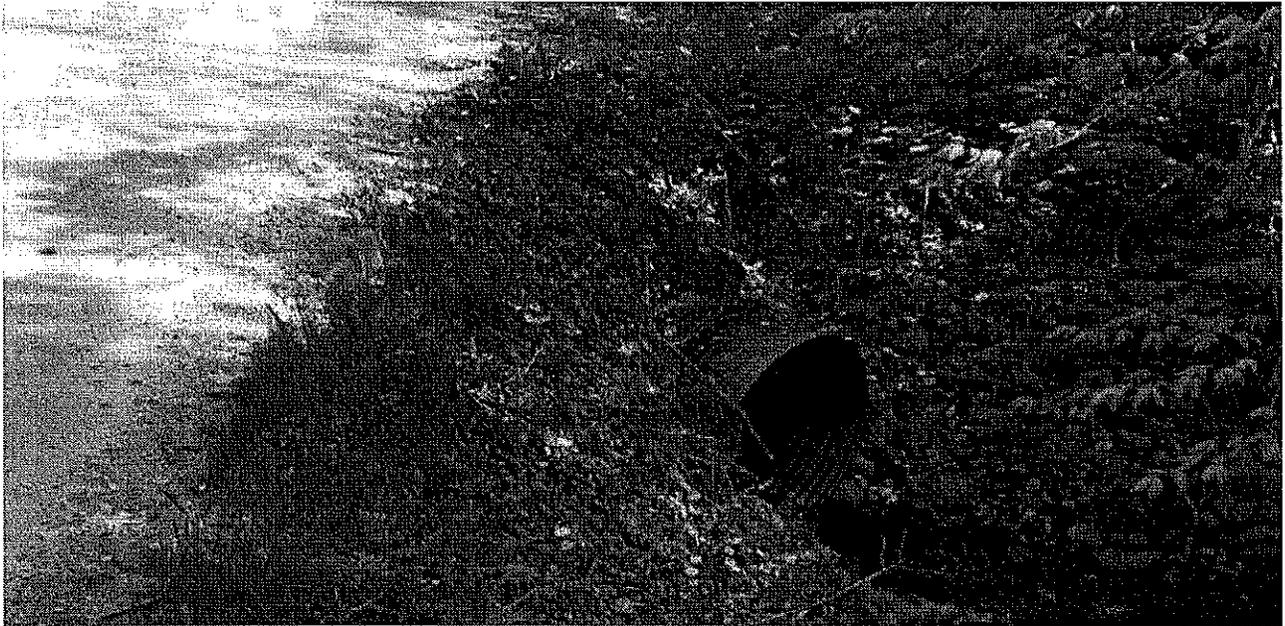
This photo shows the very small shoulder area for this 60 inch culvert:

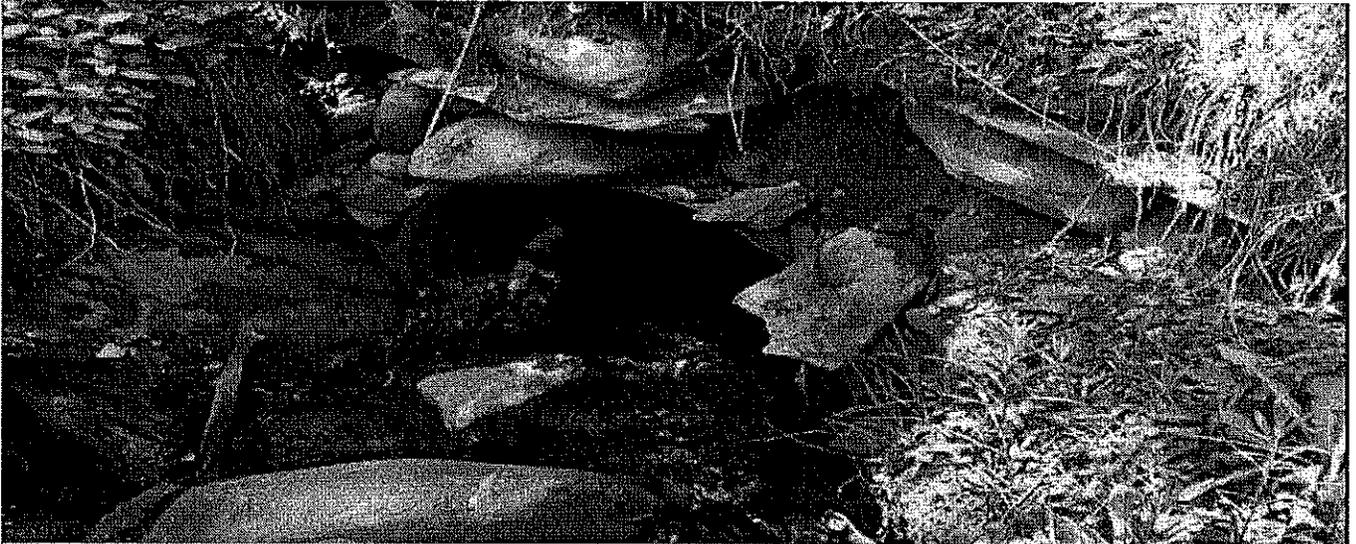
Photos of the 36 inch culvert indicate a similar problem where stream culvert is too short and the Highway Department has made repeated attempts to stabilize this culvert crossing:

Attempts have been repeated to add headwall protection but there is really not adequate shoulder space to be successful. The culvert is in fair condition and can likely be reused.

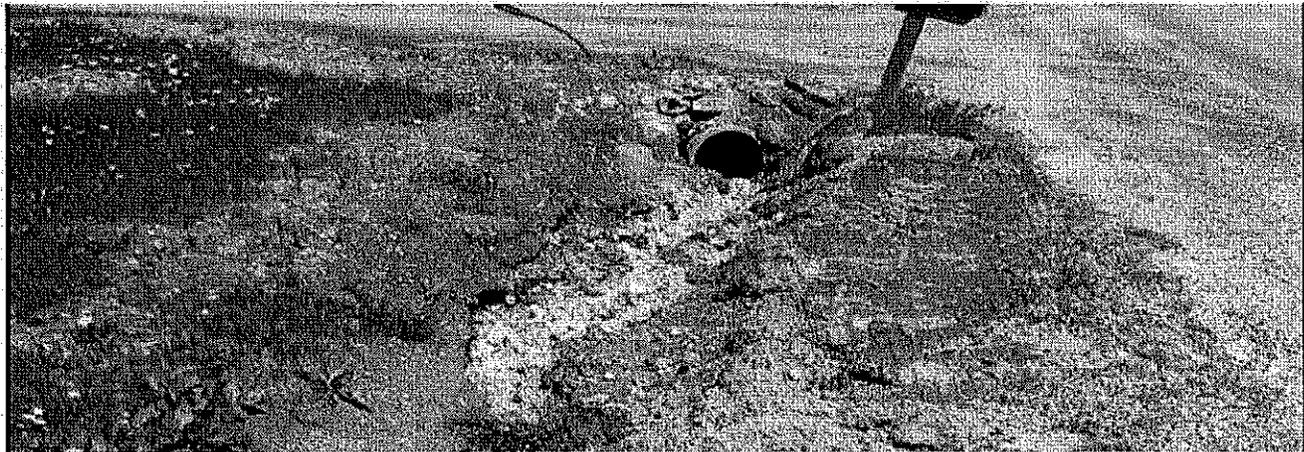
This is the view (below) from the woods standing halfway between the stream and driveway. In the foreground is a large pile of sediment pushed toward the stream.

The picture above shows erosion at the culvert invert above the driveway

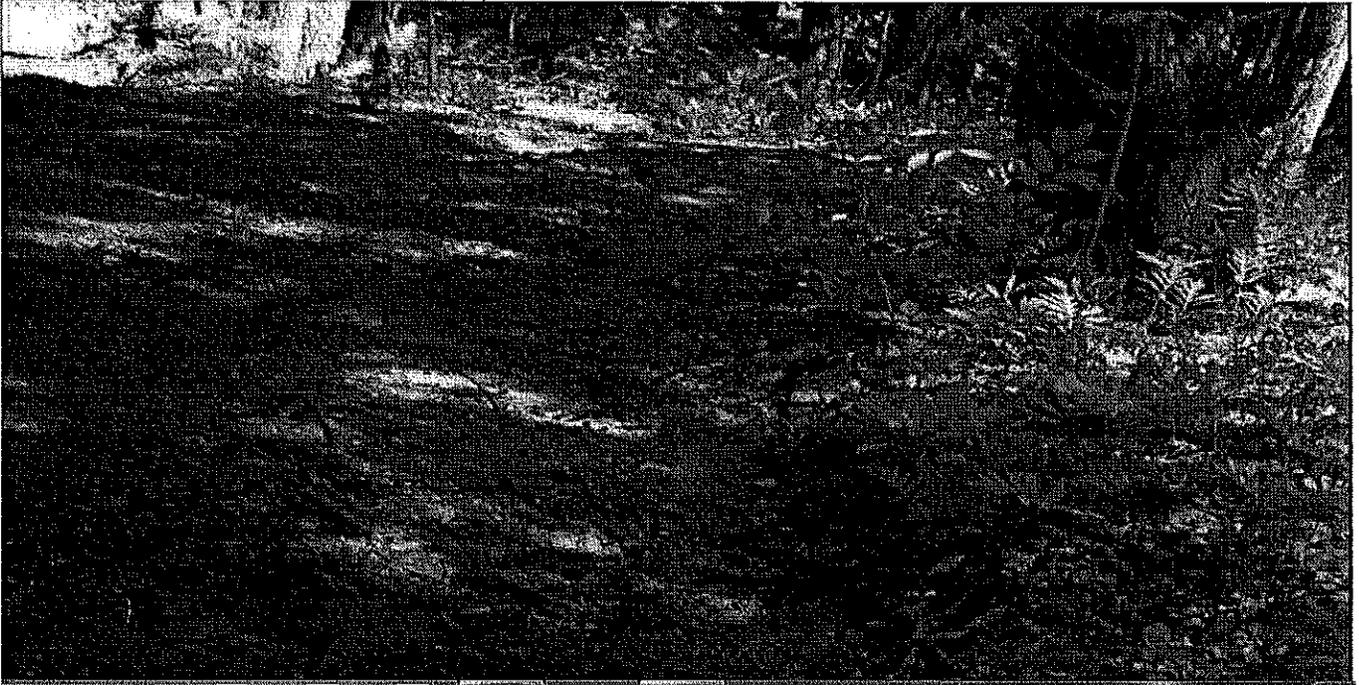
The road culvert is located less than 100 feet up hill from this stream crossing. The invert side is constantly filling with sediment which can reach the stream from the outflow side. Also, on the other side of the road there is one drainage turnout that is close to the stream and needs to be addressed because sediment is leaving the road at this location.

When standing on the edge of the road, you can see the stream from this turnout.
