Irasburg IM DECK (46) Alternatives Presentation Meeting

I-91 North– Bridge #107N over

December 14, 2015

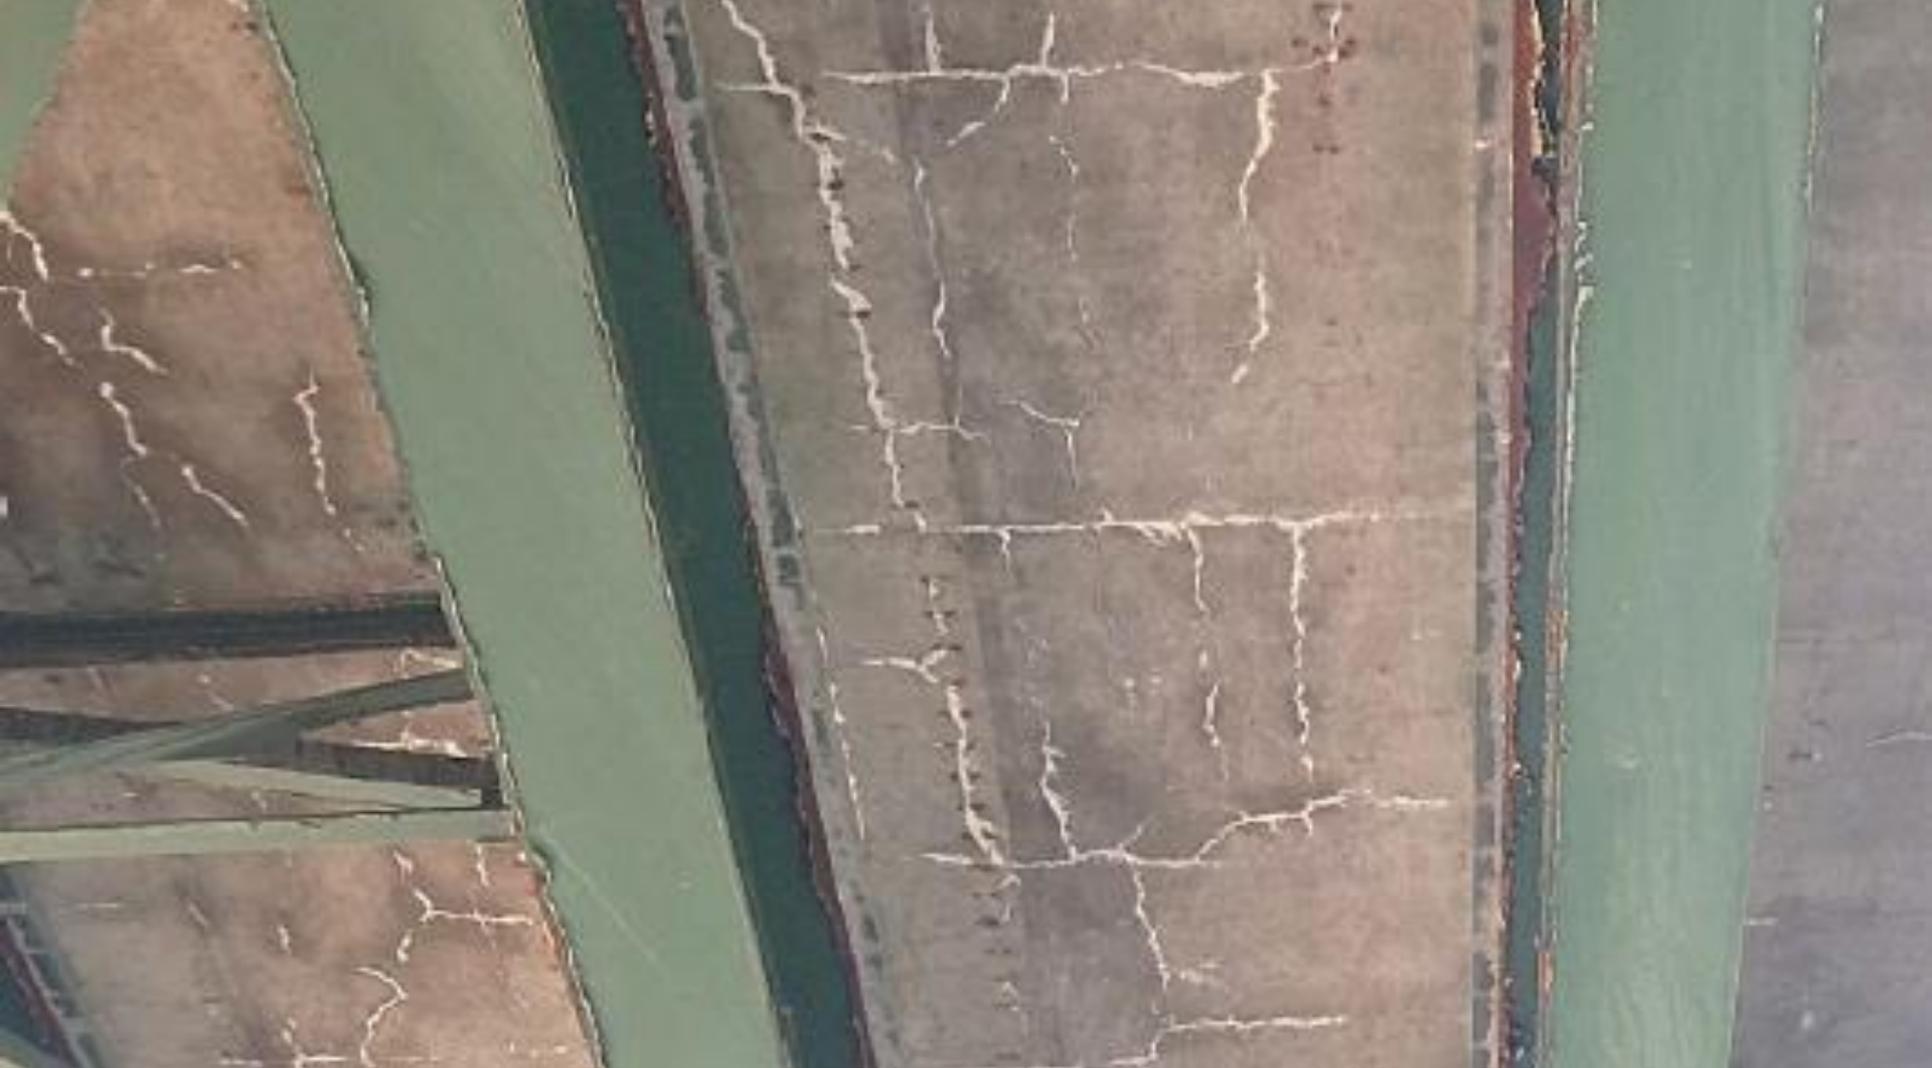
- Concrete deck has a partial depth hole that has been patched, as well as additional signs of deterioration such as efflorescence and delamination.

Signs of Deterioration

- Deck Replacement
 - Replace 3 spans of the deck with a cast-in-place concrete bare deck
 - Resident Engineer to determine if Span 1 will be patched or replaced

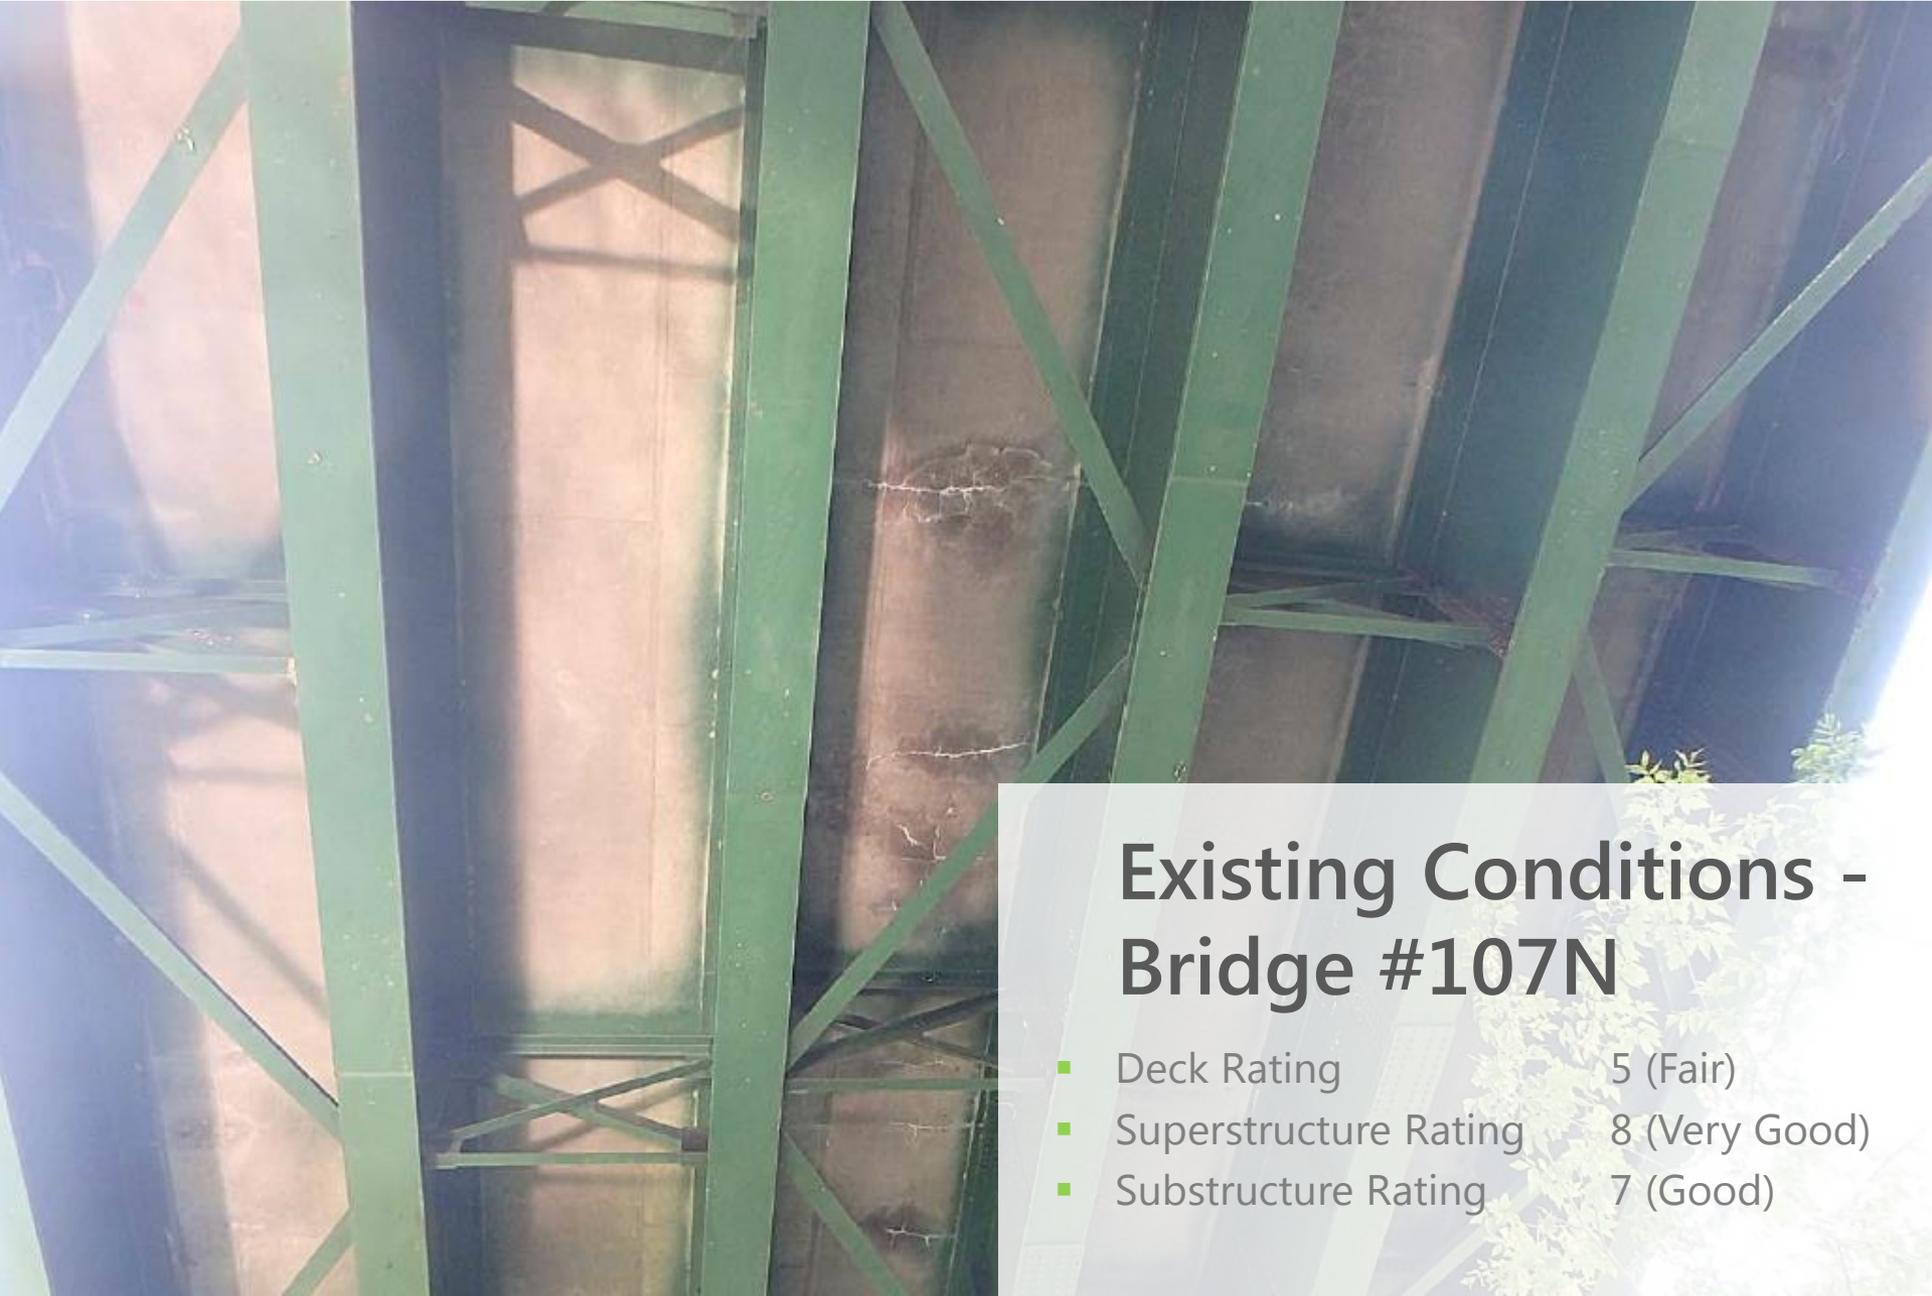
Span #1

- Deck Rating 5 (Fair)
- Superstructure Rating 8 (Very Good)
- Substructure Rating 7 (Good)

- Span 1 may be salvageable
- No signs of deterioration from below the deck
