# **Historic Barracks to Modern Homes:**

## **10<sup>th</sup> Cavalry Apartments at Fort Ethan Allen**

**2026 Downtown & Historic Preservation Conference**

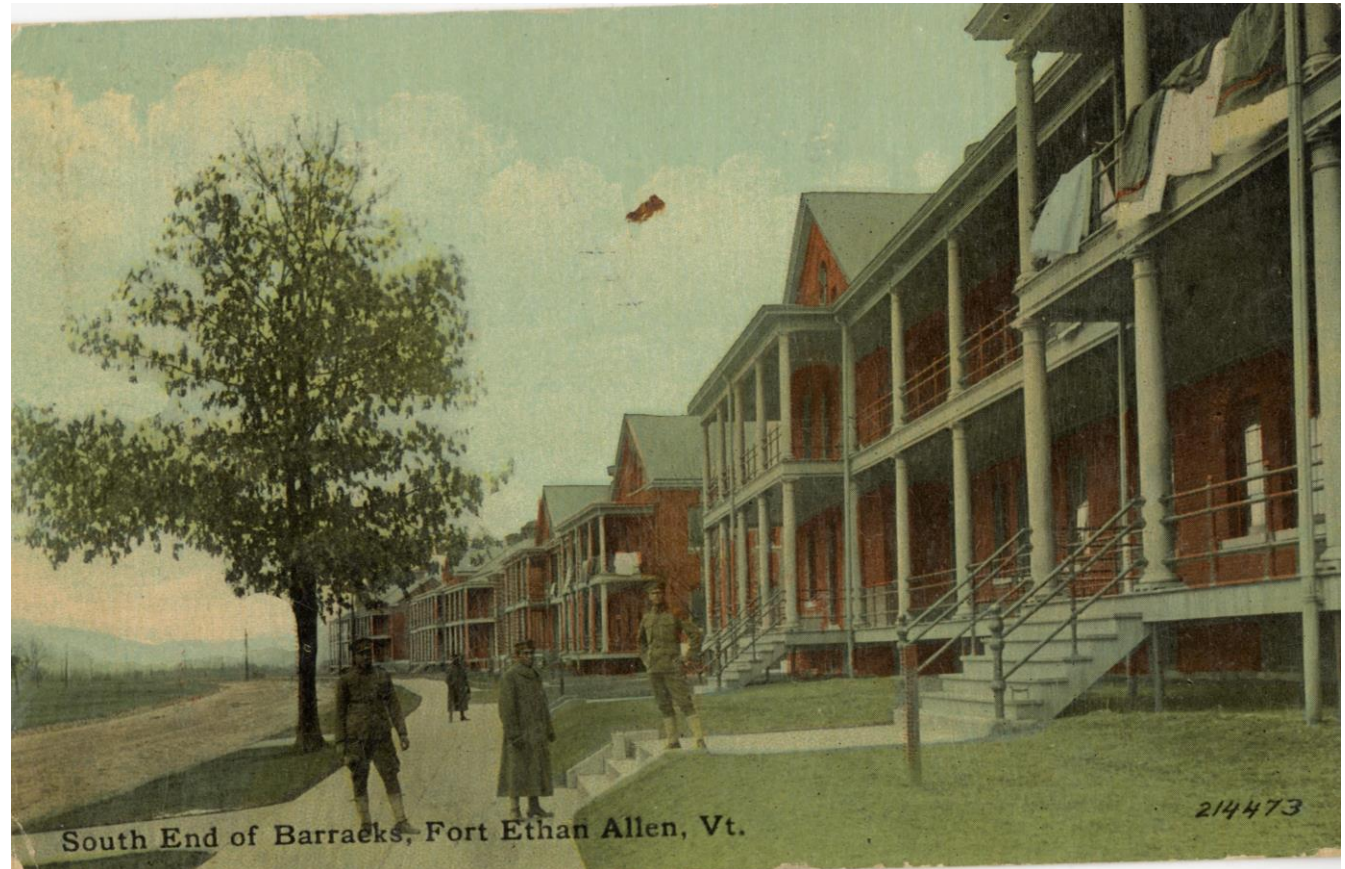
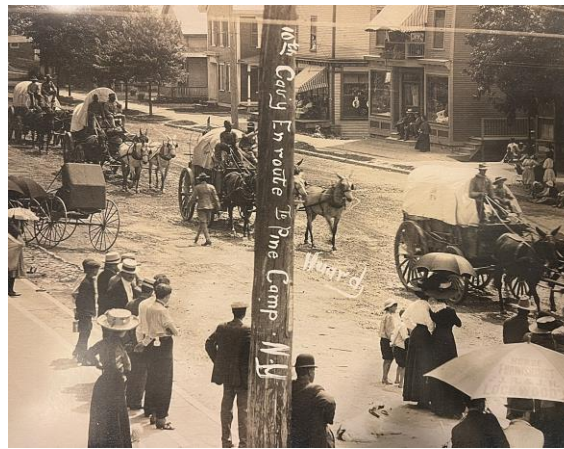
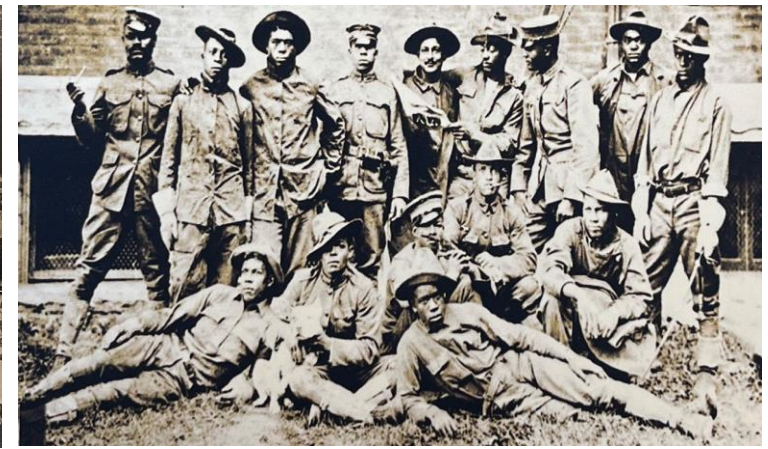
# Cavalry and Artillery Barracks

- Standardized Colonial Revival design
- Load-bearing brick on granite foundation
- Local materials and design expertise
- Living & dining quarters for enlisted men
- Project included two identical artillery barracks and one double cavalry barracks

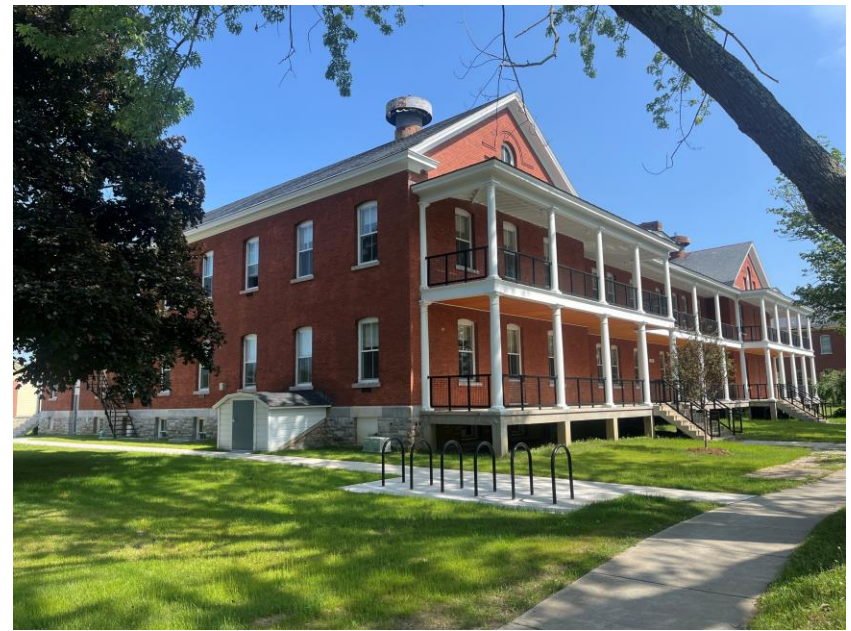
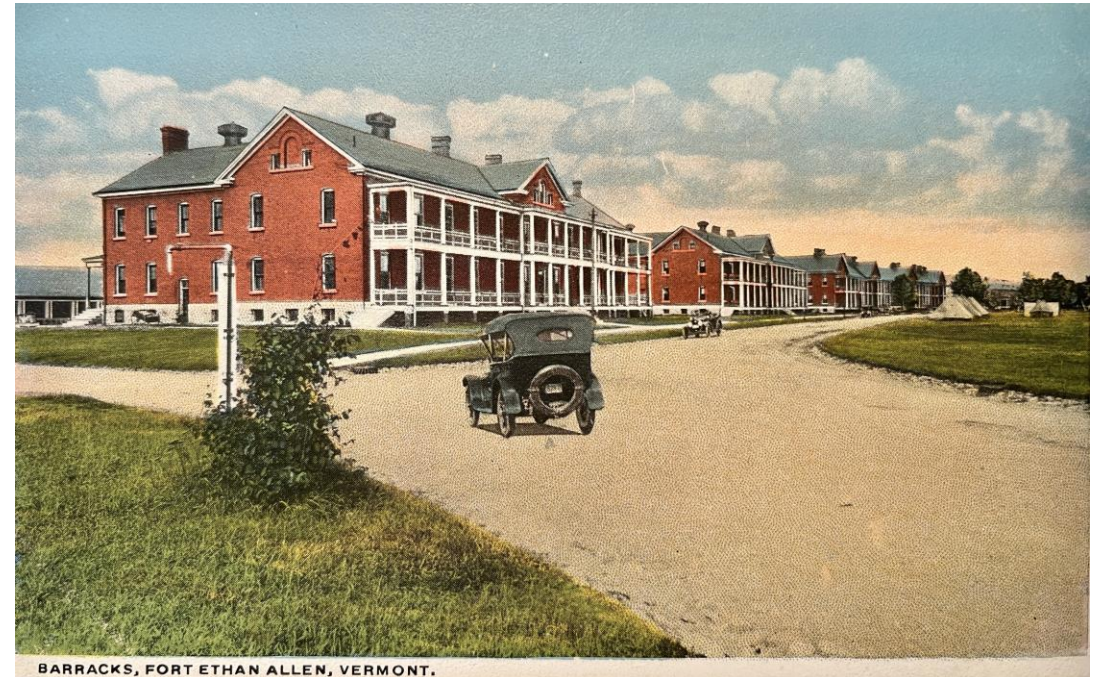
# Barracks Interiors

- Bunk rooms, mess halls, & lounges
- Large volumes of open space supported by columns
- Decorative ceilings & ample windows
- Military hierarchy

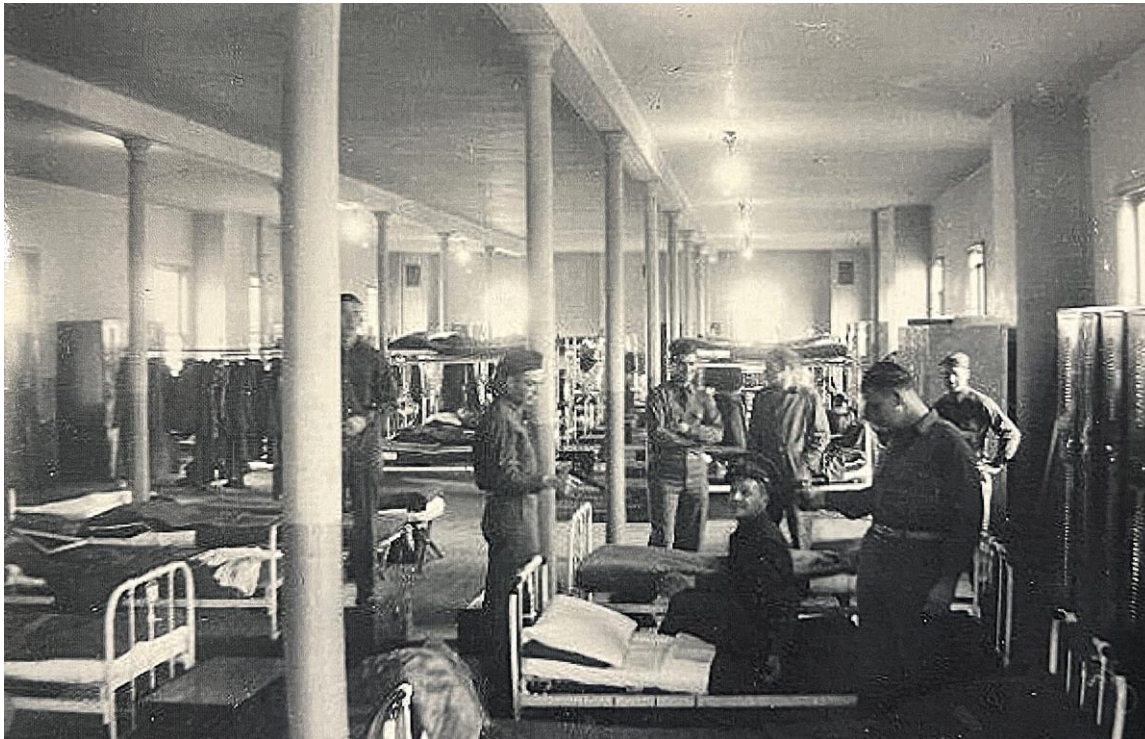
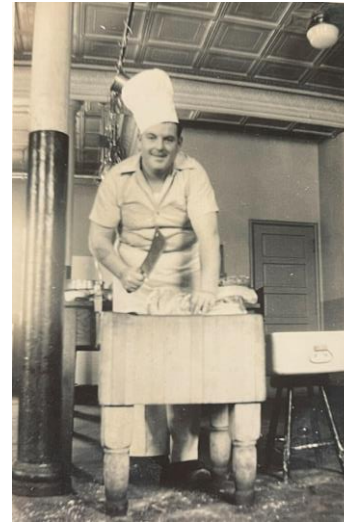
# Character Defining Features

- Two Artillery barracks almost identical
- Double Cavalry barracks similar but slightly higher style
- U-shaped form with rear porches and entrances
- Exterior: slate roof, granite foundation & sills, brick construction, cornice, segmental arch lintels, mushroom vents
- Two-story front porch with Tuscan columns
- Palladian windows in gables
- Pressed metal ceilings on first floor – revealed historic arrangement of spaces
- Grid of structural iron columns
- Wood windows in Double Cavalry barracks
- Chair rails

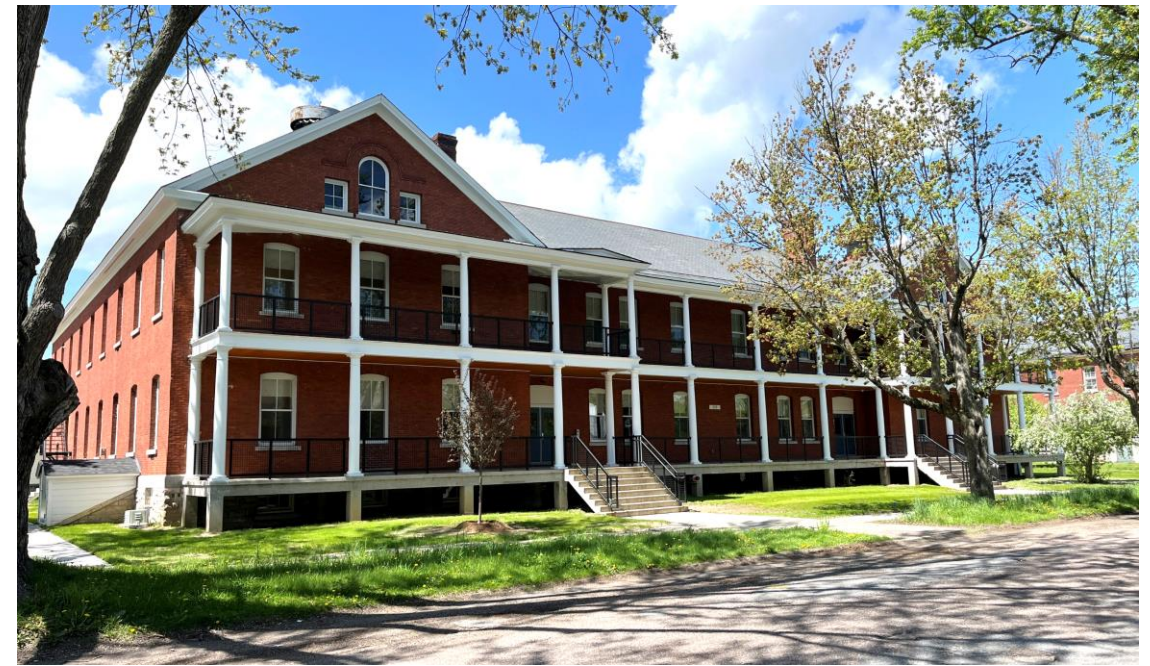
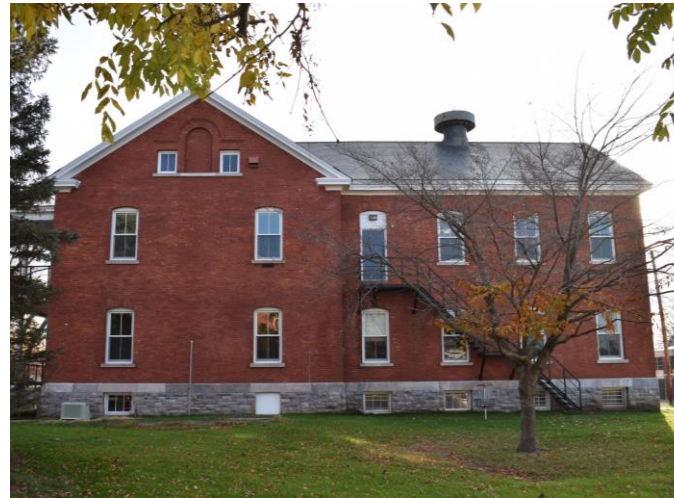
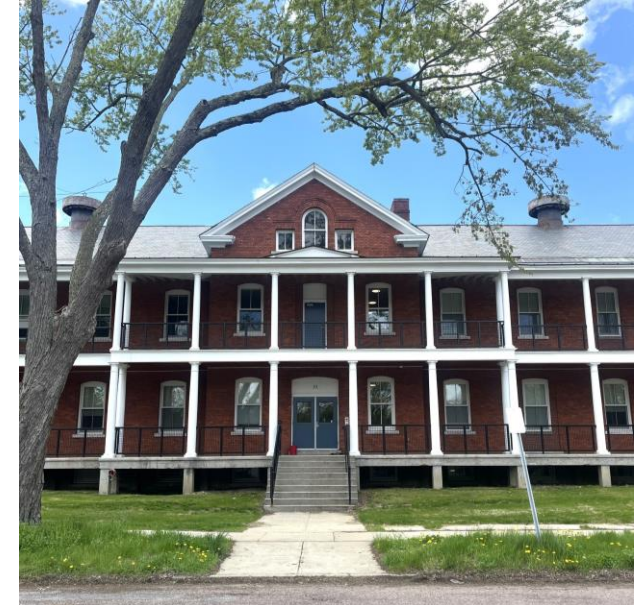
# Secretary of the Interior's Standards for Rehabilitation

- Retain / replicate pressed metal ceilings
- Retain historic volume of interior spaces
- Retain grid of iron columns
- Masonry cleaning & repairs
- Roof repairs & mushroom vents
- Porch rehabilitation – repair / rebuild
- ADA accessible entrances & ramps
- Historic wood window restoration & storms
- Energy efficiency
- Code compliance
- Mechanical systems

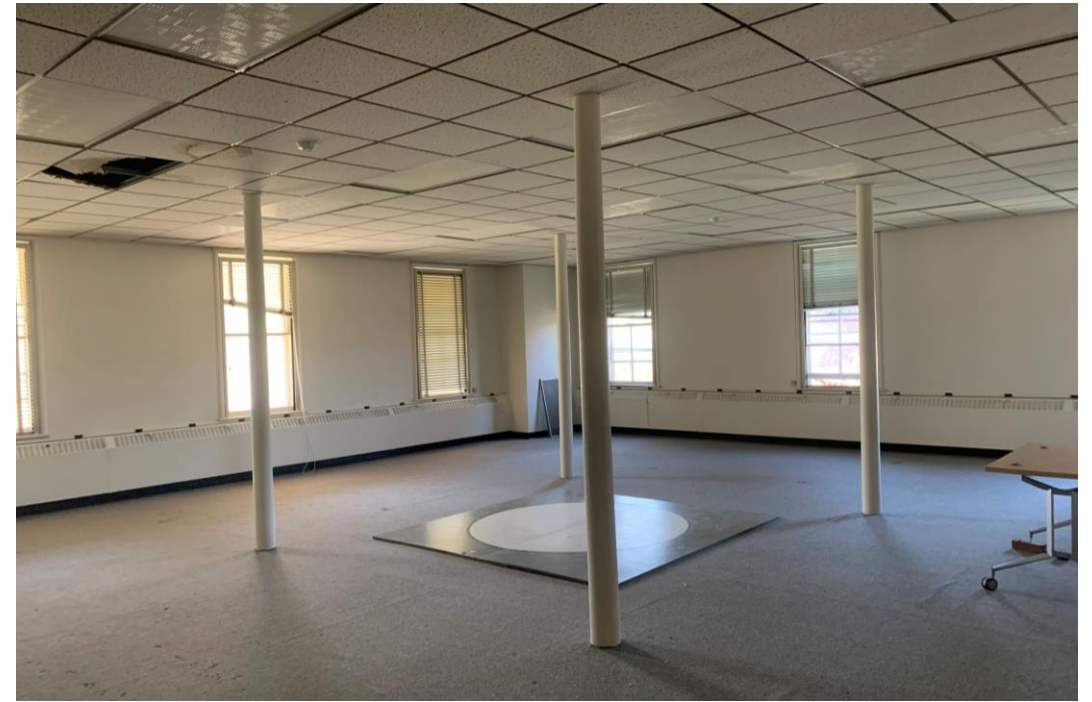
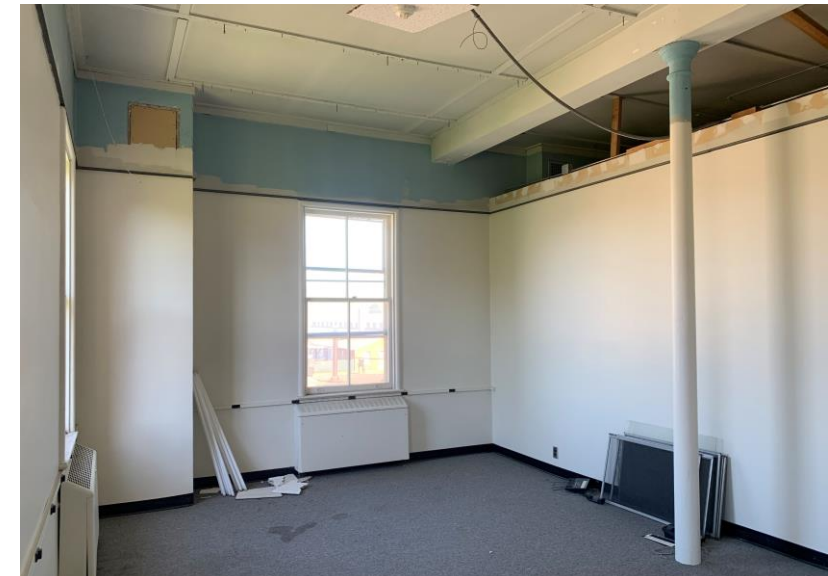
# Pressed Metal Ceilings

- Retain & repair historic decorative beam wrap
- Retain & repair historic ceilings in lobbies & common areas
- Replica / new ceilings in living units – W. F. Norman & Co.

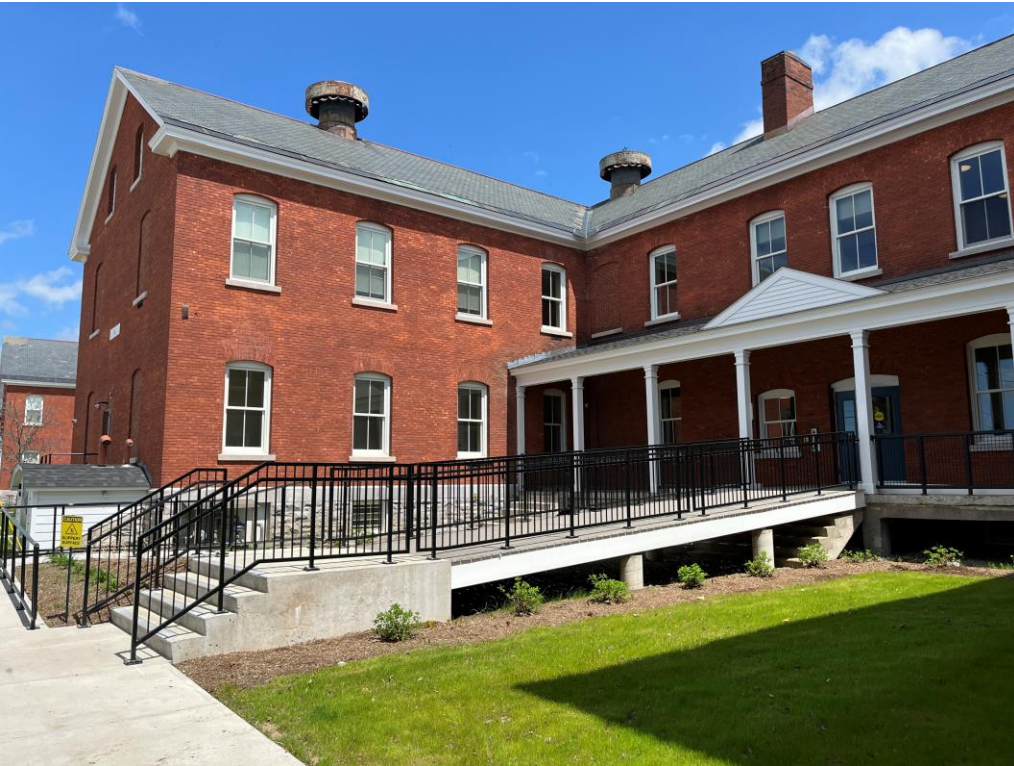
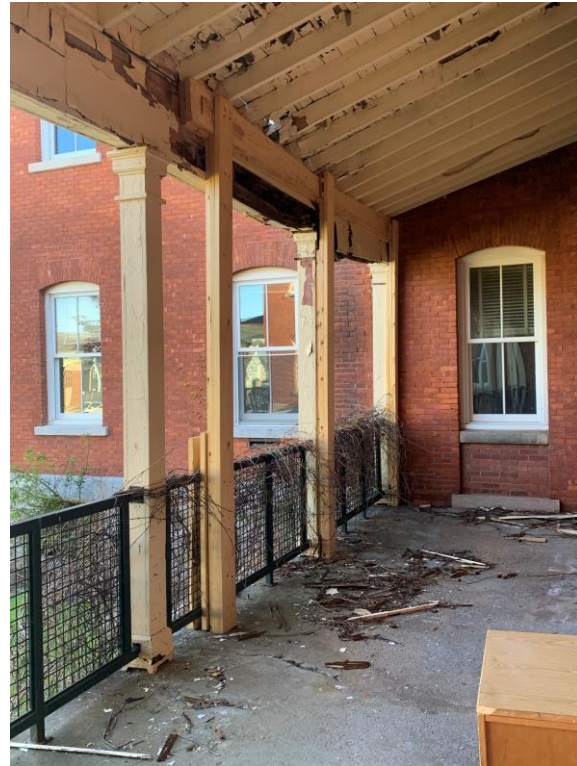
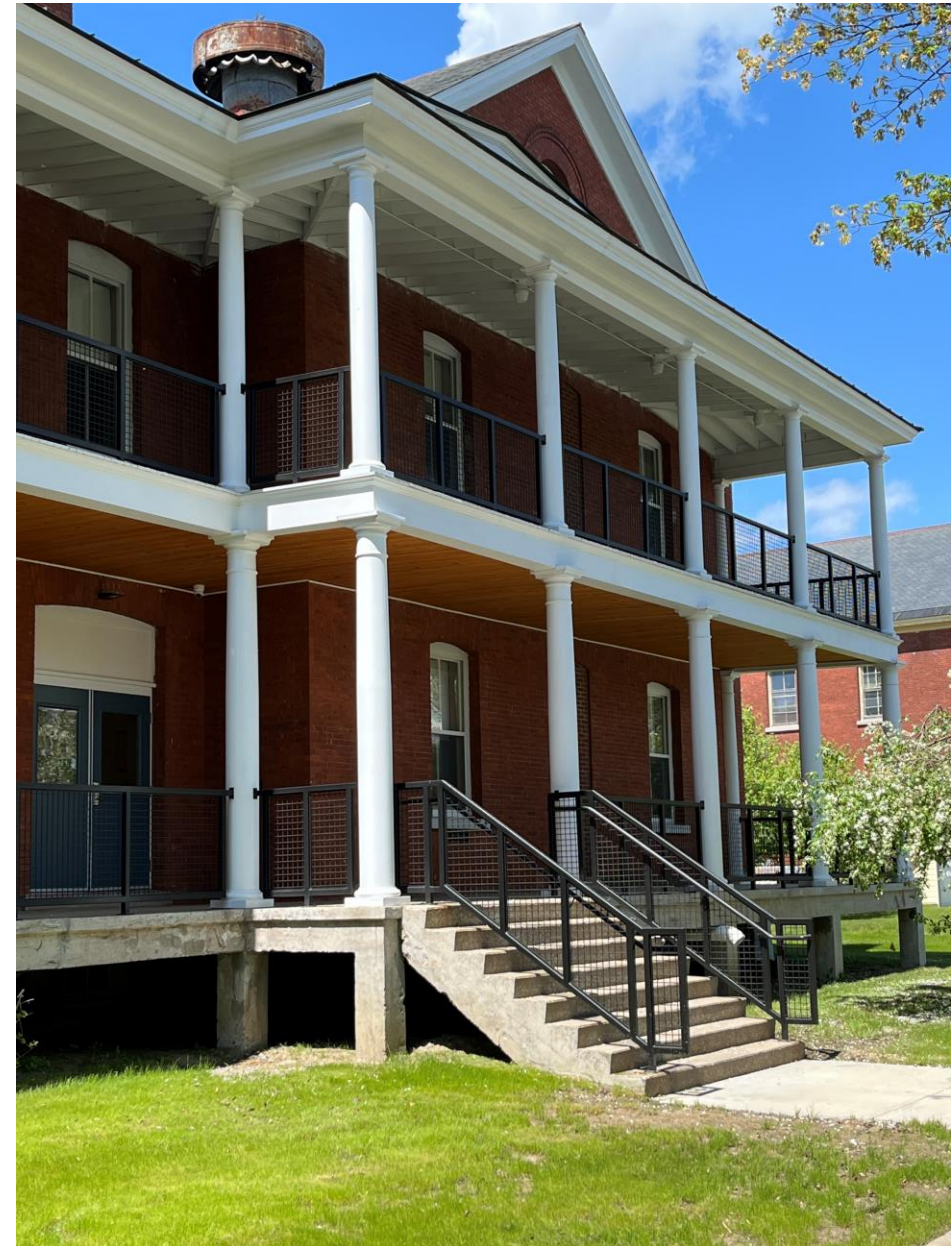
# Porch Rehabilitation & ADA Accessibility

- Front porches columns replaced
- Rear porches rebuilt
- Ramps access rear entrances – compatible design

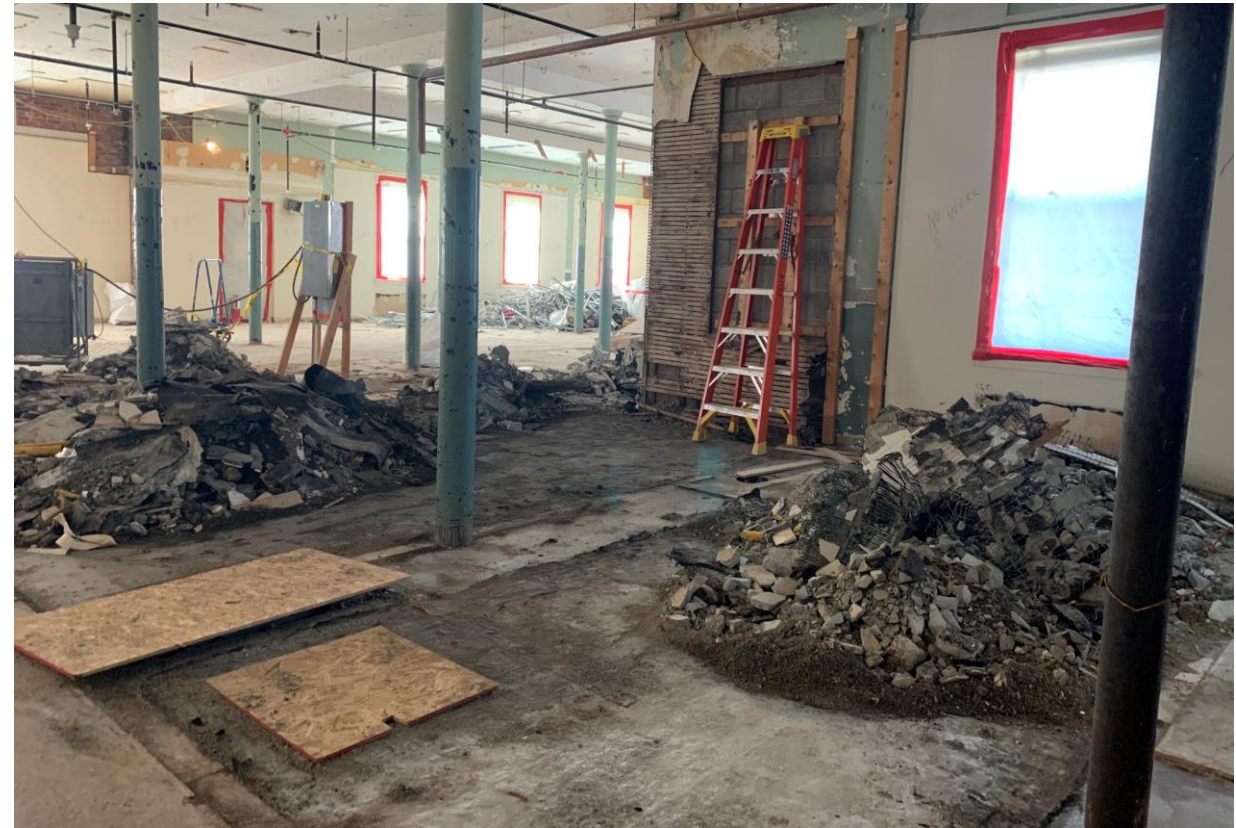
## Executing the Demo Plan

Selective deconstruction

- Salvage Historic Materials
- Properly Dispose of Waste
- Identify Hidden Conditions
- Prep for New Work

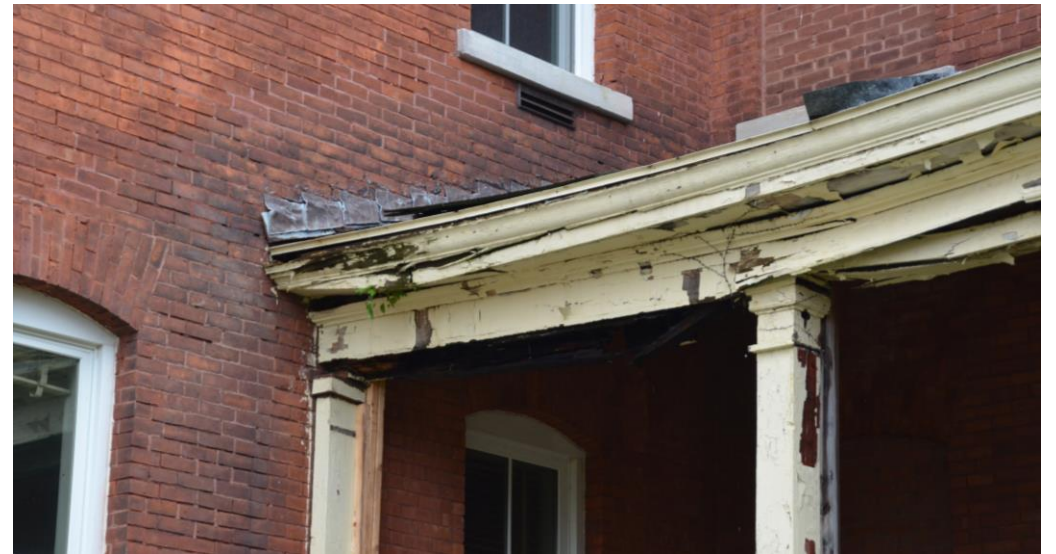
- Historical Importance
- Structural Hazard
- Aesthetic Liability
- Lack of Accessibility
- Budget Limitations

## Design Focus

Porches

- Structurally Sound
- Resolving Inherent Water Damage
- Retaining Historic Integrity

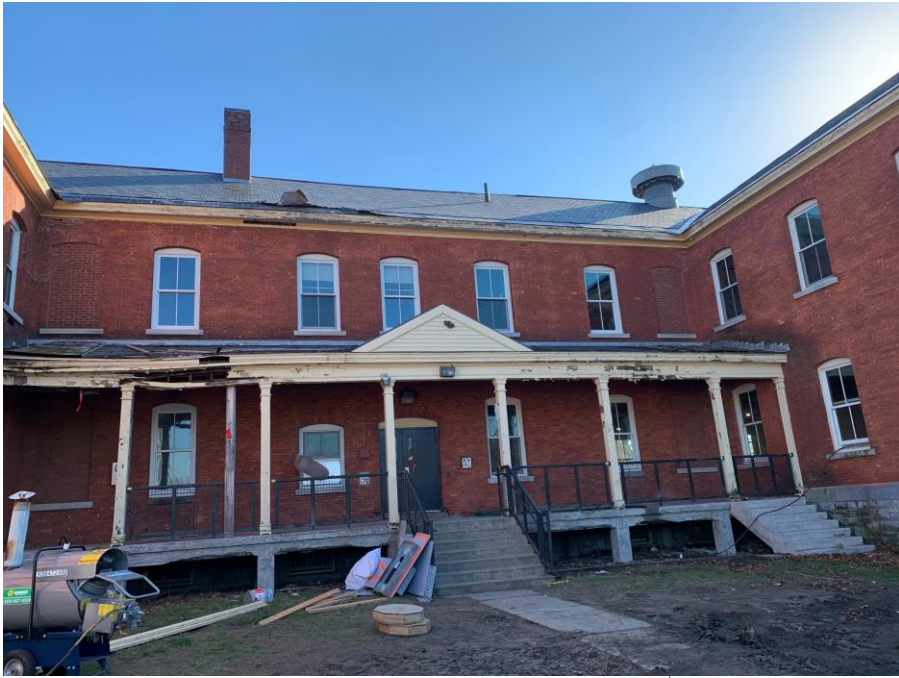
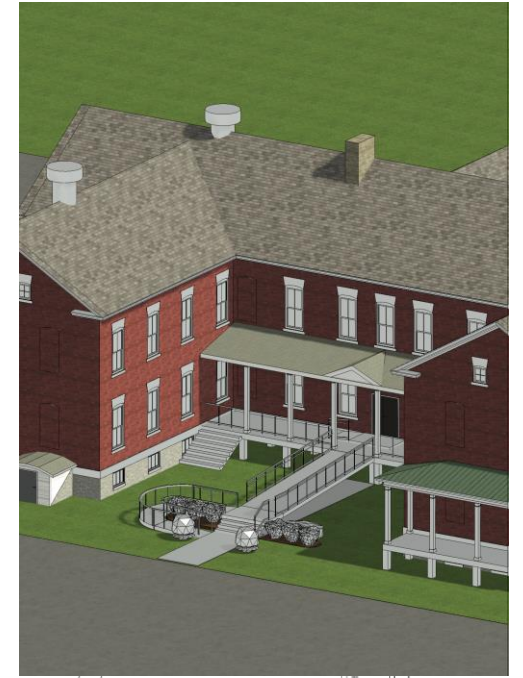
## Porches

- Inclusive Entry Experience
- Historically Appropriate
- Ceremonial but Affordable

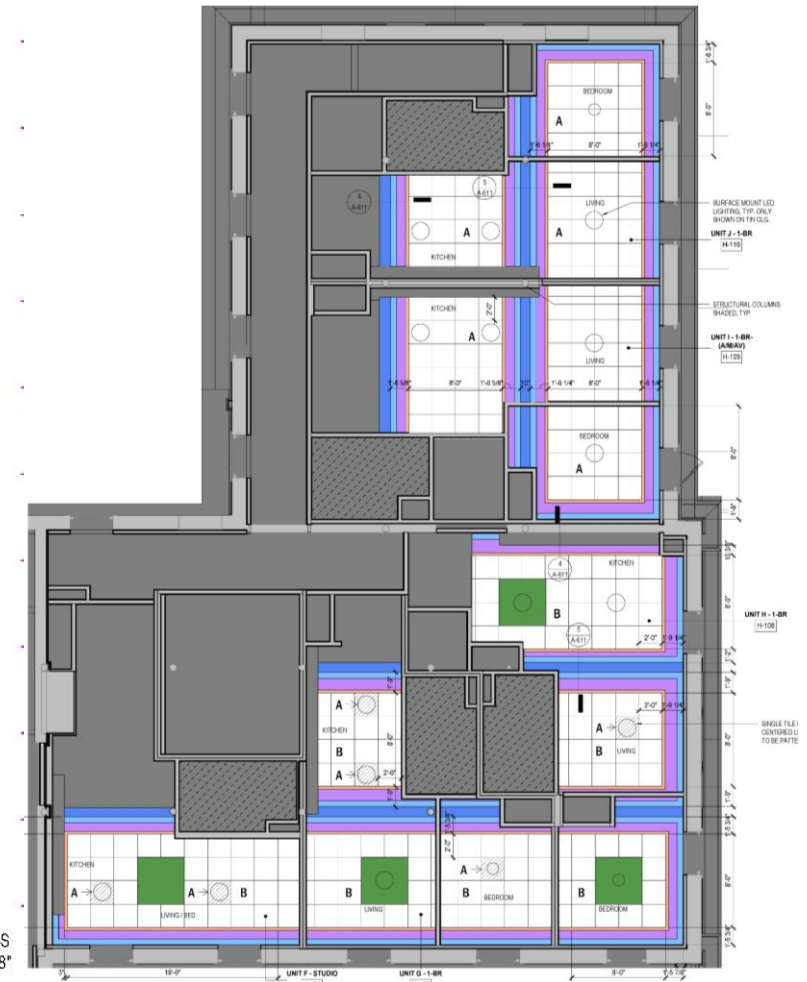
## Design Solution Pressed Metal Ceilings

- Areas to be retained
- Existing materials reuse
- Acceptable replacement materials

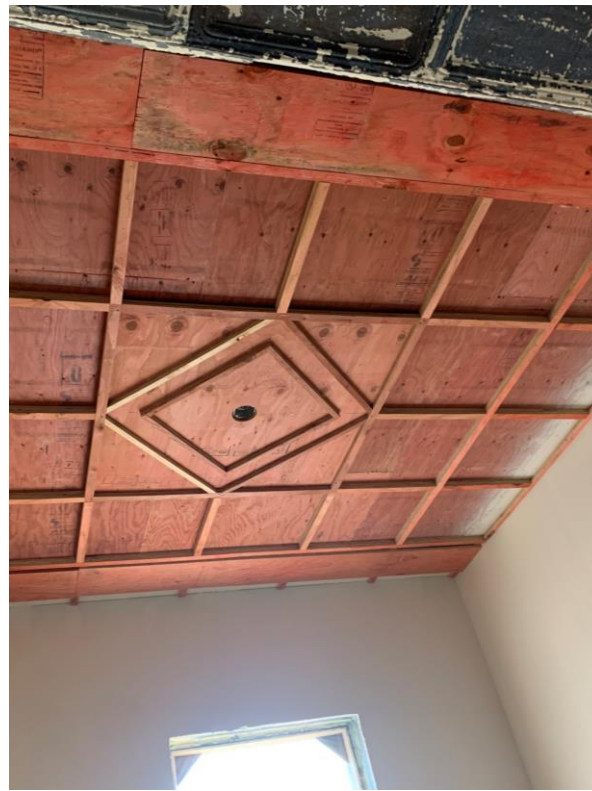
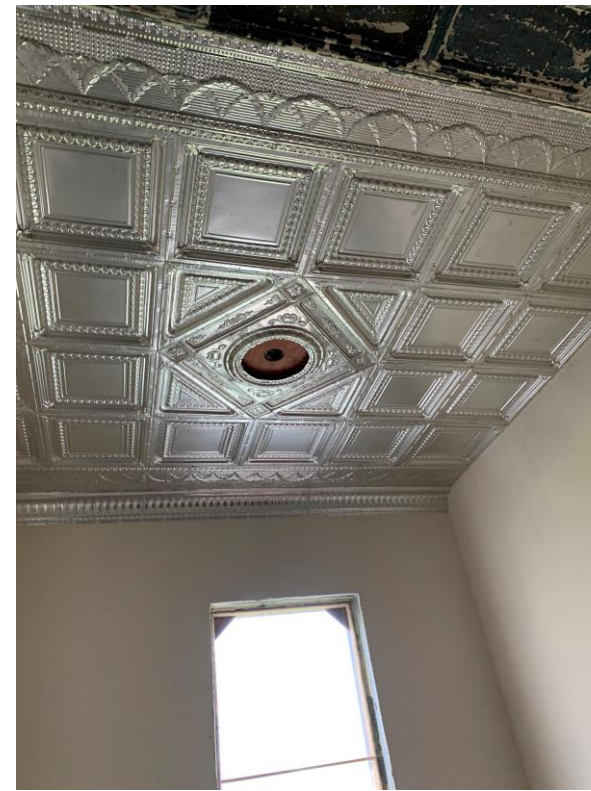
## Pressed Metal Ceilings

- Planned solution
- Develop the framework
- Install the product
- Finish the product

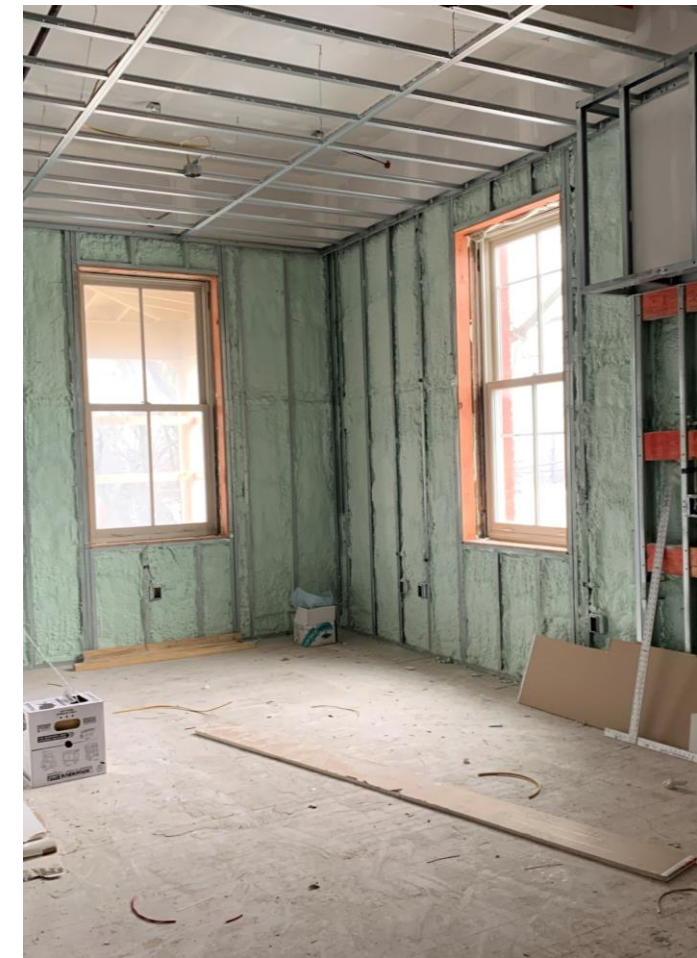
3 PROPOSED EXTERIOR WALL-FLOOR ASSEMBLY DETAIL AT TIN CLG  
A-520 SCALE: 1 1/2" = 1'-0"

# Technical Solution

## Exterior Wall Insulation

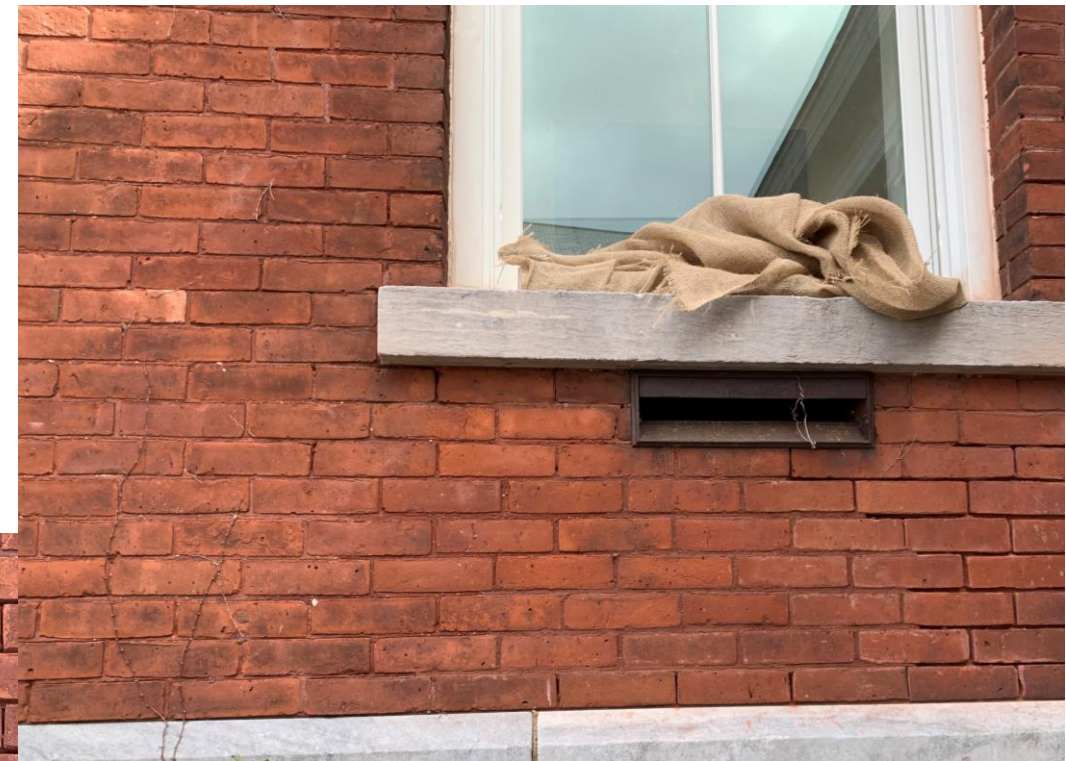
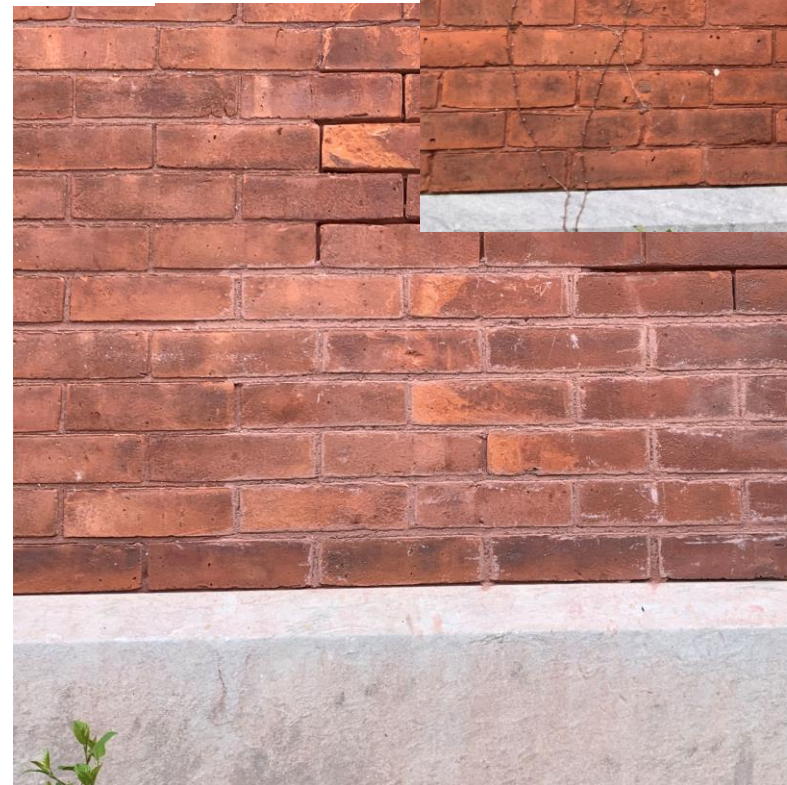
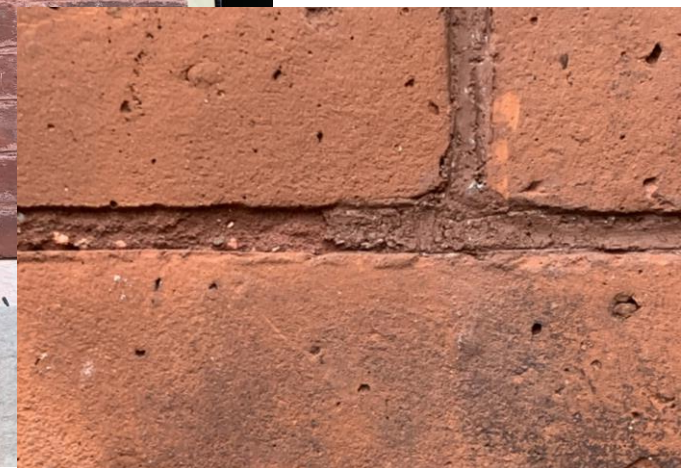
Mortar for the repointing work will be high calcium lime putty mortar mixed at a 3:1 masonry sand to lime putty ratio.  
Mortar Color additive- Solomon Grind  
Masonry cleaner is SureKlean 'Heavy Duty Restoration Cleaner'.  
Concrete patching material will be Sil Pro VOH repair mortar.

# Technical Solution

## Masonry

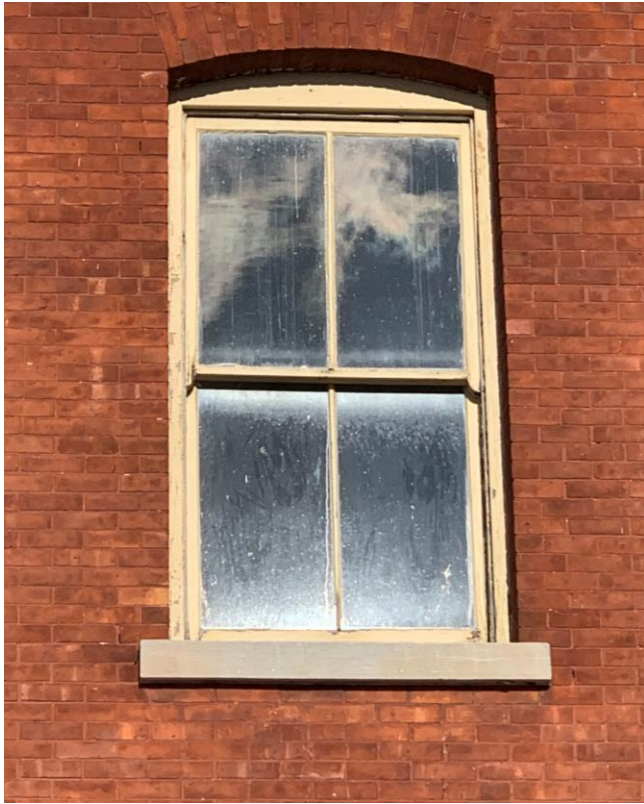
# Technical Solution

## Storm Windows

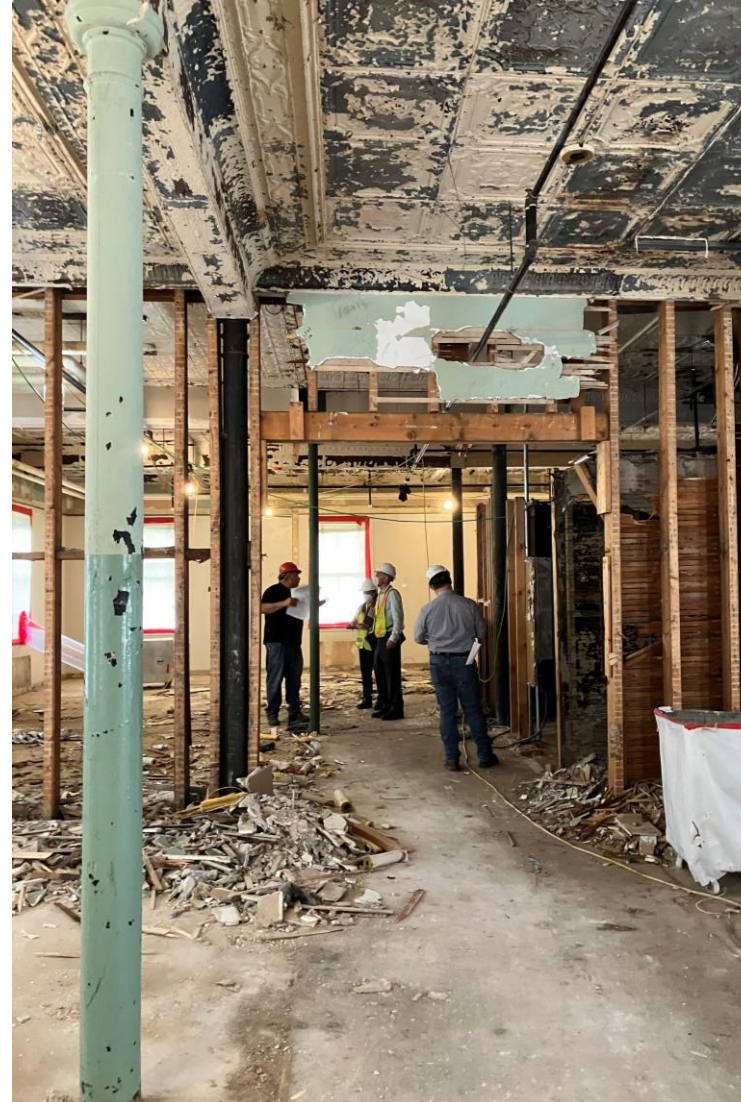
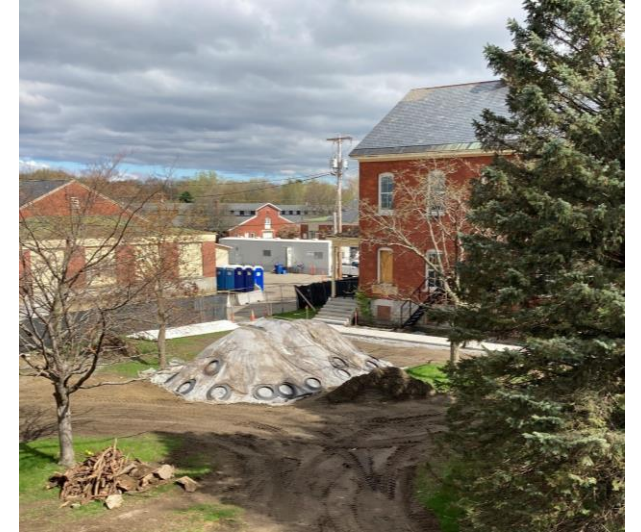
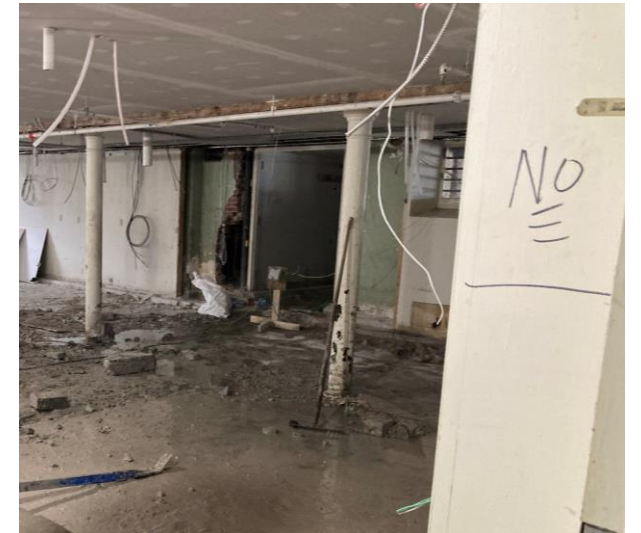
# Demolition

- Full abatement completed
- Tin ceilings and structural elements reviewed in place
- Historic elements preserved
- Existing structural features preserved

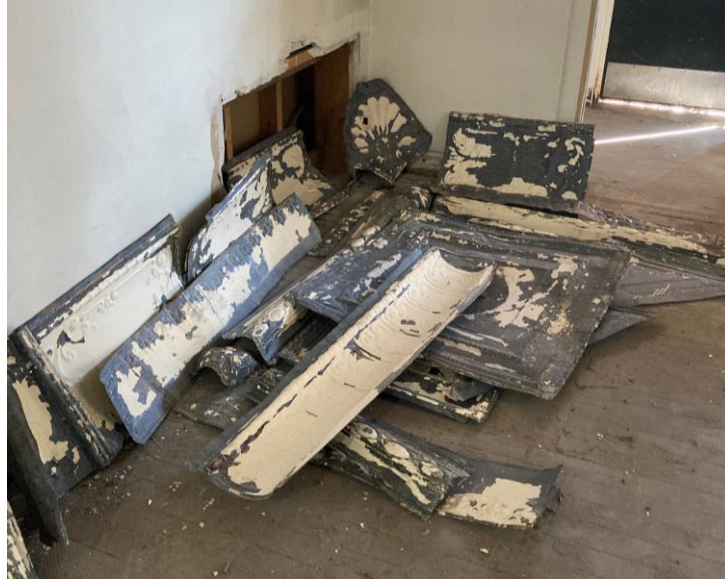
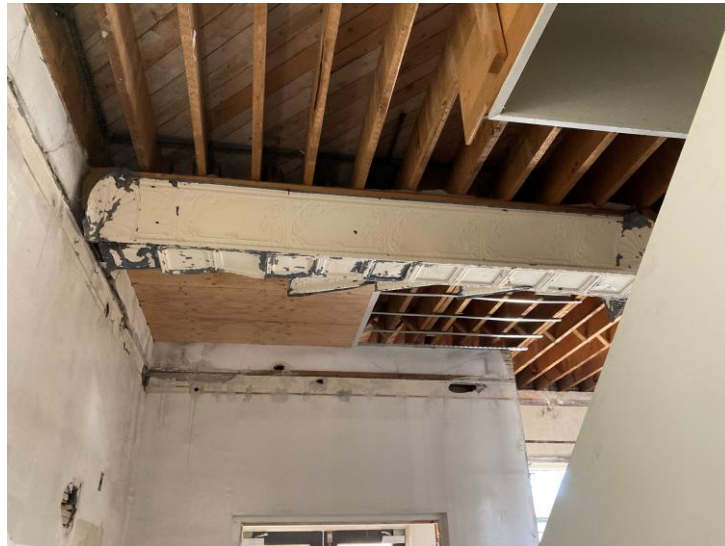
# Demolition

- Tin ceilings reviewed in place
- Tin ceilings carefully removed and stored for salvage
- Tim beam wraps preserved in place

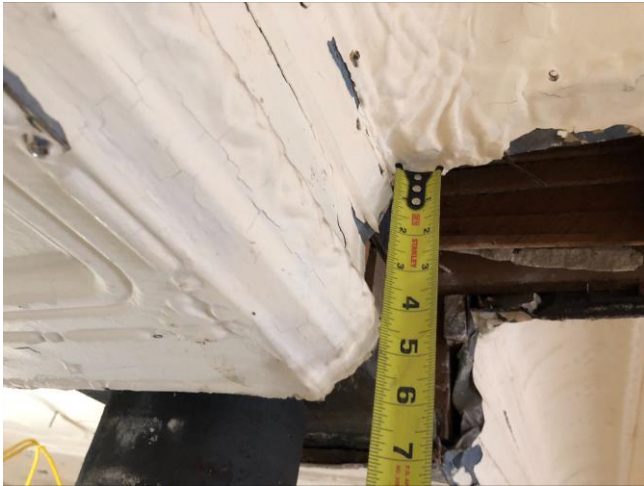
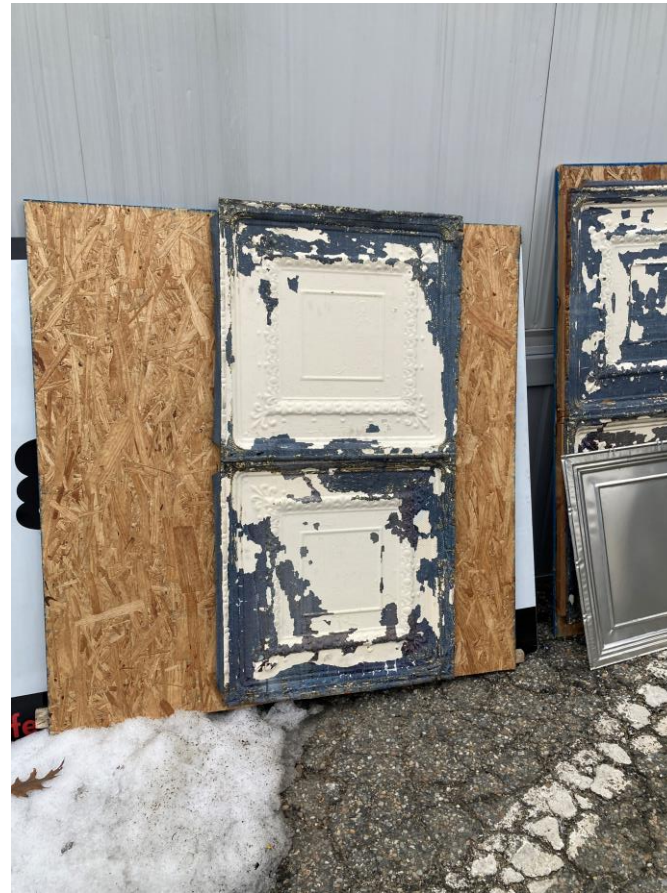
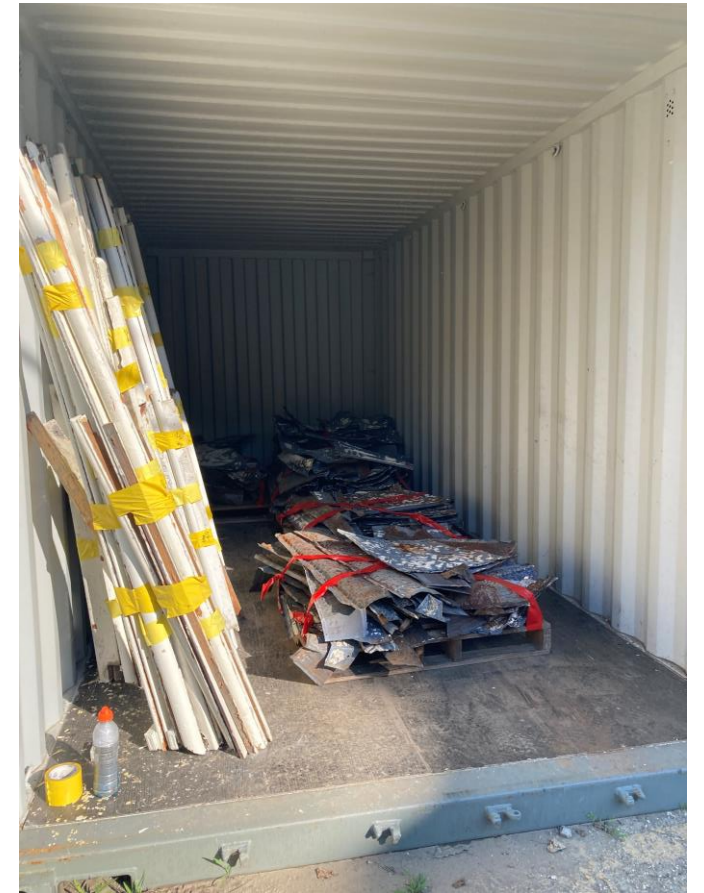
# Historic Feature Preservation

- Original tin documented and cataloged
- Materials cleaned, stabilized, stored
- Mockups built to compare with historic profiles

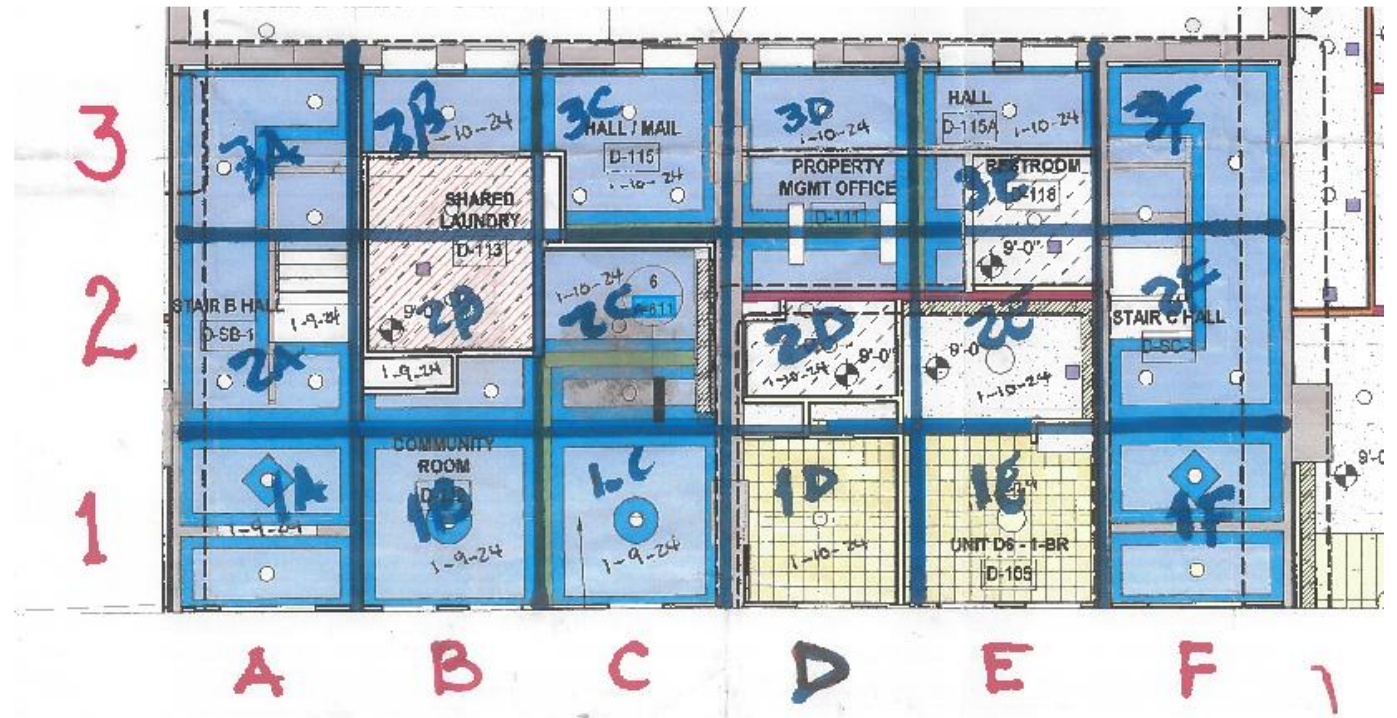
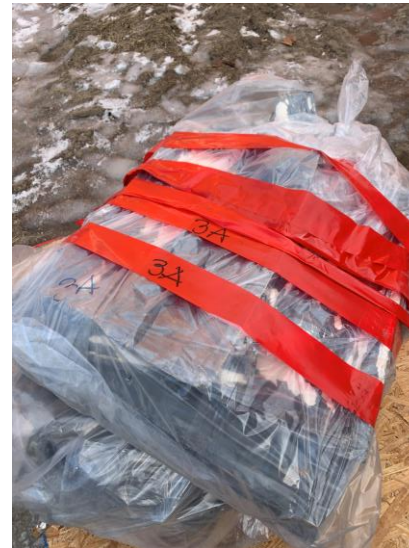
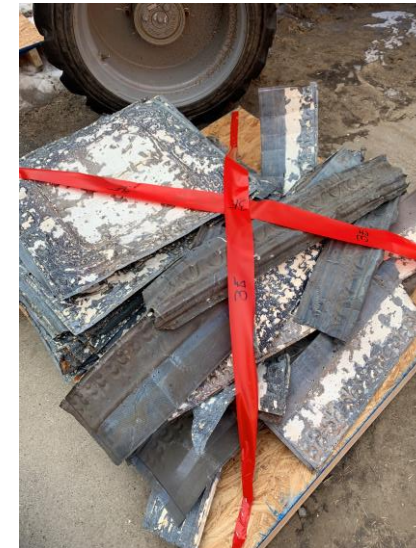
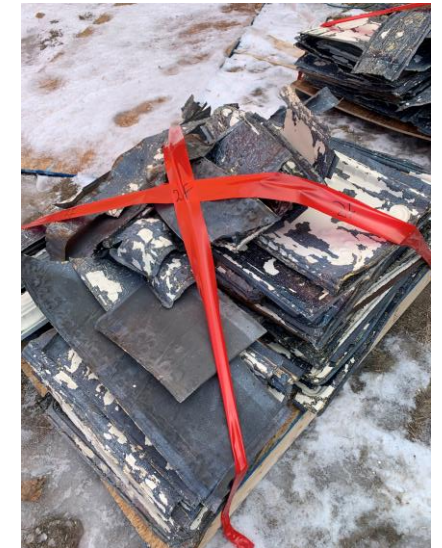
# Historic Feature Preservation

- Original tin documented and cataloged
- Materials cleaned, stabilized, stored
- Salvaged materials reused in final construction
