# **Historic Barracks to Modern Homes:**

## **10<sup>th</sup> Cavalry Apartments at Fort Ethan Allen**

**2026 Downtown & Historic Preservation Conference**

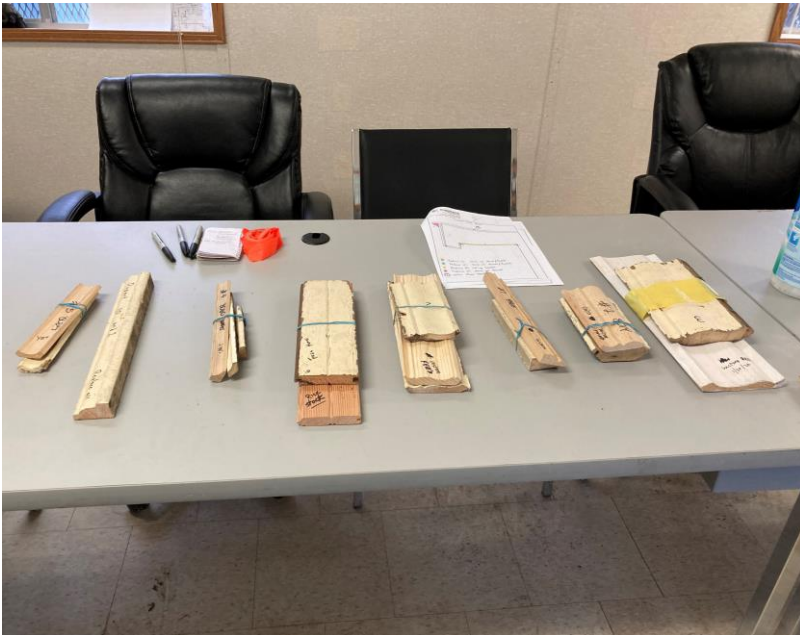
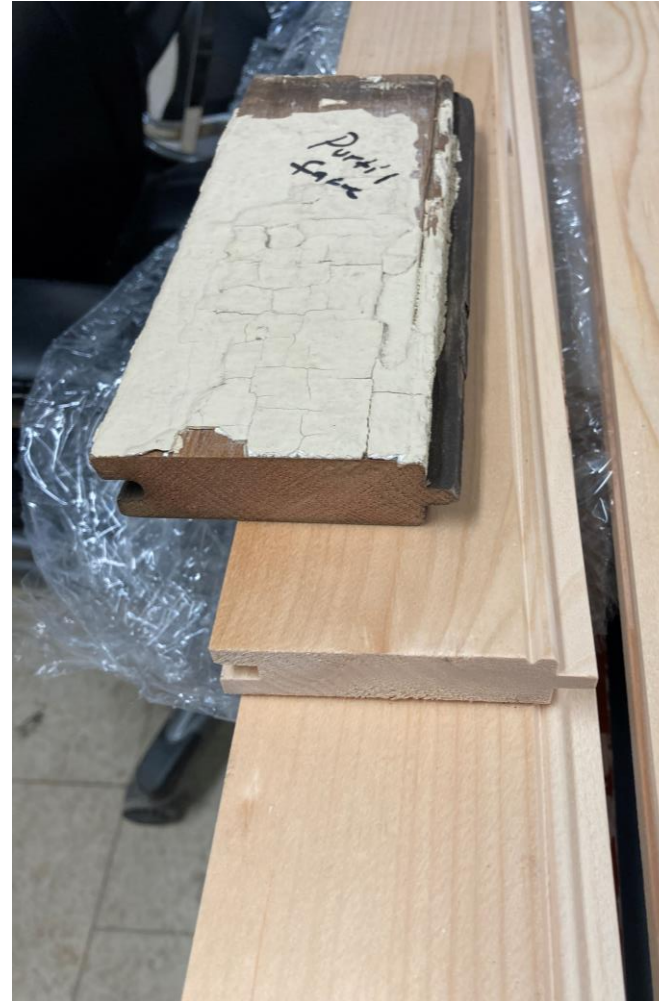
# Construction Approach

- Phased construction improved efficiency
- Approach adjusted after existing conditions were exposed
- Strong field leadership and coordination across trades
- Minimal impact to historic structure

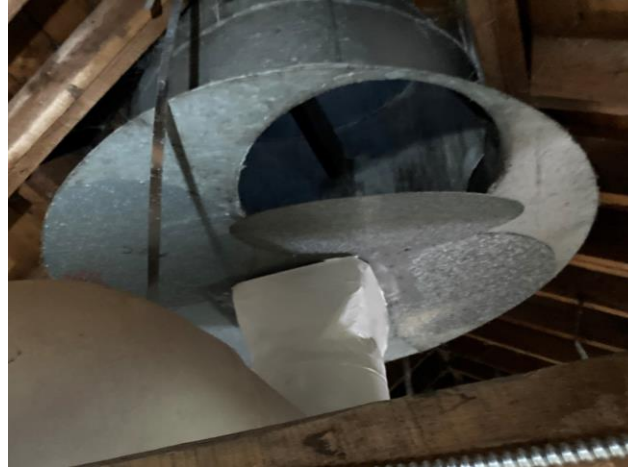
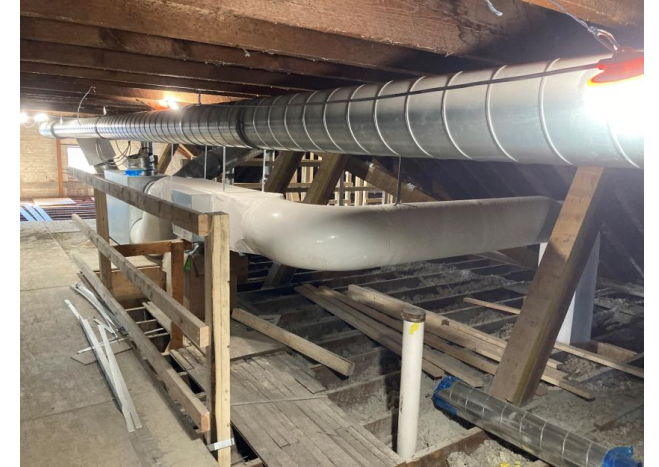
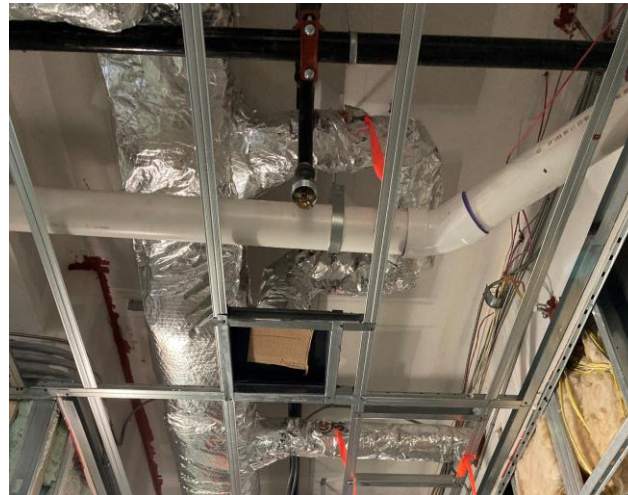
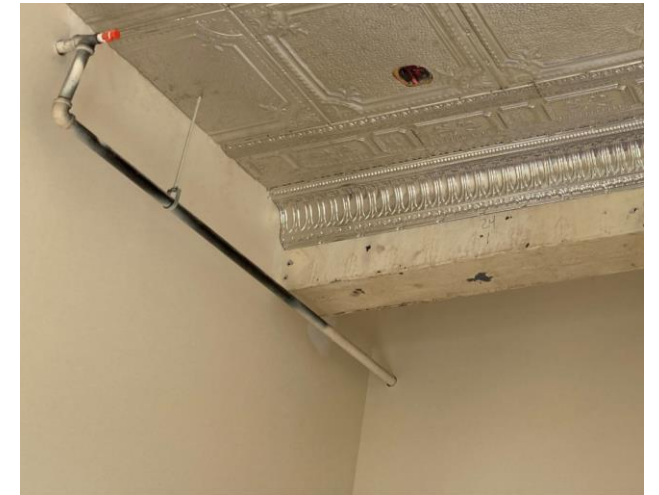
# Mushroom Ventilators

- Cleaned and bird screens added
- Reused for ventilation intake and exhaust air

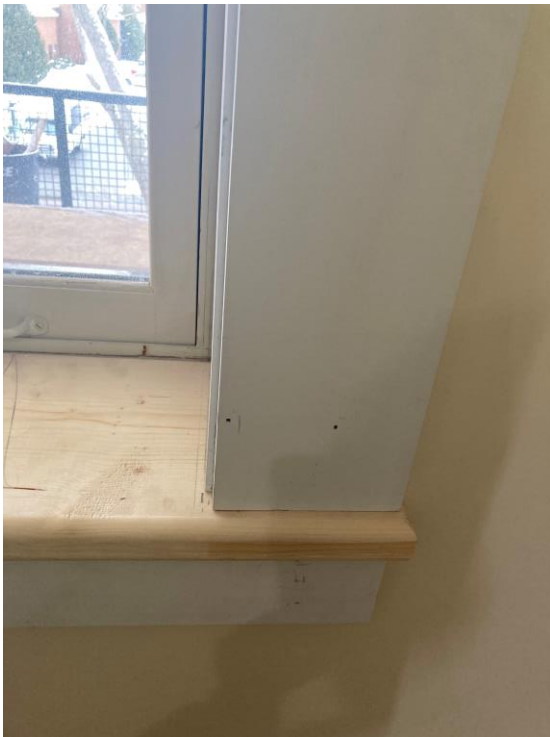
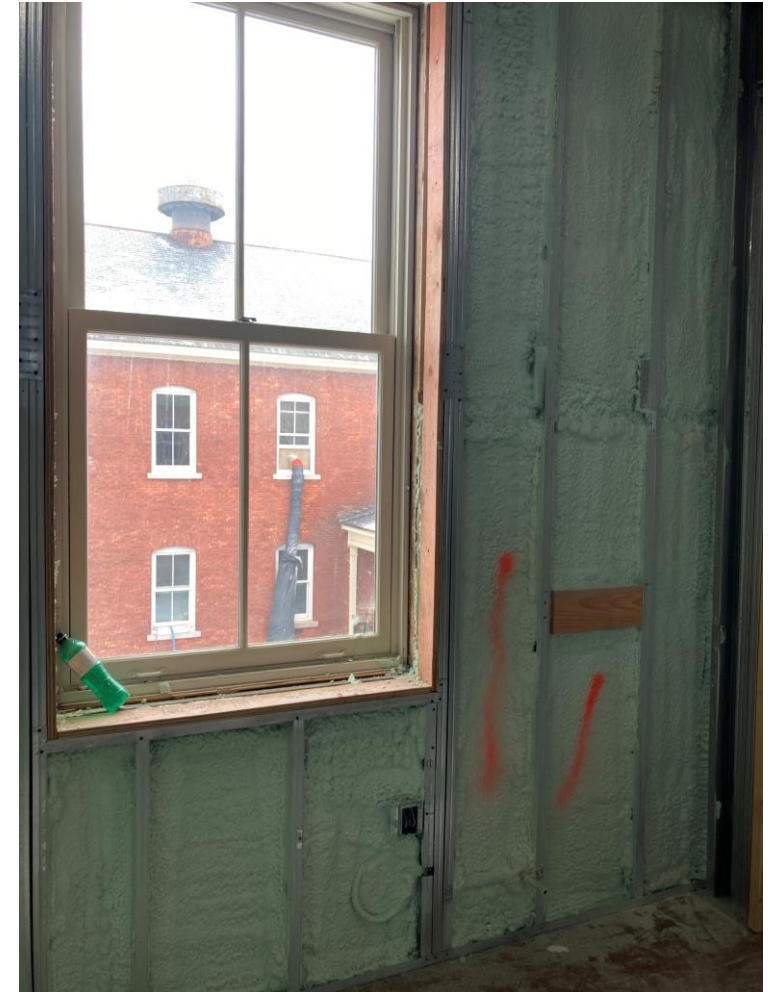
# Window Restoration

- New trim installed on thickened wall
- Trim profiles reviewed for historic compliance

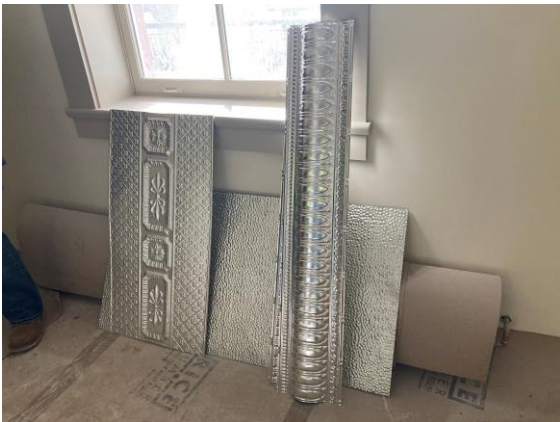
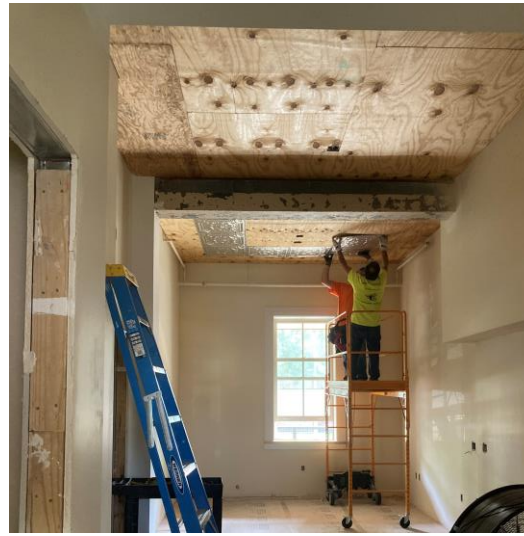
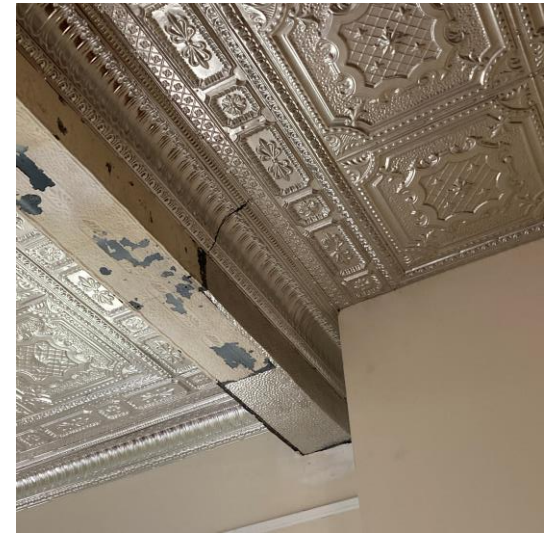
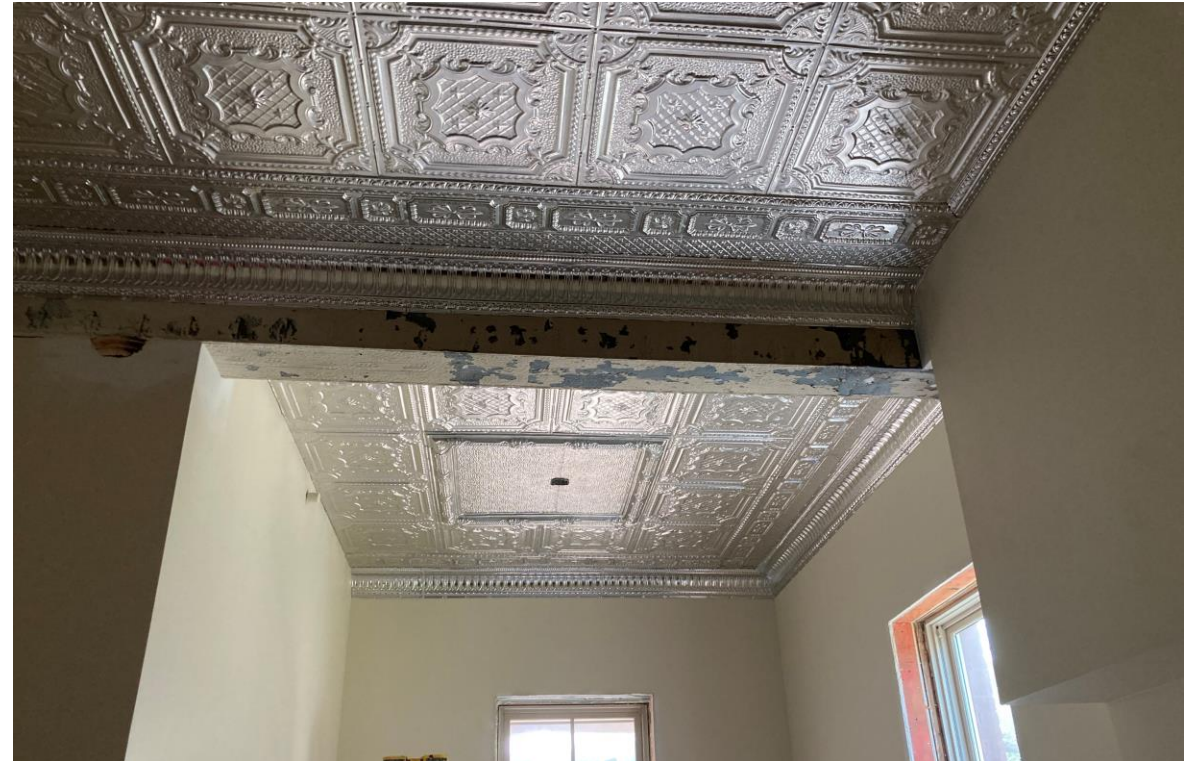
# Tin Ceiling Restoration Lobbies

- Original tin salvaged, stabilized and reinstalled in lobbies and common areas
- Scraped to refusal
- Elastomeric coating applied to stabilize surface
- Tin reinstalled over fire-rated assemblies and finished

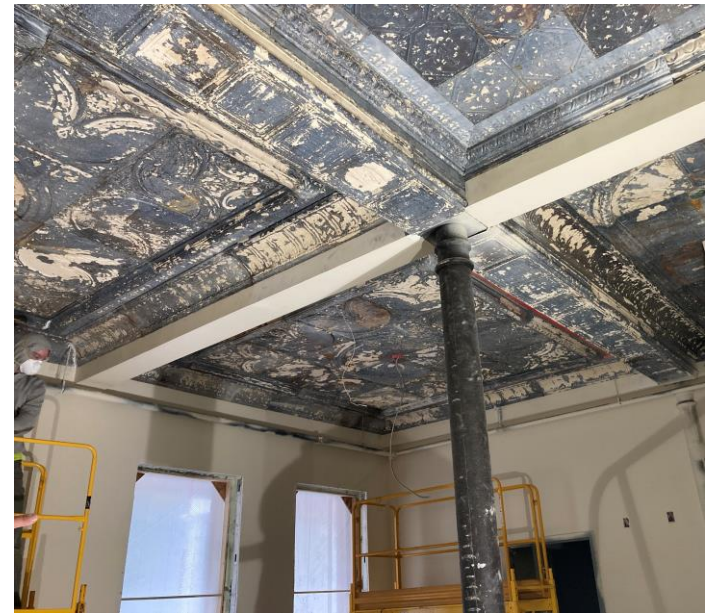
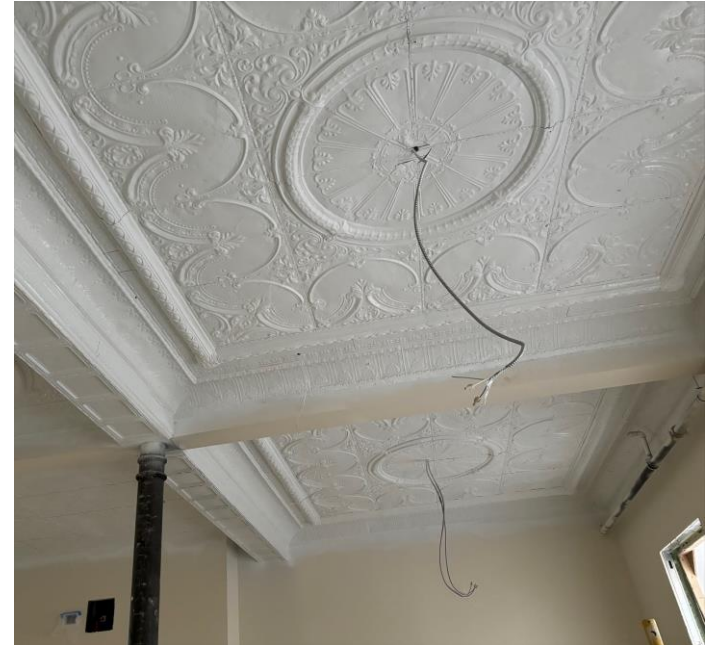
# Tin Ceiling Restoration Community Room

- Original tin salvaged, stabilized and reinstalled in lobbies and common areas
- Scraped to refusal
- Elastomeric coating applied to stabilize surface
- Tin reinstalled over fire-rated assemblies and finished
