# Burnham Hall

### Dry Floodproofing Case Study

# New England Youth Theater

### Wet and Dry Floodproofing Case Study

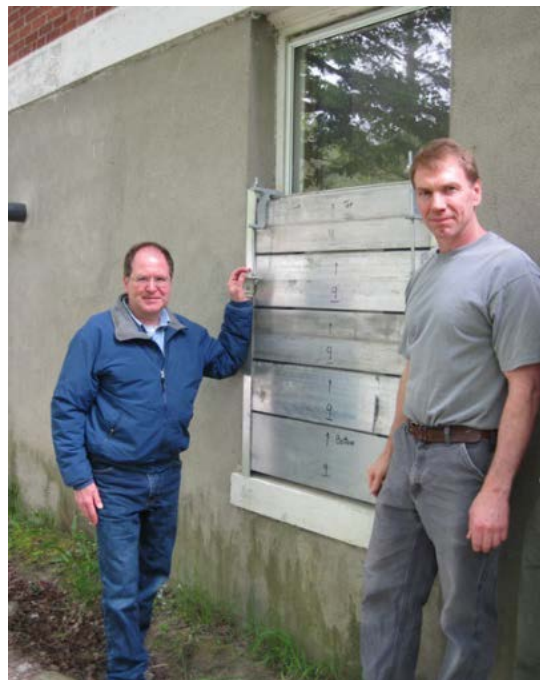
- Individual planks, weighing approximately 15 pounds each, are carried to and installed at each window or door site.
- Sealing of holes made for utilities - electricity, telephone, and fuel – where water can enter.

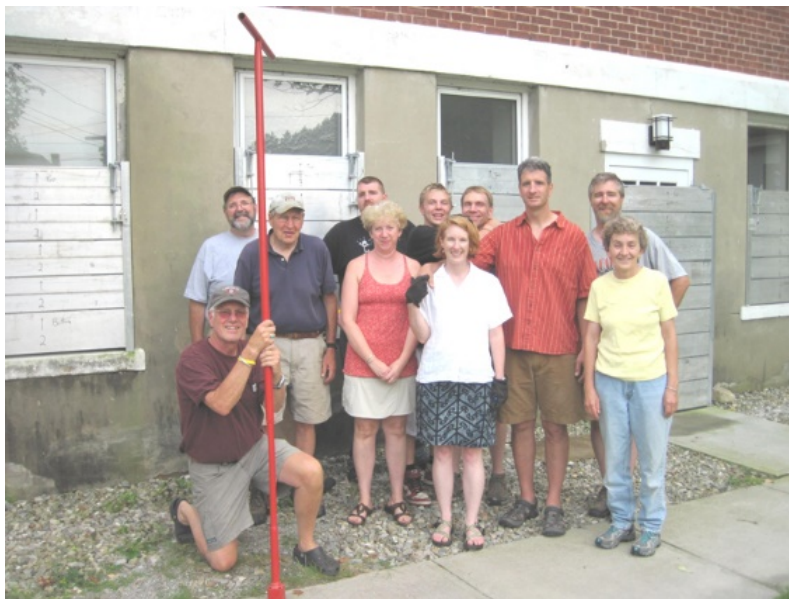
The rain arrived during the night and continued throughout Sunday at a fast and furious pace. Local rain gauges registered between six and eight inches of rain. The New Haven River rose quickly, flooding its banks, then the lawn of Burnham Hall, and finally up the walls to a level 47 inches above the first floor.

The planks held tight. Water and mud were kept out of the building. As the river raged by, the pressure of nearly four feet of water outside the building activated the pressure pop-up valves, and kept the floor from buckling upward. By design, a small amount of sand filtered water came in through these valves, and was easily handled by the sump pump system. Power failure during the afternoon, necessitated bringing a generator online to keep the sump pump operating. By Monday, the river receded, and clean up started.

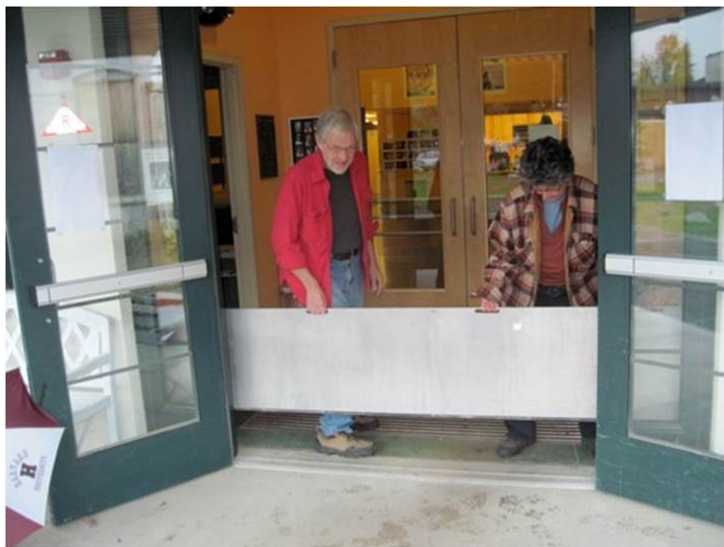
- **Floodgates.** Finally, the five doorways had to be protected from floodwaters. The solution was inexpensive and effective: flood gates were made for each door, the gates consisting of 1/4” thick aluminum sheets that slide into tracks at each side of the door frame, and tighten against gaskets with a set of thumbscrews. The gates are located inside rather than outside to allow the doors to swing outwards and let people out. And the doors themselves bear the brunt of the surging water, relieving the gates of most of the water pressure.

Although the 20” high floodgates exceeded FEMA requirements by almost a foot, waters from the overflowing Whetstone Brook came to 4” from the top of the gates. NEYT is now considering raising the gates another 10” higher. While many of the control measures described above were built into the foundation of the building, floodgates like NEYT’s can fairly easily be adapted into an existing building that has adequate foundation strength to resist infiltration of floodwaters. In those cases, this technique may be the best insurance against “the next one.”
