Vermont Agency of Transportation

Project Delivery Bureau - Environmental Section

To: Vermont Advisory Council on Historic Preservation
From: Judith Williams Ehrlich, VTrans Historic Preservation Officer
Jeannine Russell, VTrans Archaeology Officer
Copy: Laura Trieschmann, State Historic Preservation Officer
Elizabeth Peebles, State Architectural Historian
Regarding: Proposal to Remove T-Hangars at Franklin County State Airport in Highgate, Vermont
Date: January 10, 2025

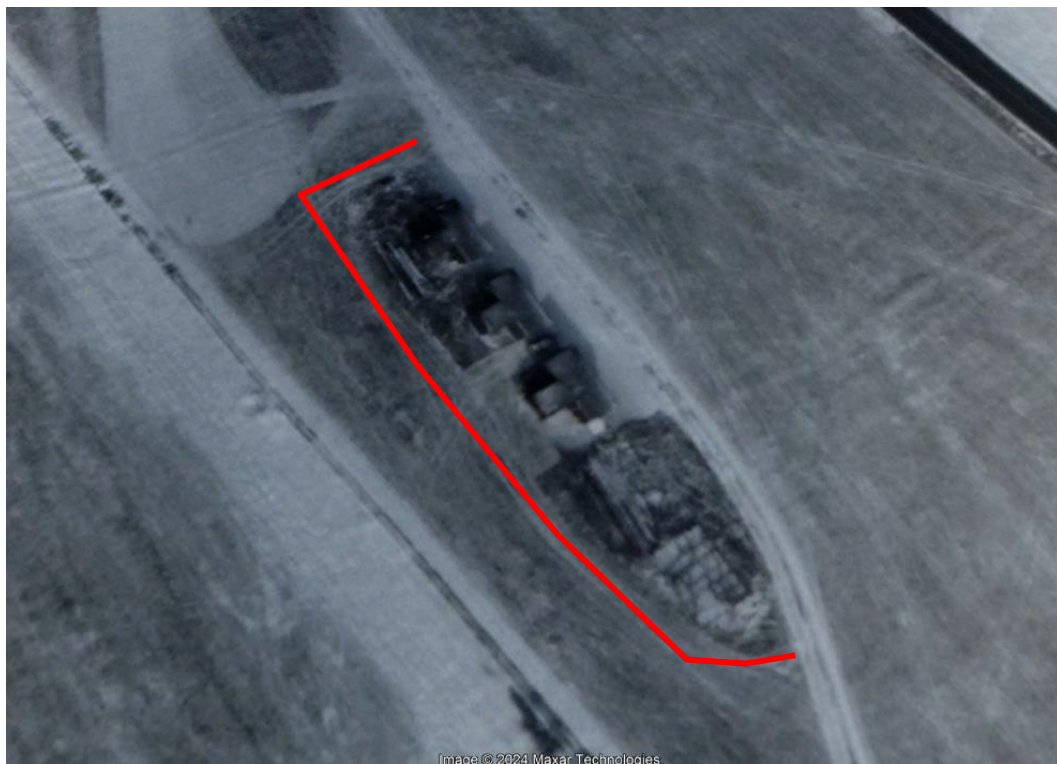
Image showing hangar locations and proposed protective fencing.

These disturbances combined with the shallow soil profiles from the nearby FY20-005 study from 2021 suggest that the area within and immediately surrounding the hangars is not considered archaeologically sensitive as this area would have been disturbed to a depth that would have removed any cultural soil layers during original construction. However, areas outside the immediate vicinity could still remain sensitive based on the conclusions from NE Arch's ARA and should be avoided during hangar removal. Given that the concrete slabs are to remain in place combined with the limited APE required for removal, the VTrans Archaeology Officer concludes that removal of the hangars will not affect archaeological sites or sensitive areas provided that equipment accesses the hangars using the existing roadway for entrance and egress to the hangars and activities associated with the removal of the hangars be limited to the area outlined in red below. Protective fencing will be required along the limits of this area to prevent equipment from encroaching on potentially undisturbed areas that exist outside the immediate area of the hangars. See image immediately below for recommended fenced area. *If the hangars can be removed during winter on frozen ground, then the stipulation for fencing will not be required.

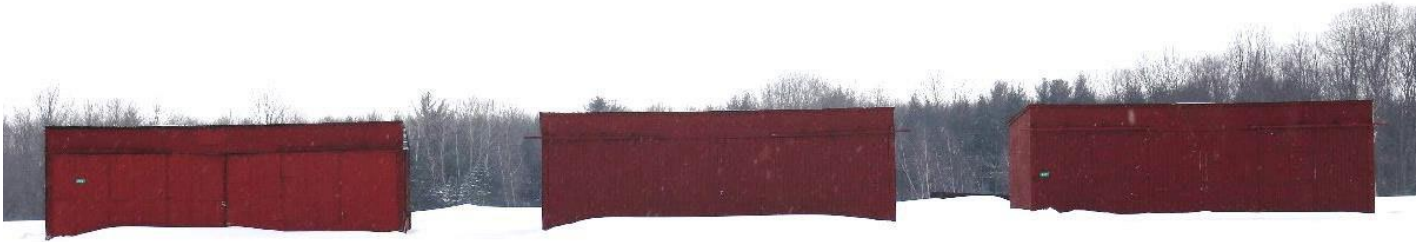
Image of three historic T-Hangars along Airport Drive. View facing west. Image from 2019 Mead & Hunt report.

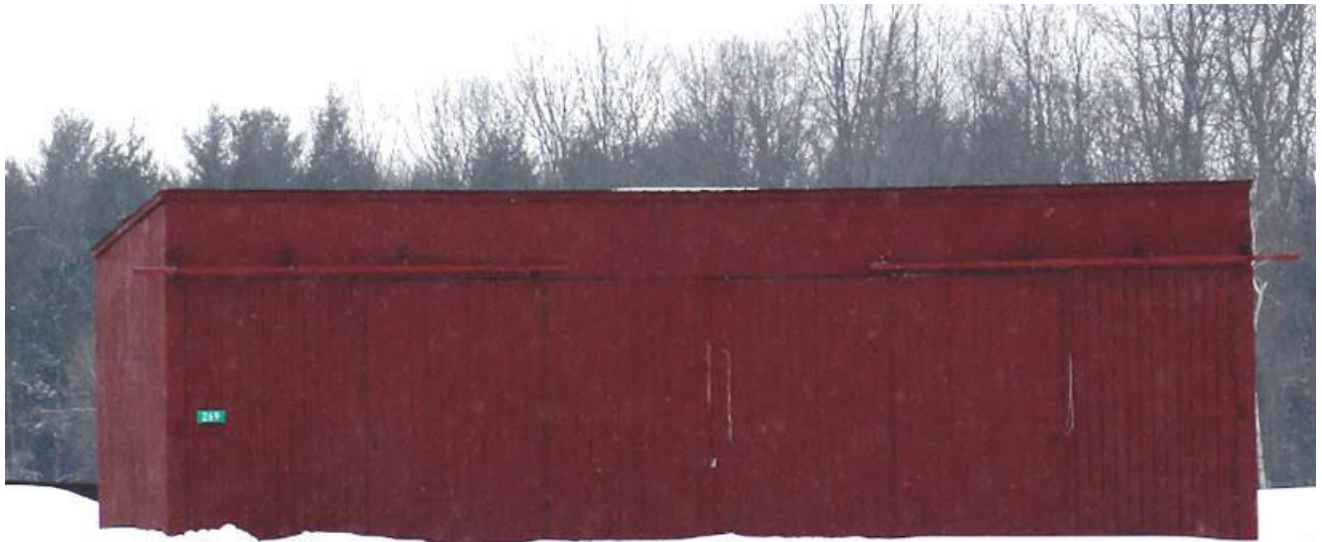
Image of T-Hangar 3 (northernmost). View facing west. Image from 2019 Mead & Hunt report.

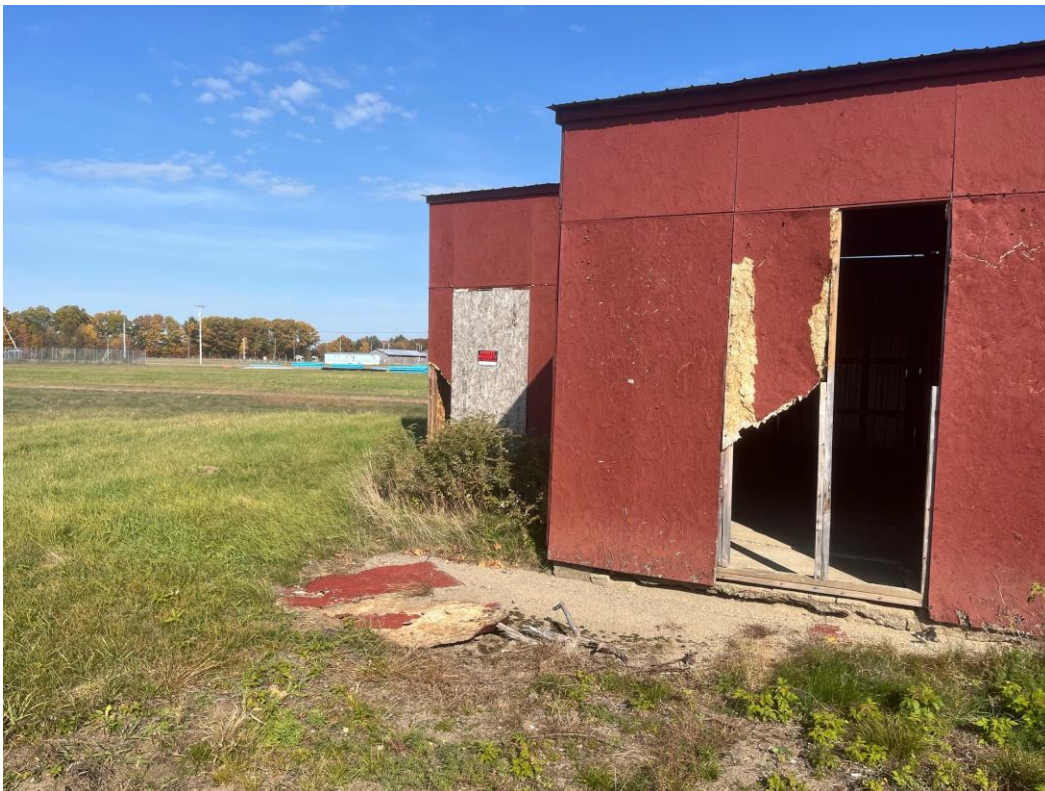
View of rear elevation of T-Hangar #1 showing damage from recent vandalism. Image from 2024.

VTrans is concerned that these recently acquired and deteriorating, isolated buildings pose an ongoing threat to safety. As shown in the photos below, vandals have torn off siding to gain access. Because the state has no functional need for the buildings and they are not in use, they are not monitored on a regular basis. In addition, the slab floors are cracked and crumbling and the siding has been completely replaced with particle board, which does not hold up well over time and is not as strong as plywood, the likely original cladding material. State funding is limited and is generally not available to repair buildings that no longer serve any function. Therefore, VTrans is seeking to remove the deteriorating buildings to improve the overall safety at this state-owned property. The concrete slab foundations will remain in place.

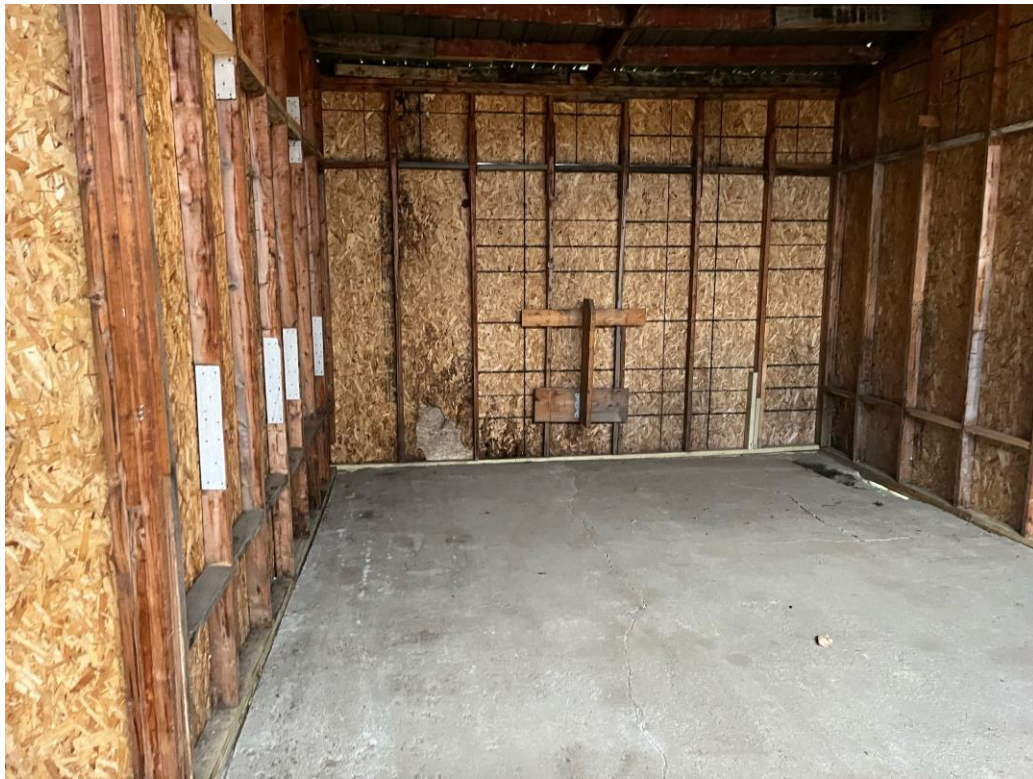
Interior view of one of the T-hangars showing particle board. Condition is similar in all three buildings. Image from 2024.

Since the resource identification survey, we have acquired additional information regarding the condition of the hangars. When the consultants completed the survey in 2019, there was snow on the ground and the T-hangars were difficult to access so the consultants were not able to view them up close. We now understand that the cladding on the buildings is particle board, some of which has a date stamp of 2016, so it is not the original material. As the buildings were constructed ca. 1935 and particle board was not widely used until starting in the 1950’s, one can assume the original siding on the buildings was likely plywood. Once painted, the plywood and particle board would appear similar from a distance.

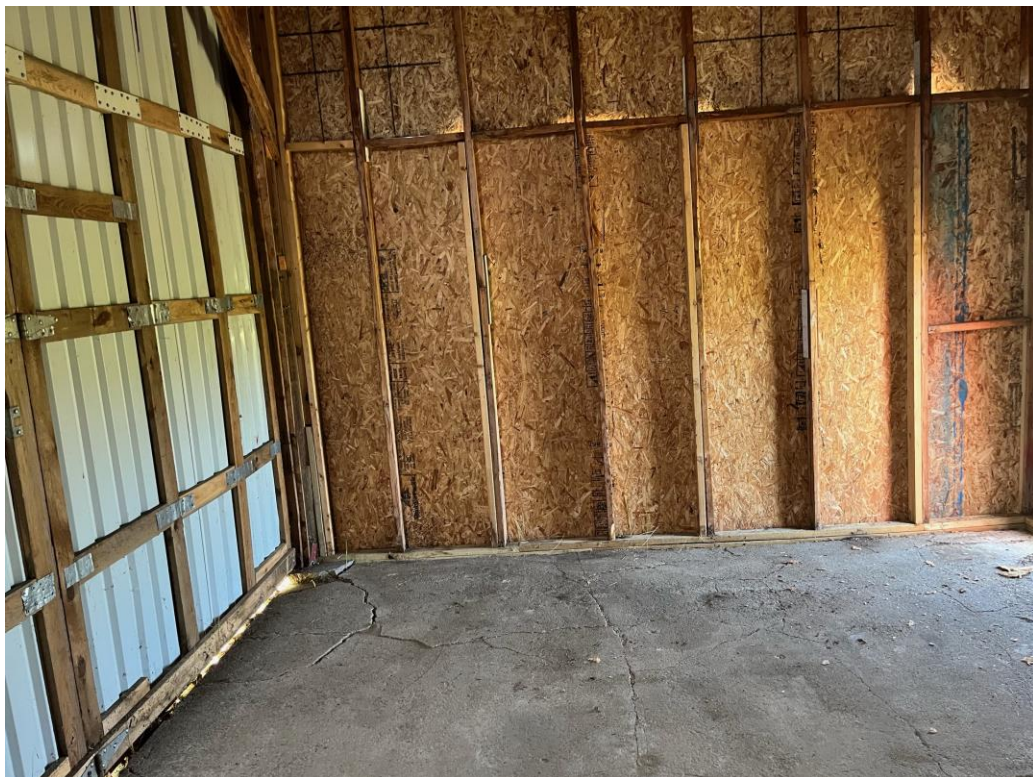
Interior view of one of the T-hangars showing the deteriorating concrete slab floor. Condition is similar in all three buildings. Image from 2024.

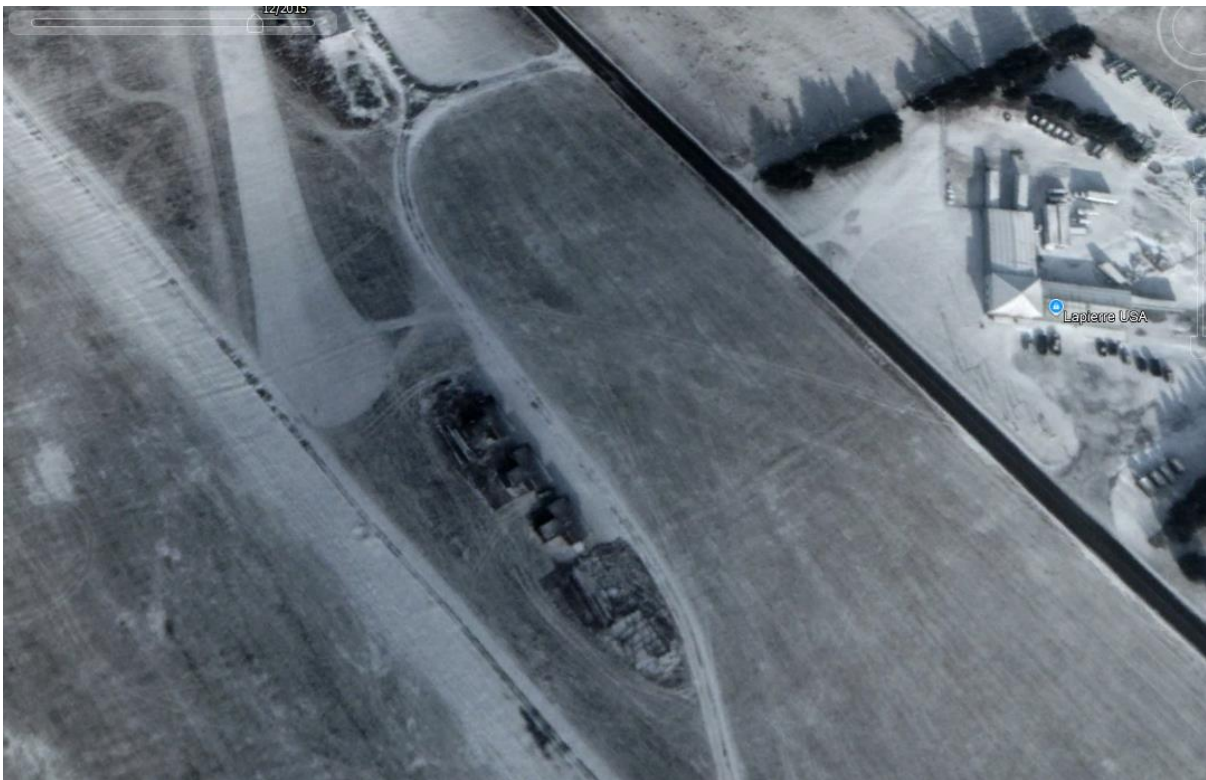
Google Image from 2015 showing the existing roadway and area of hangars. Disturbance can be seen in the areas immediately surrounding the hangars.

In addition, visual disturbance can be observed from past Google imagery dated 2015 included with this memo, and images from the Mead & Hunt report included in this memo also show the ground immediately outside the hangars and one can see some evidence of disturbance. There would have been previous disturbance associated with the construction of these hangars involving minimal excavation and leveling of the ground within the vicinity of each in order to pour the concrete slab on which these hangars are constructed. In addition, evidence of disturbance can be seen in the closeup Google 2015 image extending from the existing road immediately east of the hangars directly up to and in-between each structure.

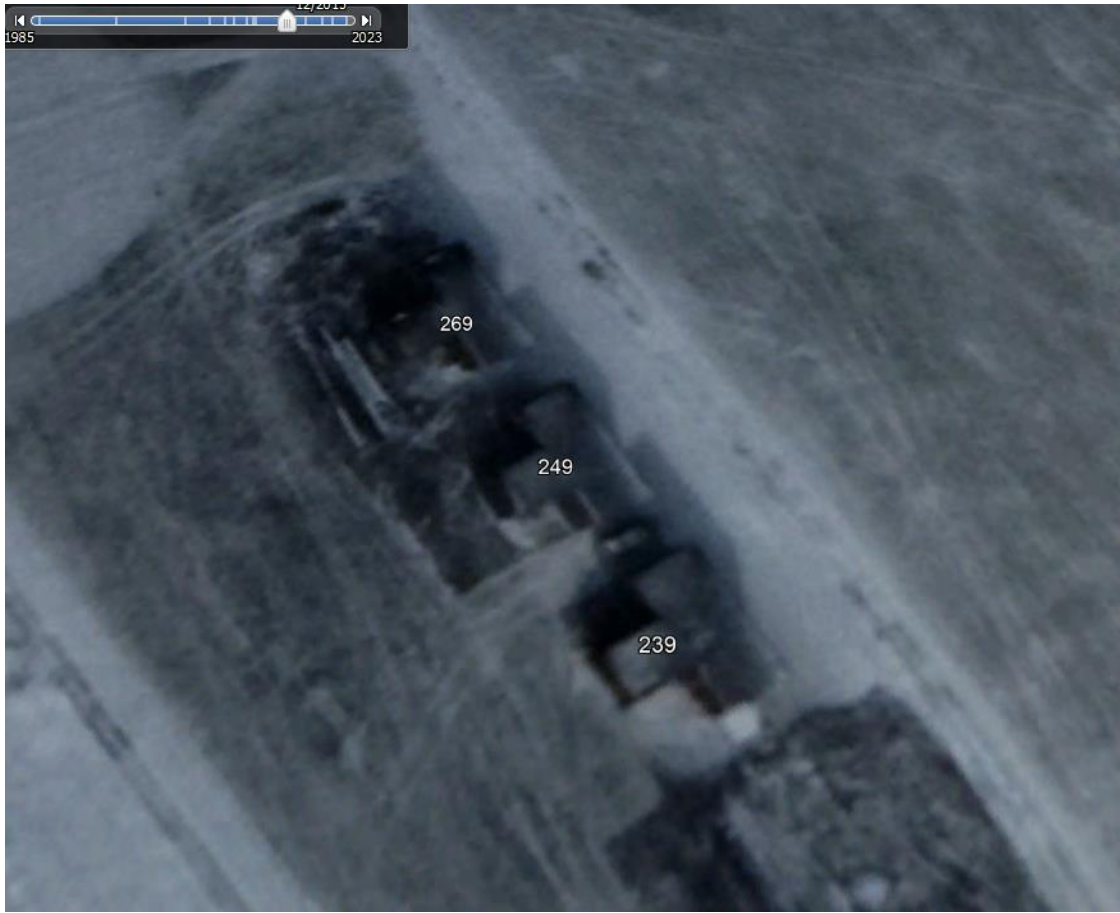
Closeup view from Google image (Dec 2015) showing disturbance from road right up to the edge of and in-between each structure.

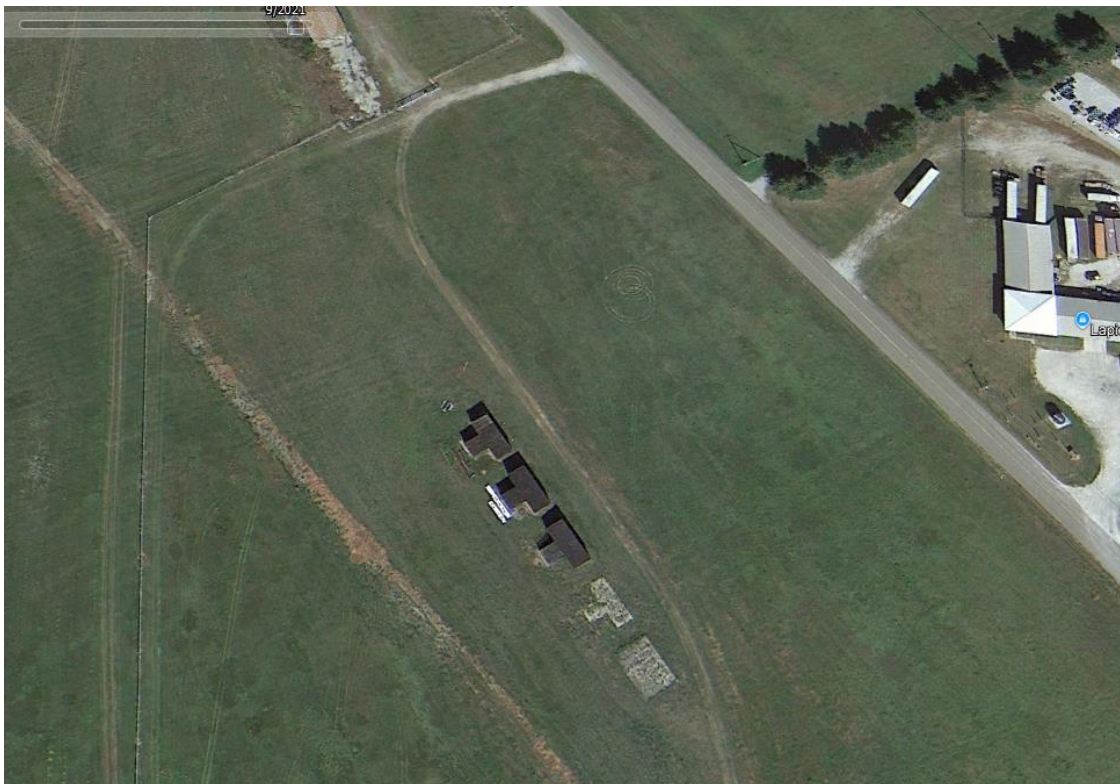
Google Image from 2021 showing foundations from two other structures as well as the three existing hangars.

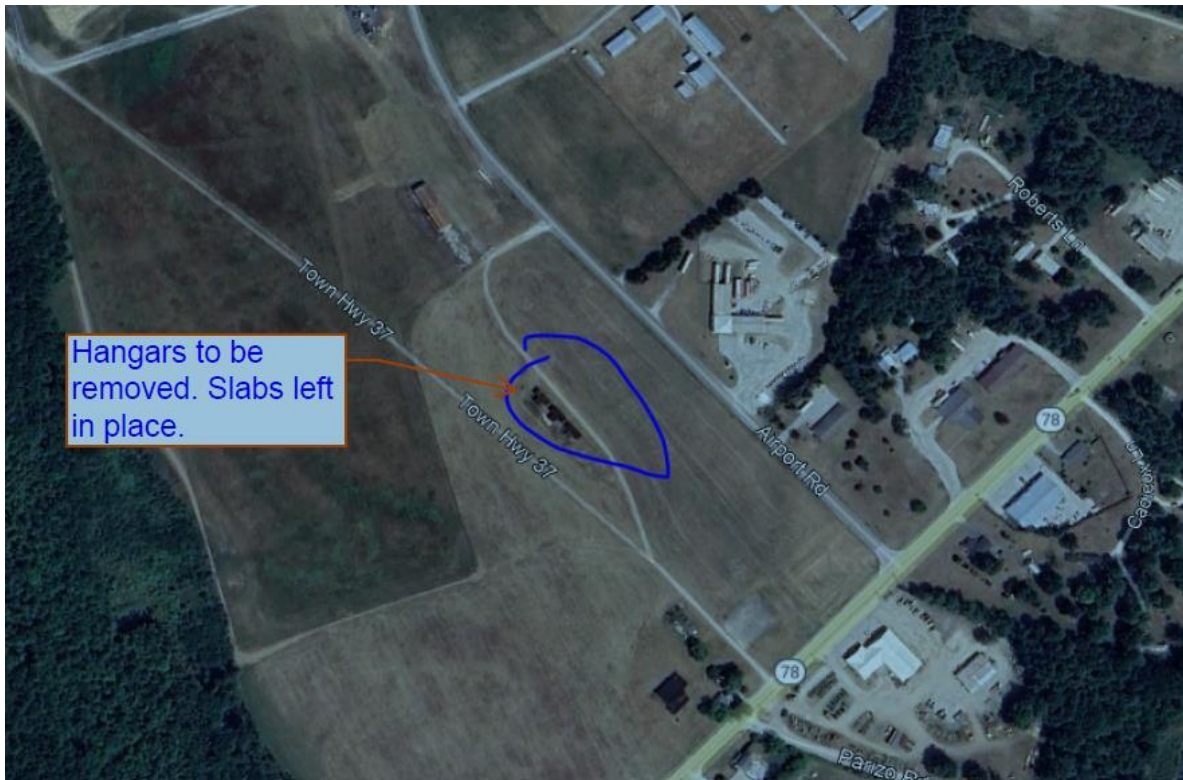
Image from Project Manager noting that the concrete slabs are to be left in place.
