Vermont Agency of Transportation

Memorandum

To: Vermont Advisory Council on Historic Preservation
From: Judith Williams Ehrlich, VTrans Historic Preservation Officer
Copy: Laura Trieschmann, State Historic Preservation Officer
Elizabeth Peebles, State Architectural Historian
Regarding: Proposal to Remove 9596 VT Route 36, East Fairfield, Vermont
Date: May 6, 2025

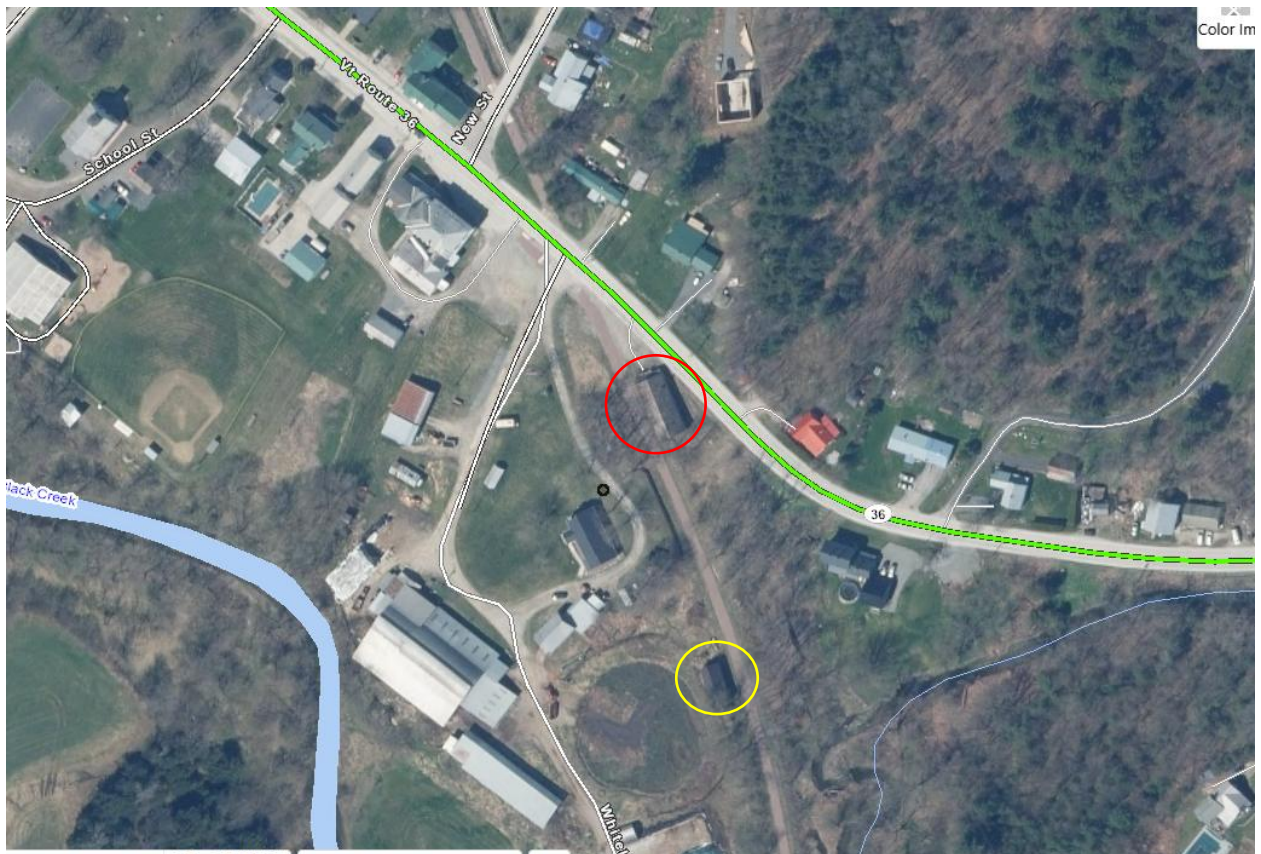
Figure 1: East Fairfield, VT. The building in the red circle is the metal clad building. The building in yellow is the Cary Maple Sugar Co. building. Both are within the LVRT ROW.

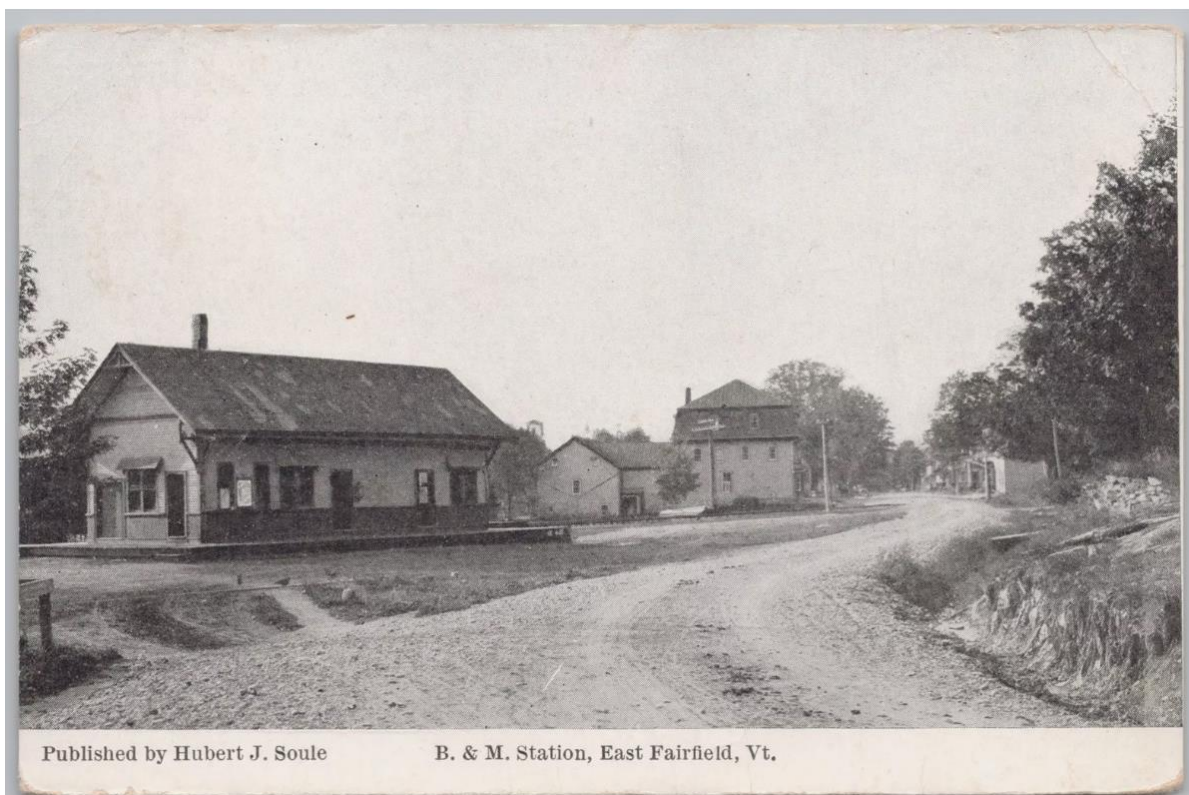
Figure 2: The historic East Fairfield depot, no longer extant. The building in the center of the photo remains – 9534 VT Route 36. The railroad runs diagonally across the image, on the opposite side of the depot in this image.

The previous building in this location was the East Fairfield depot, constructed ca. 1898 (see Figure 2). The East Fairfield depot was removed in the 1940s. The nearby Sheldon Junction depot was removed in the early 1940s (per rail valuation sheets). Passenger rail service decreased in popularity in the 1930/1940s and at that time, the St. J & LC was facing bankruptcy, and the Boston & Maine acquired the St. J & LC. Needing to cut costs, some buildings were removed. Additional evidence of this removal date is found in a set of highway plans that date to 1950. The plans show a different building in this location ("feed store" – see Figure 3) with a small "RR Sta" addition.

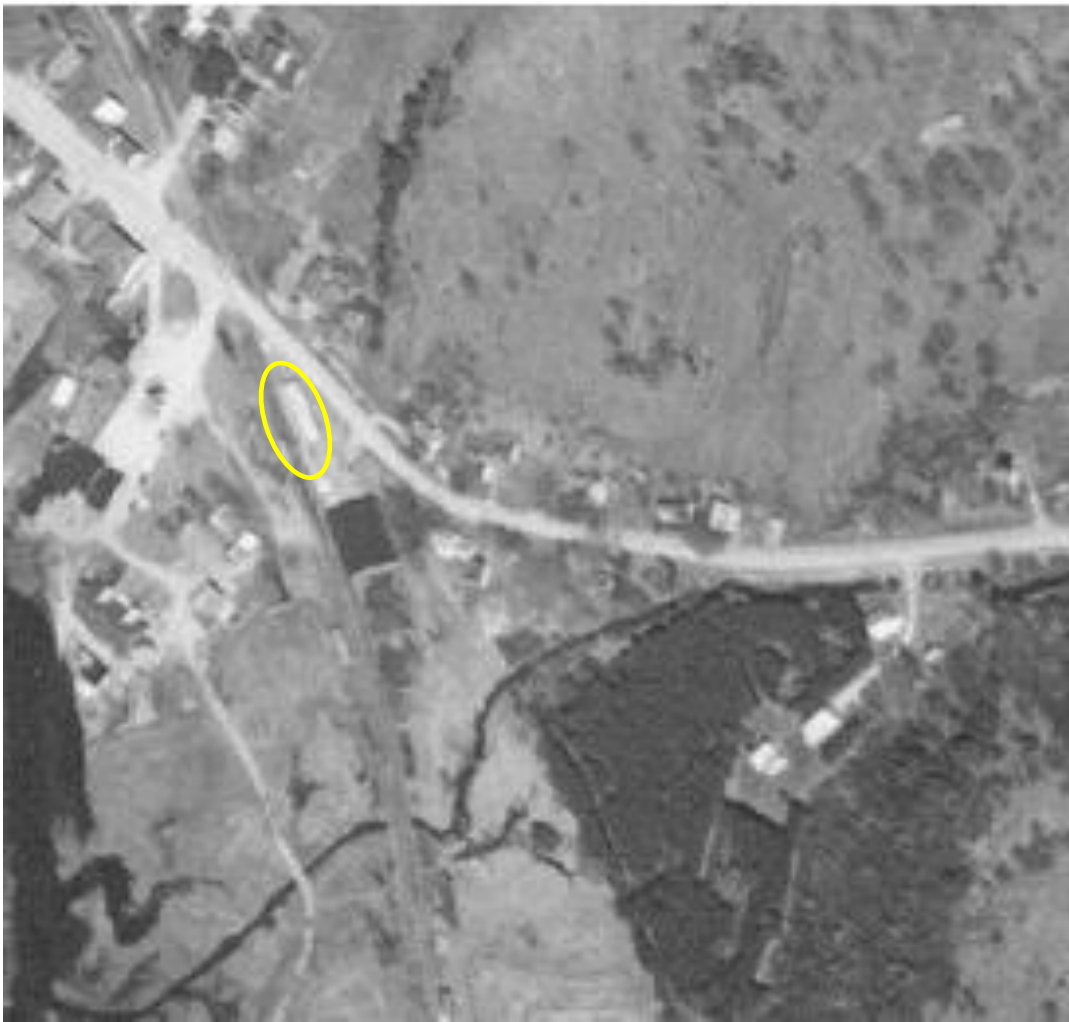
Figure 4: 1962 aerial, VCGI, shows only a rectangular building without its small angled “RR Sta” addition. The larger feed store to the south remains in this 1962 image. It was removed ca. 2000.

Given that the building on these plans does not match the footprint of the original depot, it is fair to assume that the depot had been removed by 1950, and perhaps the railroad leased space in this small addition. Passenger service ended in 1956 on the St. J & LC, at which time this portion of the building would no longer be needed. It does not appear in the 1962 aerial (see Figure 4) so the small station appendage had been removed by that time.

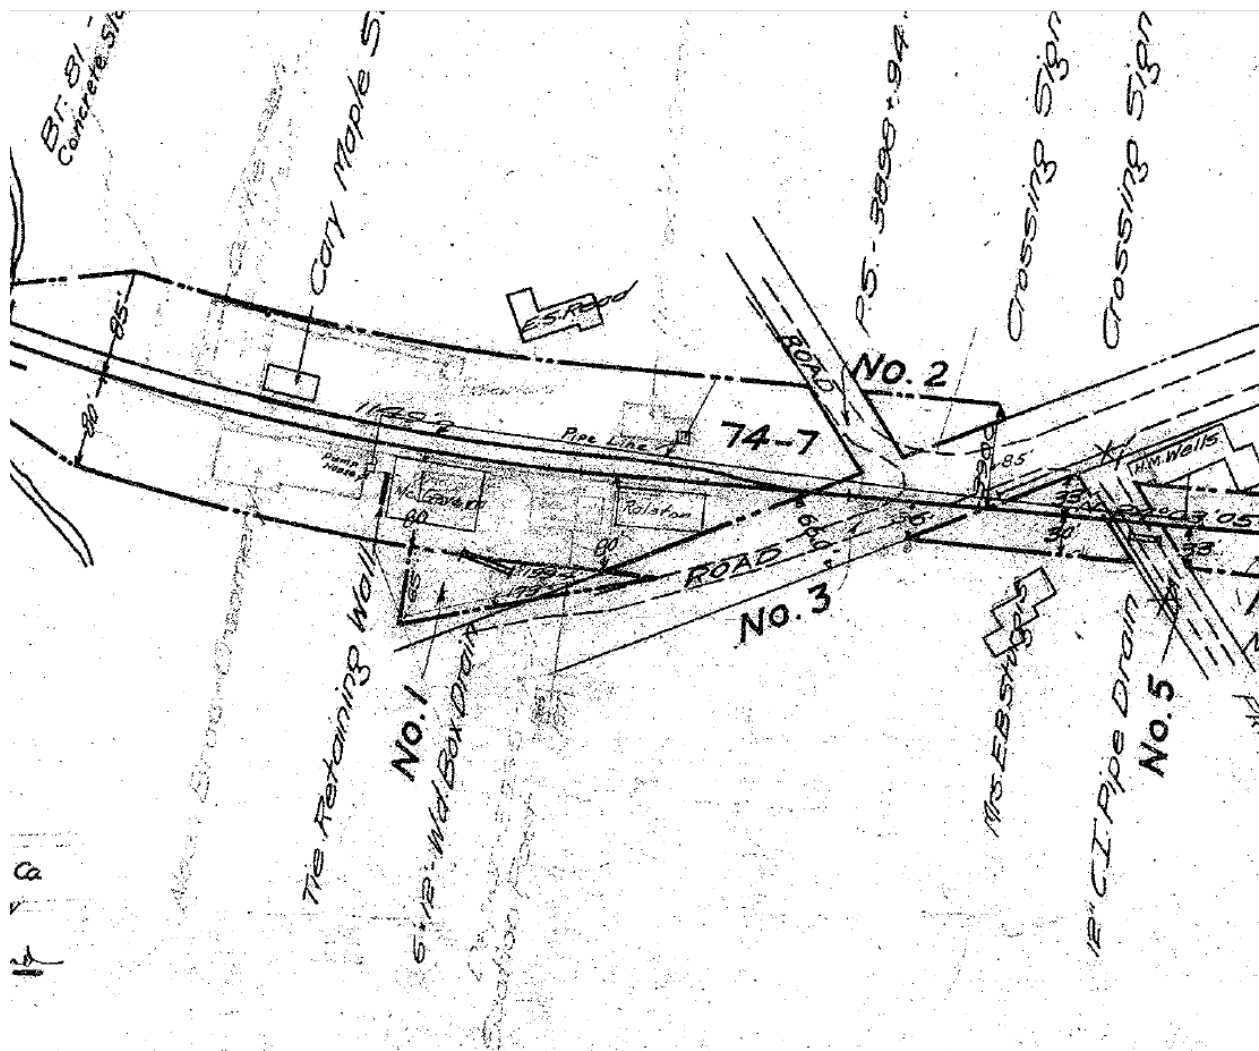
Figure 5: Railroad valuation sheets. Note the “Ralston” building and “Cary Maple Sugar Co.” buildings, which still stand. The “McGovern” building was removed by 2000. And grayed out in this image, at left, is a “Creamery” building. The building between the “McGovern” and “Ralston” buildings is not quite legible and no information is known about it at this time.

The railroad valuation plans note "Ralston" on this building (see Figure 5), a reference to the Ralston Company (later Ralston Purina), whose main Vermont factory was headquartered in St. Johnsbury, VT. One end of the St. J & LC RR. Ralston operated from the 1948-1974 in St. Johnsbury and had multiple buildings along the St. J & LC to serve as warehouses or stores, including one in nearby Sheldon Junction and this one in East Fairfield. During this time, the building served as a feed store. Feed stores located adjacent to the railroad in villages were common because these buildings were served by the railroad. With additional feed stores/warehouses adjacent to the rail line, it is fair to assume that this building would have benefited from the railroad.

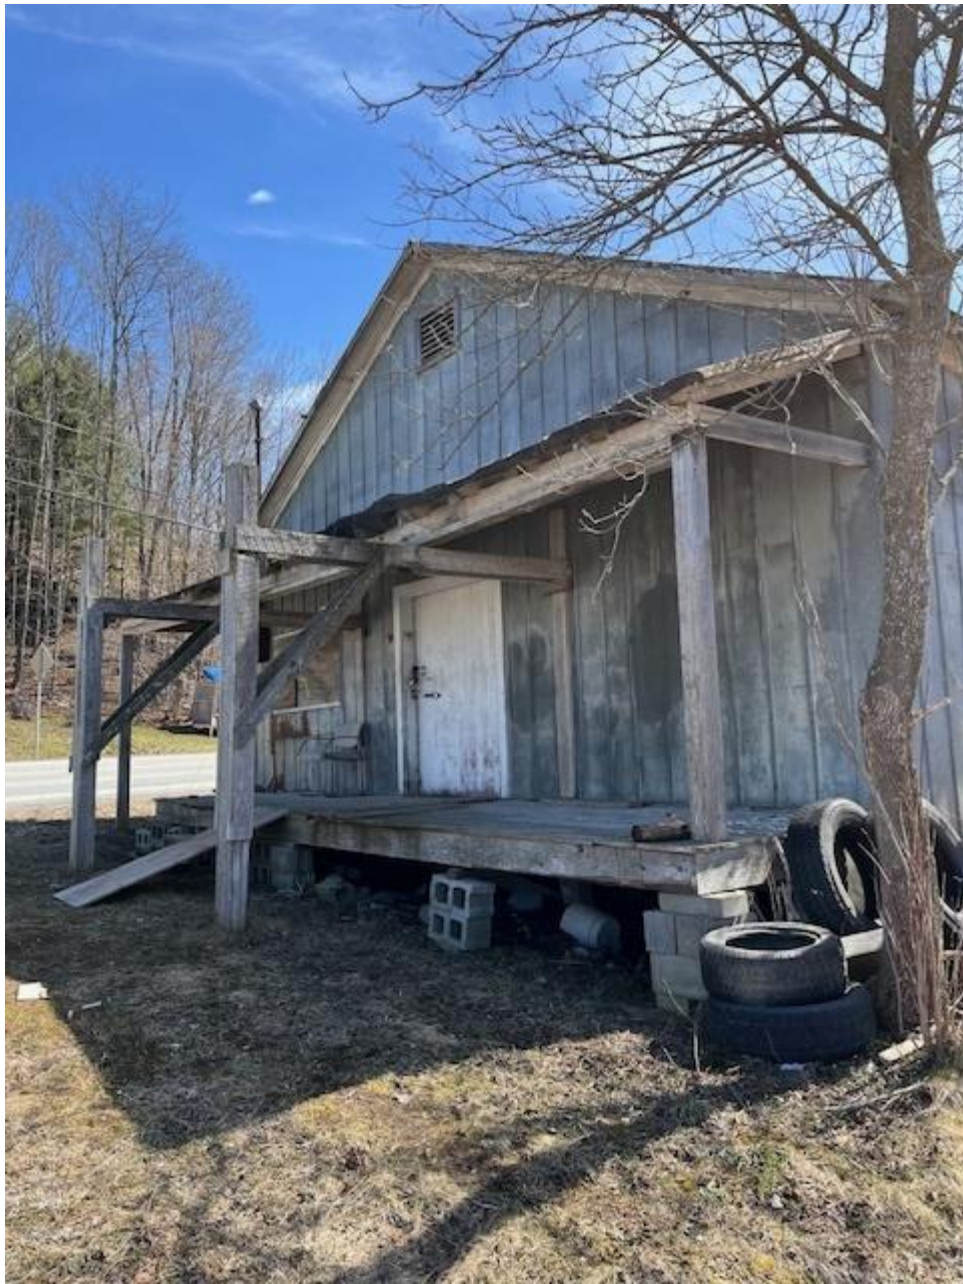
Figure 6: Ralston building façade. Note the platform and central, wide freight door. The front porch likely served as the loading platform. Photo by VTrans, April 2025.

Ralston Building, 9596 VT Route 36 — Brief Description and History: The building at 9596 VT Route 36, East Fairfield, is a one-story, rectangular 70' x 30', shallow gable roof, wood-frame building on concrete piers with standing seam metal siding and a metal roof and a full width, shed roof front porch on the gable end. A large central entrance that resembles a sliding freight door is accessed from the front porch. A large window opening is to the left of the front door. The side elevations of the building have five three-pane small, hopper windows set just under the eaves. On the rear elevation is an outline of the small addition that was removed. Its gable roof ghost lines are visible, as well as a large freight door, similar to the one on the façade. See Figures 6-10.

It does not appear that the Ralston building was constructed with trackside freight doors or a side platform; rather, the only platform is on the front of the building. However, given that feed stores were constructed by private entities, there was not a standard railroad company design to follow. The Ralston building has been minimally altered on the exterior and interior. One change to the exterior is the removal of the small railroad station addition. The removal of this small addition does not affect the integrity of the feed store, as the building operations related to freight for a greater period than as a small passenger stop. Once the original depot was removed, the passenger service was second to the commerce and freight service in this location. Similar to agricultural buildings, buildings within the railroad ROW often changed their use. It was more economical to reuse a building than to demolish it and construct a new building. Although its setting has been somewhat altered by the conversion of the railroad to the rail trail, the Ralston building retains its historic integrity of location, design, materials, workmanship, feeling, and association.

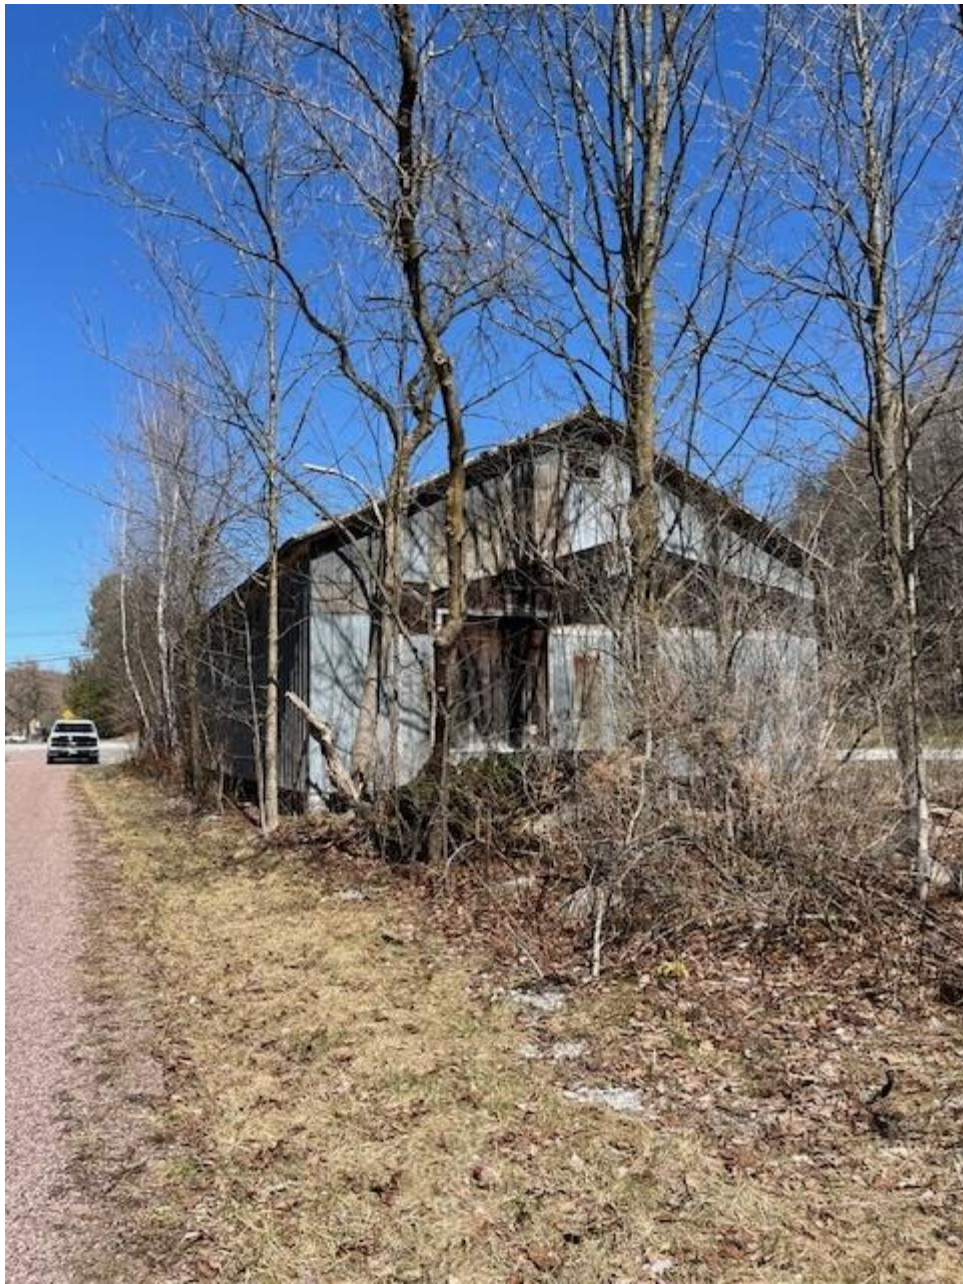
Figure 7: Rear of the Ralston building shows the outline of the former “RR Sta” addition where it was attached. Note the large freight door left of center. Photo by VTrans, April 2025.

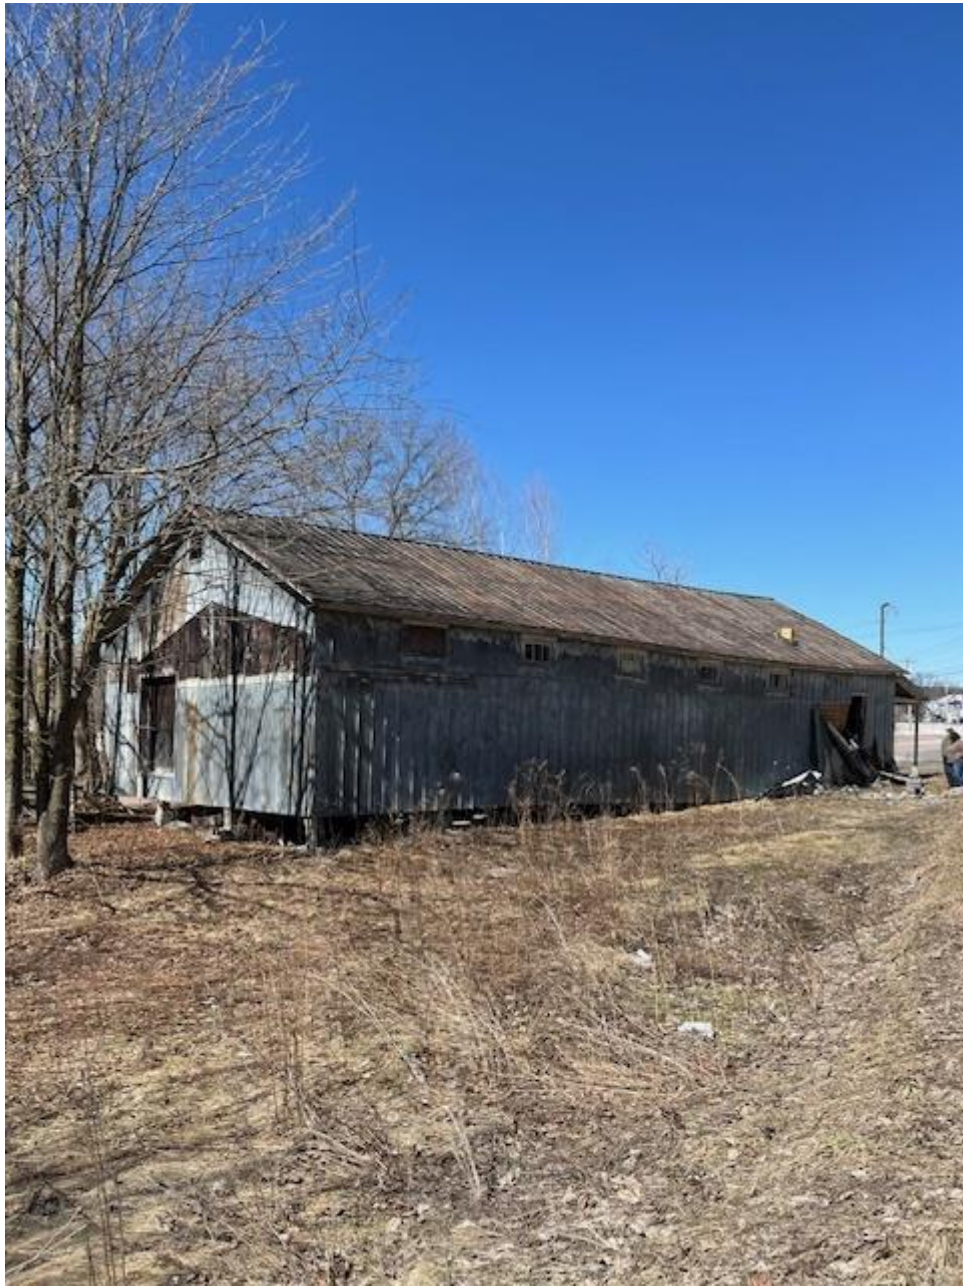
Figure 8: East elevation of the Ralston building. Evidence of the recent collision is seen at right. Photo by VTrans, April 2025.

Analysis and Recommendation of Effect: Due to the condition of the building and the siting of the building, VTrans proposes to remove the Ralston building to improve safety. The building is in poor condition. The walls are leaning, and the car collision appears to have weakened the already failing east elevation. The building sits on concrete piers. Its location creates poor sight distance at this curve of VT

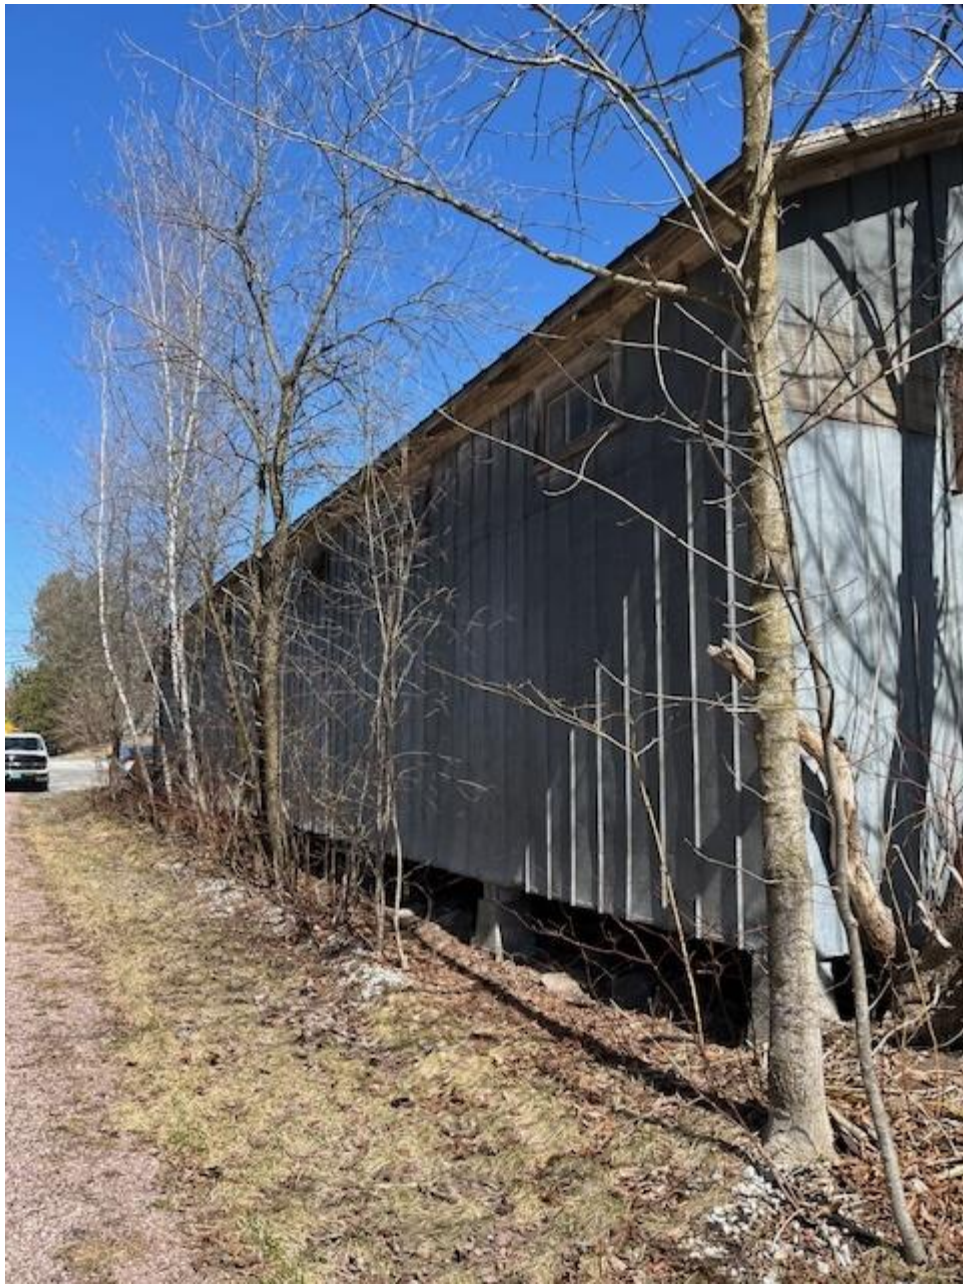
Figure 9: West (trackside / trail side) elevation of the Ralston building. Photo by VTrans, April 2025.

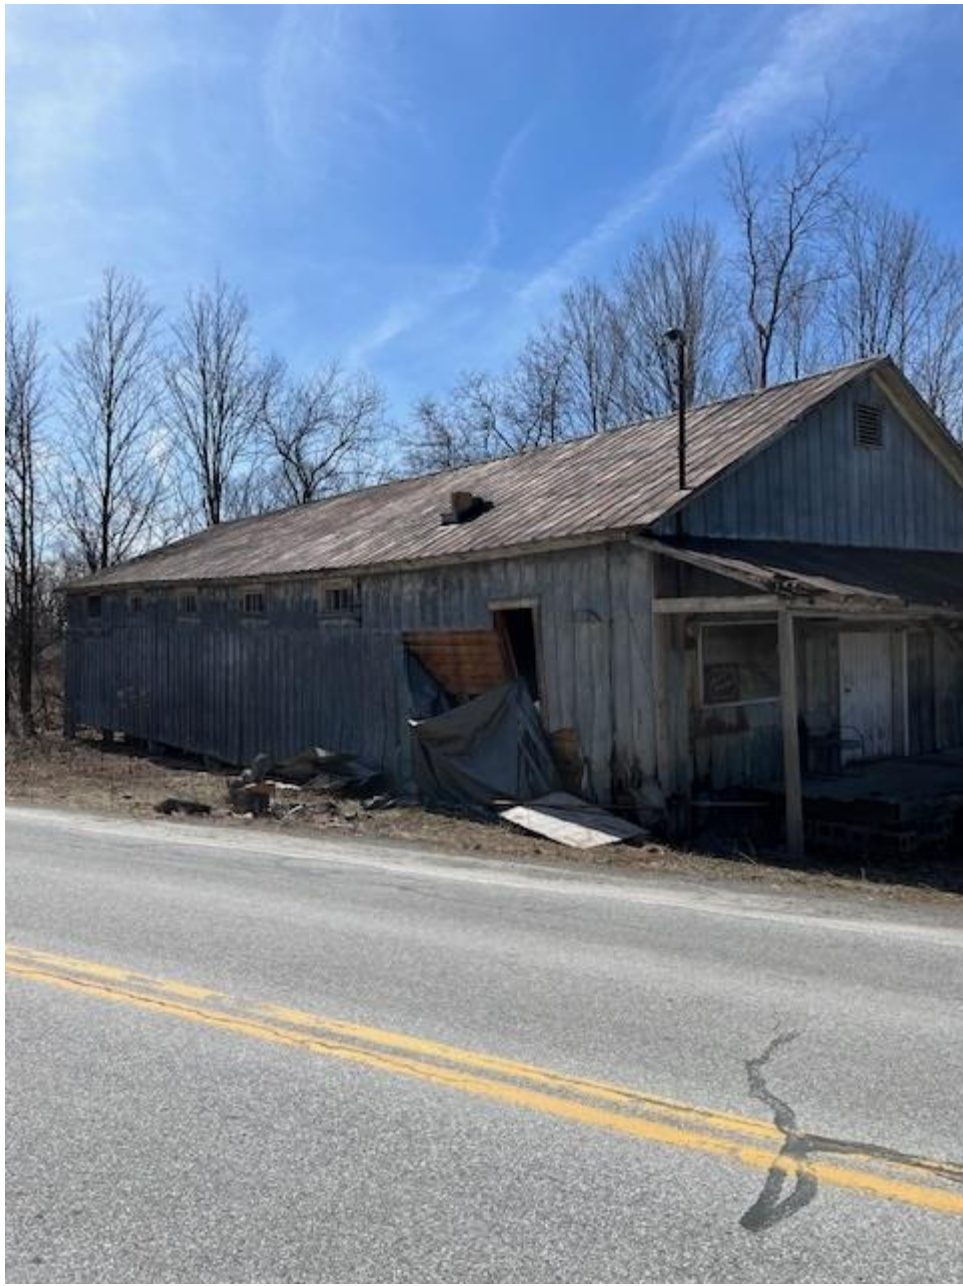
Figure 10: View of the Ralston building from VT Route 36. Photo by VTrans, April 2025.

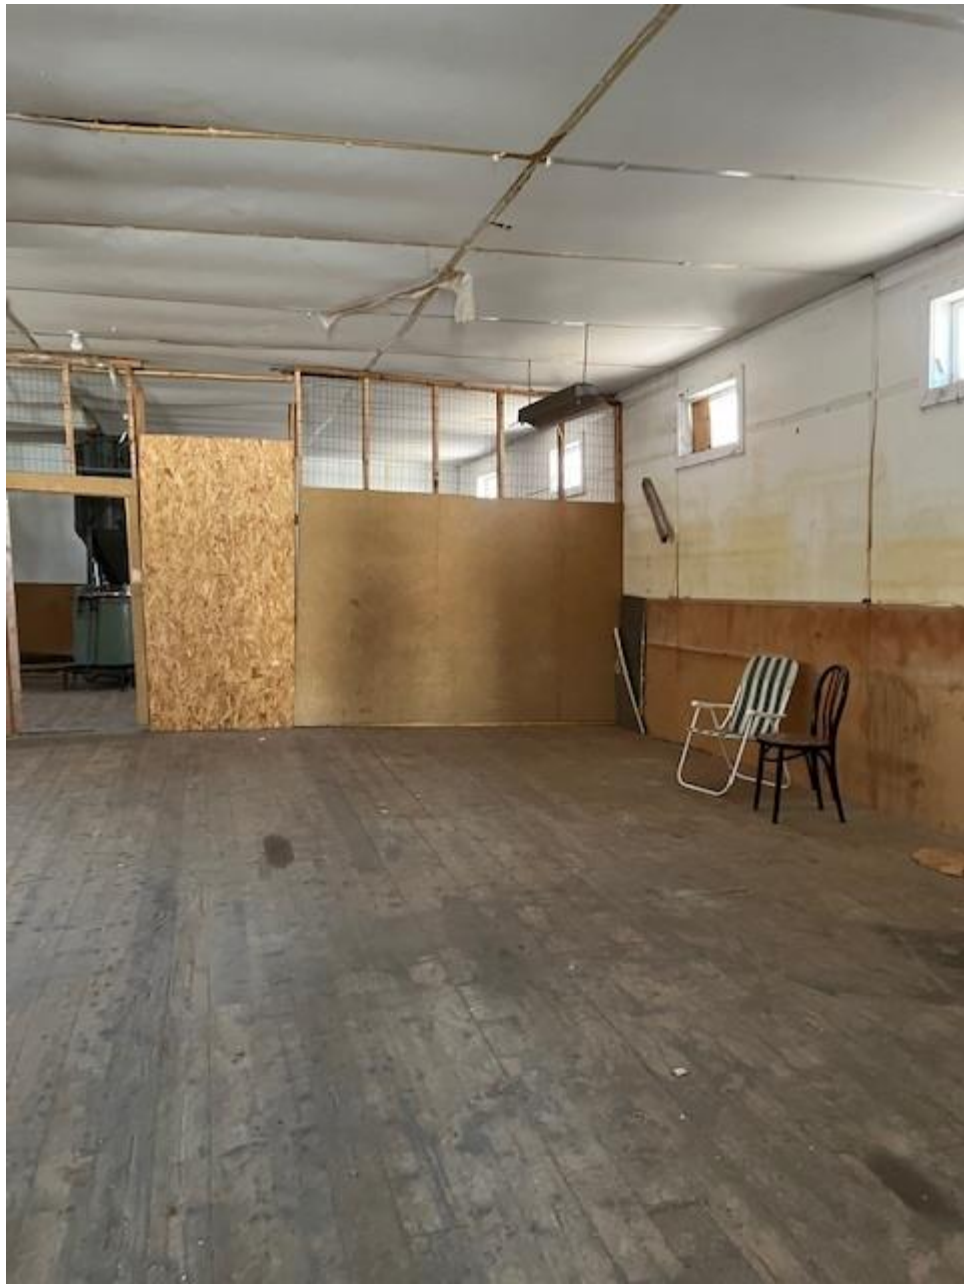
Figure 11: Interior of the Ralston building, looking to the rear. Photo by VTrans, April 2025.

The interior of the building is simple. Original wood flooring remains, and a drop ceiling has been added. Wallboard covers the wood sheathing. There is a small office at the front of the building and the office walls are clad in flushboard siding and a ladder is constructed into the wall. A second section across from the office has been walled off, presumably for separate storage. A large evaporator remains in the building. See Figures 11-12.

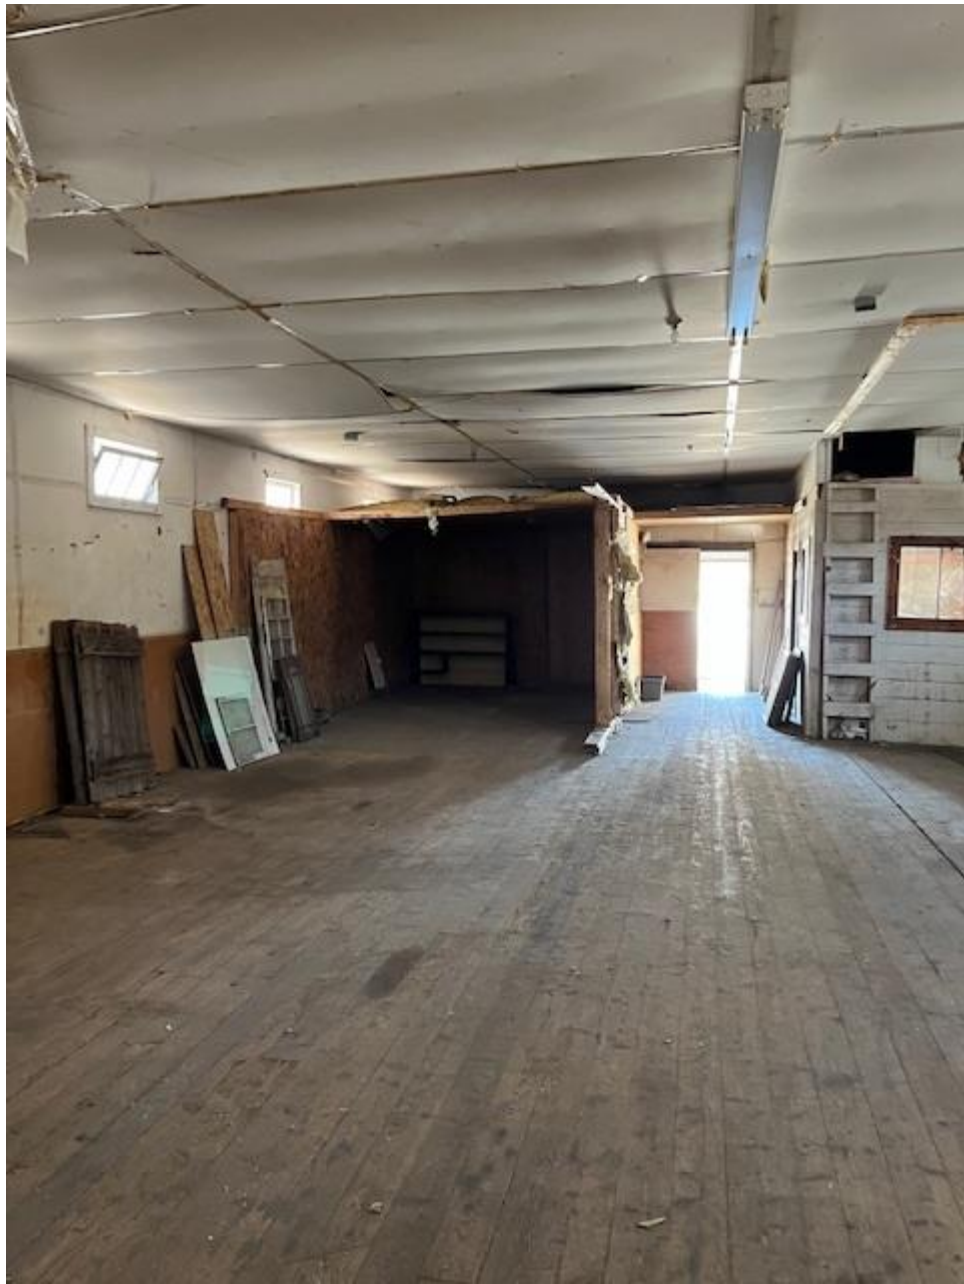
Figure 12: Interior of the Ralston building, looking to the front of the building. The storage area at left is not original. The office at right is original. Photo by VTrans, April 2025.

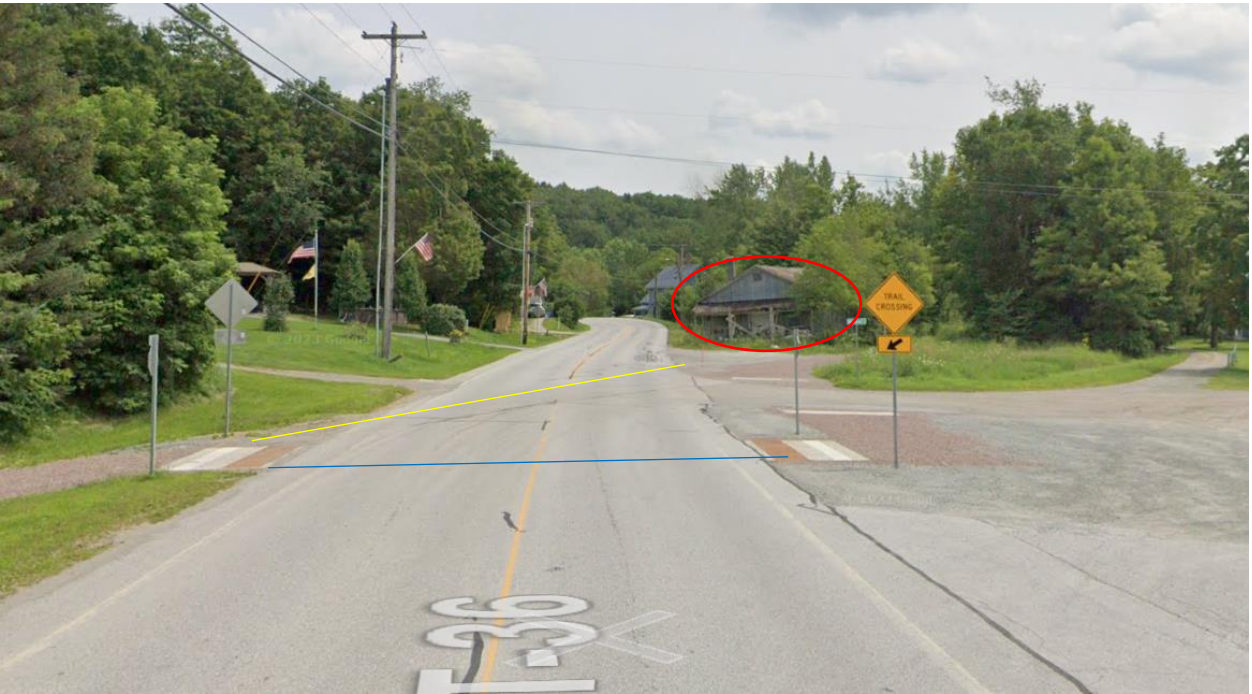
Figure 13: Google Street View (July 2023) shows the LVRT crossing (in blue). The yellow line shows the prior railroad crossing, and the route that many trail users take. The red circle shows 9596 VT Route 36. Note the curve in VT Route 36 just beyond 9596.

Route 36, and at the adjacent LVRT crossing. While the design of the LVRT attempts to direct people to cross at a 90-degree angle to the road, most trail users will cross diagonally, adding to unsafe conditions. See Figures 13-14. Removal of the building will improve sight distance for drivers and trail users.

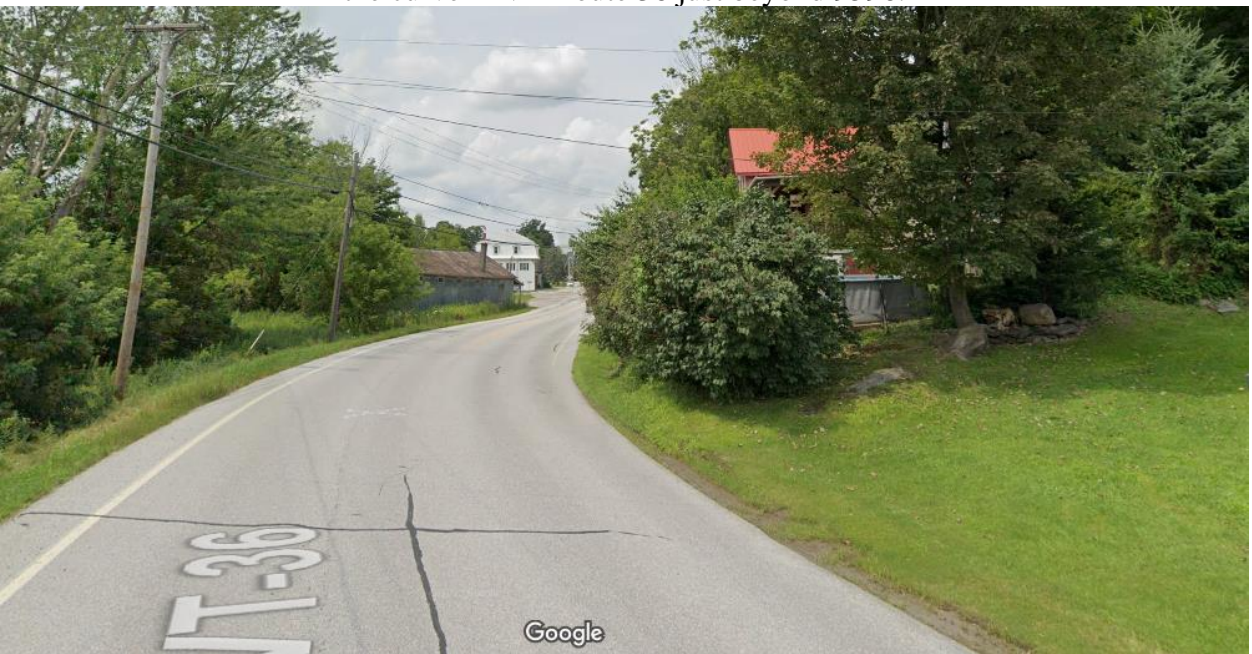
Figure 14: Google Street View (July 2023), just west of 9596 VT Route 36 (left) and 9617 VT Route 36 (right, red roof) shows the poor sight distance created by the curve in the road. The curve obstructs a driver's ability to see trail users crossing VT Route 36.

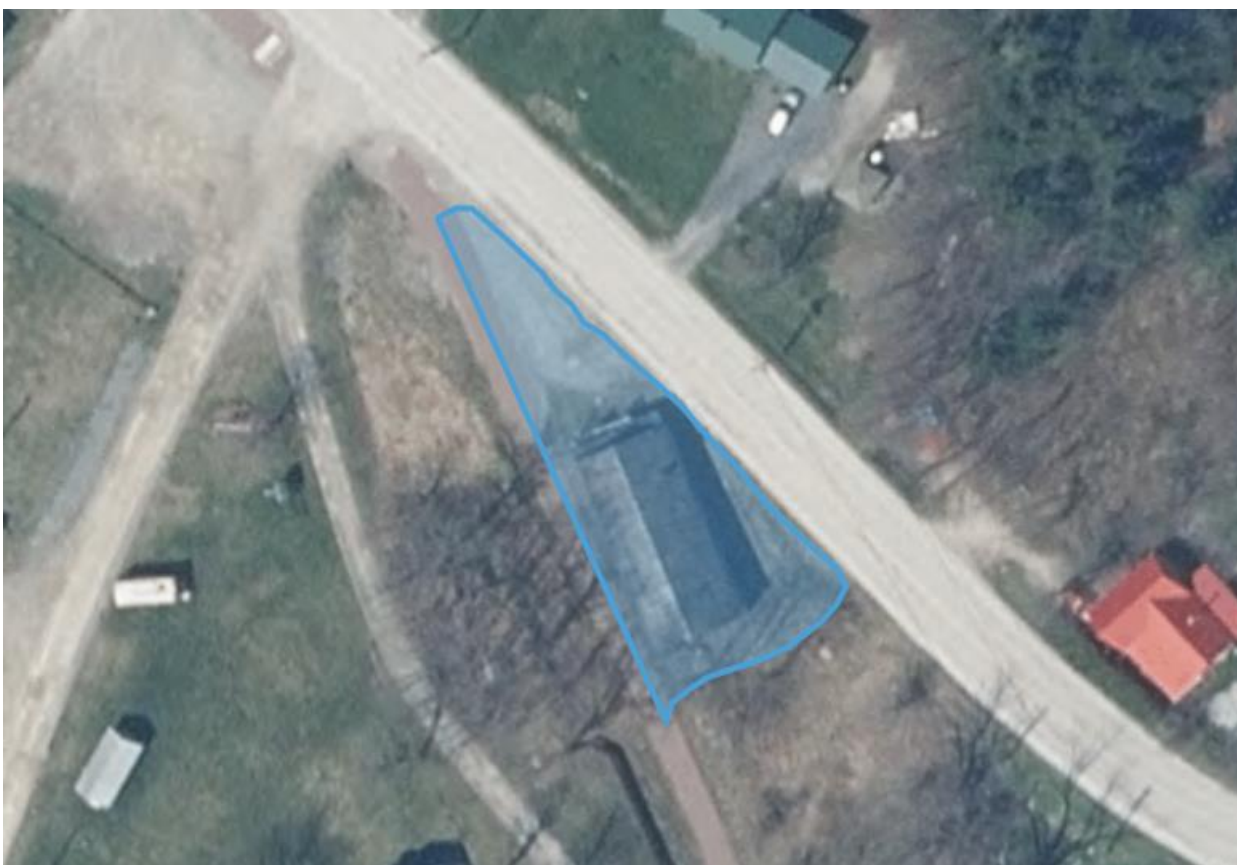
Aerial view of project area showing the general outline of the approved impact area for the project. As noted above, all work shall take place from previously disturbed areas.

Archaeological Resources: Jeannine Russell, VTrans Archaeology Officer, reviewed the proposed project area, which is located near the Black Creek. The general area is considered archaeologically sensitive and there are several previously recorded sites northwest of the village within a mile of the project area. However, the area around the building to be removed was previously disturbed by the construction of the building, construction of the railroad, the parking area, and the removal of the addition from the rear of the building. VTrans does not anticipate the project will have impacts to archaeologically sensitive areas provided the work to remove the building occurs within the footprint of the previously disturbed areas. Please see the image below for details.
