United States Department of the Interior
National Park Service**National Register of Historic Places Registration Form**

1. Name of PropertyHistoric name: Clemmons Farm

Agricultural Resources of Vermont

2. LocationStreet & number: 2158 Greenbush RoadCity or town: CharlotteState: VermontCounty: ChittendenNot For Publication: ☐Vicinity: ☐**3. State/Federal Agency Certification**

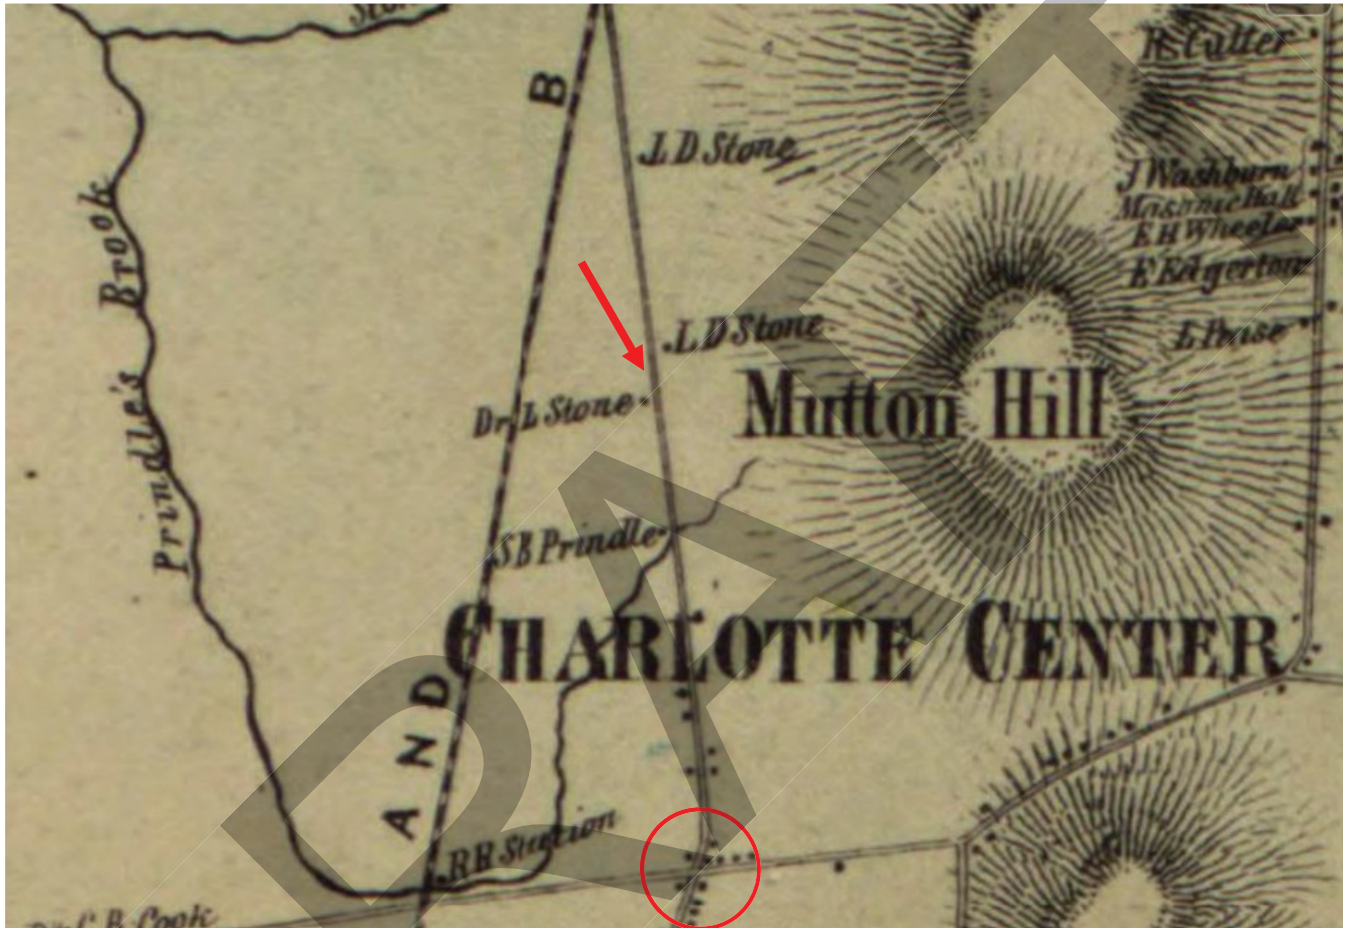
Figure 2. Detail of 1857 Walling Map of Charlotte showing Charlotte Four Corners (red circle), the north-south road (Greenbush Road) which was a stagecoach route, and the new Rutland Railroad line. At this time, the Clemmons farm (shown by red arrow) was part of a large sheep farm operated by Dr. Luther Stone and his son Luther D. Stone.²

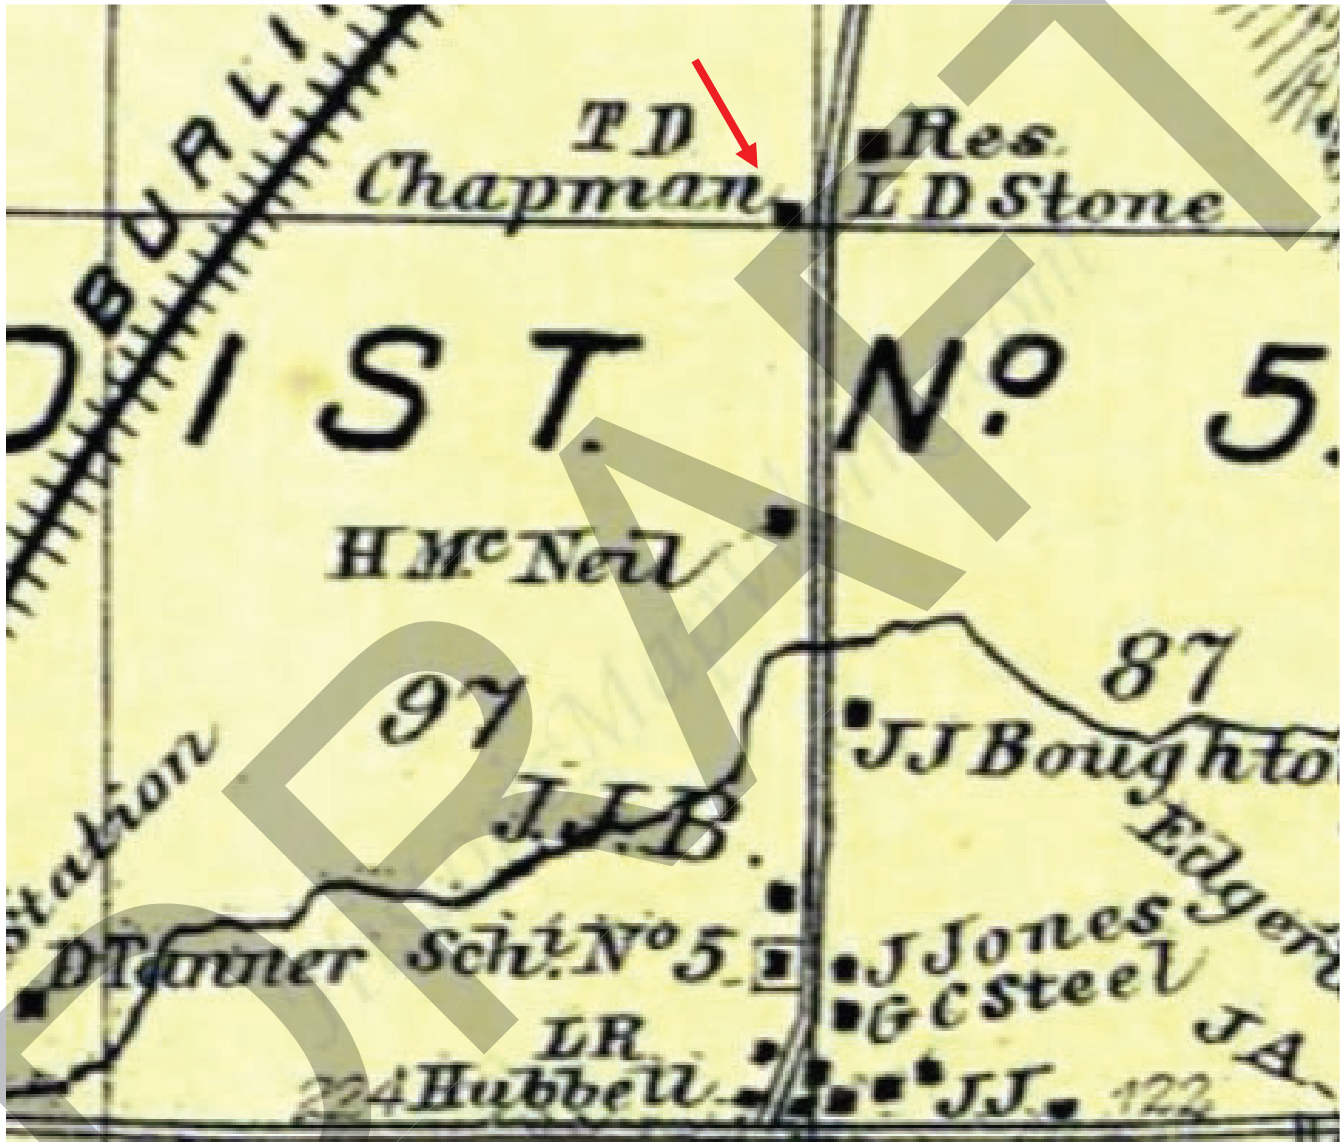
Figure 3. Detail of 1869 Beers Map showing the same area roughly a decade later. Thomas D. (“T.D.”) Chapman was Dr. Luther Stone’s son-in-law. Note the H. McNeil farmstead directly south of the Chapman farmstead. In 1882, Henry McNeil, grandson of John McNeil, purchased the farm (red arrow) from Thomas Chapman and gifted it to his son William Hazard McNeil.³

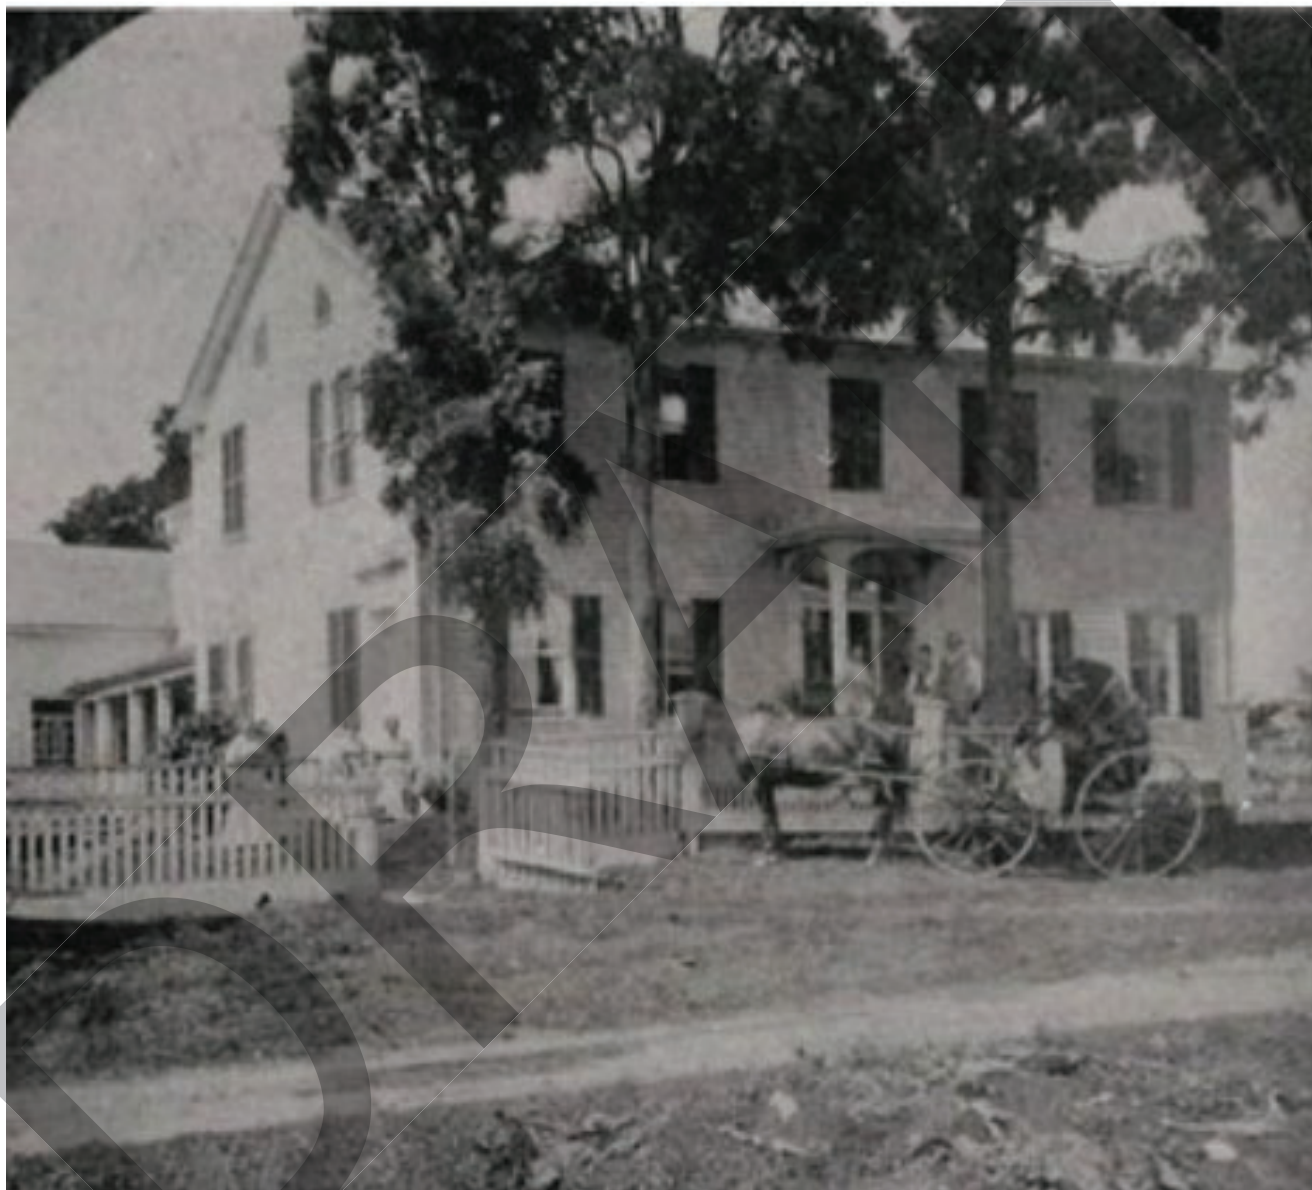
Figure 4. Circa 1860 photograph of the farmhouse, camera facing northwest. The connected barn in the back was lost in the historic period. Source: Charlotte Historical Society.

Immediately southwest of the enclosed porch, there are foundation remnants of a former addition or attached barn to the house. A c.1860 photograph of the house (see Figure 4) shows this addition as an ell and shows the south elevation prior to the addition of the enclosed porch. Dr. Clemmons converted this area into a patio supported by a stone wall with stone steps on the north side leading down to a grassy area behind the house.

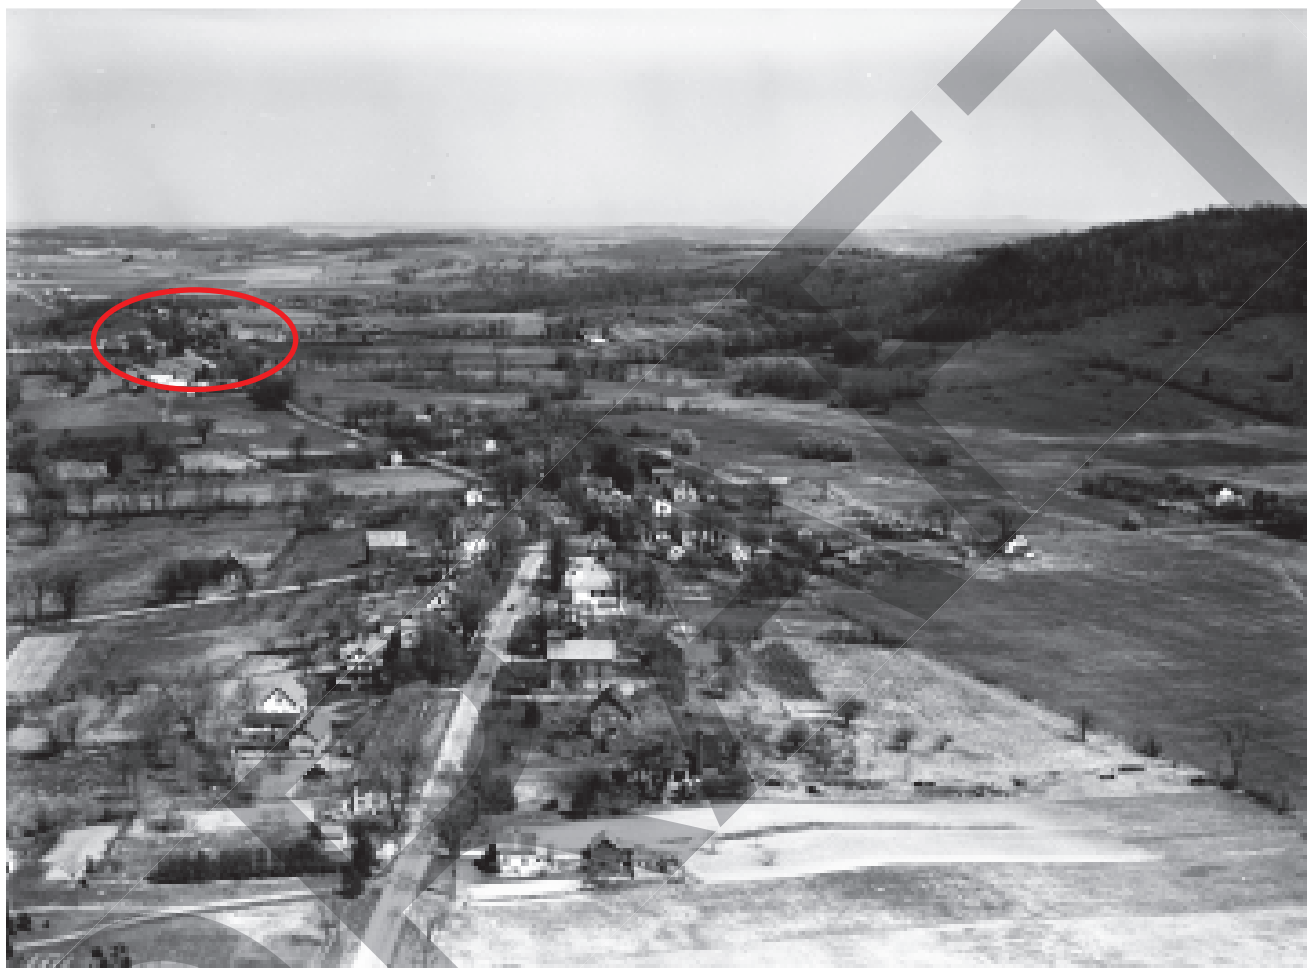
Figure 7. This 1941 aerial photograph of Charlotte, looking north, with Mutton Hill on the right. The photograph shows that the village retained a strongly agricultural character in the mid-20th century. The intersection of Ferry Road and Greenbush Road is roughly center of the photograph. The Clemmons Farm is circled. Source: Henry Sheldon Museum.

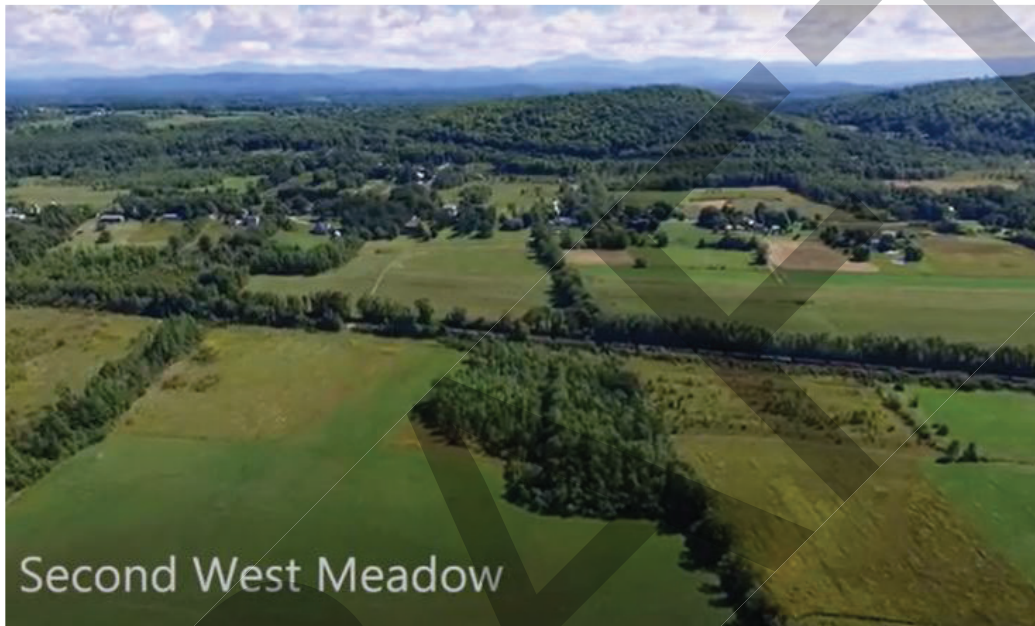
Figure 8. Drone photograph of the west meadows, looking east toward the farmstead. The railroad tracks cut through the center of the photo, separating the Clemmons Farm fields.

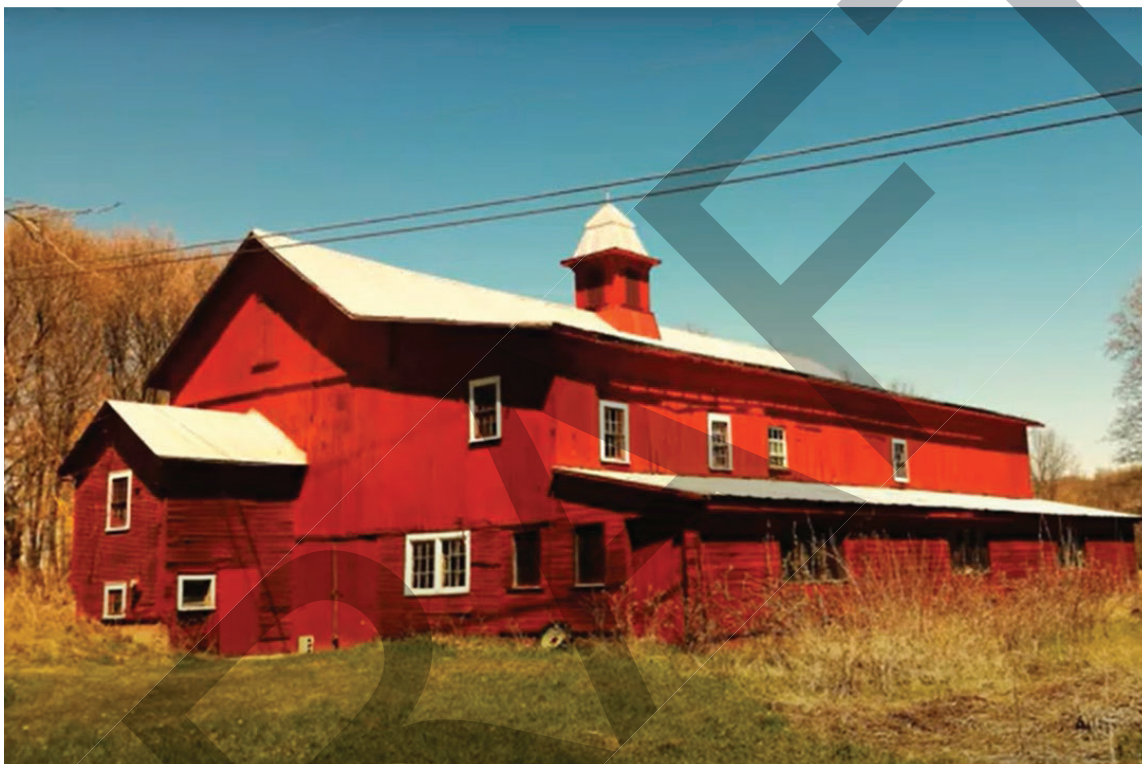
Figure 10. Circa 1980 photo of the main barn with a shed addition on the long south elevation. This was removed in 2018. Camera facing northeast. Source: Clemmons Family Farm.

Alterations. Between 2018 and 2020, the main barn was rehabilitated in order to stabilize the barn's timber structure and to ensure the cistern was adequately supported. During this time, the 1950s enclosed shed roof addition was removed and the rotten south sill replaced; the five open bays on the ground level were created; a stairwell leading from the ground floor to the main level was removed; the earthen bank was lowered to access the north sill plate which needed replacement; a wooden enclosure around the cistern was removed; and ground floor windows were removed on the west elevation with new vertical siding applied in their place. The fieldstone wall was rehabilitated between 2022 and 2024.

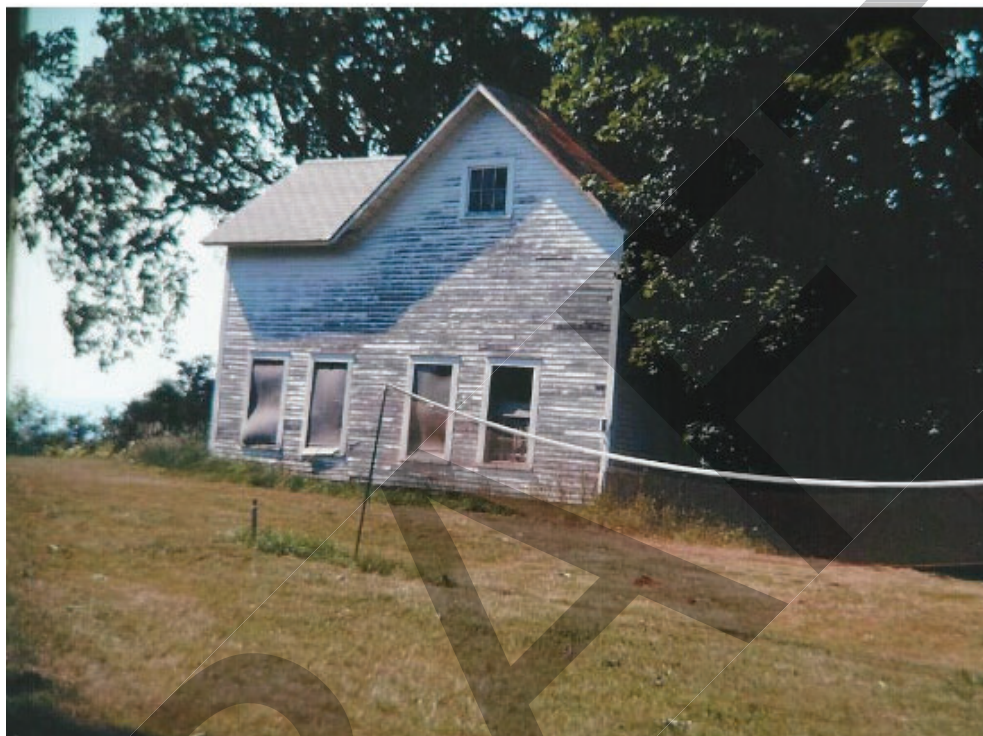
Figure 11: Circa 1965 view of the Blacksmith Shop, camera facing east. Source: Clemmons Family Farm.

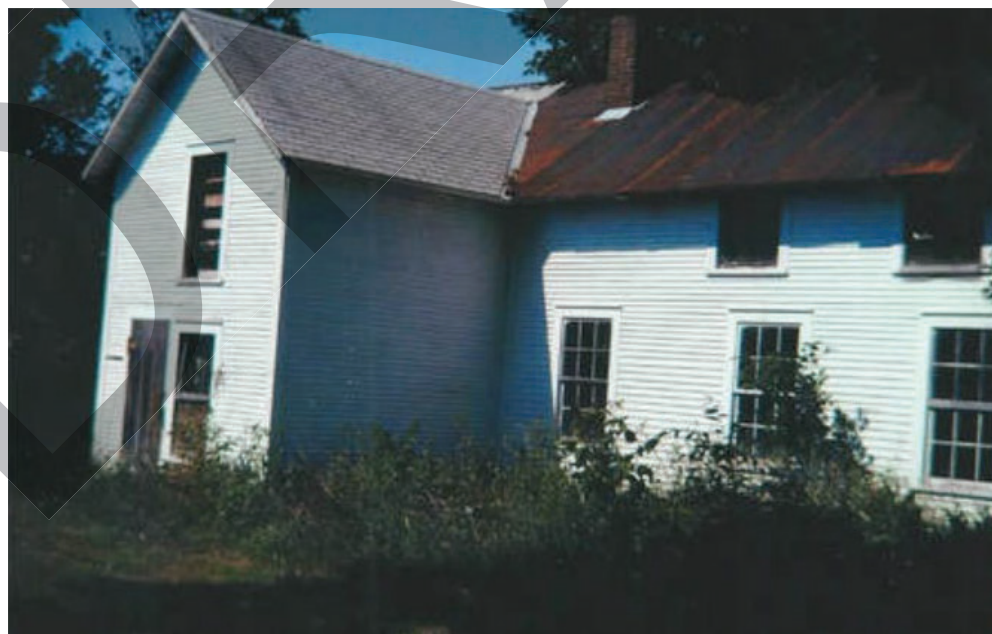
Figure 12: Circa 1965 view of the Blacksmith Shop, camera facing northeast. Source: Clemmons Family Farm.

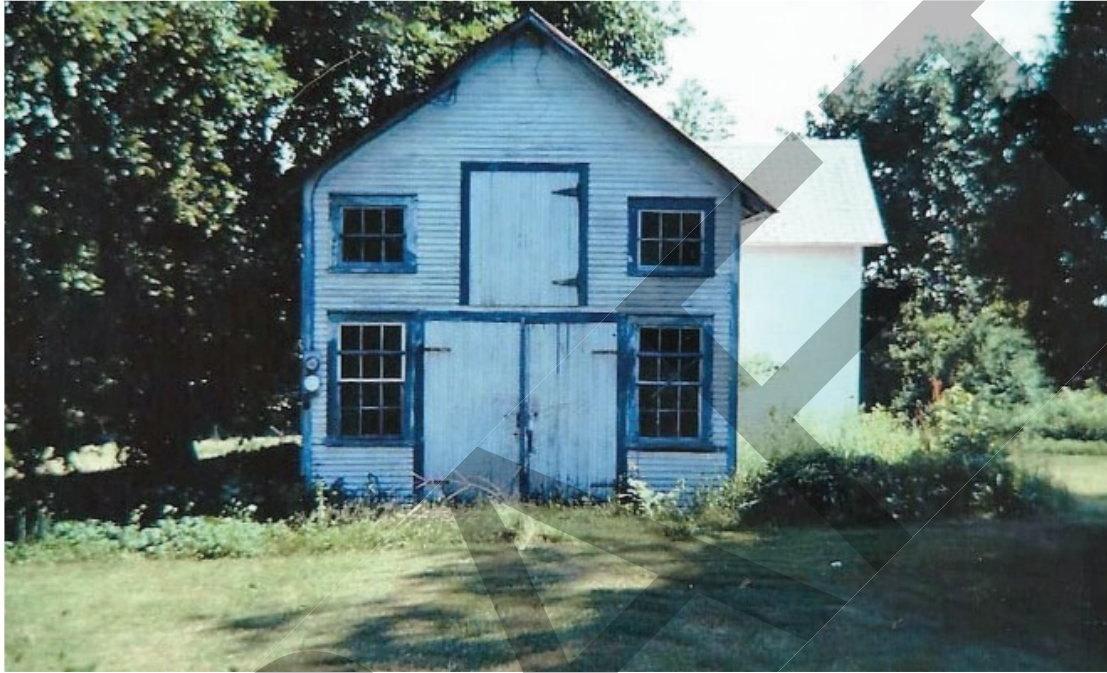
Figure 13 Circa 1960s view of the Blacksmith Shop at the time the Clemmons family purchased the farm. Camera facing south. Source: Clemmons Family Farm.

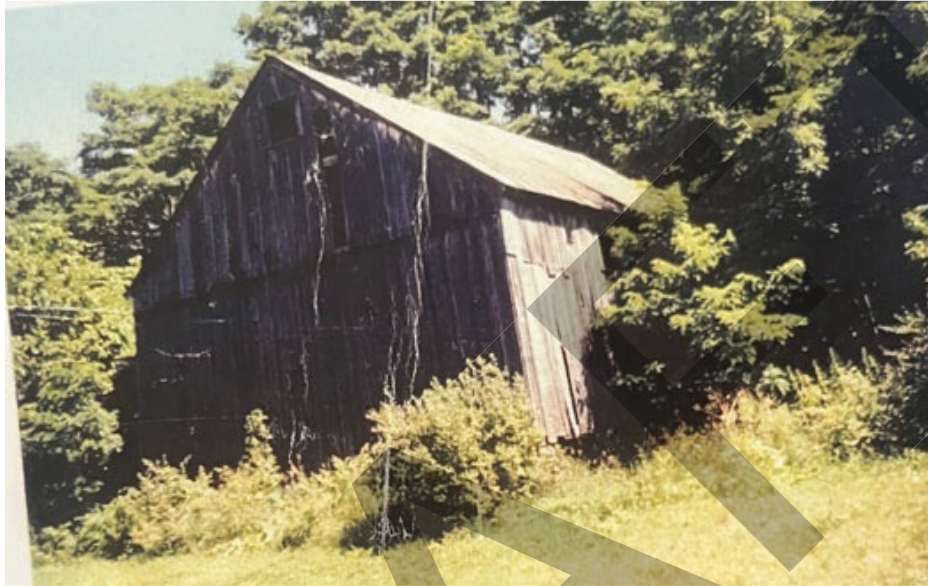
Figure 15. Undated photograph of the unused field barn on the west side of Greenbush Road, prior to Dr. Jackson moving it to create the Barn House. Source: Clemmons Family Farm.

The Barn House is made from historic timber frame pieces from two historic barns, the structures of which are clearly readable on the interior. The Barn House was created by Dr. Clemmons who, along with an apprentice, David Dupris, joined together a decaying field barn that stood to the northwest on the property and a granary that stood on the east side of the road, south of the English barn (see Figures 14 and 15). Dr. Clemmons poured a new concrete foundation for the two buildings and moved each one onto the foundation by means of a flatbed truck (see Figures 16-17). With a design-build approach that was largely dictated by the function of the interior spaces, he seamlessly integrated the two buildings and transformed them into a contemporary timber frame building. It is a non-contributing building as it was constructed outside of the Period of Significance.

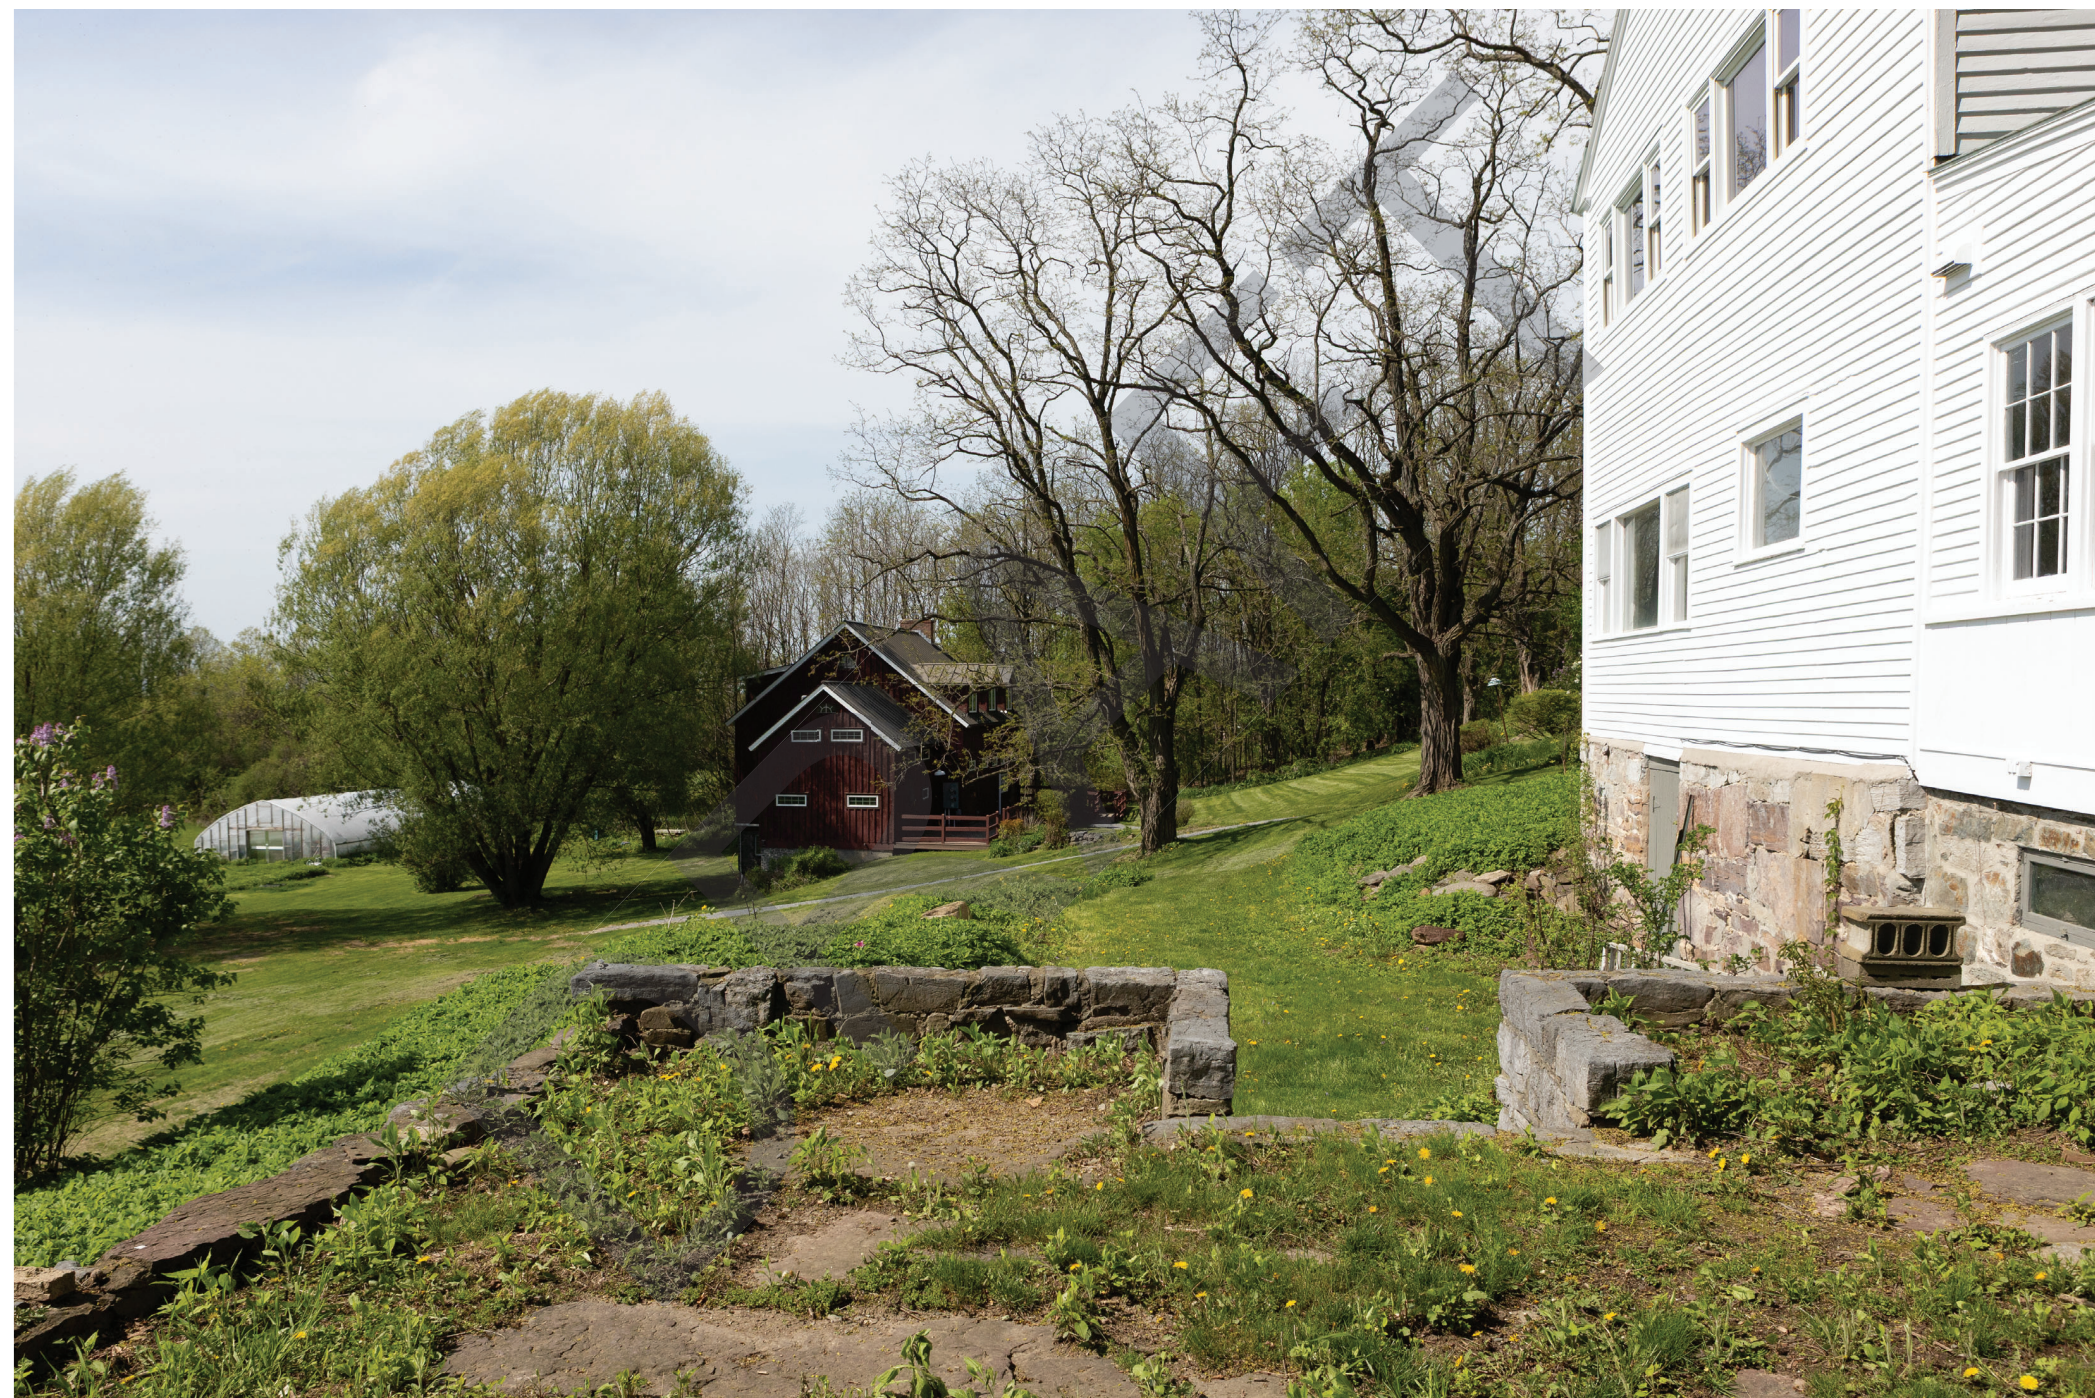
Photograph 5

- VT_Chittenden County_Clemmons Farm_005: Main House rear (west) elevation at right, foundation remains at center, and Barn House and Greenhouse beyond. Looking north.
