STATE OF VERMONT Division for Historic Preservation VERMONT ARCHITECTURAL RESOURCE INVENTORY Individual Property Survey Form	SURVEY NUMBER: (Assigned by VDHP)
	Listed in State Register <input type="checkbox"/> Eligible for State Register Yes <input type="checkbox"/> -or- No <input type="checkbox"/> Date:
	PRESENT FORMAL NAME: n/a
	ORIGINAL FORMAL NAME: Ralston building
COUNTY: Franklin	PRESENT USE: vacant
TOWN: East Fairfield	ORIGINAL USE: feed store
ADDRESS: 9596 VT Route 36	ARCHITECT/ENGINEER: unknown
COMMON NAME:	BUILDER/CONTRACTOR: unknown
PROPERTY TYPE: Building	DATE BUILT: ca. 1948
OWNER: Vermont Agency of Transportation ADDRESS: 219 N Main St, Barre, VT 05641	
ACCESSIBILITY TO PUBLIC: Yes <input type="checkbox"/> No <input checked="" type="checkbox"/> Restricted <input type="checkbox"/>	PHYSICAL CONDITION OF STRUCTURE: Good <input type="checkbox"/> Fair <input checked="" type="checkbox"/> Poor <input type="checkbox"/>

ADDITIONAL ARCHITECTURAL OR STRUCTURAL DESCRIPTION:

The building at 9596 VT Route 36, East Fairfield, is a one-story, rectangular 70' x 30', shallow gable roof, wood-frame building with standing seam metal siding, a standing seam metal roof, and a full width

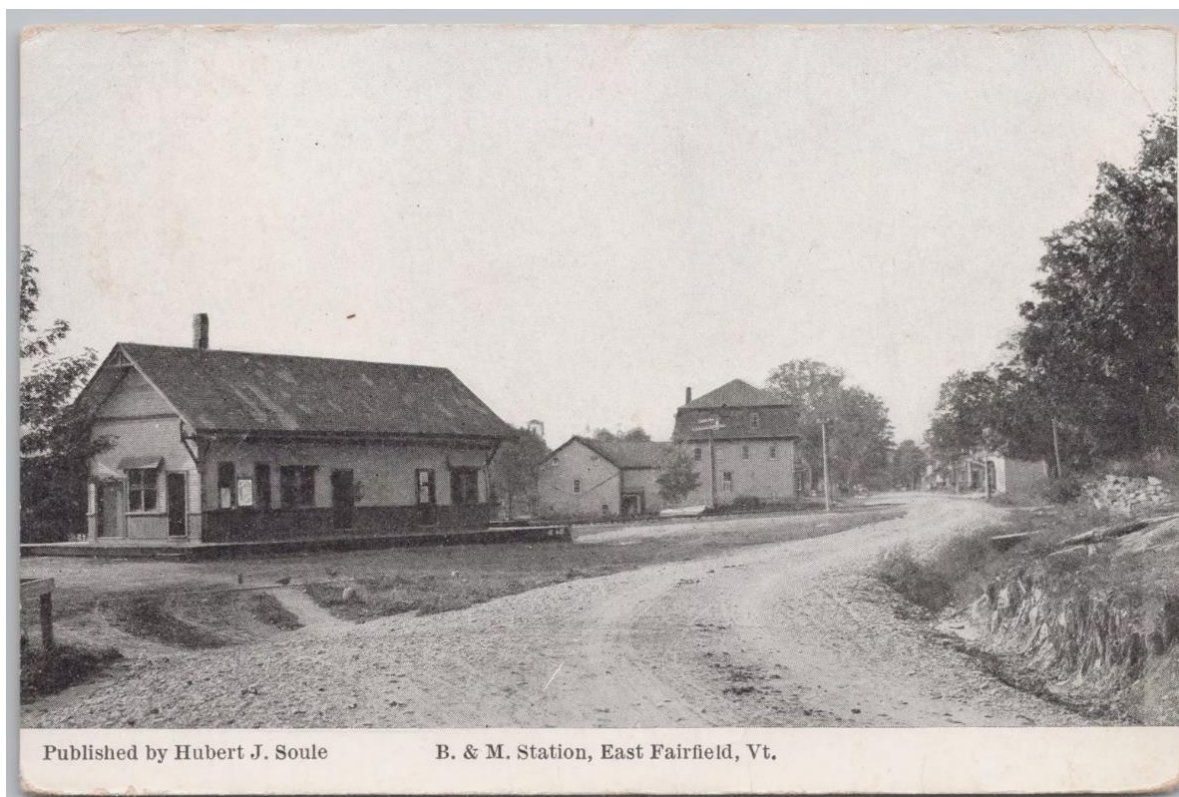
Figure 2: The historic East Fairfield depot, no longer extant. The building in the center of the photo remains – 9534 VT Route 36. The railroad runs diagonally across the image, on the opposite side of the depot in this image.

The previous building in this location was the East Fairfield depot, constructed ca. 1898 (see Figure 2). The East Fairfield depot was removed in the 1940s. The nearby Sheldon Junction depot was removed in the early 1940s (per rail valuation sheets). Passenger rail service decreased in popularity in the 1930/1940s and at that time, the St. J & LC RR was facing bankruptcy, and the Boston & Maine acquired the St. J & LC RR. Needing to cut costs,

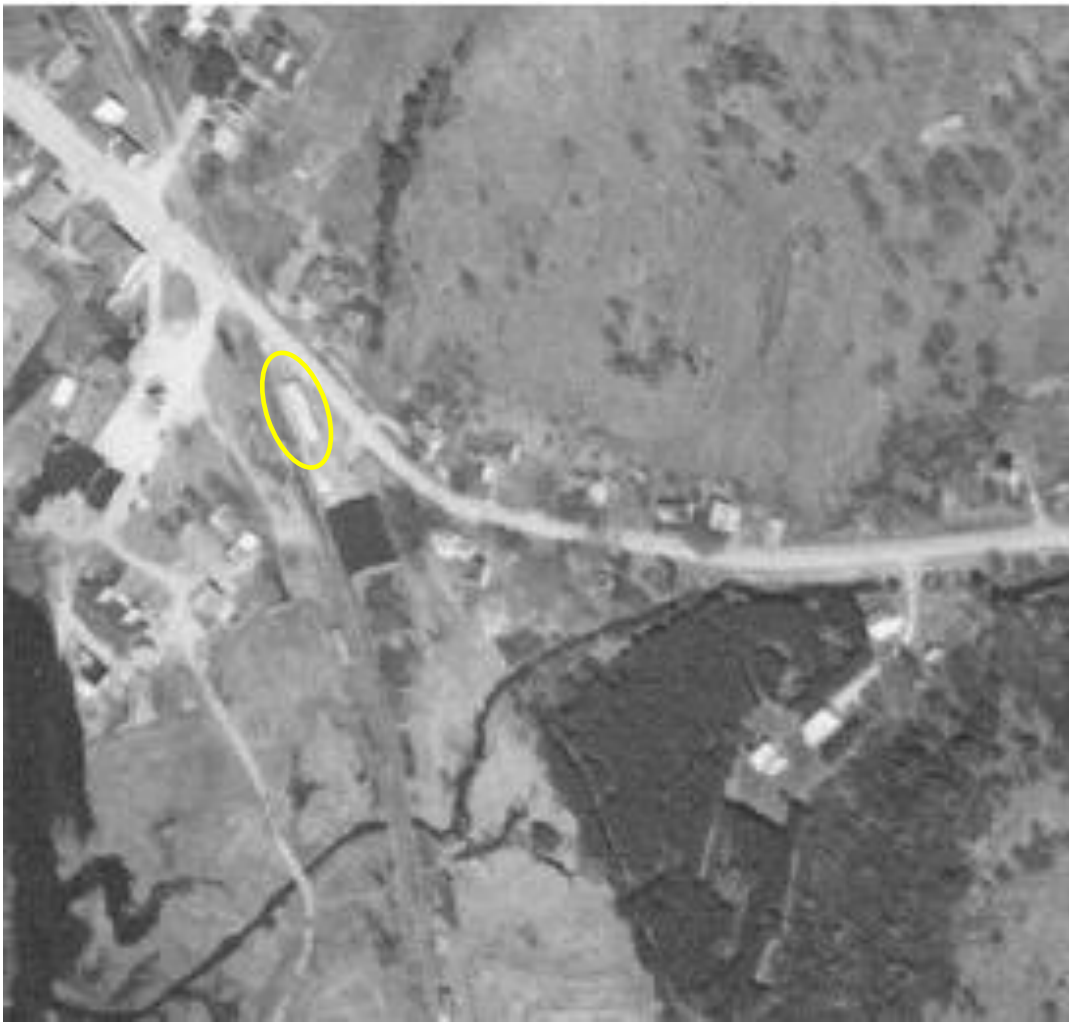
Figure 4: 1962 aerial, VCGI, shows only a rectangular building without its small angled “RR Sta” addition. The larger feed store remains at this time. It was removed ca. 2000.

Given that the building on these plans does not match the footprint of the original depot, it is fair to assume that the depot had been removed by 1950, and perhaps the railroad leased space in this small addition. Passenger service ended in 1956 on the St. J & LC RR, at which time this portion of the building would no longer be needed. It does not appear in the 1962 aerial (see Figure 4); the small station appendage had been removed by that time.

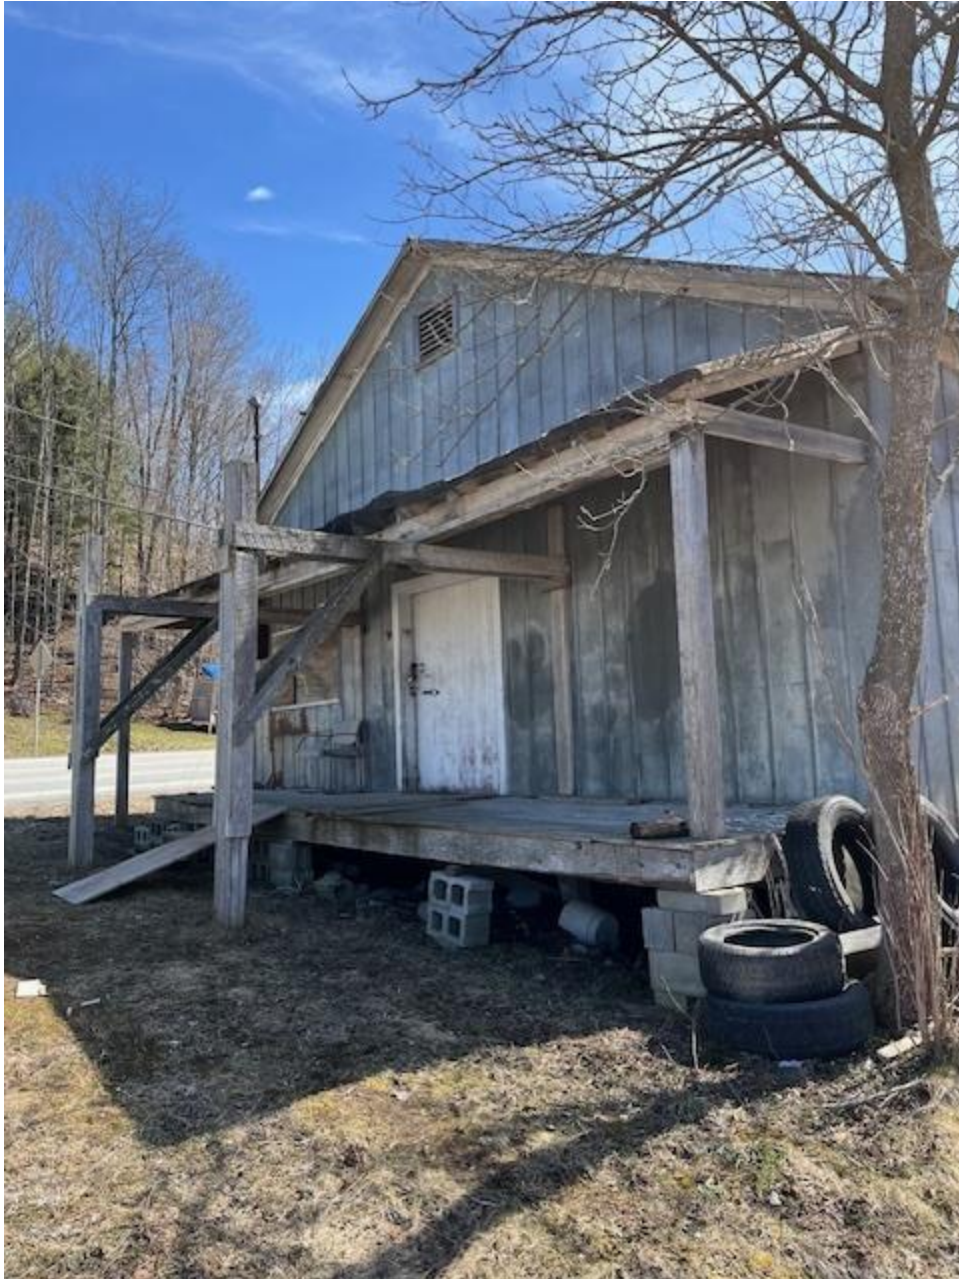
Figure 6: Ralston building façade. Note the platform and central, wide freight door. The front porch likely served as the loading platform. Photo by VTrans, April 2025.

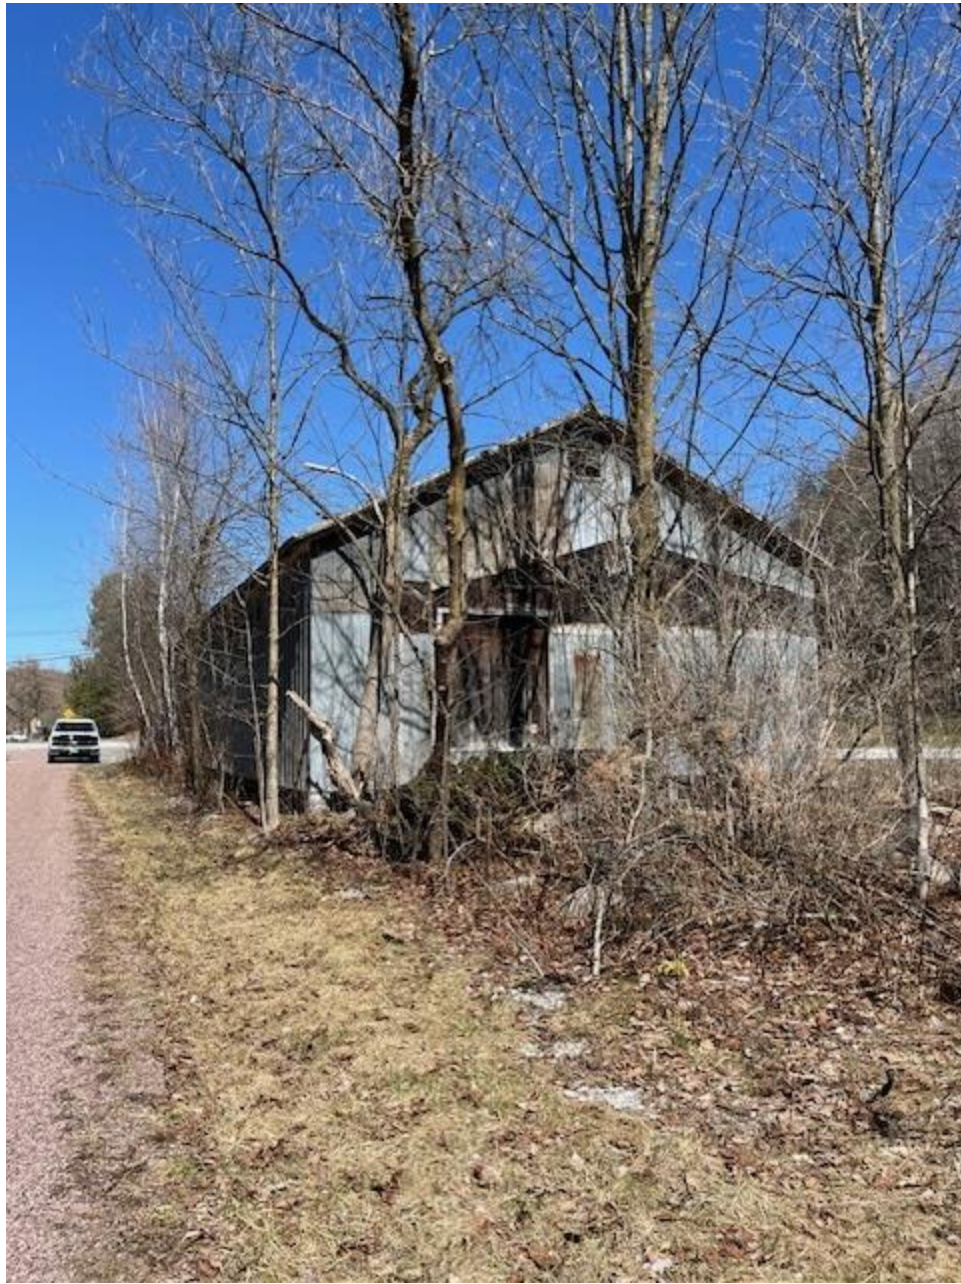
Figure 7: Rear of the Ralston building shows the outline of the former “RR Sta” addition. Note a large freight door left of center. Photo by VTrans, April 2025.

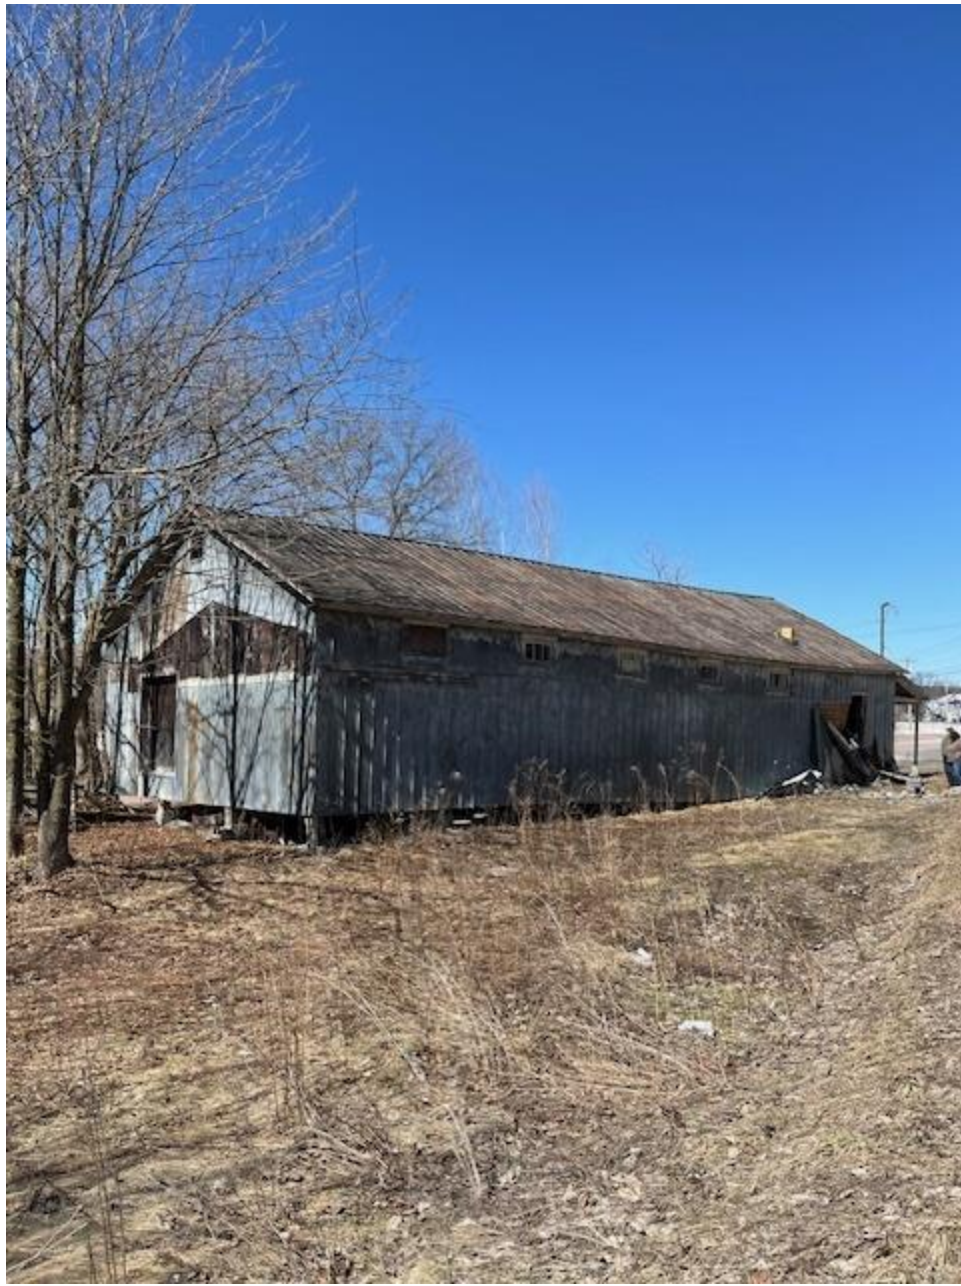
Figure 8: East elevation of the Ralston building. Evidence of a recent collision is seen at right. Photo by VTrans, April 2025.

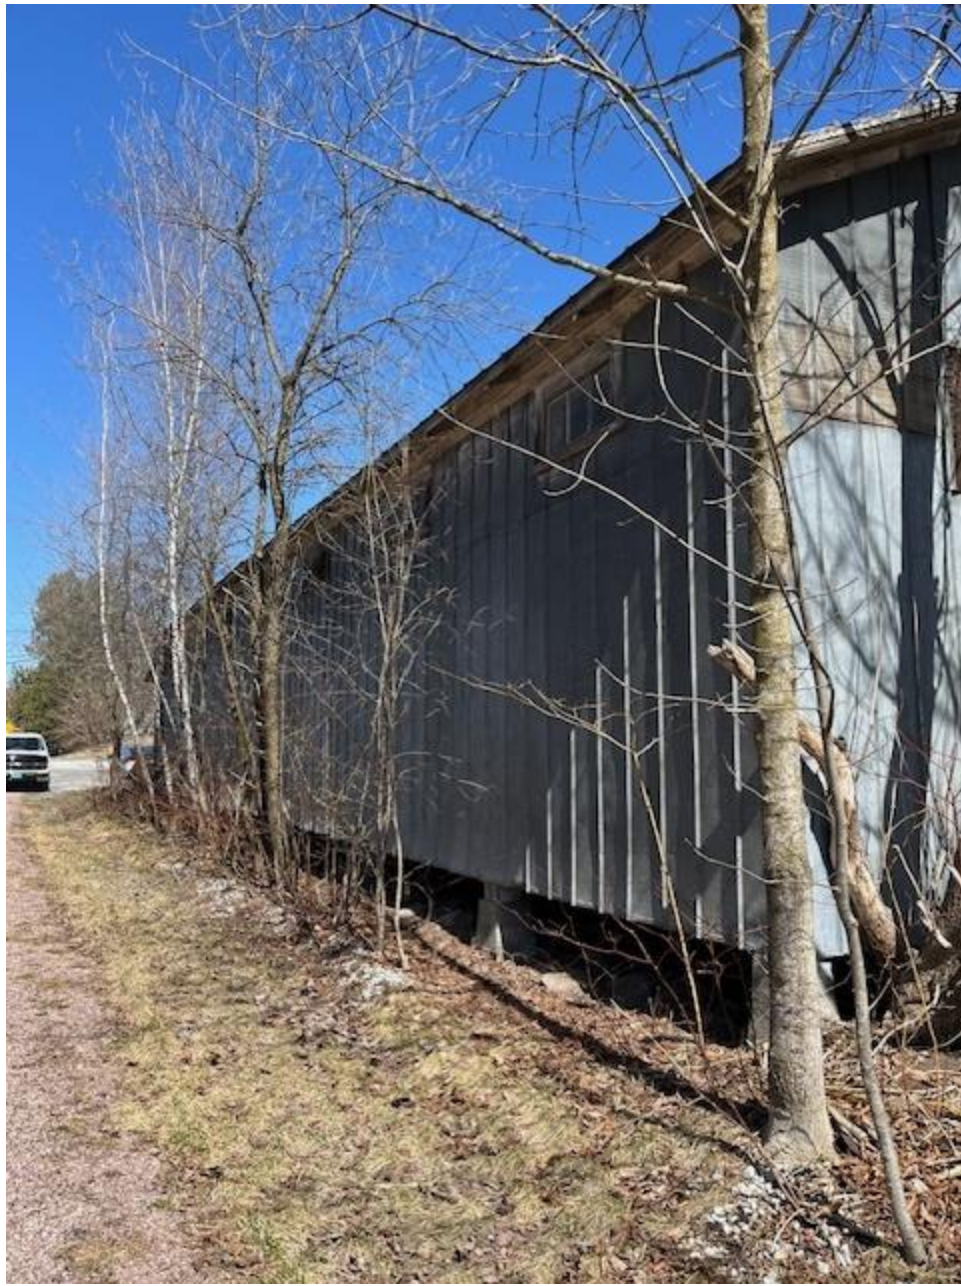
Figure 9: West (trackside / trail side) elevation of the Ralston building. Photo by VTrans, April 2025.

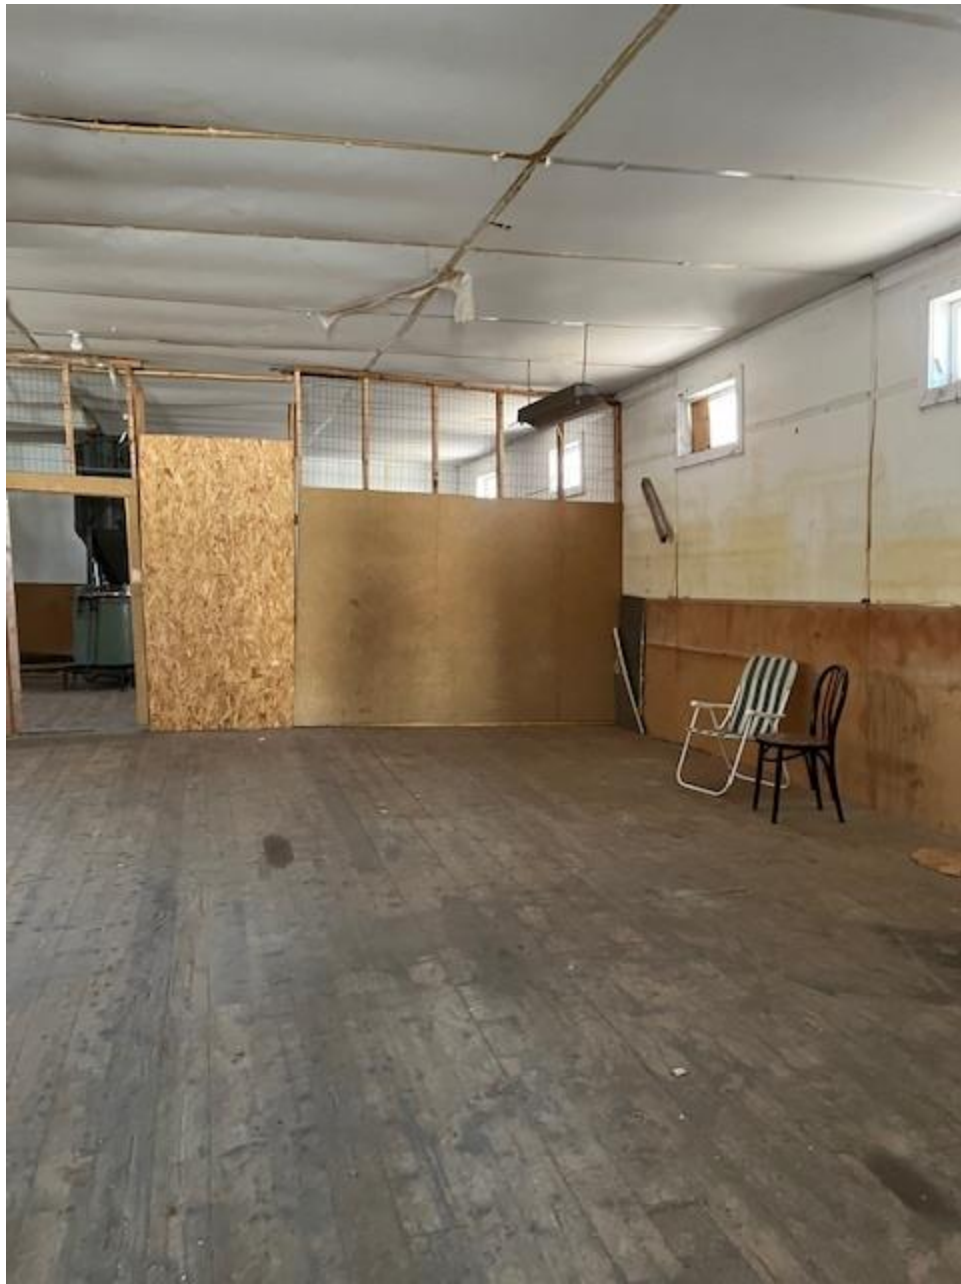
Figure 11: Interior of the Ralston building, looking to the rear. Photo by VTrans, April 2025.

The interior of the building is simple. Original wood flooring remains and a drop ceiling has been added. Wallboard covers the wood sheathing. A small office is located at the front of the building (this is where the double hung window is located). The office walls are clad in flushboard siding and a ladder is constructed into the wall. A second section across from the office has been walled off, presumably for separate storage. A large evaporator remains in the building, a remnant from its days as a storage for the Soule Company. See Figures 11-12.

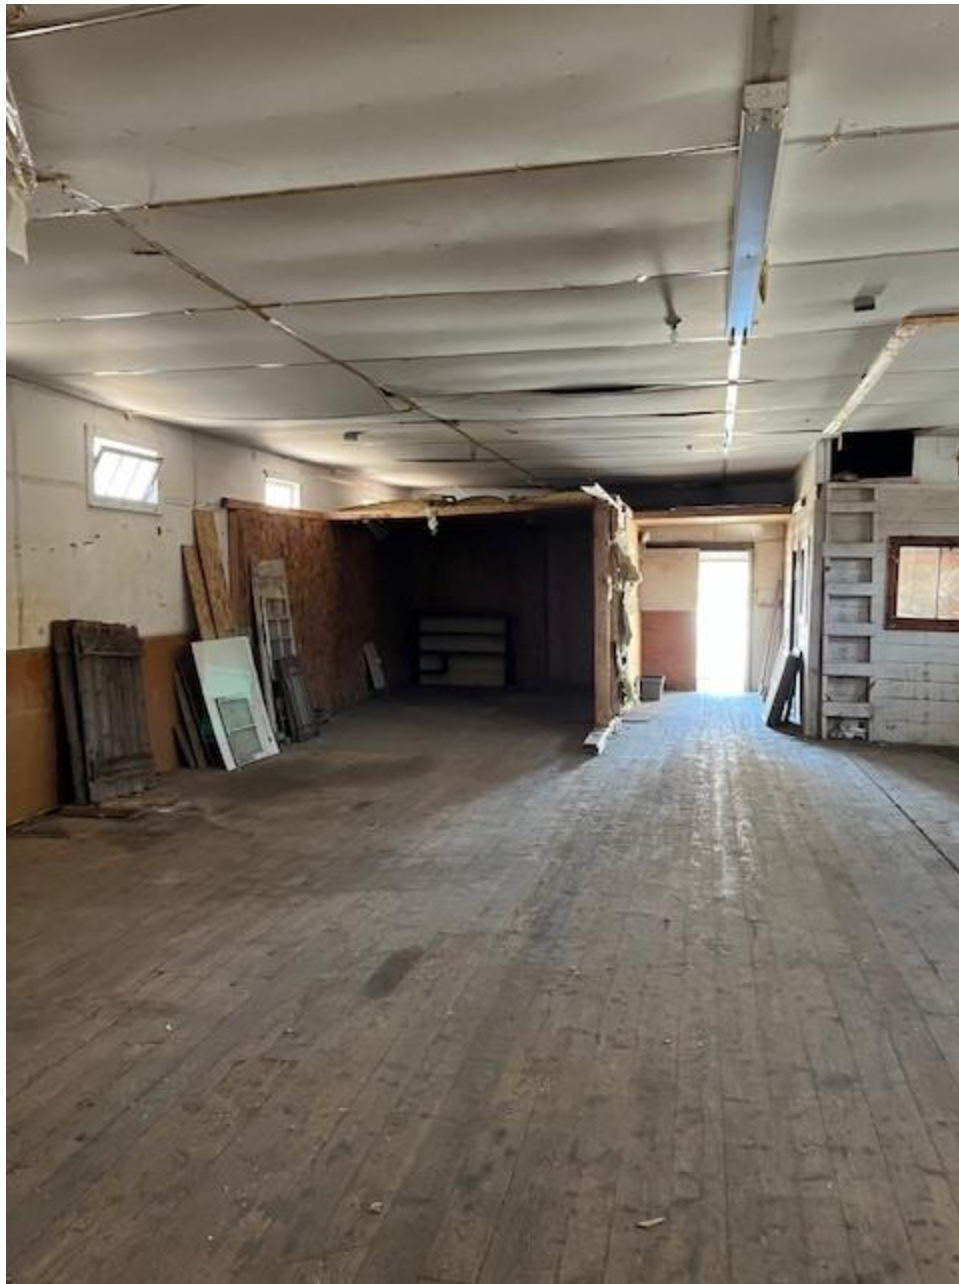
Figure 12: Interior of the Ralston building, looking to the front of the building. The storage area at left is not original. The office at right is original. Photo by VTrans, April 2025.

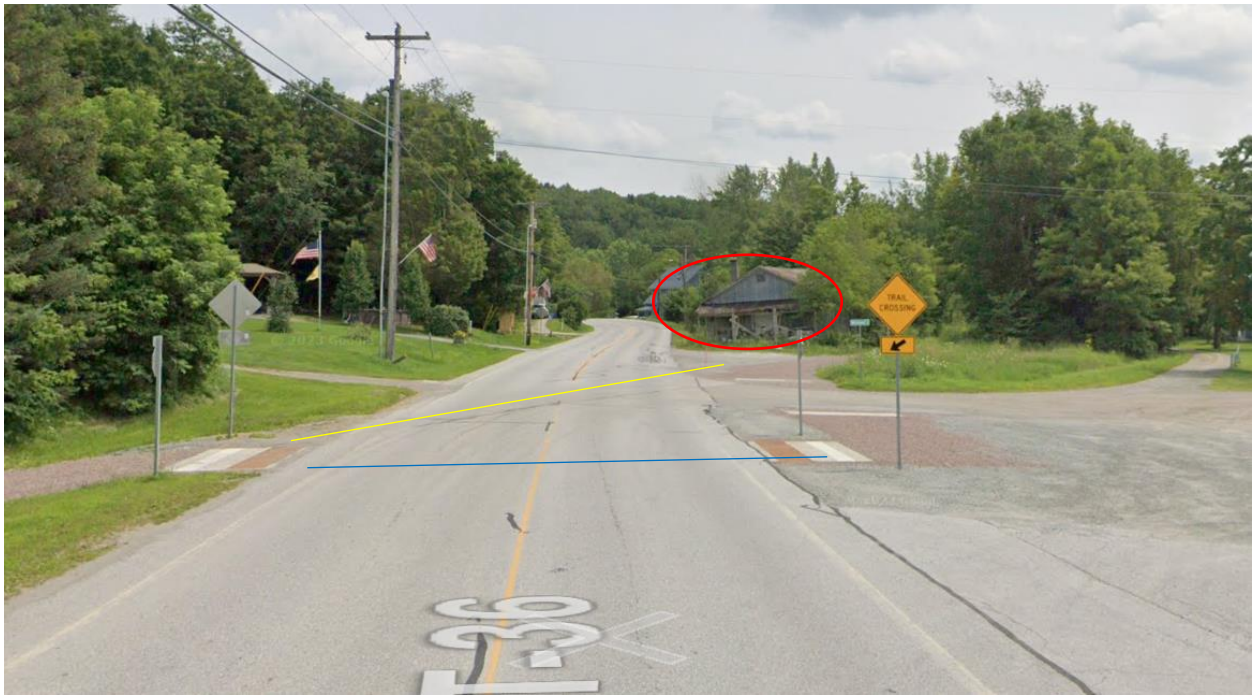
Figure 13: Google Street View (July 2023) shows the LVRT crossing (in blue). The yellow line shows the prior railroad crossing, and the route that many trail users take. The red circle shows 9596 VT Route 36. Note the curve in VT Route 36 just beyond 9596.
