## HISTORIC PRESERVATION PROJECT REVIEW COVER FORM

Attachment E Draft MOA (also included under separate cover as a word doc)

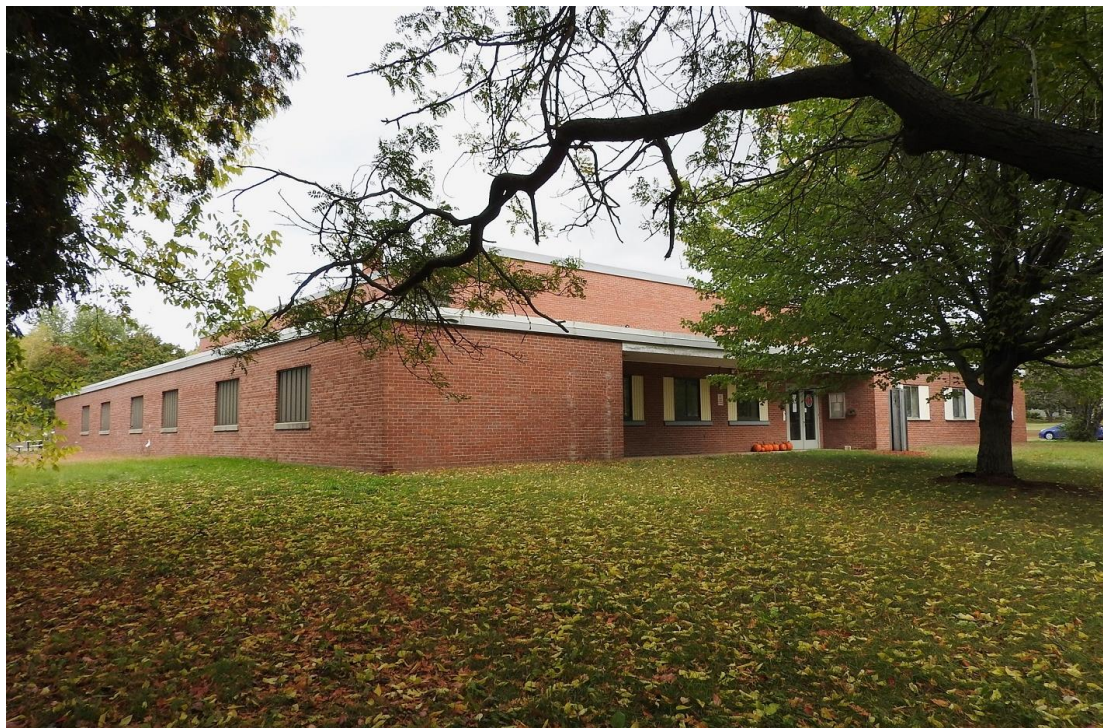
Figure 4. Facing northeast toward Winooski Armory, 2020

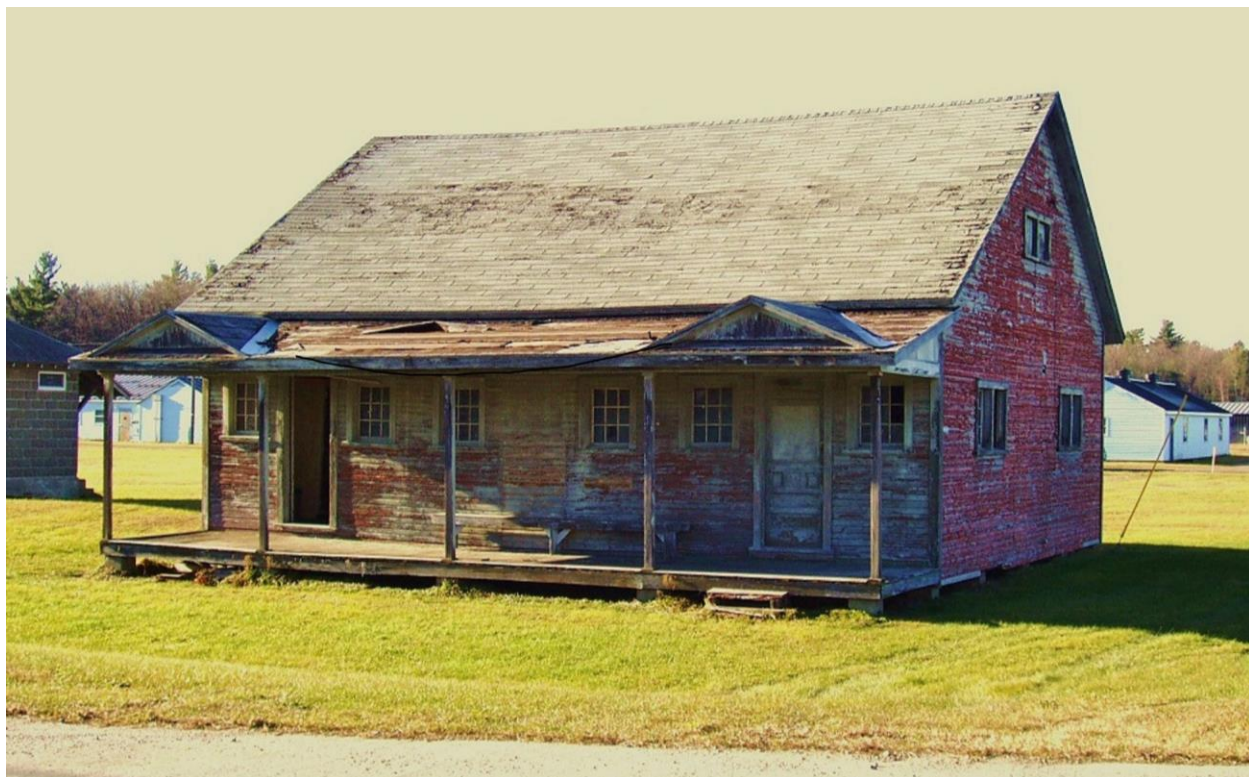
Figure 7. Facing northwest toward front of Officer's Club, 2014 (prior to being rotated 90 degrees).

The current proposed mitigation of the adverse effect caused by the removal of the Armory is the rehabilitation or partial rehabilitation of the historic “Officer’s Club” at Camp Johnson. The Officer’s Club is a ca. 1929 building that was documented in the 2000 “Building Inventory and Evaluation Report for Camp Johnson”, as well as a 2014 report, both by Paula Sagerman. (See attachments.) About 2015, the Officer’s Club was rotated 90 degrees. Historically, it faced southeast, and now faces northeast. Otherwise, it has not been altered, with the exception of the in-kind replacement of the asphalt-shingle roof. (See Figures 3, 7-13.)

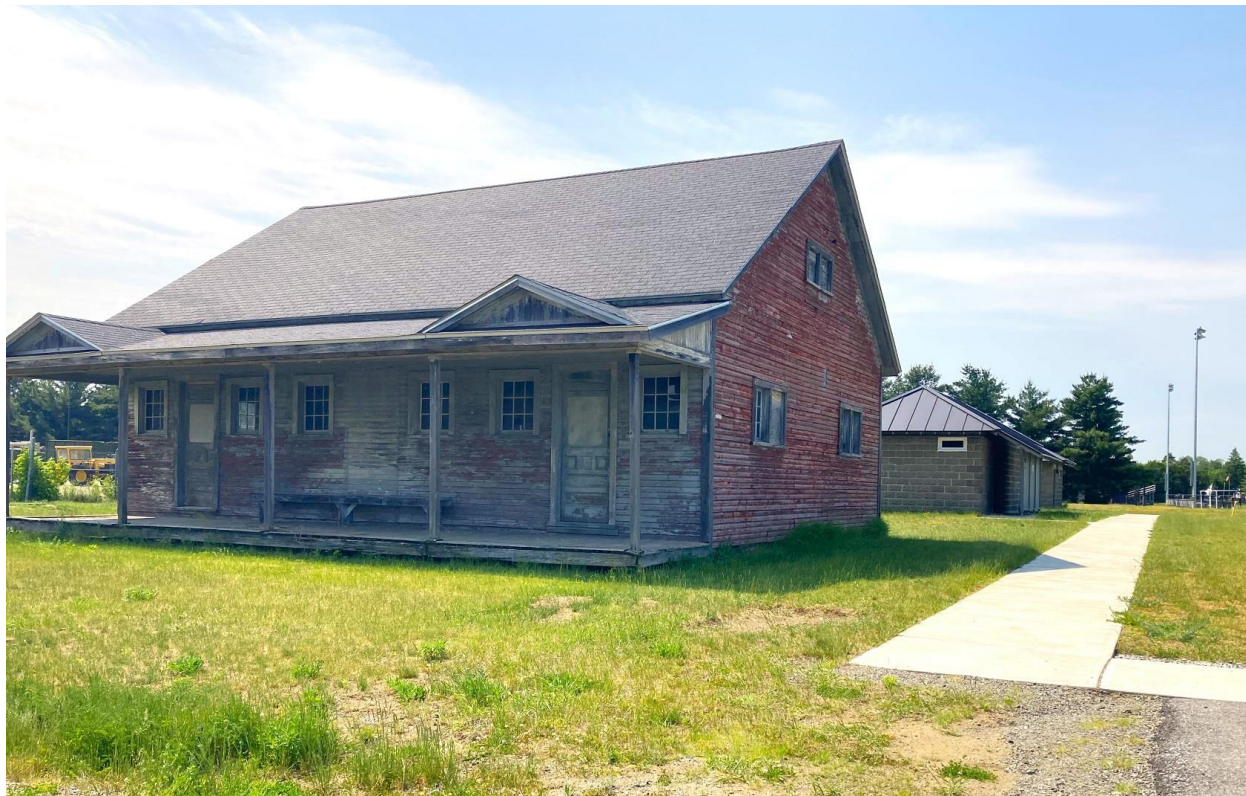
Figure 8. Facing south toward front of Officer's Club, 2016. Photo by VTARNG.

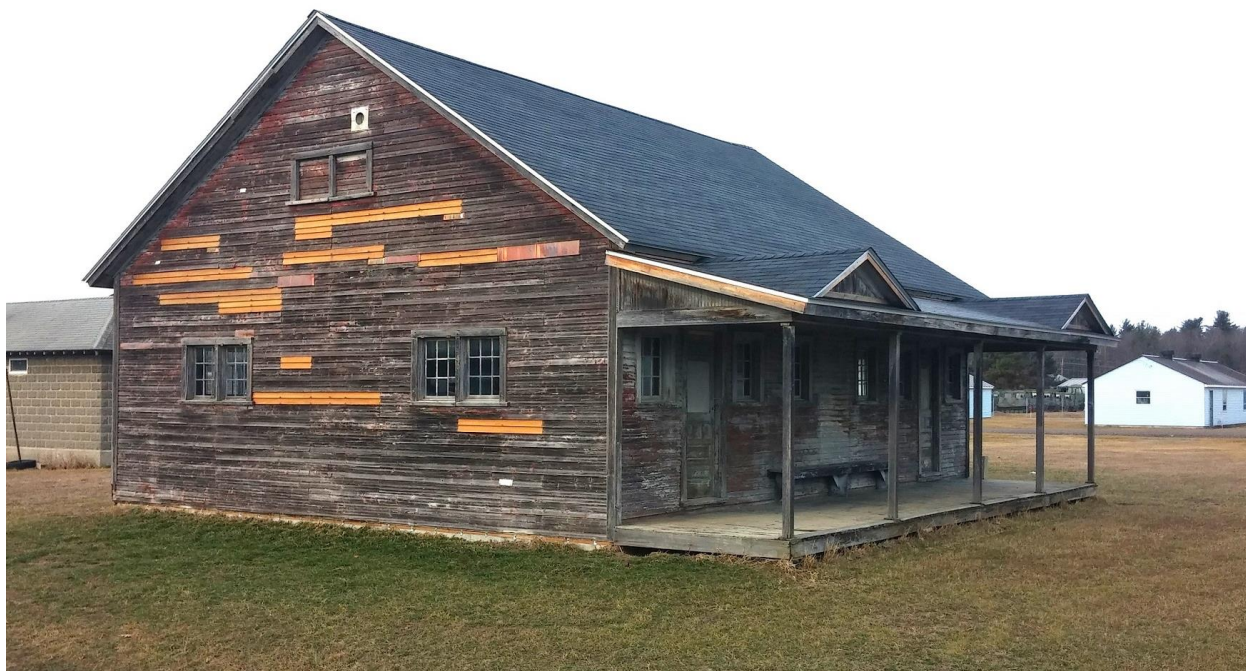
Figure 9. Facing west toward side and front of Officer's Club, 2022. Photo by VTARNG.

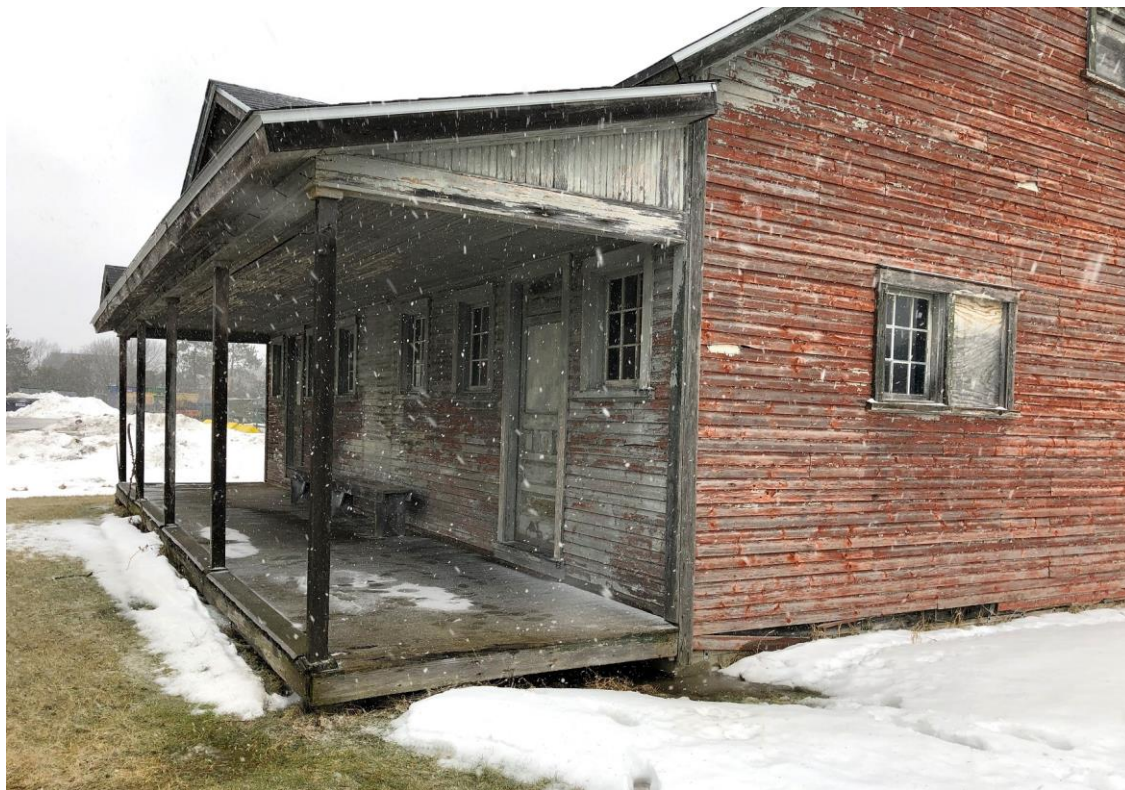
Figure 10. Facing southeast toward front of Officers Club, 2022. Photo by Elizabeth Peebles.

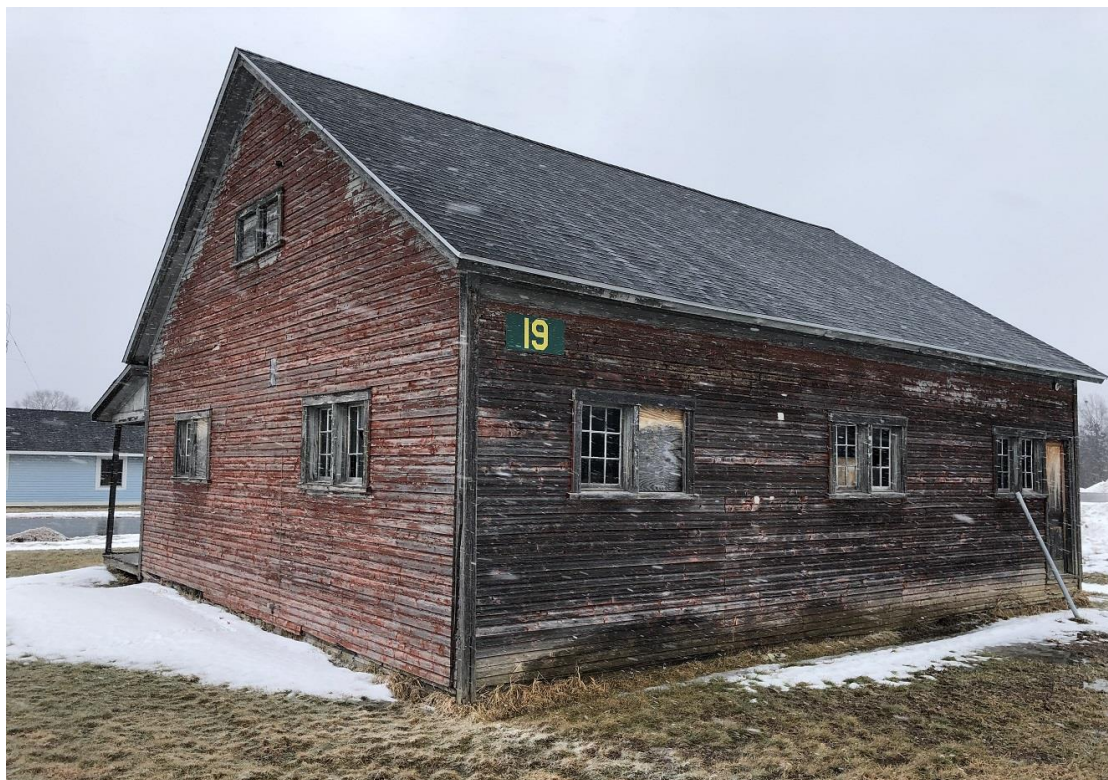
Figure 11. Facing east toward side & rear of Officer's Club, 2022. Photo by Elizabeth Peebles.

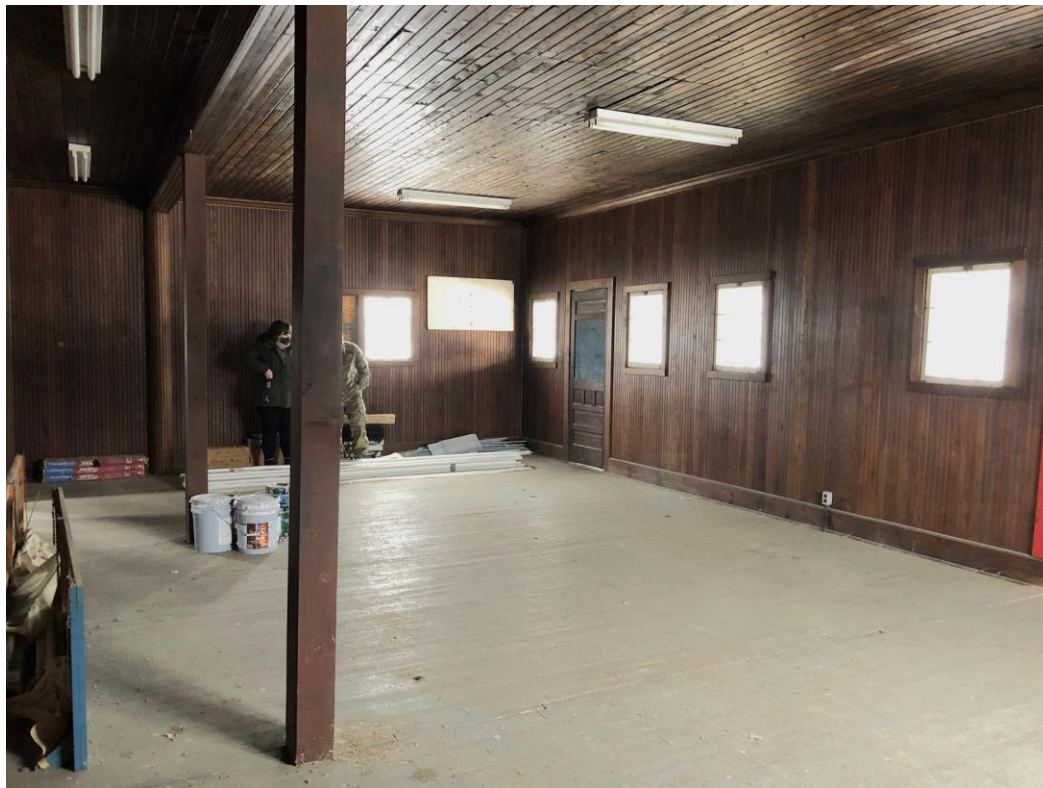
Figure 12. Facing east in interior of Officer's Club, 2022. Photo by Elizabeth Peebles.

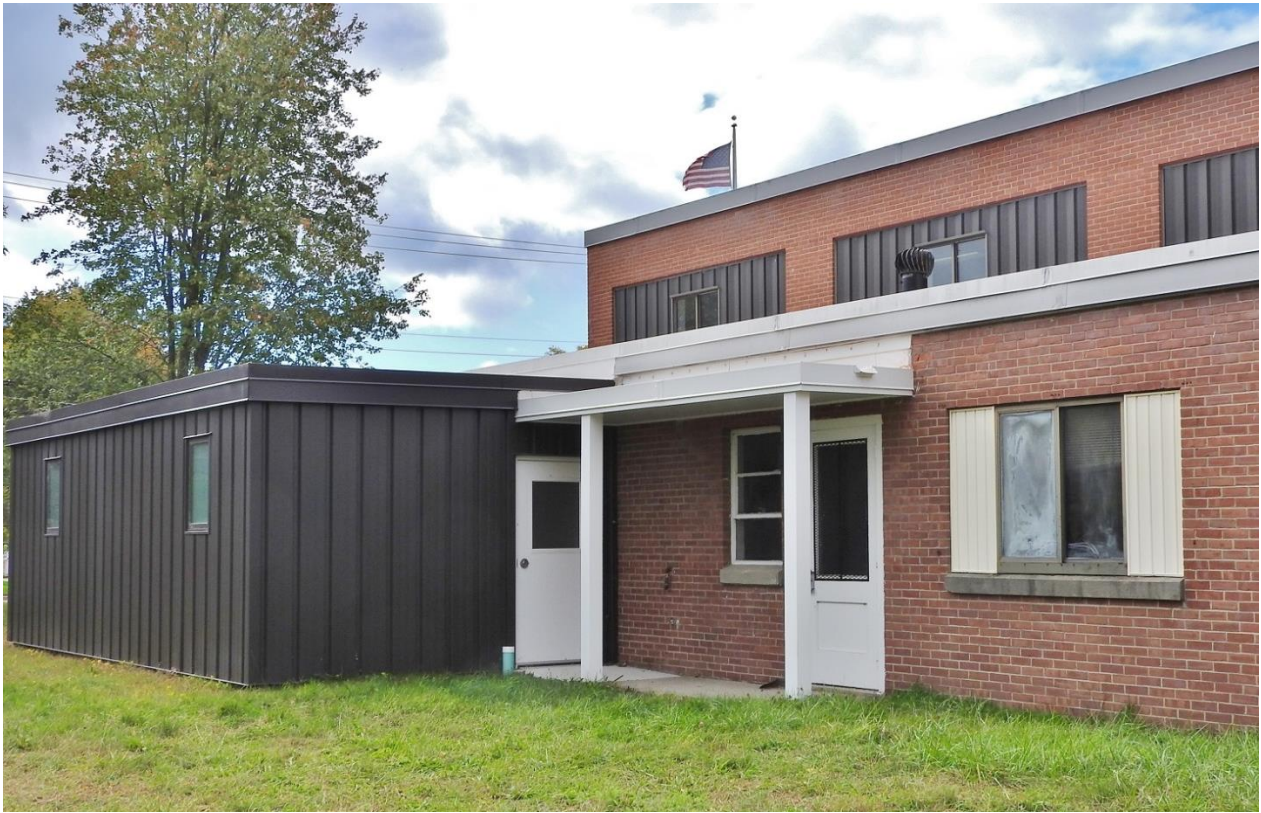
13. Facing southwest toward addition and east elevation

The addition was constructed in 2017 in order to provide the appropriate facilities for female guard members and an ADA-compliant bathroom. The addition caused the removal of two horizontal window openings; as noted in the 2009 survey, one had been previously blocked up on the interior, and the other contained paired two-pane awning windows.

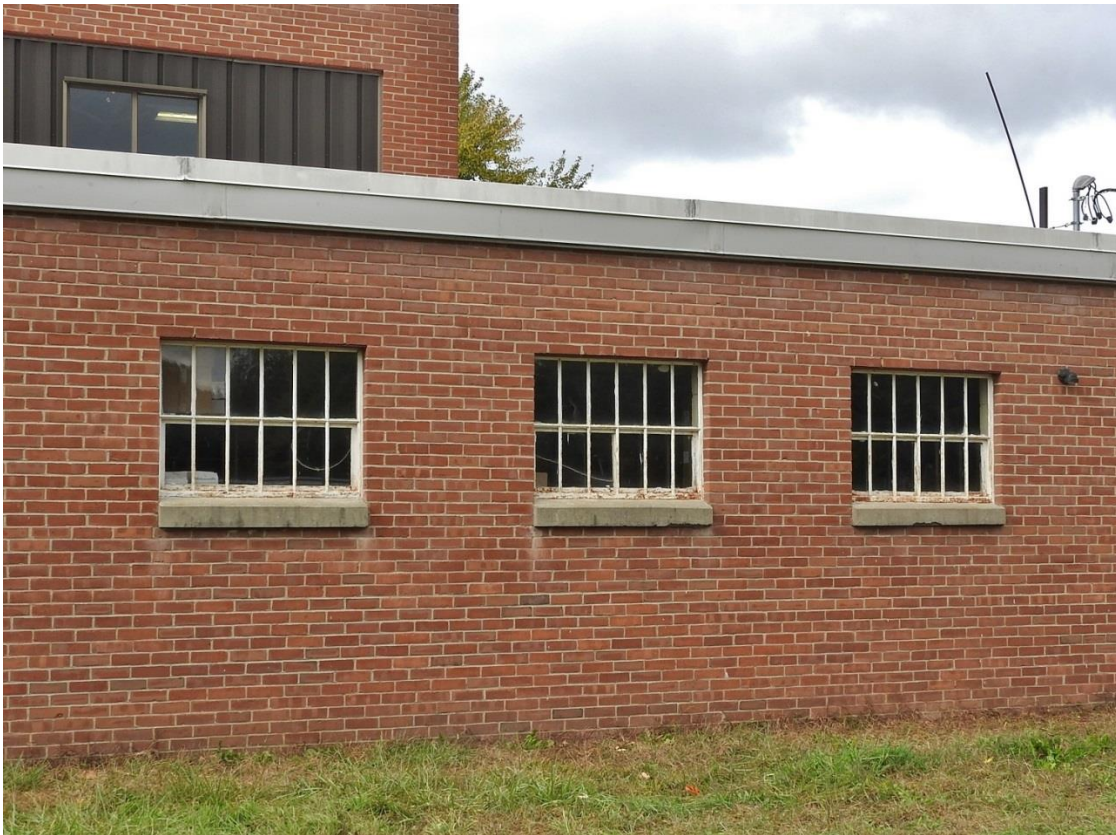
14. Facing west toward original windows at east elevation

The armory was constructed in 1955, and is mostly intact, with the exception of the replacement of most of the original windows and the construction of the 2017 addition. The first story windows that have been infilled were originally triplets of horizontal panes; the smaller windows had two panes each and the larger windows had three panes each. The windows at the west elevation, which lit an interior firing range, were protected on the interior by double-leaf steel shutters. The drill hall's clerestory windows were originally triplets of four-pane horizontal windows. The window alterations date to 1983 and were undertaken at all of Vermont's Cold War armories in order to improve energy efficiency.

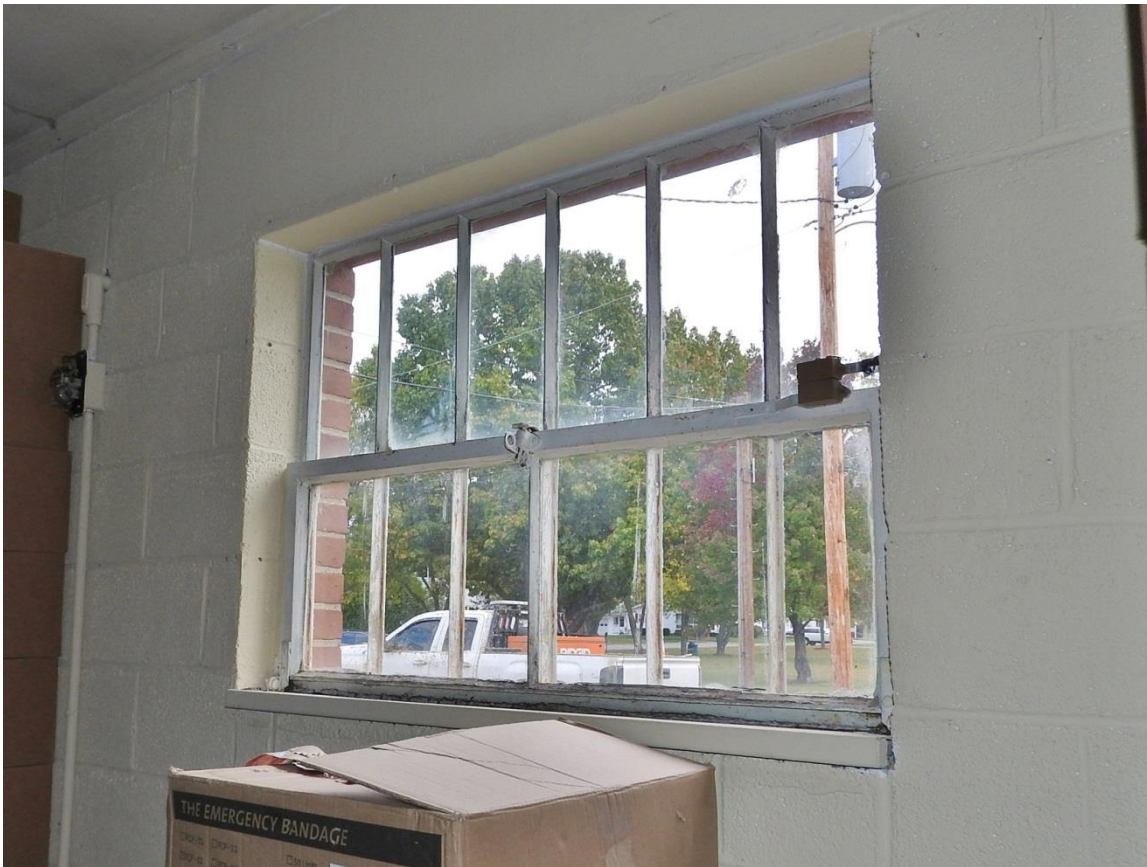
35. Original window at east elevation
