STATE OF VERMONT Division for Historic Preservation  VERMONT ARCHITECTURAL RESOURCE INVENTORY*  Individual Property Survey Form	SURVEY NUMBER: (Assigned by VDHP)
	Listed in State Register <input checked="" type="checkbox"/> Date: 1992
	Determined Eligible for State Register <input type="checkbox"/> Date:
	PRESENT FORMAL NAME: Former Store
	ORIGINAL FORMAL NAME: Lou Gordon Store
COUNTY: Addison	PRESENT USE: None
TOWN: Starksboro	ORIGINAL USE: Commercial Store
ADDRESS: 3165 VT Route 116	ARCHITECT/ENGINEER: Unknown
COMMON NAME: Former Store	BUILDER/CONTRACTOR: Unknown
PROPERTY TYPE: Commercial	DATE BUILT: 1908
OWNER: Vermont Agency of Transportation ADDRESS: 219 North Main Street, Barre, Vermont 05641	
ACCESSIBILITY TO PUBLIC: Yes <input type="checkbox"/> No <input checked="" type="checkbox"/> Restricted <input type="checkbox"/>	PHYSICAL CONDITION OF STRUCTURE: Good <input type="checkbox"/> Fair <input type="checkbox"/> Poor <input checked="" type="checkbox"/>

**ADDITIONAL ARCHITECTURAL OR STRUCTURAL DESCRIPTION:** The former Lou Gordon Store was listed on the Vermont State Register of Historic Places as a contributing resource in the Starksboro village historic district. The buildin

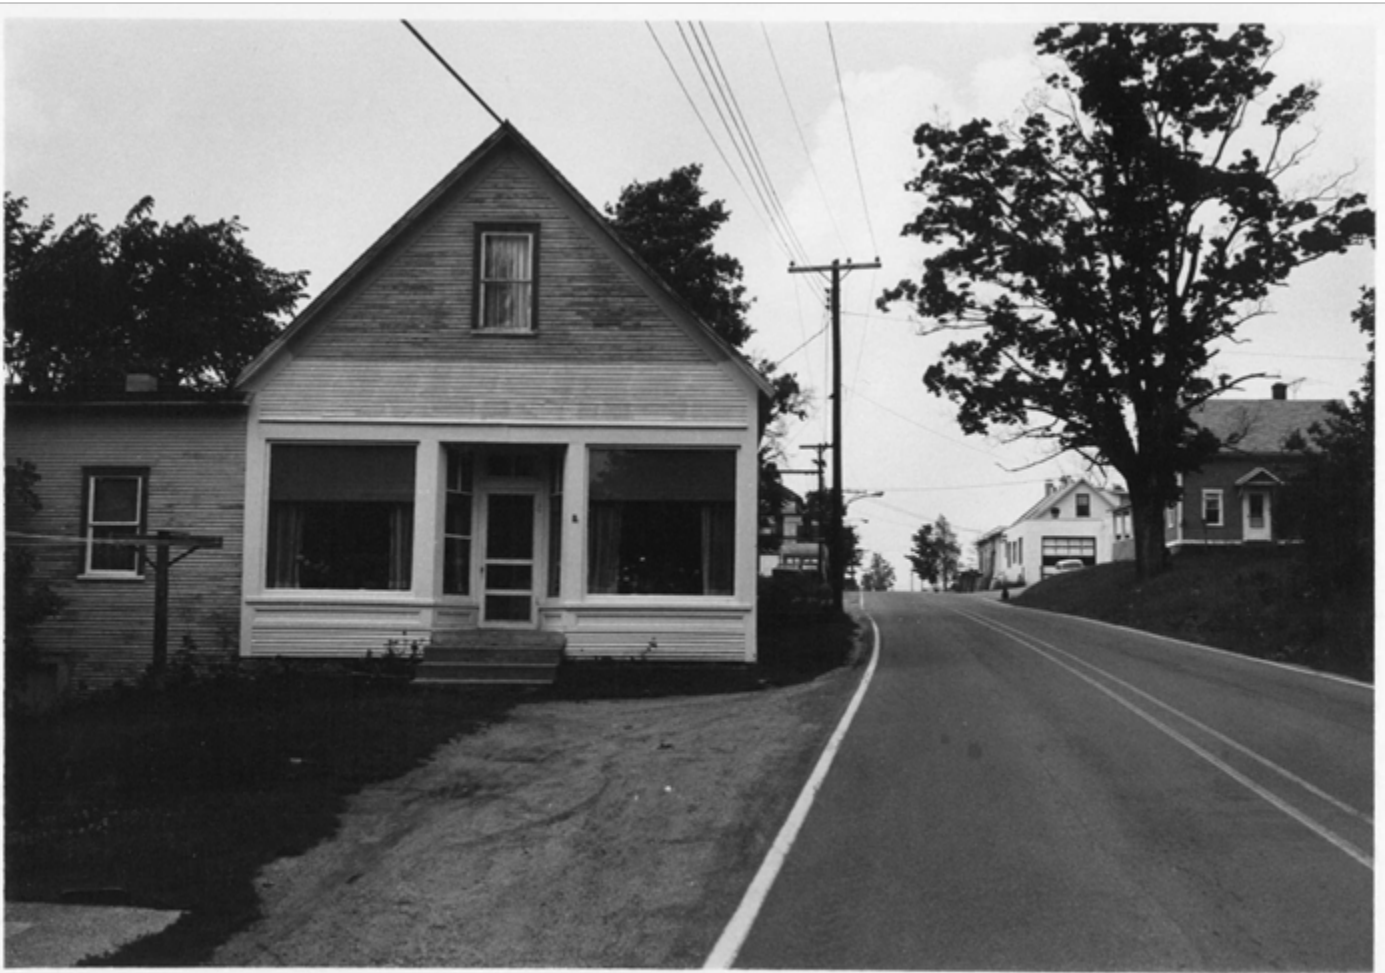
Copy of photograph from the 1975 Historic Sites and Structures Survey.

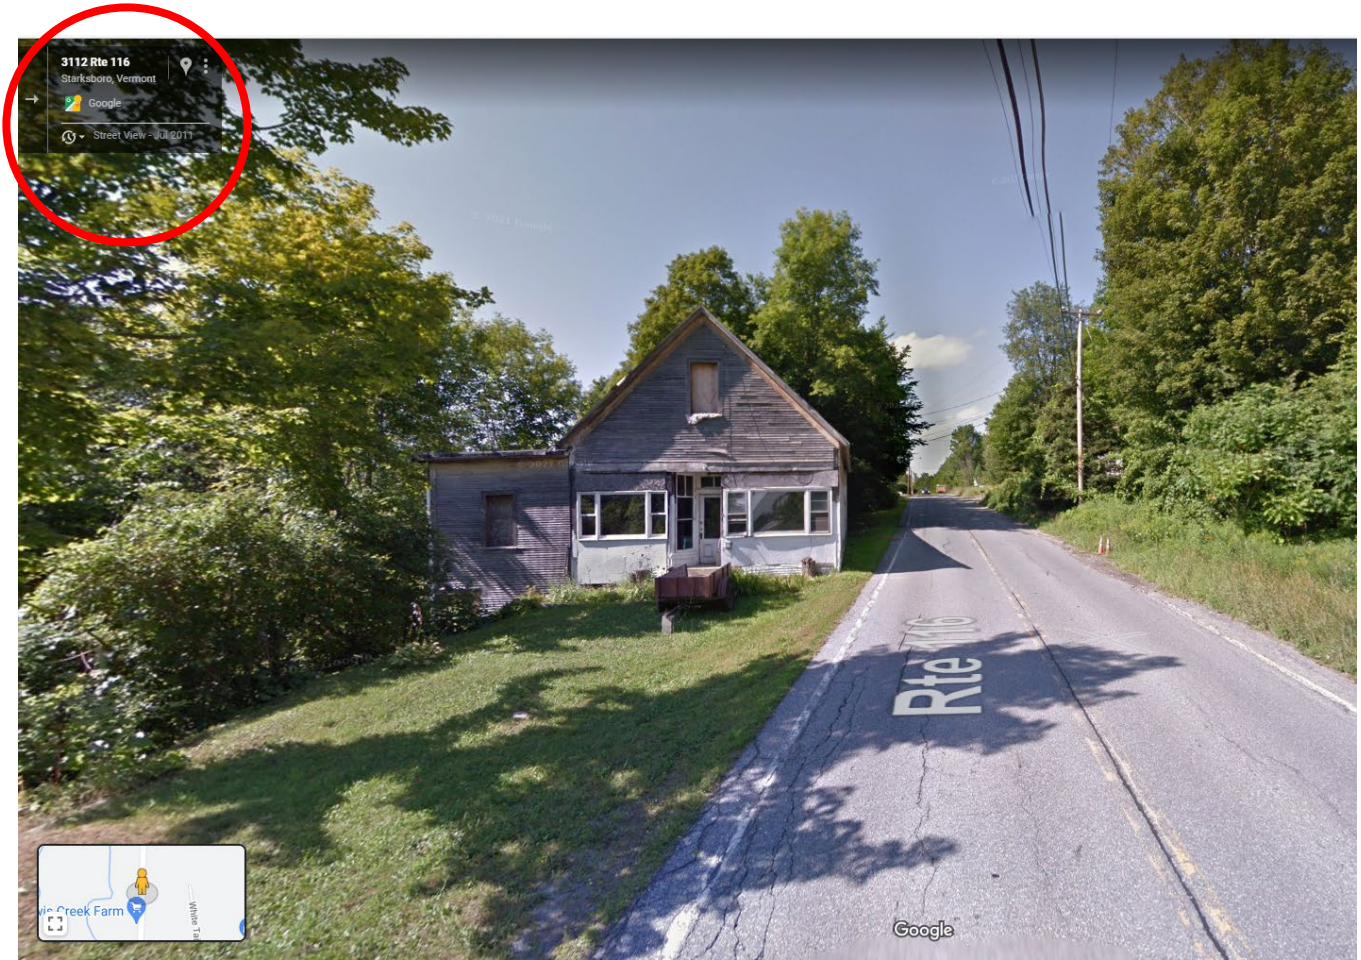
The original storefront façade of the former Lou Gordon store was extensively altered sometime prior to 2011. The original pair of matching plate glass windows were replaced with different sized Chicago windows, the right bay was widened resulting in the loss of the façade’s symmetry, and the central entryway was reconfigured to accommodate the widened bay. Wall surface areas above and below the replacement windows are clad in painted plywood. The interior was gutted down to the framing. The shed-roofed addition on the west elevation has pulled away from the main building and collapsed.

Google Earth image from 2011. The red circle encircles the date of the image.

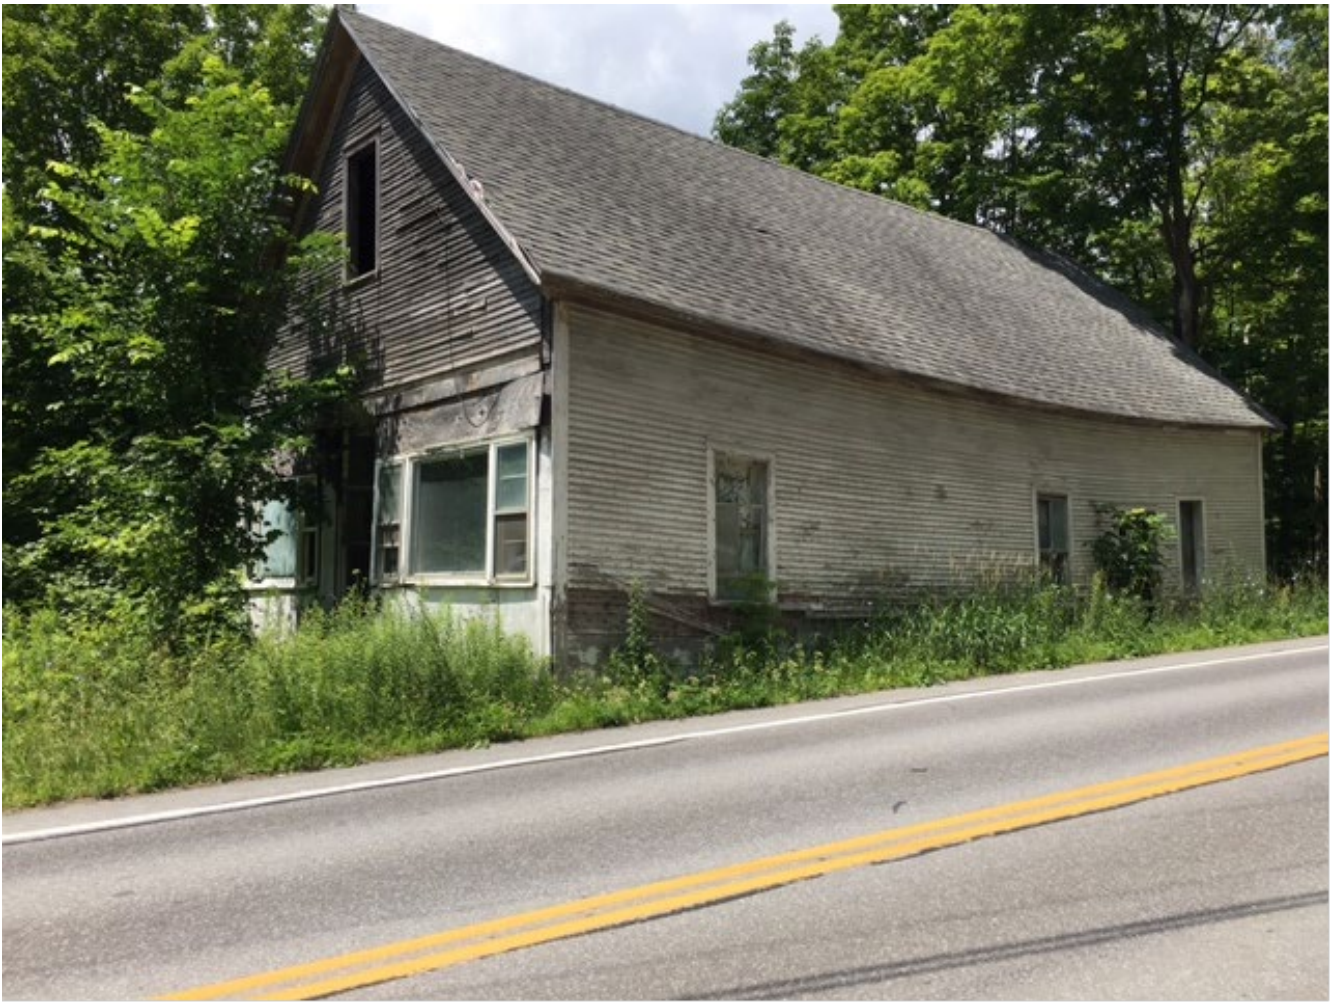
Existing condition, façade (south) and side (east) elevations, July 2022.

Due to the loss of the original storefront windows, changes to the configuration of the recessed entryway, gutting of the interior, and collapse of the addition on the west elevation, the building no longer retains sufficient integrity of design, materials, workmanship, feeling, or association to be considered a contributing resource in the Starksboro Village Historic District.

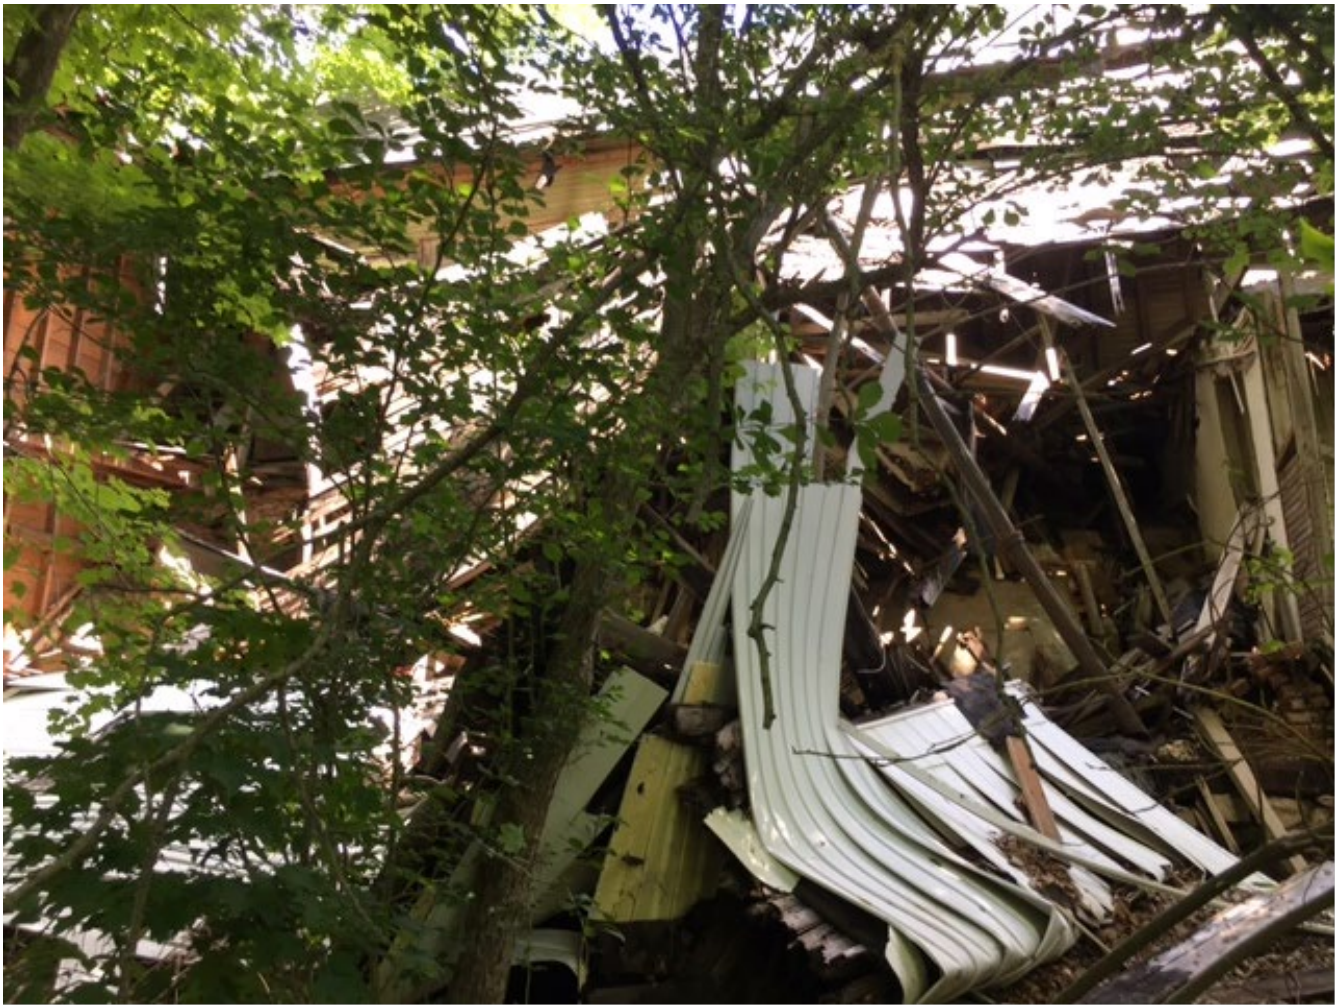
Existing condition, shed-roof addition on west elevation, July 2022.
