National Register of Historic Places Registration Form

Historic name: District No. 5 Schoolhouse
 Other names/site number: Underhill Center School
 Name of related multiple property listing:
Educational Resources of Vermont
 (Enter "N/A" if property is not part of a multiple property listing)

Street & number: 32 Pleasant Valley Road
 City or town: Underhill State: Vermont County: Chittenden
 Not For Publication: Vicinity:

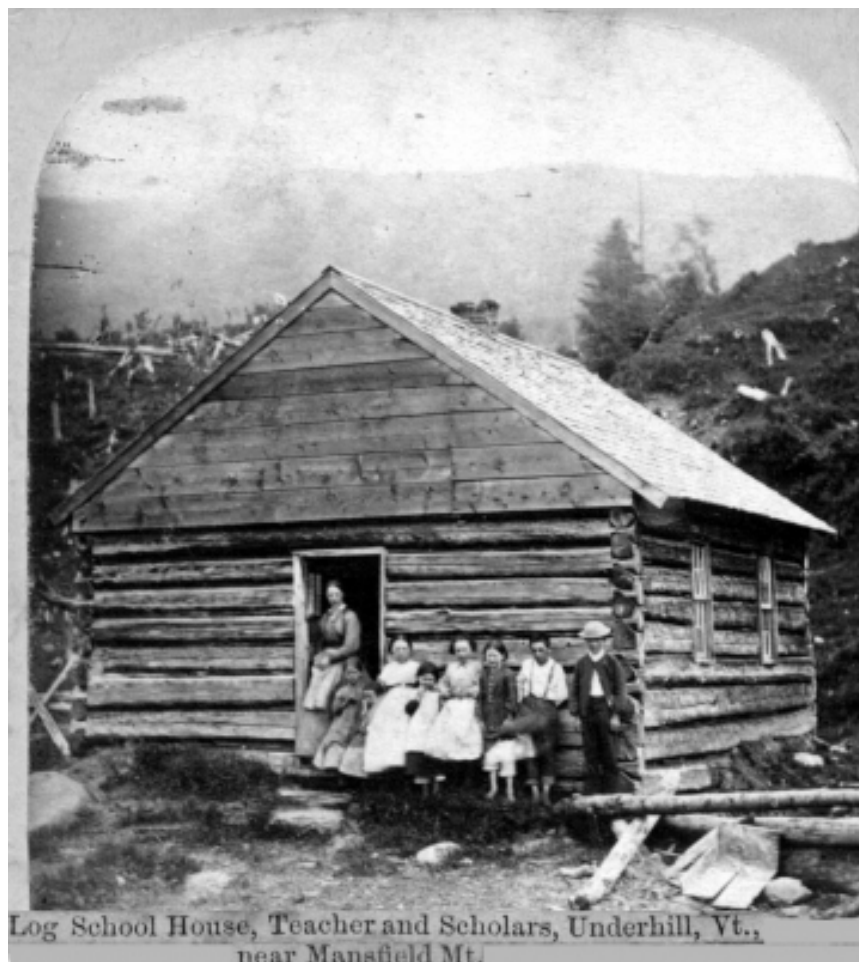
Figure 1. Log Schoolhouse, Underhill, VT.
Courtesy of UVM Landscape Change Program
