# Architectural History Report

The Architectural History Report for the 'Waterbury Office Complex', formerly known as the 'Vermont State Hospital', and the 'Vermont State Asylum for the Insane', provides a historical framework to assess various reuse scenarios for the site following damage by Storm Irene in 2011. The main observations of this report are:

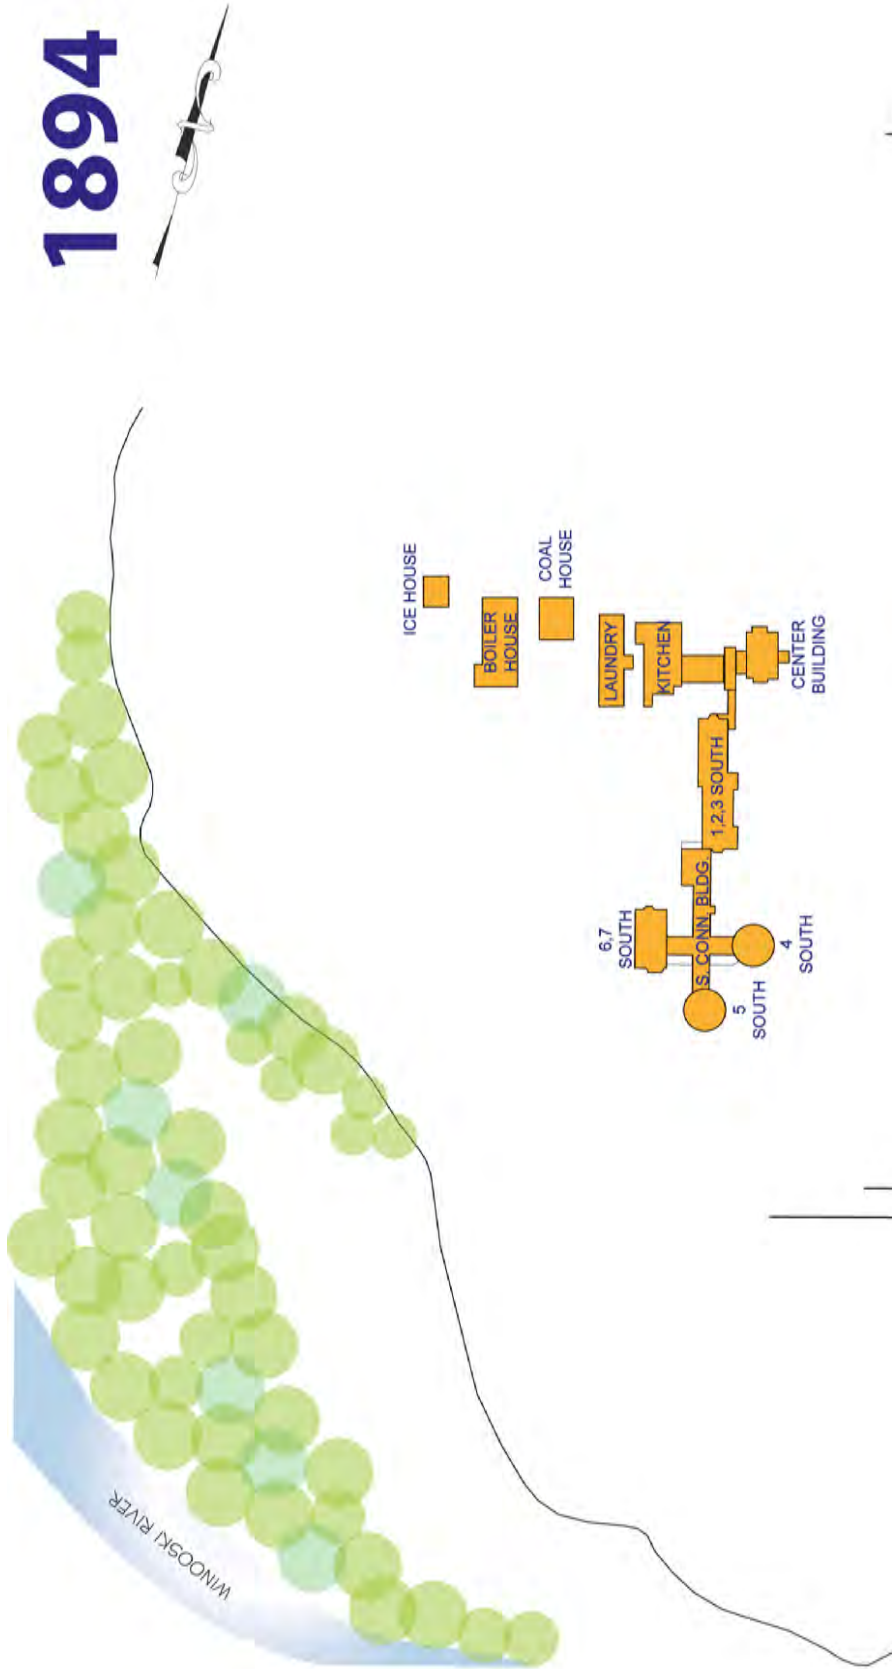
Figure 9. Period Plan 1894  
Source: GCA

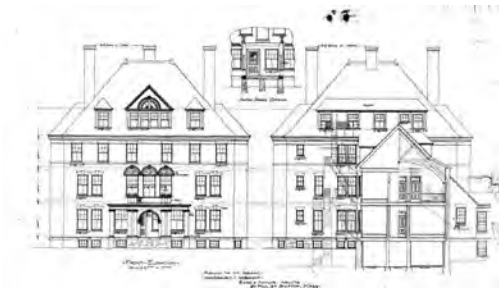
Figure 11. **Center Administration Building- East-West Elevations**  
Source: Vermont State BGS Drawings Scan Archive

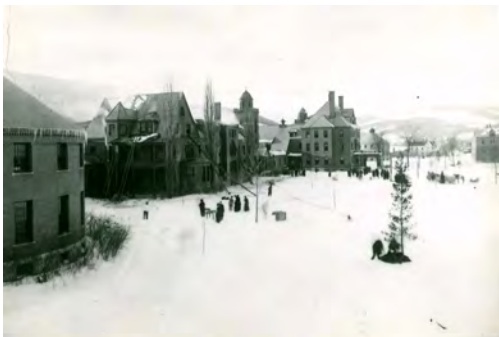
Figure 20. View of 1,2,3 South after the fire of 1909

There were two fire outbreaks in the hospital, one in 1909 and the other in 1910. The first one damaged the third floor of the '1, 2, 3 South Building' with water damage on the lower floors. The later fire damaged a paint shop in the rear of the campus. The importance of fireproof construction was increasingly being recognized and the first "genuinely fireproof building in Vermont<sup>12</sup>", was built on the campus in 1912. Known as the 'Male Criminal Insane Building' (currently known as 10 South), this 3-story brick building was detached from the main group though located in close proximity and probably accessed via a first floor connector. This time period saw an increased classification of mentally ill patients into different categories- criminally insane, inebriates and drug addicts, convalescents, chronics etc. necessitating specialized wards and buildings for effective treatment. A 'Female Criminal Insane Building' (currently known as 10 North) similar to male side was built on the north side in 1914. By this time the hospital patient population exceeded 700.

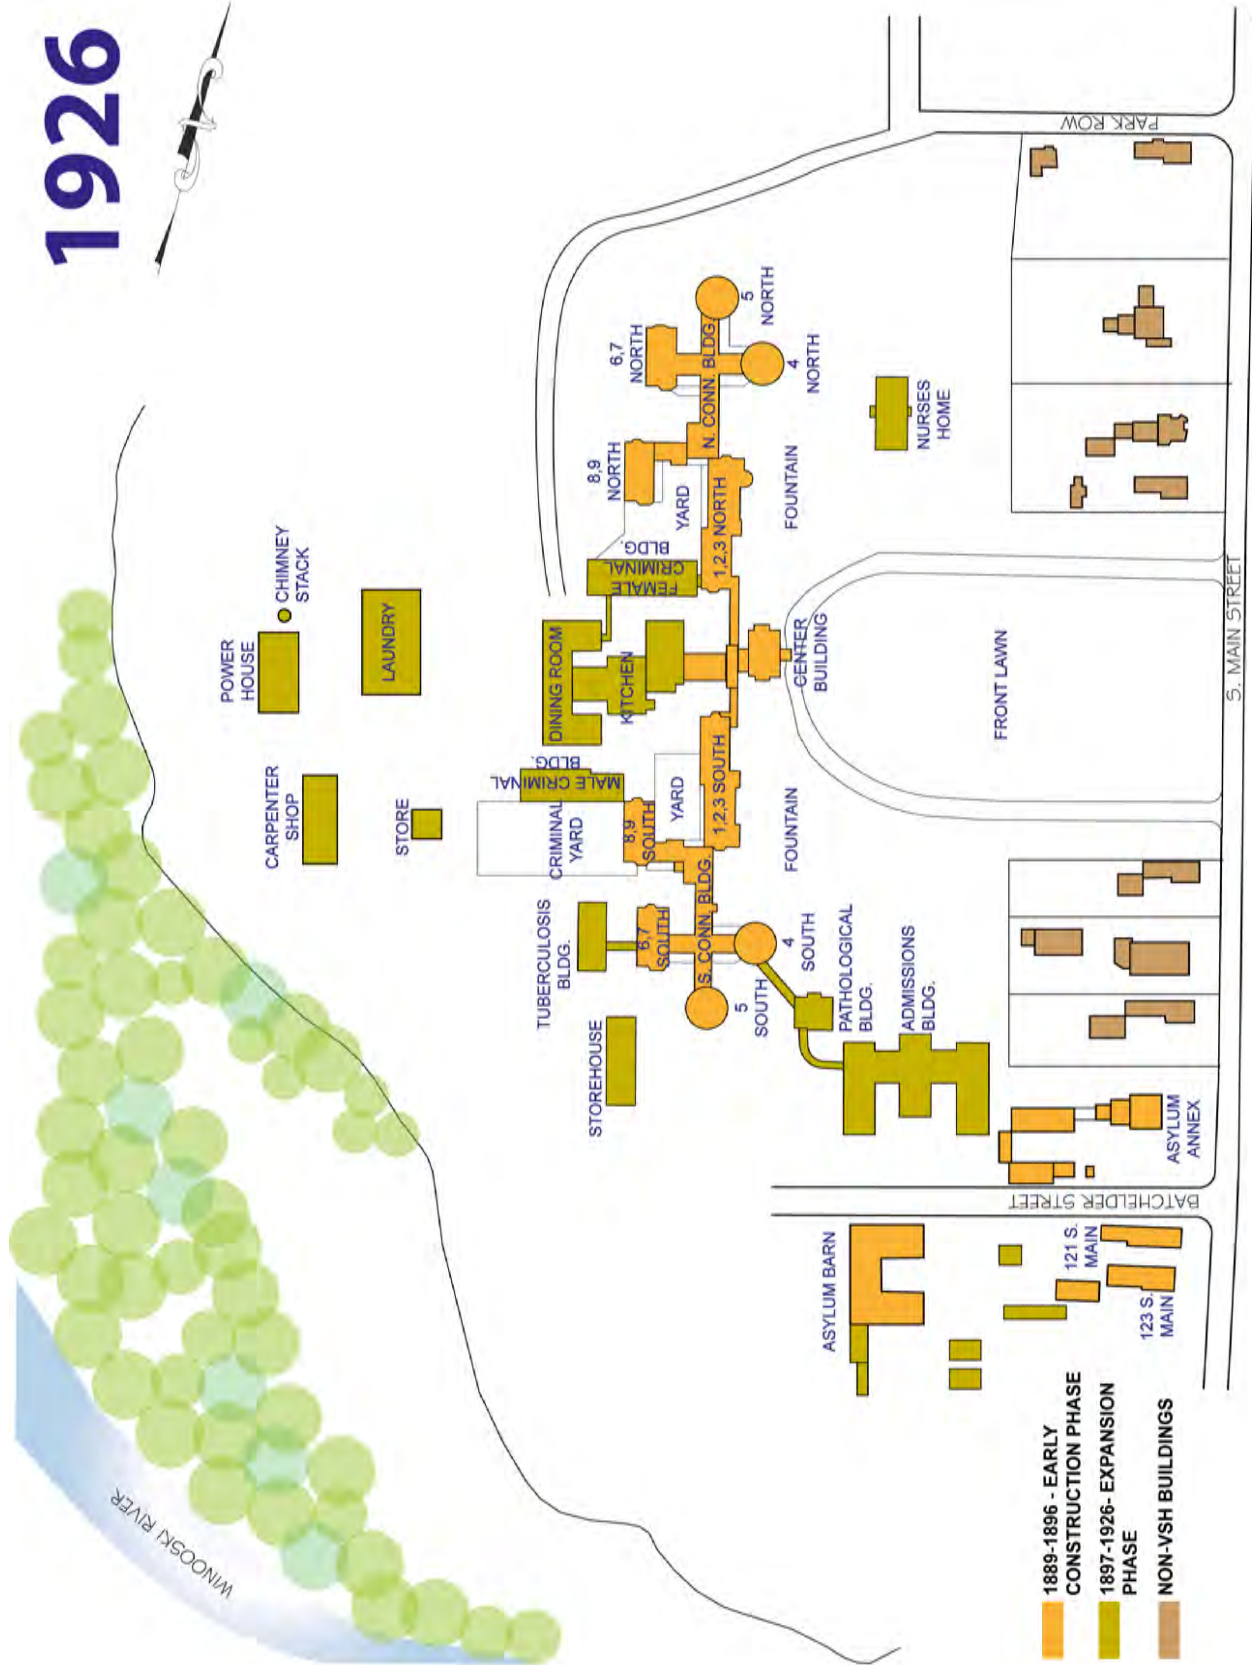
Figure 23. Period Plan 1926

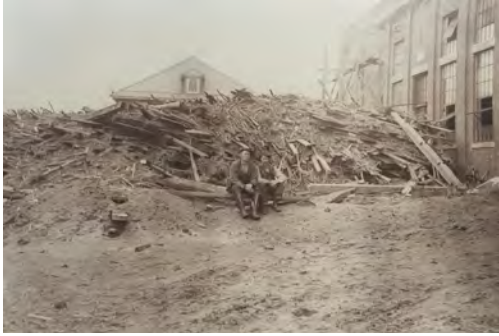
Figure 24. 1927 Flood damage behind Power House  
Source: VSH Archives

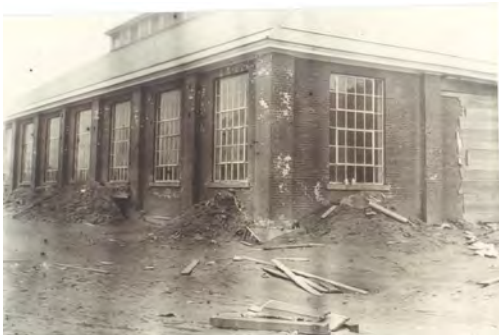
Figure 25. 1927 Flood damage at Laundry  
Source: VSH Archives

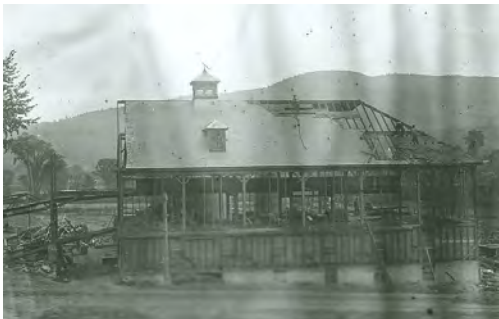
Figure 26. 1927 Flood damage at Asylum Barn  
Source: VSH Archives

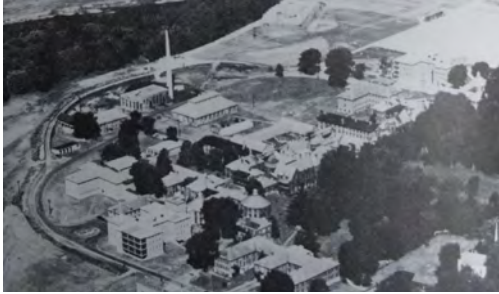
Figure 33. Aerial view showing earthen dike along the rear of buildings
