US Route 5 & US Route 4 Intersection Scoping Report

Hartford, VT

June 2, 2021

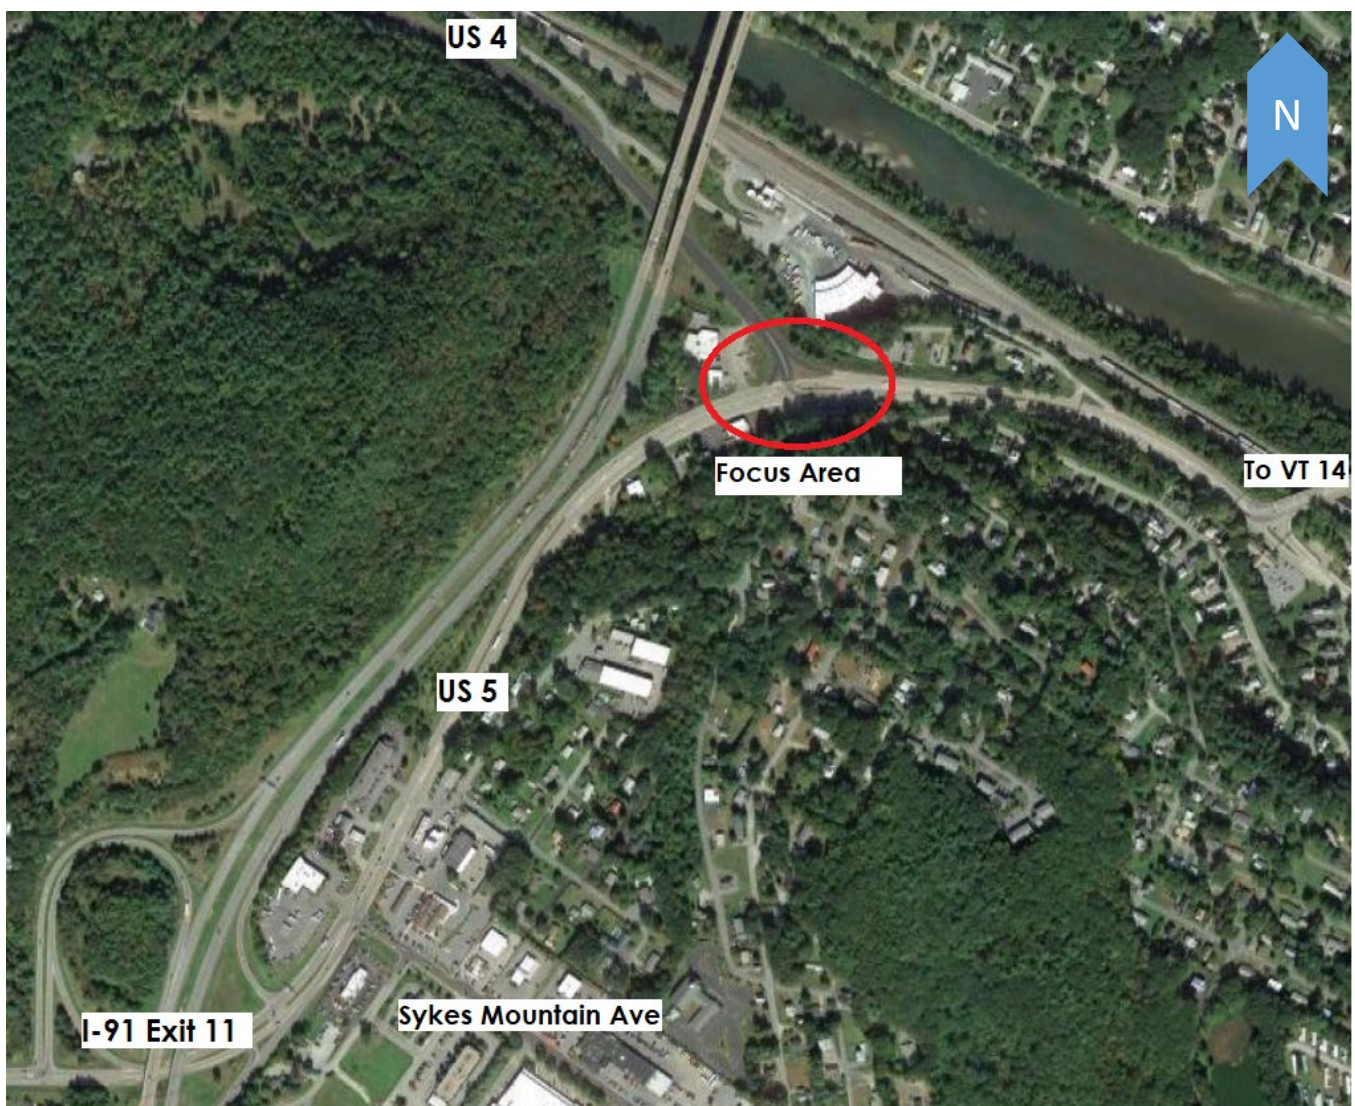
Figure 1. *Location of Intersection.*

The study area consists of the US Route 5/US Route 4 intersection and its respective approaches. This intersection is located within the designated growth center for Hartford. Positioned directly at the South end of the intersection is a commercial business, which has a paved surface out front and is separated from US Route 5 by an existing sidewalk. The northwest corner also has a commercial business, which may be accessed from either US Route 4 or US Route 5. Additional businesses and other residences – to which minimal impacts are anticipated – exist along US Route 5 as well.

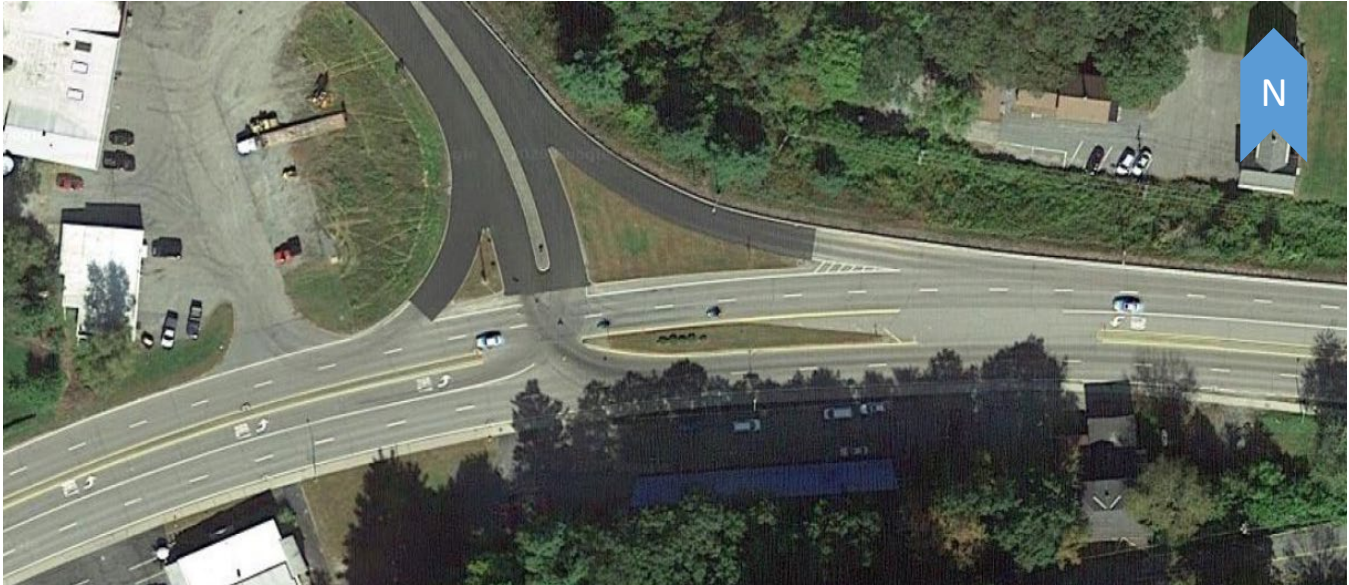
Figure 8. *Alternative #1 Intersection Layout.*

A no-build alternative, shown in *Fig. 8* (below), is included to understand whether no improvements to the intersection could be a viable option for the area. This also provides baseline and future comparison for the other alternatives under review. In this case, a no build alternative does not address the safety concerns exemplified by crash patterns or voiced by local stakeholders.

Per *Table 5* (below), the 2040 PM Peak Hour volume-to-capacity (V/C) ratio of 1.22 demonstrates that a no-build alternative does not meet the need to retain mobility for motorists. Pedestrian and cyclist mobility would also go unaddressed without any improvements. Without enhancements to safety or mobility, this no-build condition would not meet any of the three components of the purpose and need statement.

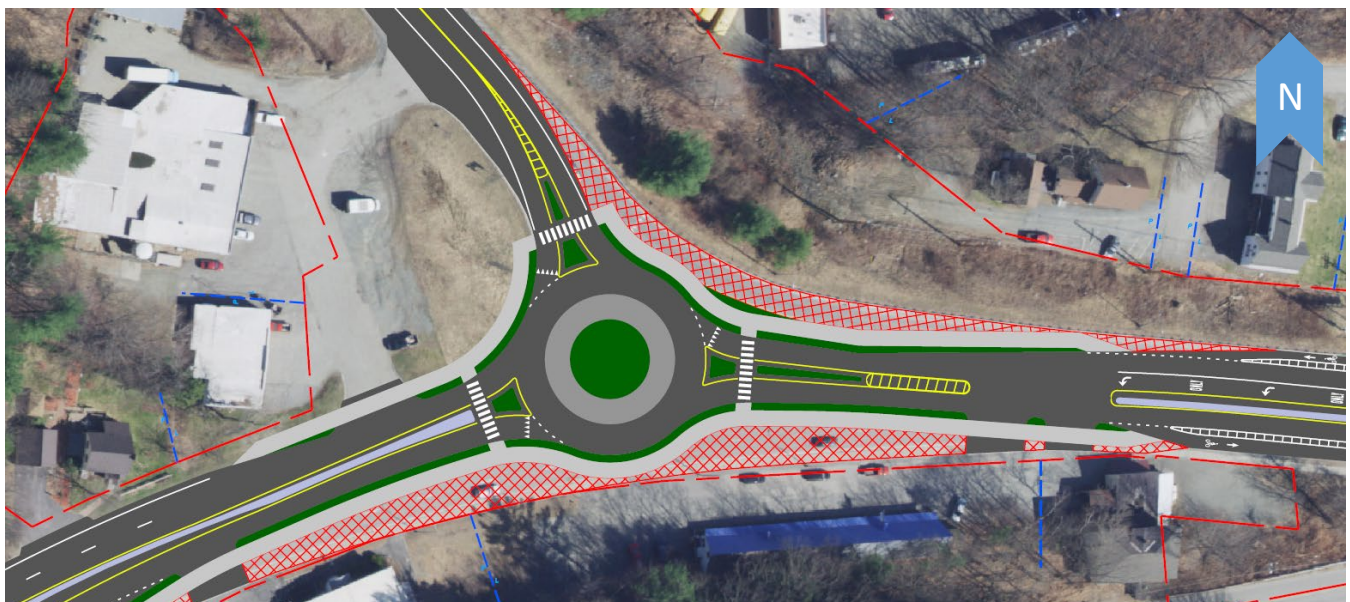
Figure 12. *Alternative #5 Intersection Layout.*

The final alternative – Alternative #5 – once again includes the road diet features shown along the US Route 5 approaches in the previous layouts, only now paired with a single-lane roundabout at the intersection (see *Fig. 12*). The proposed roundabout center is shifted slightly north of the existing intersection center to allow for proper deflection at all approaches and help mitigate right-of-way impacts. It features a 125-foot inscribed diameter and an 85-foot-diameter mountable truck apron to accommodate truck traffic.

Alternative #5 accommodates pedestrians and cyclists better than any of the other alternatives. Under this design, the bike lanes on US Route 5 transition to a shared use path at the roundabout's approaches. Like Alternatives #3 and #4, shoulder widening to the west of the intersection is included here to maintain a 5-foot width for cyclists, effectively providing adequate bicycle facilities in both directions along US Route 5. Lastly, proposed crossings at each leg of the intersection will allow pedestrians to safely navigate the entire intersection – something that could not be achieved by the other alternatives.

As with Alternative #4, access to the southern commercial property will also be impacted by this alternative. Proposed modifications once again include closing the access directly at the intersection closed and formalizing the eastern access. Other commercial driveways within the project area will largely remain the same, featuring only slight modifications needed to extend access beyond the shared use path.

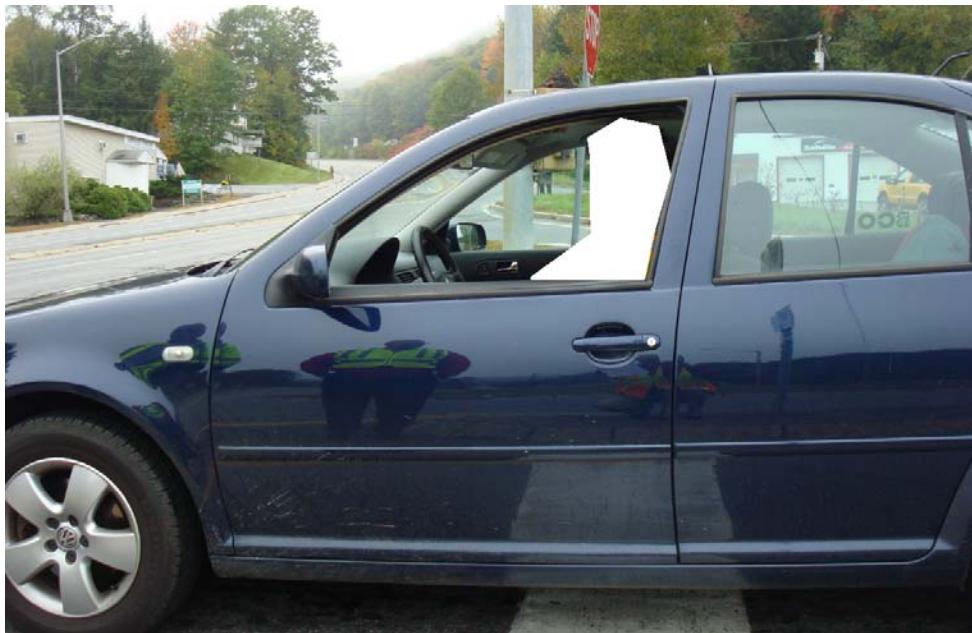
1. The view to US 5 northbound vehicles for left turners off US 4 looking south on US 5 could potentially be blocked by US 5 motorists that are waiting in the US 5 northbound left turn lane to turn onto US 4.
2. The pole in the grass island on US 4 could block the view of oncoming traffic from the south.

3. Motorists who are making a left turn from US 4 have to cross many lanes.
4. Motorists coming down the hill during winter could be an issue.
5. There is a lot of truck traffic.

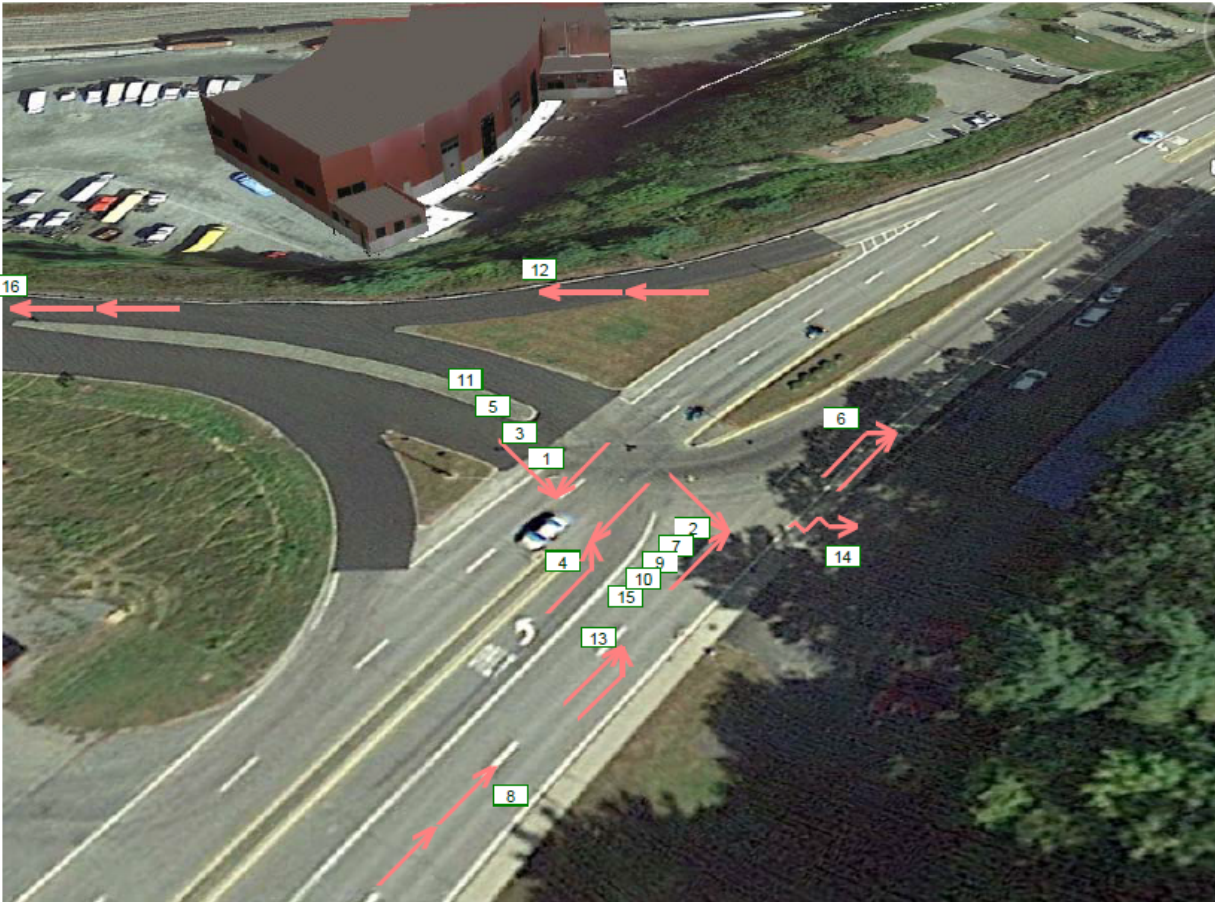
MUNICIPALITY: Hartford COUNTY: _____
 INTERSECTION: US-5
 PERIOD: 5 YEARS 0 MONTHS FROM 1/1/2011 TO 12/31/2015

FILE: hartforUS4US5B
 CASE # : _____
 BY: _____ DATE: 12/29/2016

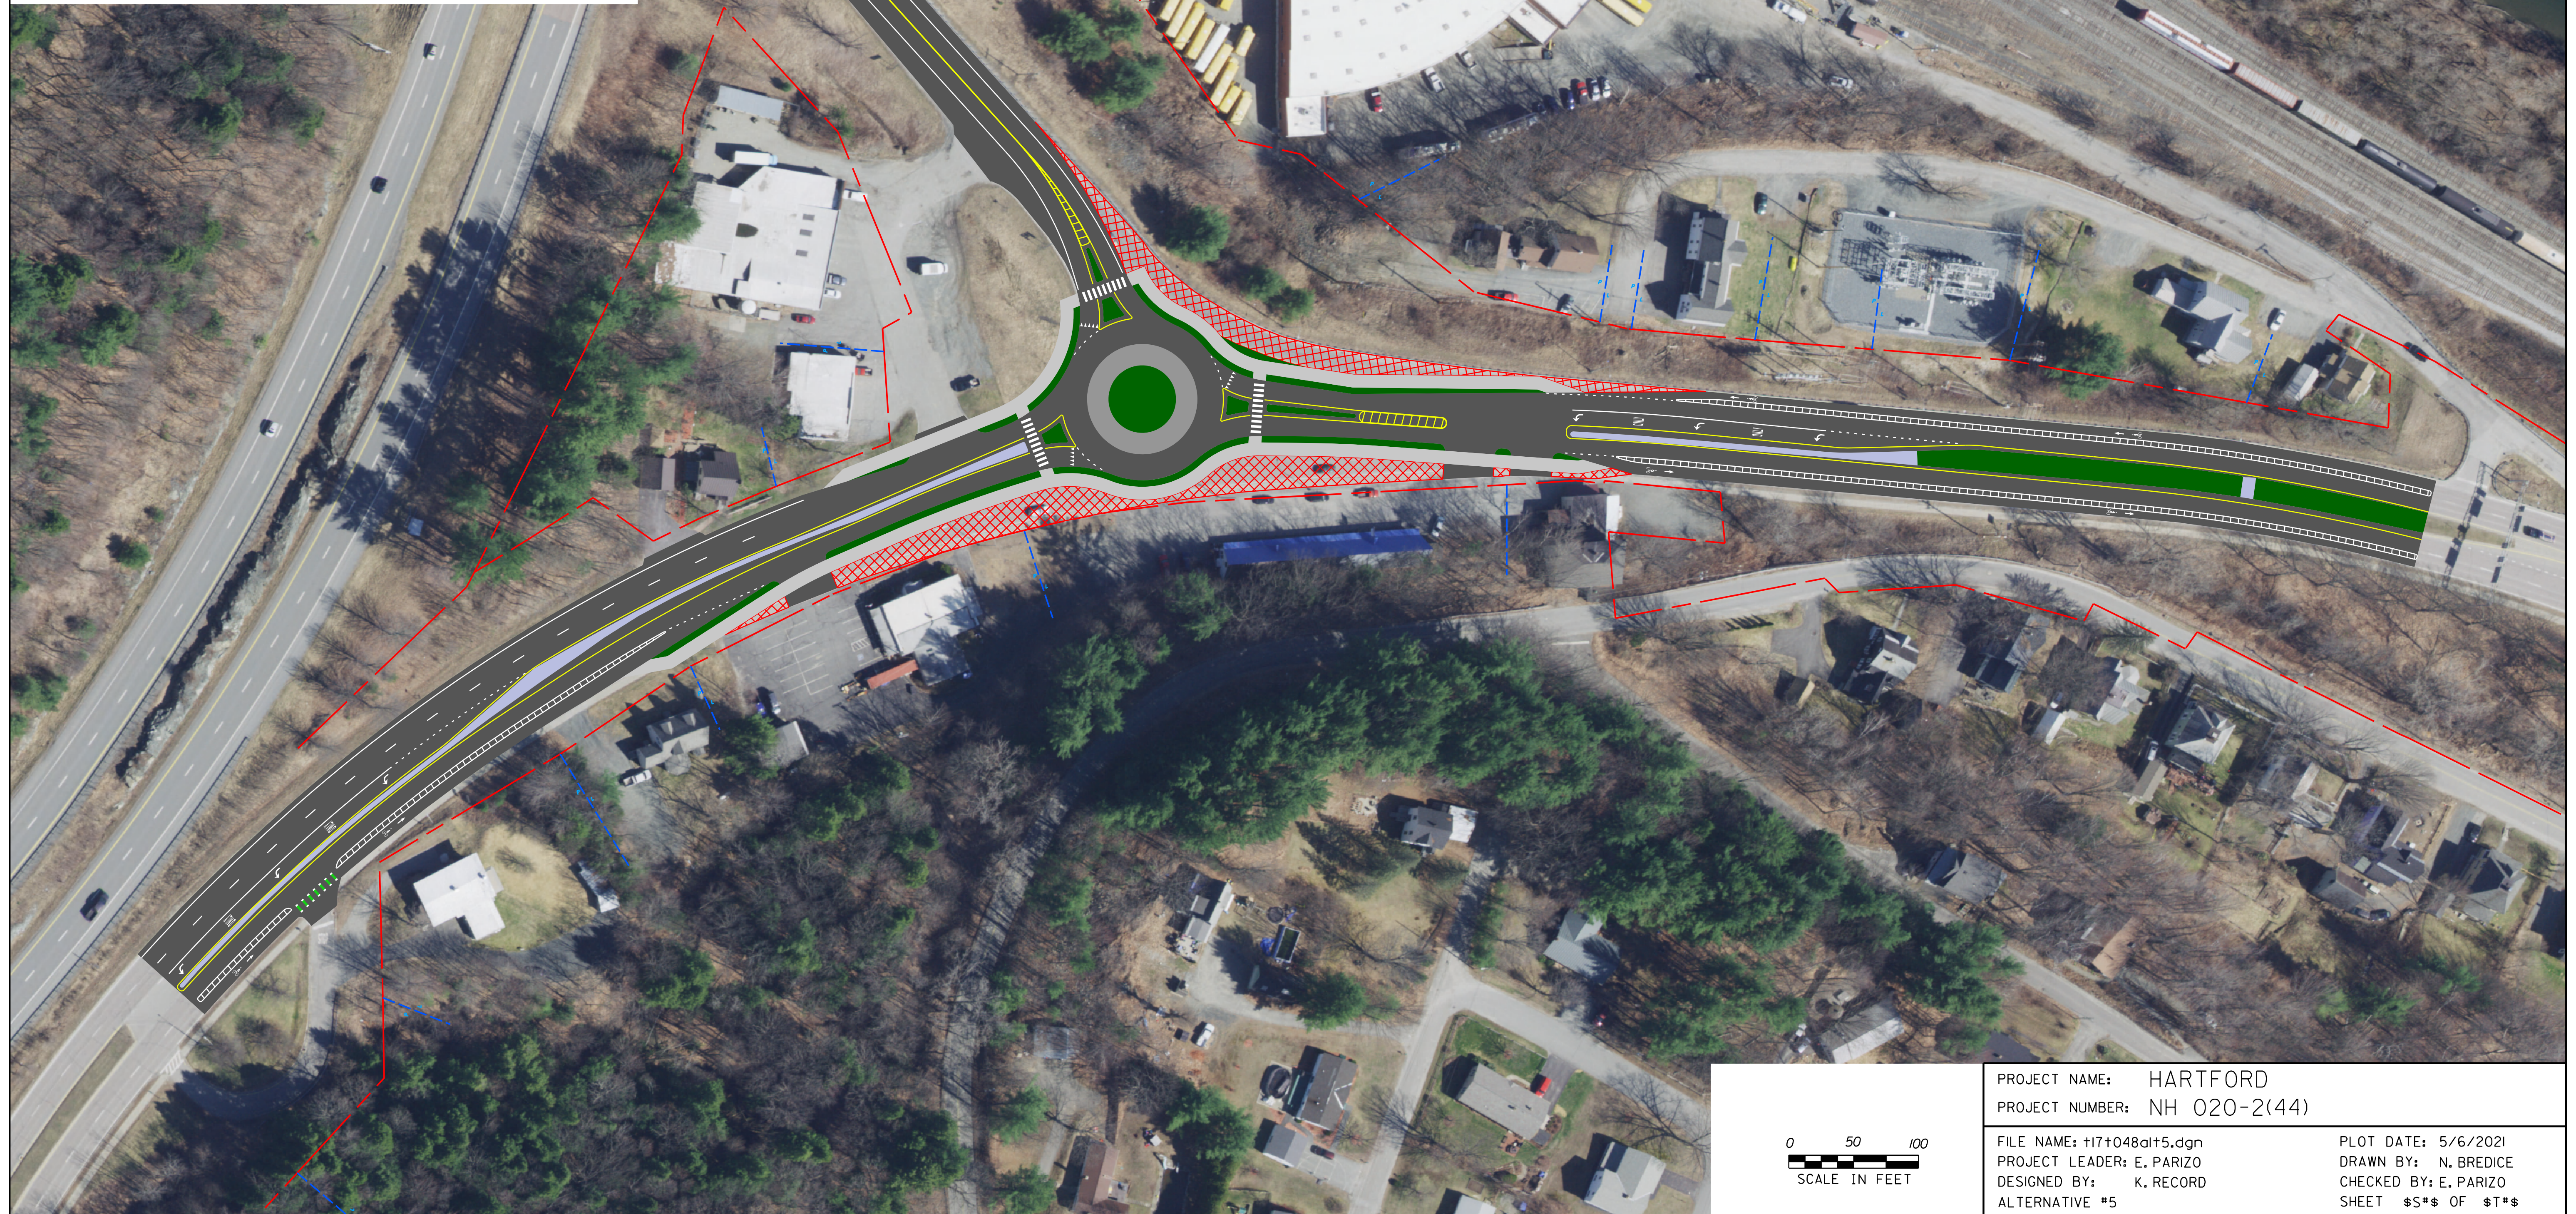
FILE NAME: t17+048alt5.dgn
PROJECT LEADER: E. PARIZO
DESIGNED BY: K. RECORD
ALTERNATIVE #5

- PROPOSED ROADWAY
- EXISTING CONCRETE ISLAND
- EXISTING GRASS ISLAND
- REMOVAL OF EXISTING ROADWAY
- PROPOSED SHARED USE PATH
- PROPOSED ROUNDABOUT APRON
- EXISTING STATE RIGHT-OF-WAY LINE
- EXISTING PROPERTY LINE
