US Route 7 - Exchange St & Happy Valley Rd Intersection and Corridor Improvements Scoping Report

Middlebury, VT

May 2, 2024

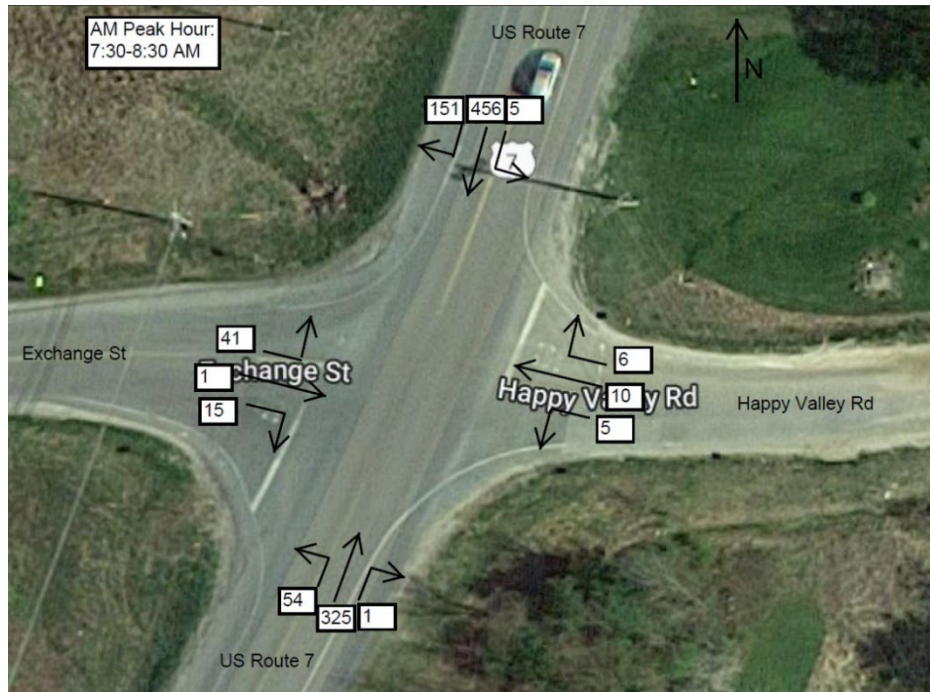
Figure 2. AM peak hour turning movement visualization.

The most recent VTrans turning movement counts at this intersection were performed on April 27th, and April 28th in 2015. The three peak hours were determined to be 7:30-8:30 AM, 10:45-11:45 AM, and 4:15-5:15 PM. This peak hour data was used in the analysis of design alternatives explored in this report.

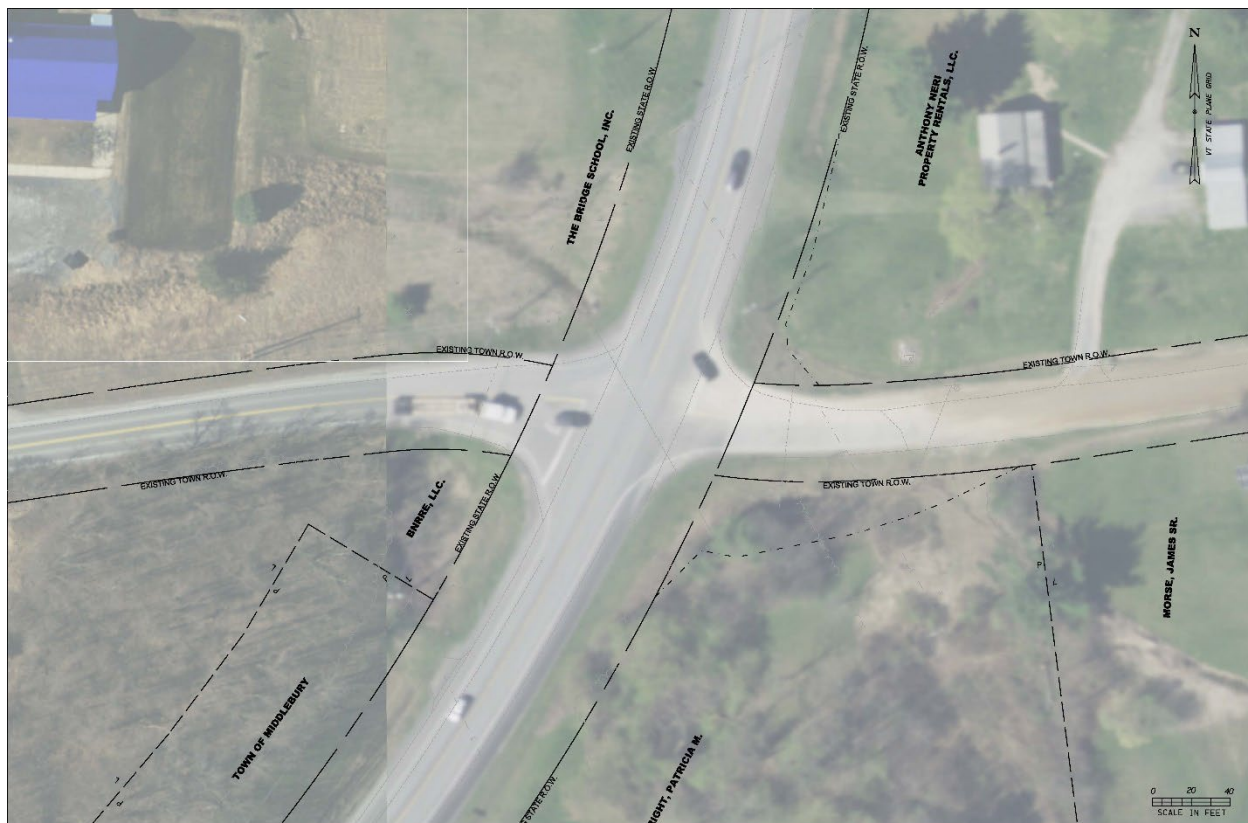
The US Route 7 right of way is approximately 66 feet wide through the project area. The right of way on both Exchange St and Happy Valley Rd is approximately 50 feet wide. The image below shows the approximate location of the existing right of way at the US Route 7 - Exchange St & Happy Valley Rd intersection.

Figure 6. Existing ROW at the US Route 7 & Exchange St/Happy Valley Rd intersection.

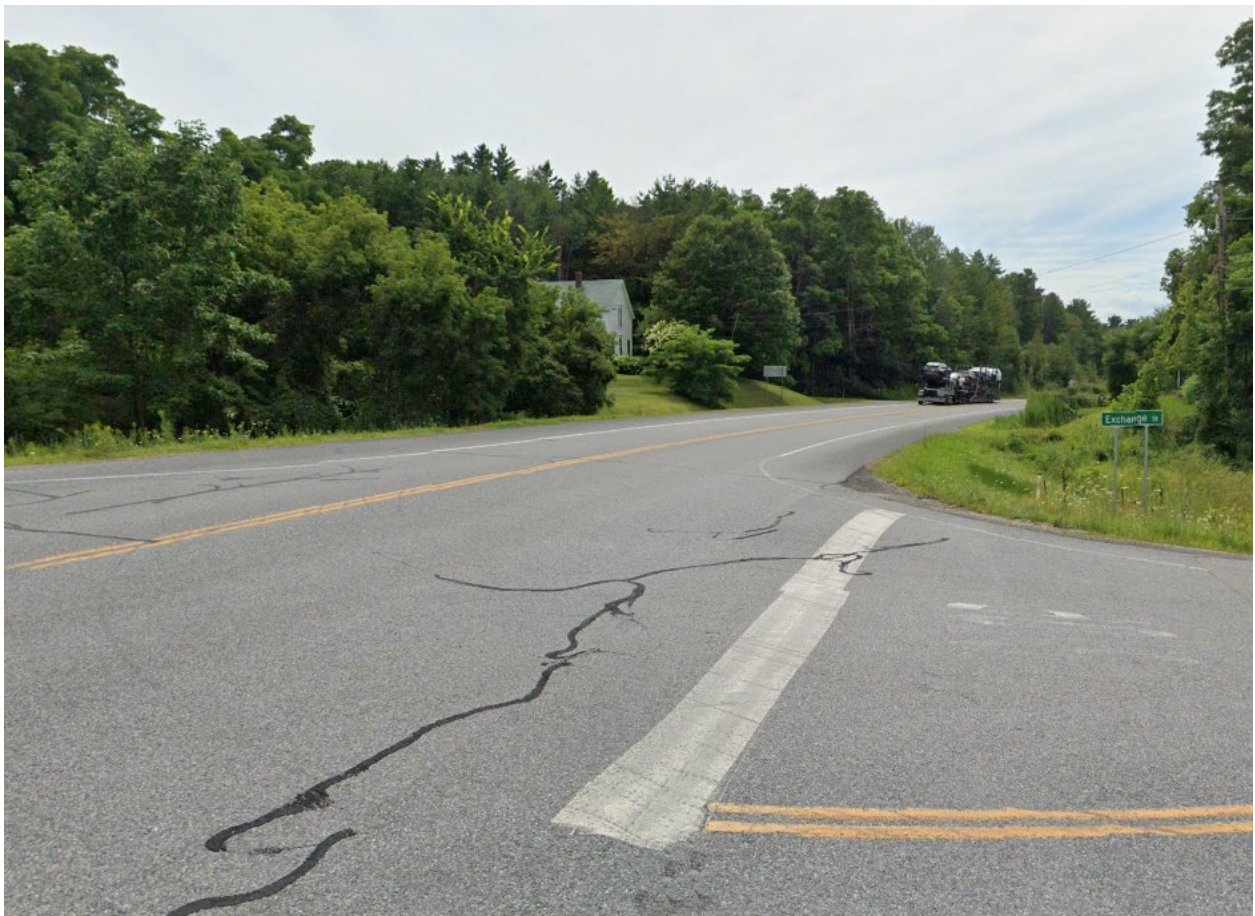
A 2004 scoping study determined that the corner sight distance for a vehicle sitting at the stop bar on the Exchange St approach is approximately 400 feet in the intersection's existing condition. Based upon AASHTO recommended guidelines, the minimum corner sight distance should be 555 feet given that the speed limit on US Route 7 is 50 MPH meaning that the current corner sight distance is inadequate by approximately 155 feet.

Figure 7. View from a vehicle at the stop bar on the Exchange St approach, looking south along US Route 7.

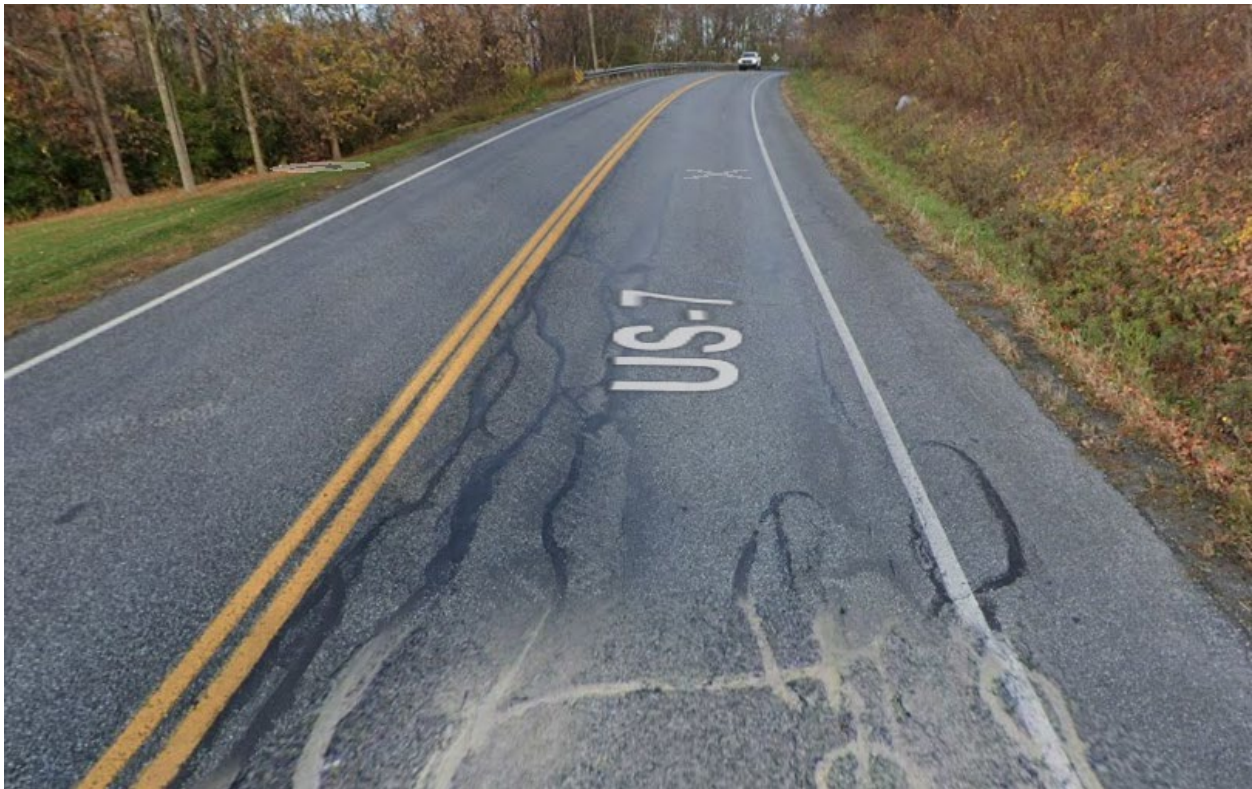
- **The pavement condition** along the corridor has been identified as a concern. The corridor was last resurfaced with a two-inch wearing course as a part of the Middlebury-New Haven NH 9813(1)S project completed in 2007. The most recent paving project that has come through the corridor was the Middlebury-Ferrisburgh NH SURF (55) project which was completed in 2017. The work that was performed as a part of that project included pothole repair, crack sealing, and micro-milling and overlay with a thin layer of bituminous material. Upon visual inspection of the corridor's pavement condition, it can be seen that some cracks have formed in the pavement surface since the completion of the Middlebury-Ferrisburgh NH SURF(55) project, see the images below.

Figure 8. Google street view imagery of the pavement condition as of October 2022.

In order to address the aging pavement condition along the corridor, it is recommended that a two-inch depth coarse mill and overlay be performed along the length of the corridor. The total cost of this work was estimated to be approximately \$219,000. An additional consideration for an even more durable solution to the pavement condition would be to perform a full-depth reclamation of the corridor. The cost of this work historically averages approximately \$1.5 million per mile, making the roughly estimated cost to perform a full depth reclamation of the entire corridor approximately \$1.45 million. These totals do not account for any additional costs incurred by traffic control, contingency, mobilization, or engineering costs.

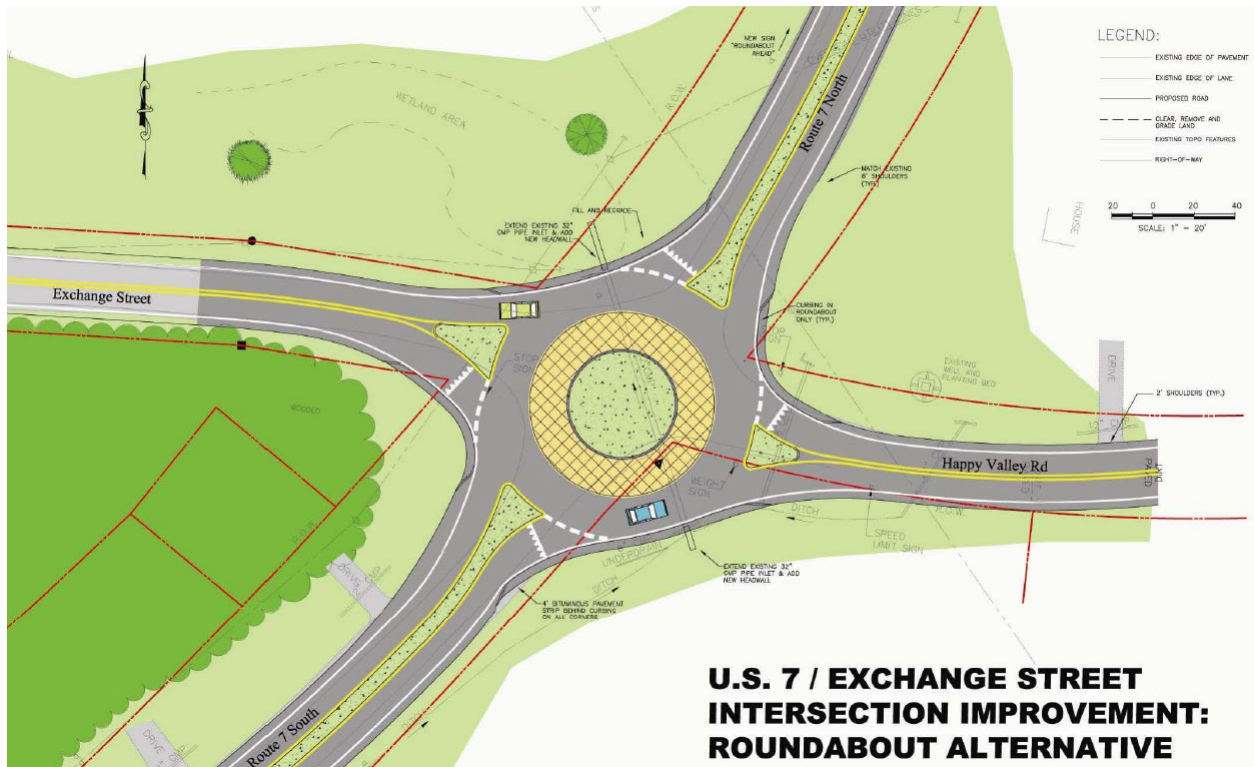
Figure 9. Visualization of the conceptual roundabout design from the 2004 scoping study.

The intersection performance as a roundabout was analyzed using SIDRA software as a part of this report. The results from the analysis are shown in the tables below.

As can be seen from the SIDRA analysis results in Table 4, when using a single lane roundabout for traffic control, the level of service is improved to an A for almost all approaches and peak hours. The lowest level of service for any approach was a B. Compared to the existing condition SYNCHRO results in Table 3, a roundabout clearly eliminates the excessive delays that are being experienced by vehicles in the intersection's existing condition and improves the level of service for all approaches while minimizing delays.

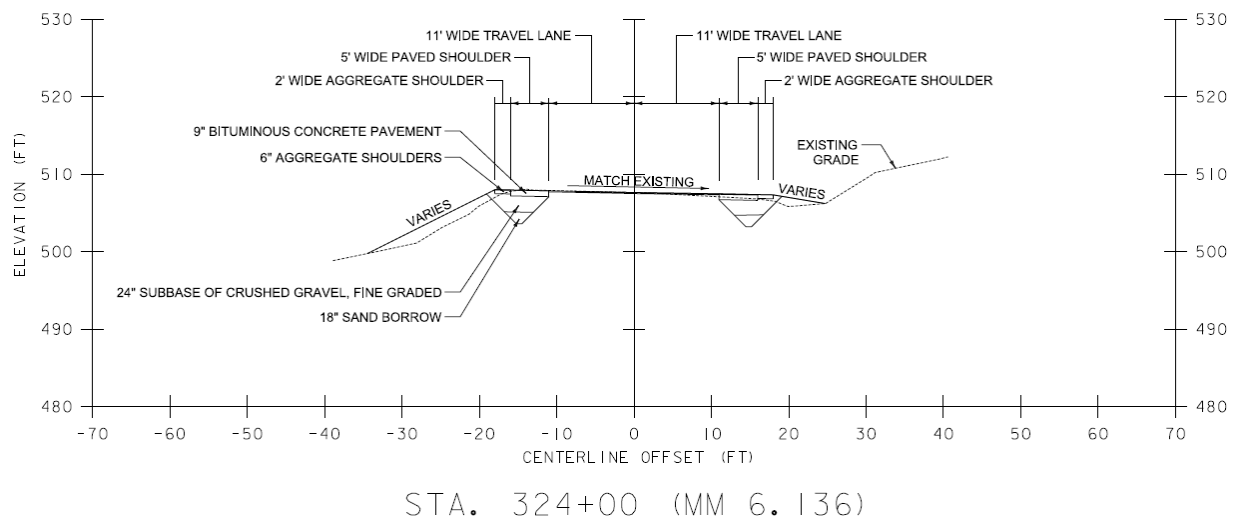
This stretch of US Route 7 has previously been identified as a high priority bicycle corridor. To address the existing inadequate shoulder width and accommodate bicyclists, it is recommended that they be expanded to a uniform width along the corridor. Following AASHTO guidance, the recommended width of a bicycle lane adjacent to guardrail is 5' minimum. Two conceptual 3D models using InRoads were created as a part of this study and their potential impacts analyzed. The conceptual models contained two scenarios. One assumed 5' paved shoulders, and 2' aggregate shoulders. The second assumed a 3' painted buffer, a 5' bicycle lane and 2' aggregate shoulders. Through the modeling, it was determined that in both scenarios expanding the existing shoulders on the eastern and western side of US Route 7 through the corridor resulted in relatively little impacts on the parcels adjacent to the corridor. In fact, the conceptual limits of construction all fell within the existing state ROW. The most significant impacts would be to the western side of the corridor, as there are existing steep embankments that would need to be bumped out to accommodate the shoulder widening. Overhead utilities running adjacent to the corridor would need to be adjusted to accommodate the widening, and culverts would need to be extended. See the visualization below of a cross section showing the typical impacts of the shoulder widening. See appendix G for a visualization in plan view showing the conceptual limits of construction that would result from both shoulder widening scenarios.

Figure 10. Cross section of the conceptual model of US Route 7 displaying the typical impacts to the corridor with 5' shoulders on the eastern and western side.

The roughly estimated cost of the 5' shoulder expansion with no painted buffer was calculated to be approximately \$547,000. The roughly estimated cost of the 8' shoulder expansion to accommodate a bike lane and painted buffer was calculated to be approximately \$856,000. This total does not account for any additional costs incurred by utility relocation, drainage extension, traffic control, mobilization, contingency, or engineering costs.

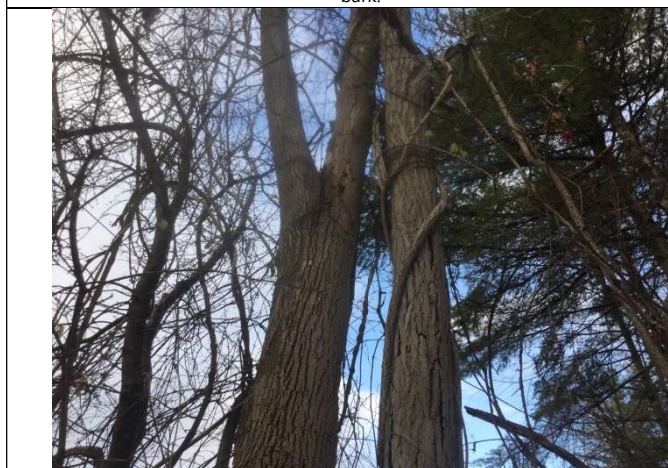
Photograph 17. PRTs 2019-103 and 2019-104. Observe Asiatic bittersweet (*Celastrus orbiculatus*) on right bole has killed the tree and caused the bark to slough, creating roost potential.

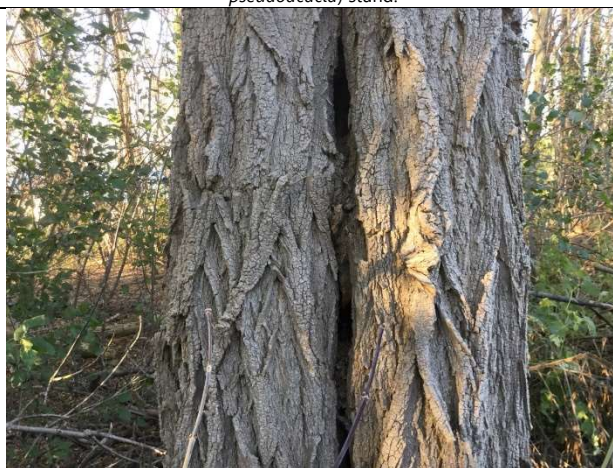
Photograph 18. PRT 2019-45. Crack within black locust (*Robinia pseudoacacia*) bole.

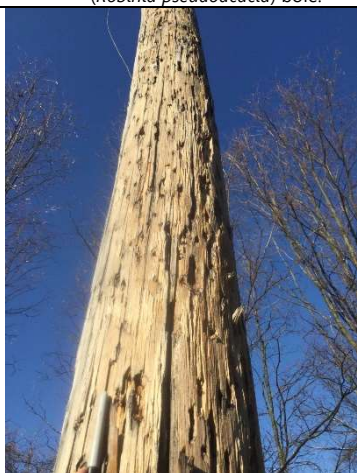
Photograph 21. PRT 2019-62. Utility pole with potential roost cavities.

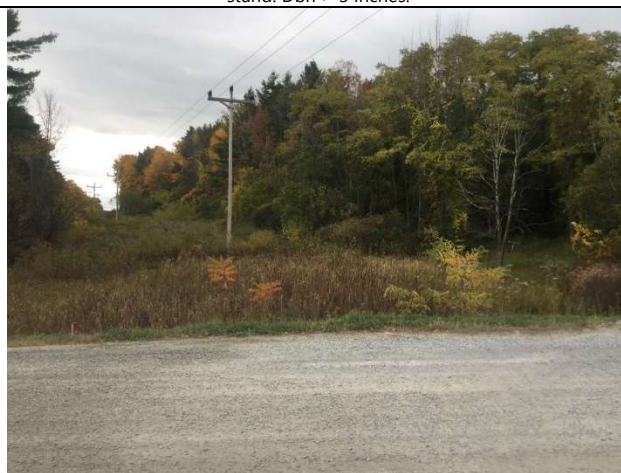
Photograph 22. OHW crossing over wetland 2019-3.

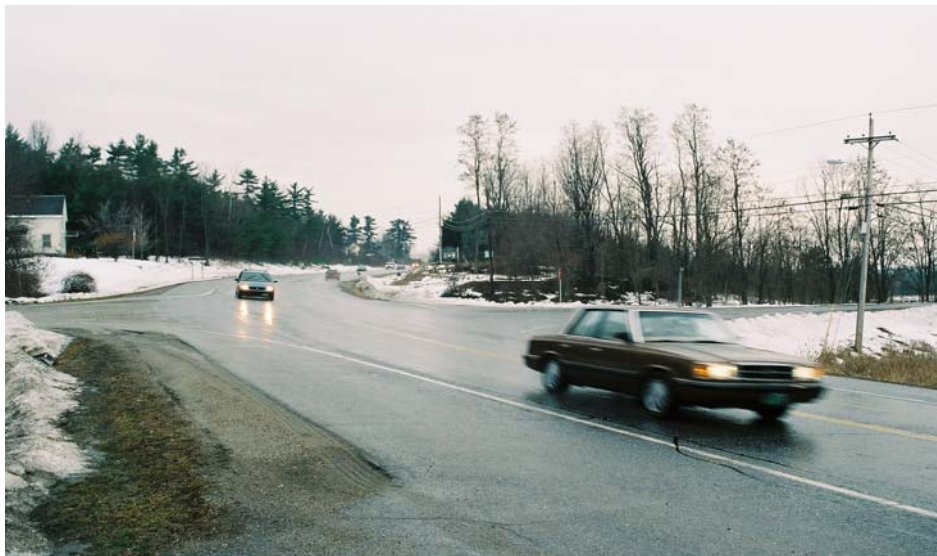
Photograph 1: Happy Valley Road, Route 7 and Exchange Street Intersection in Middlebury, Vermont.

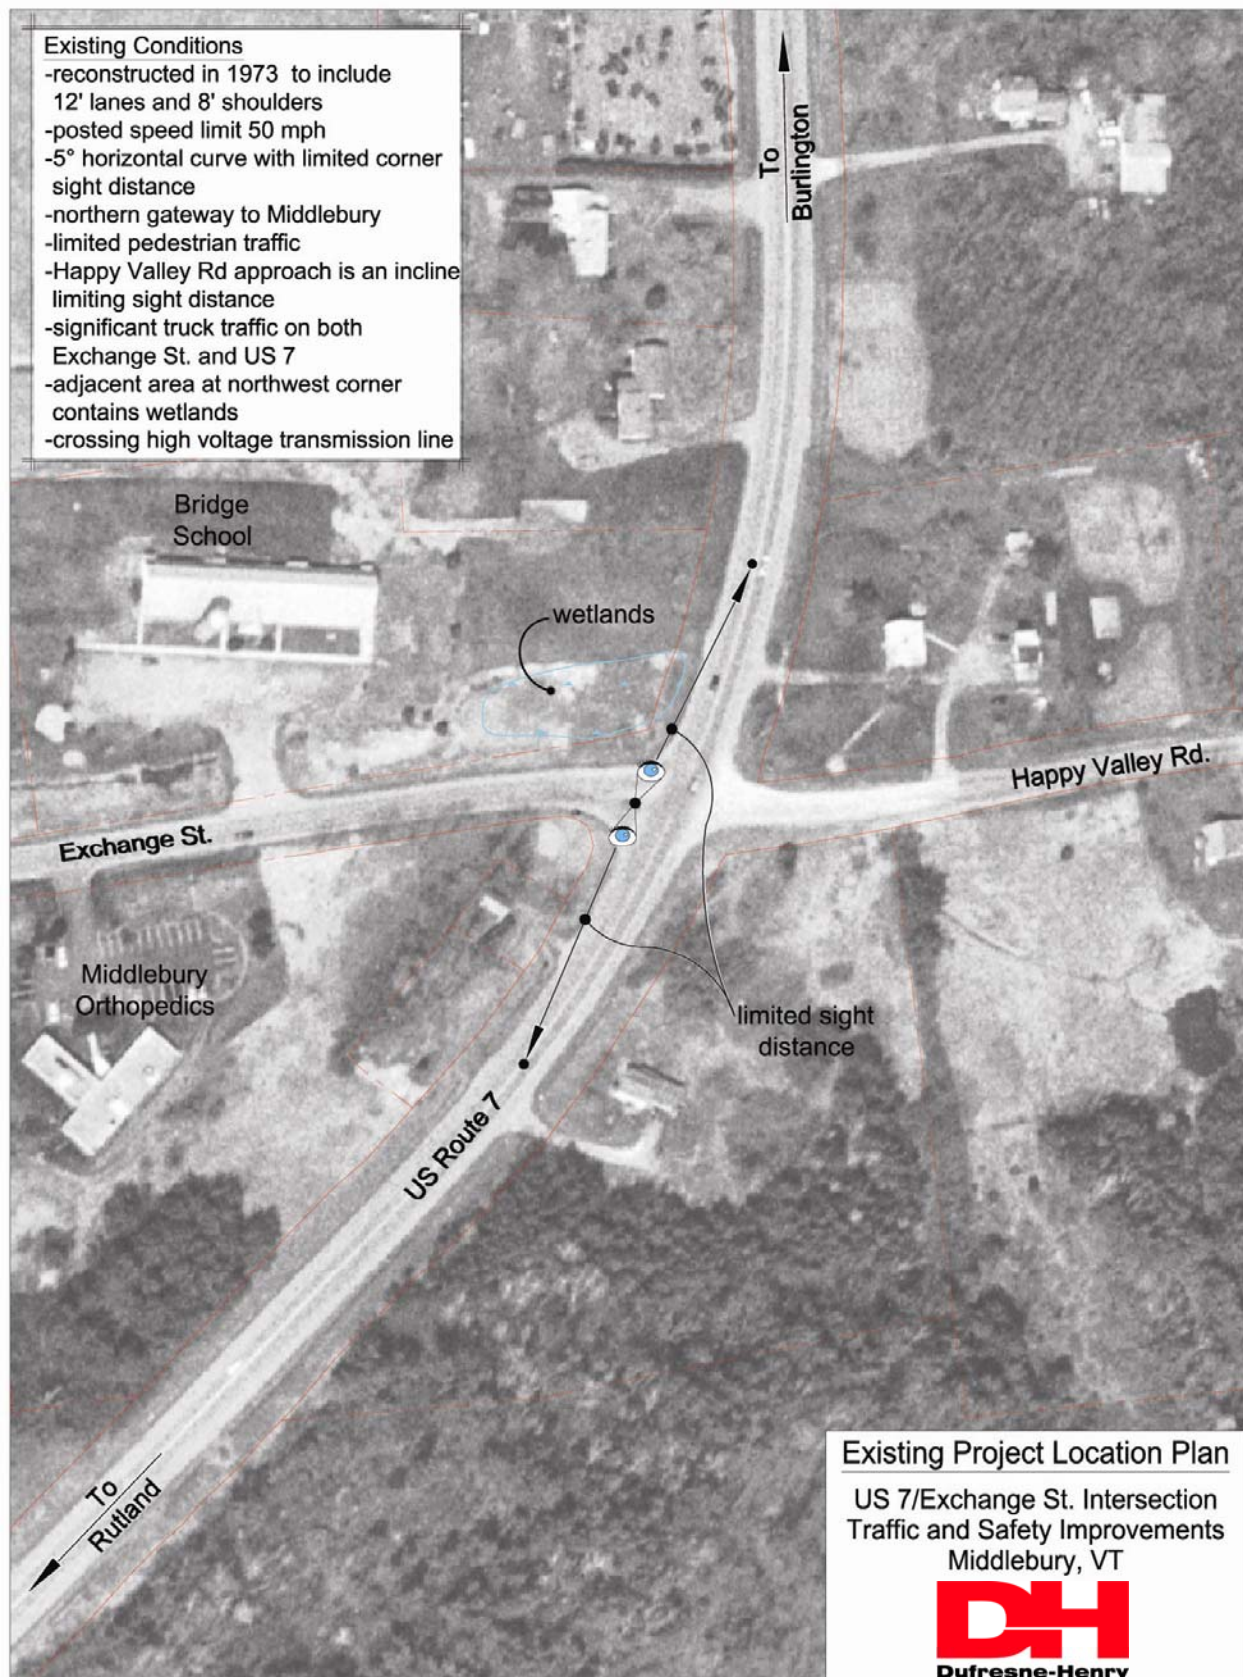
Figure 1: Existing Project Location Plan for the Exchange Street / Happy Valley / Route 7 Intersection.

U.S. Route 7 is one of Vermont's major north / south transportation corridors. It functions as a principle arterial, is state owned and maintained, and has an average annual daily traffic (AADT) of approximately 10,200 vehicles. Exchange Street provides access to the Middlebury industrial area and is an alternative route connecting Middlebury Village and U.S. Route 7 North. The intersection forms the northern gateway to Middlebury. Figure 1 shows the existing project location for this intersection.

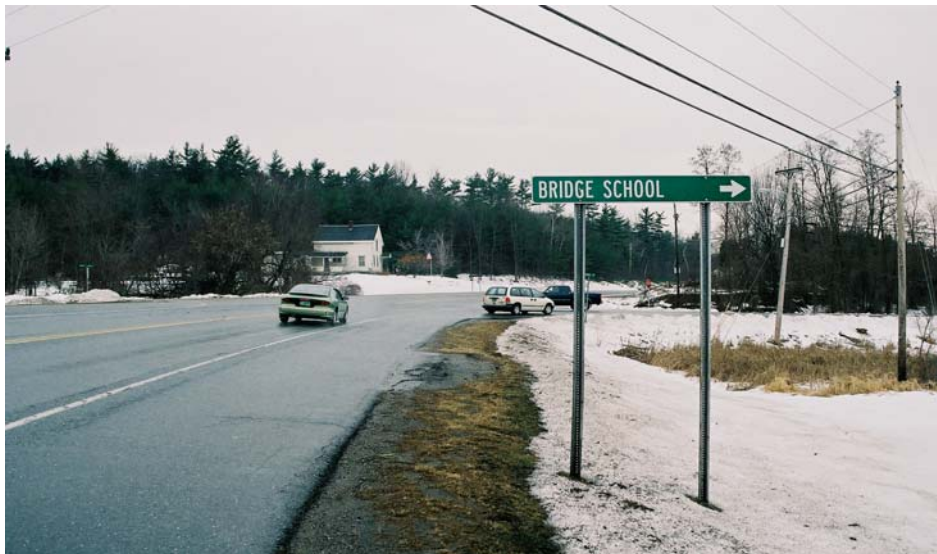
Photograph 2: This photograph was taken looking south on Route 7 at the project intersection.

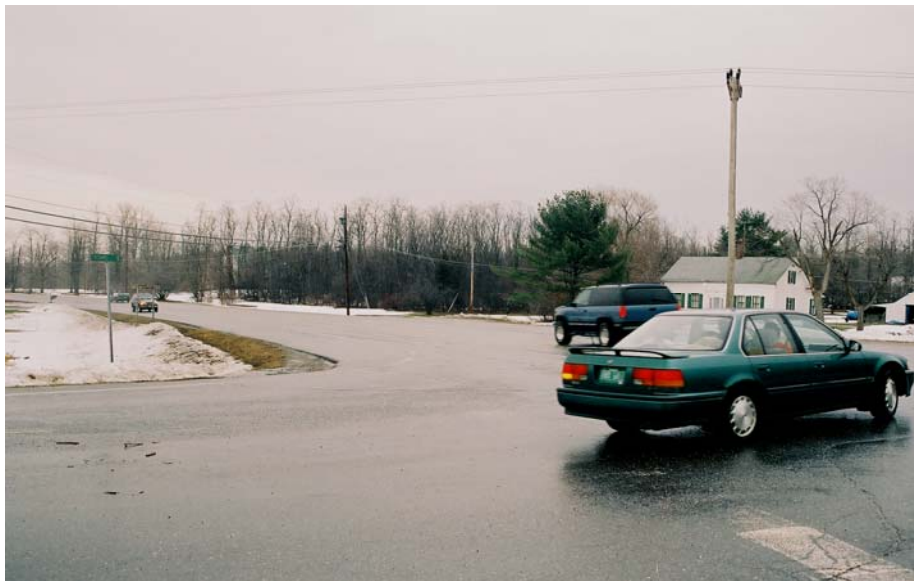
Photograph 3: Turning left from Exchange Street north onto Route 7. The known wetland is located in the left corner of this photograph.

There is an adjacent area to the northwest corner that contains a sensitive wetland.

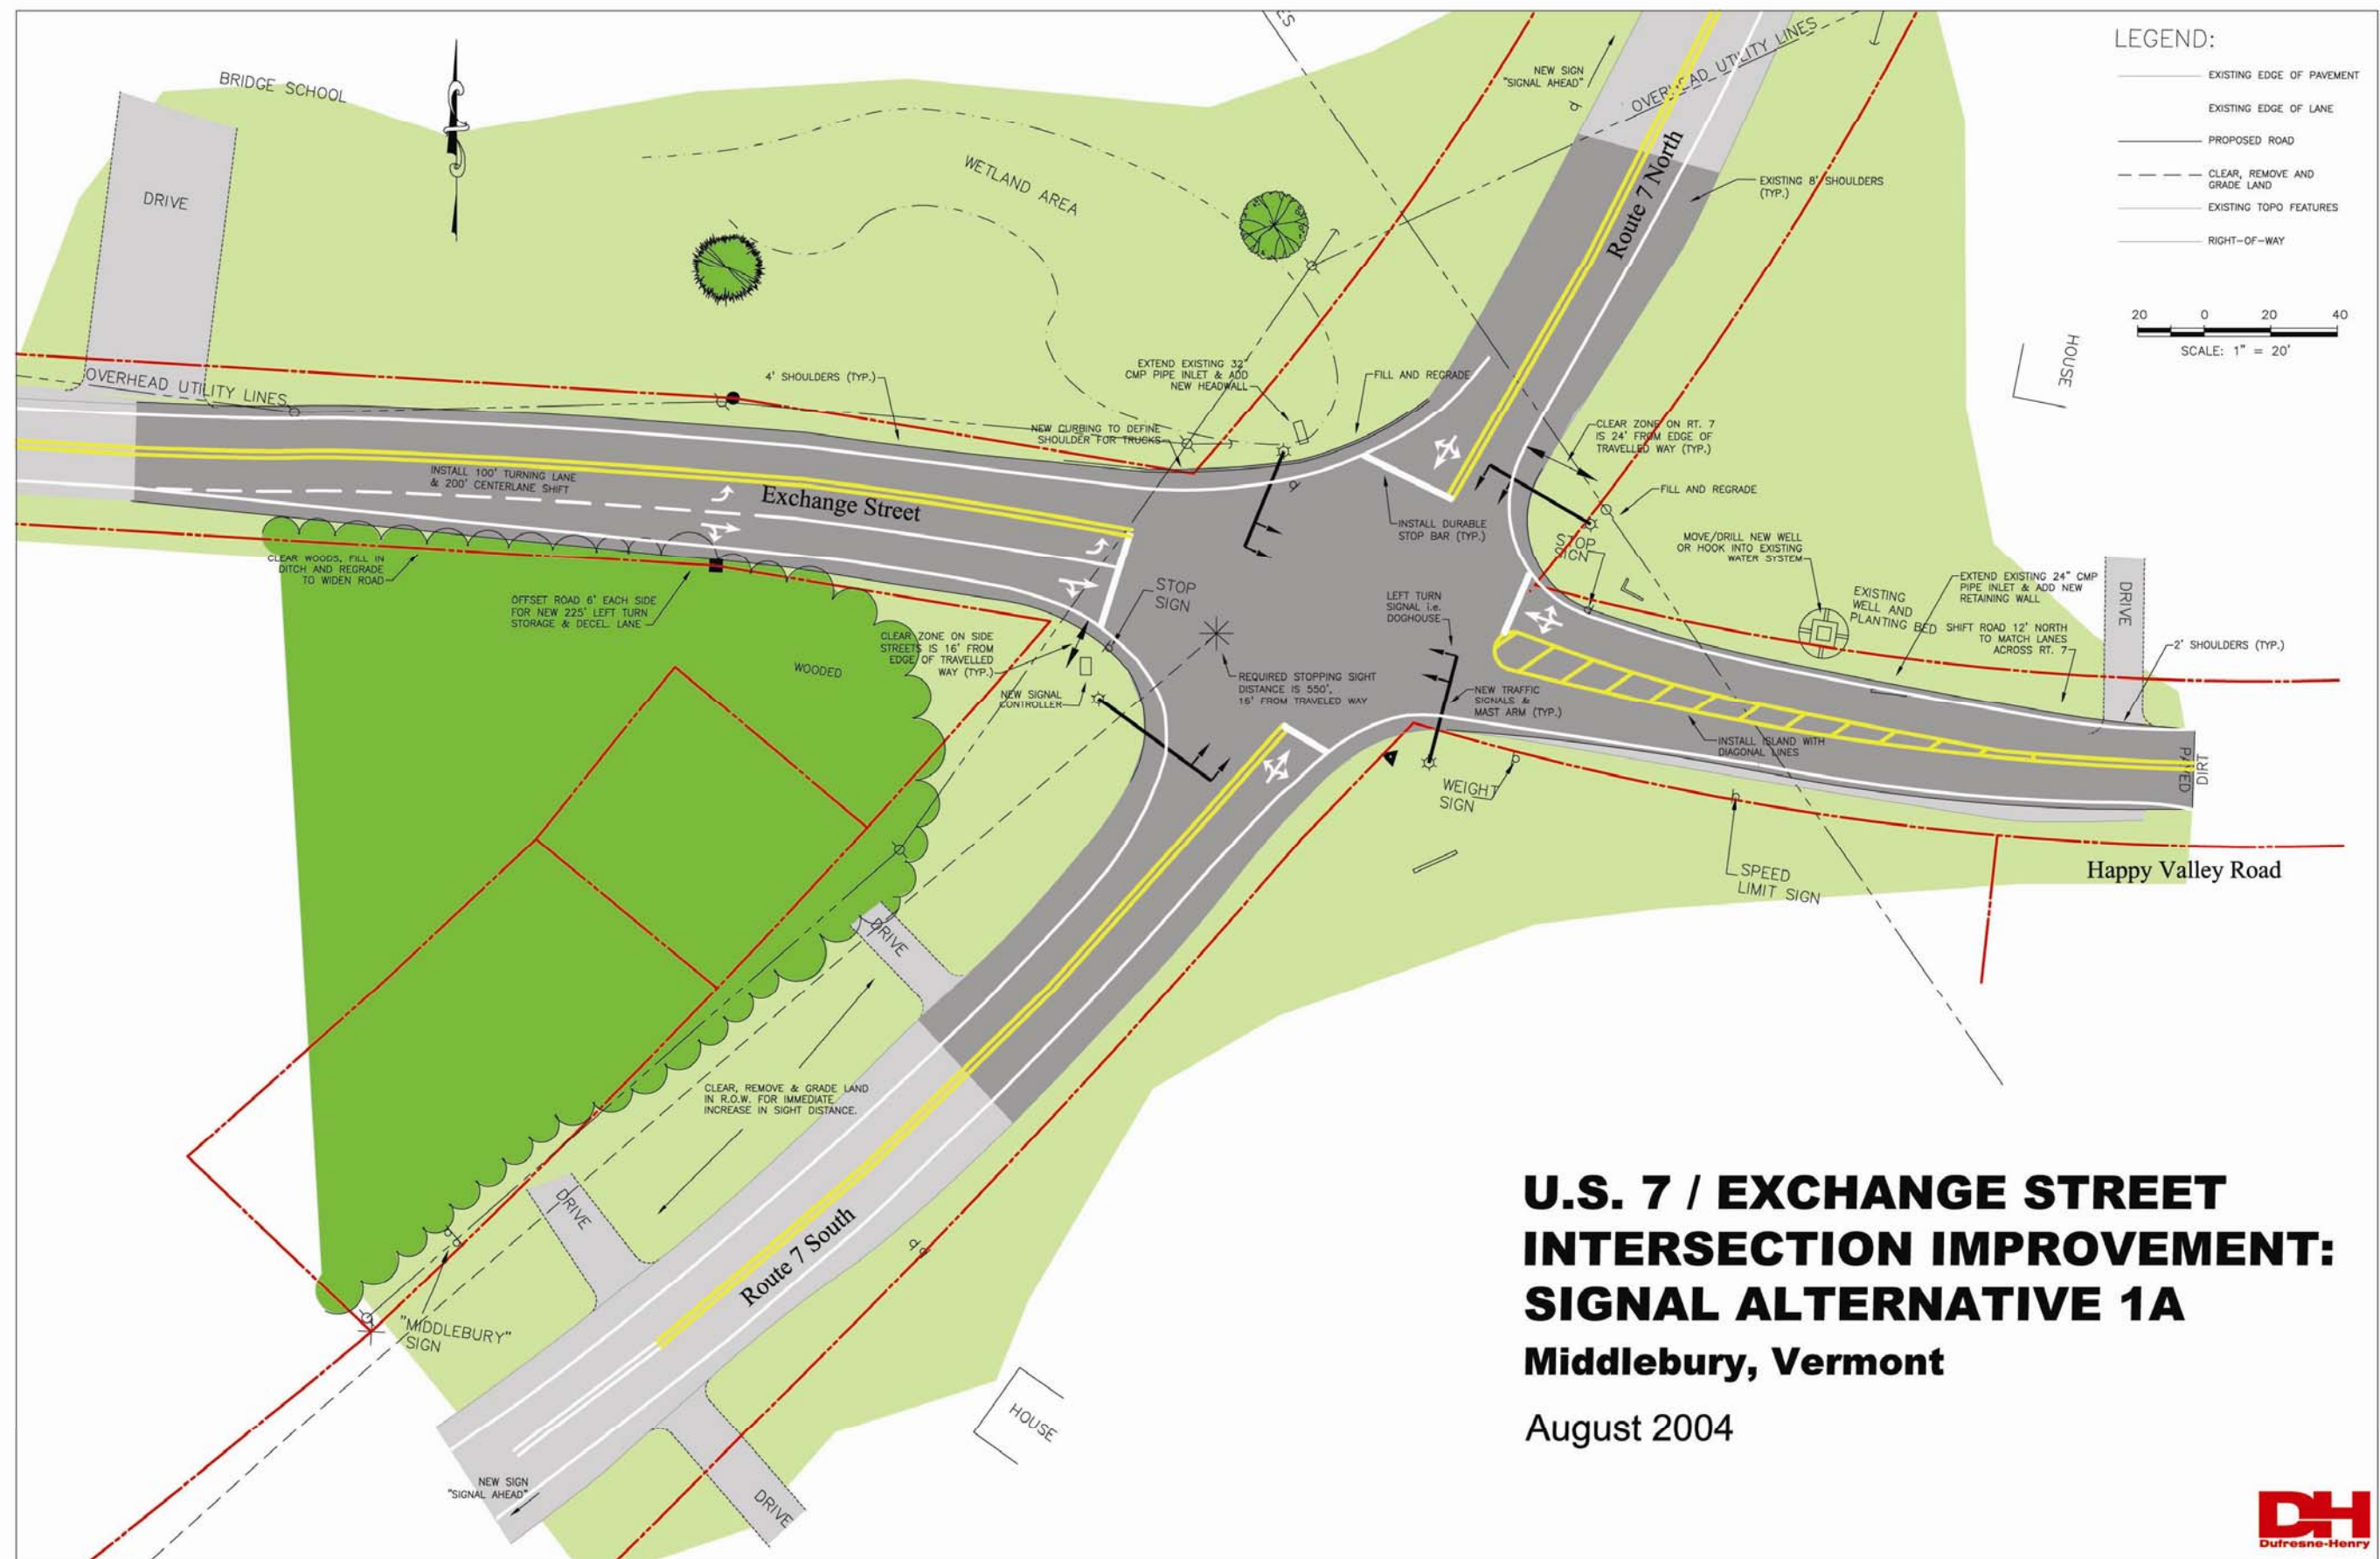
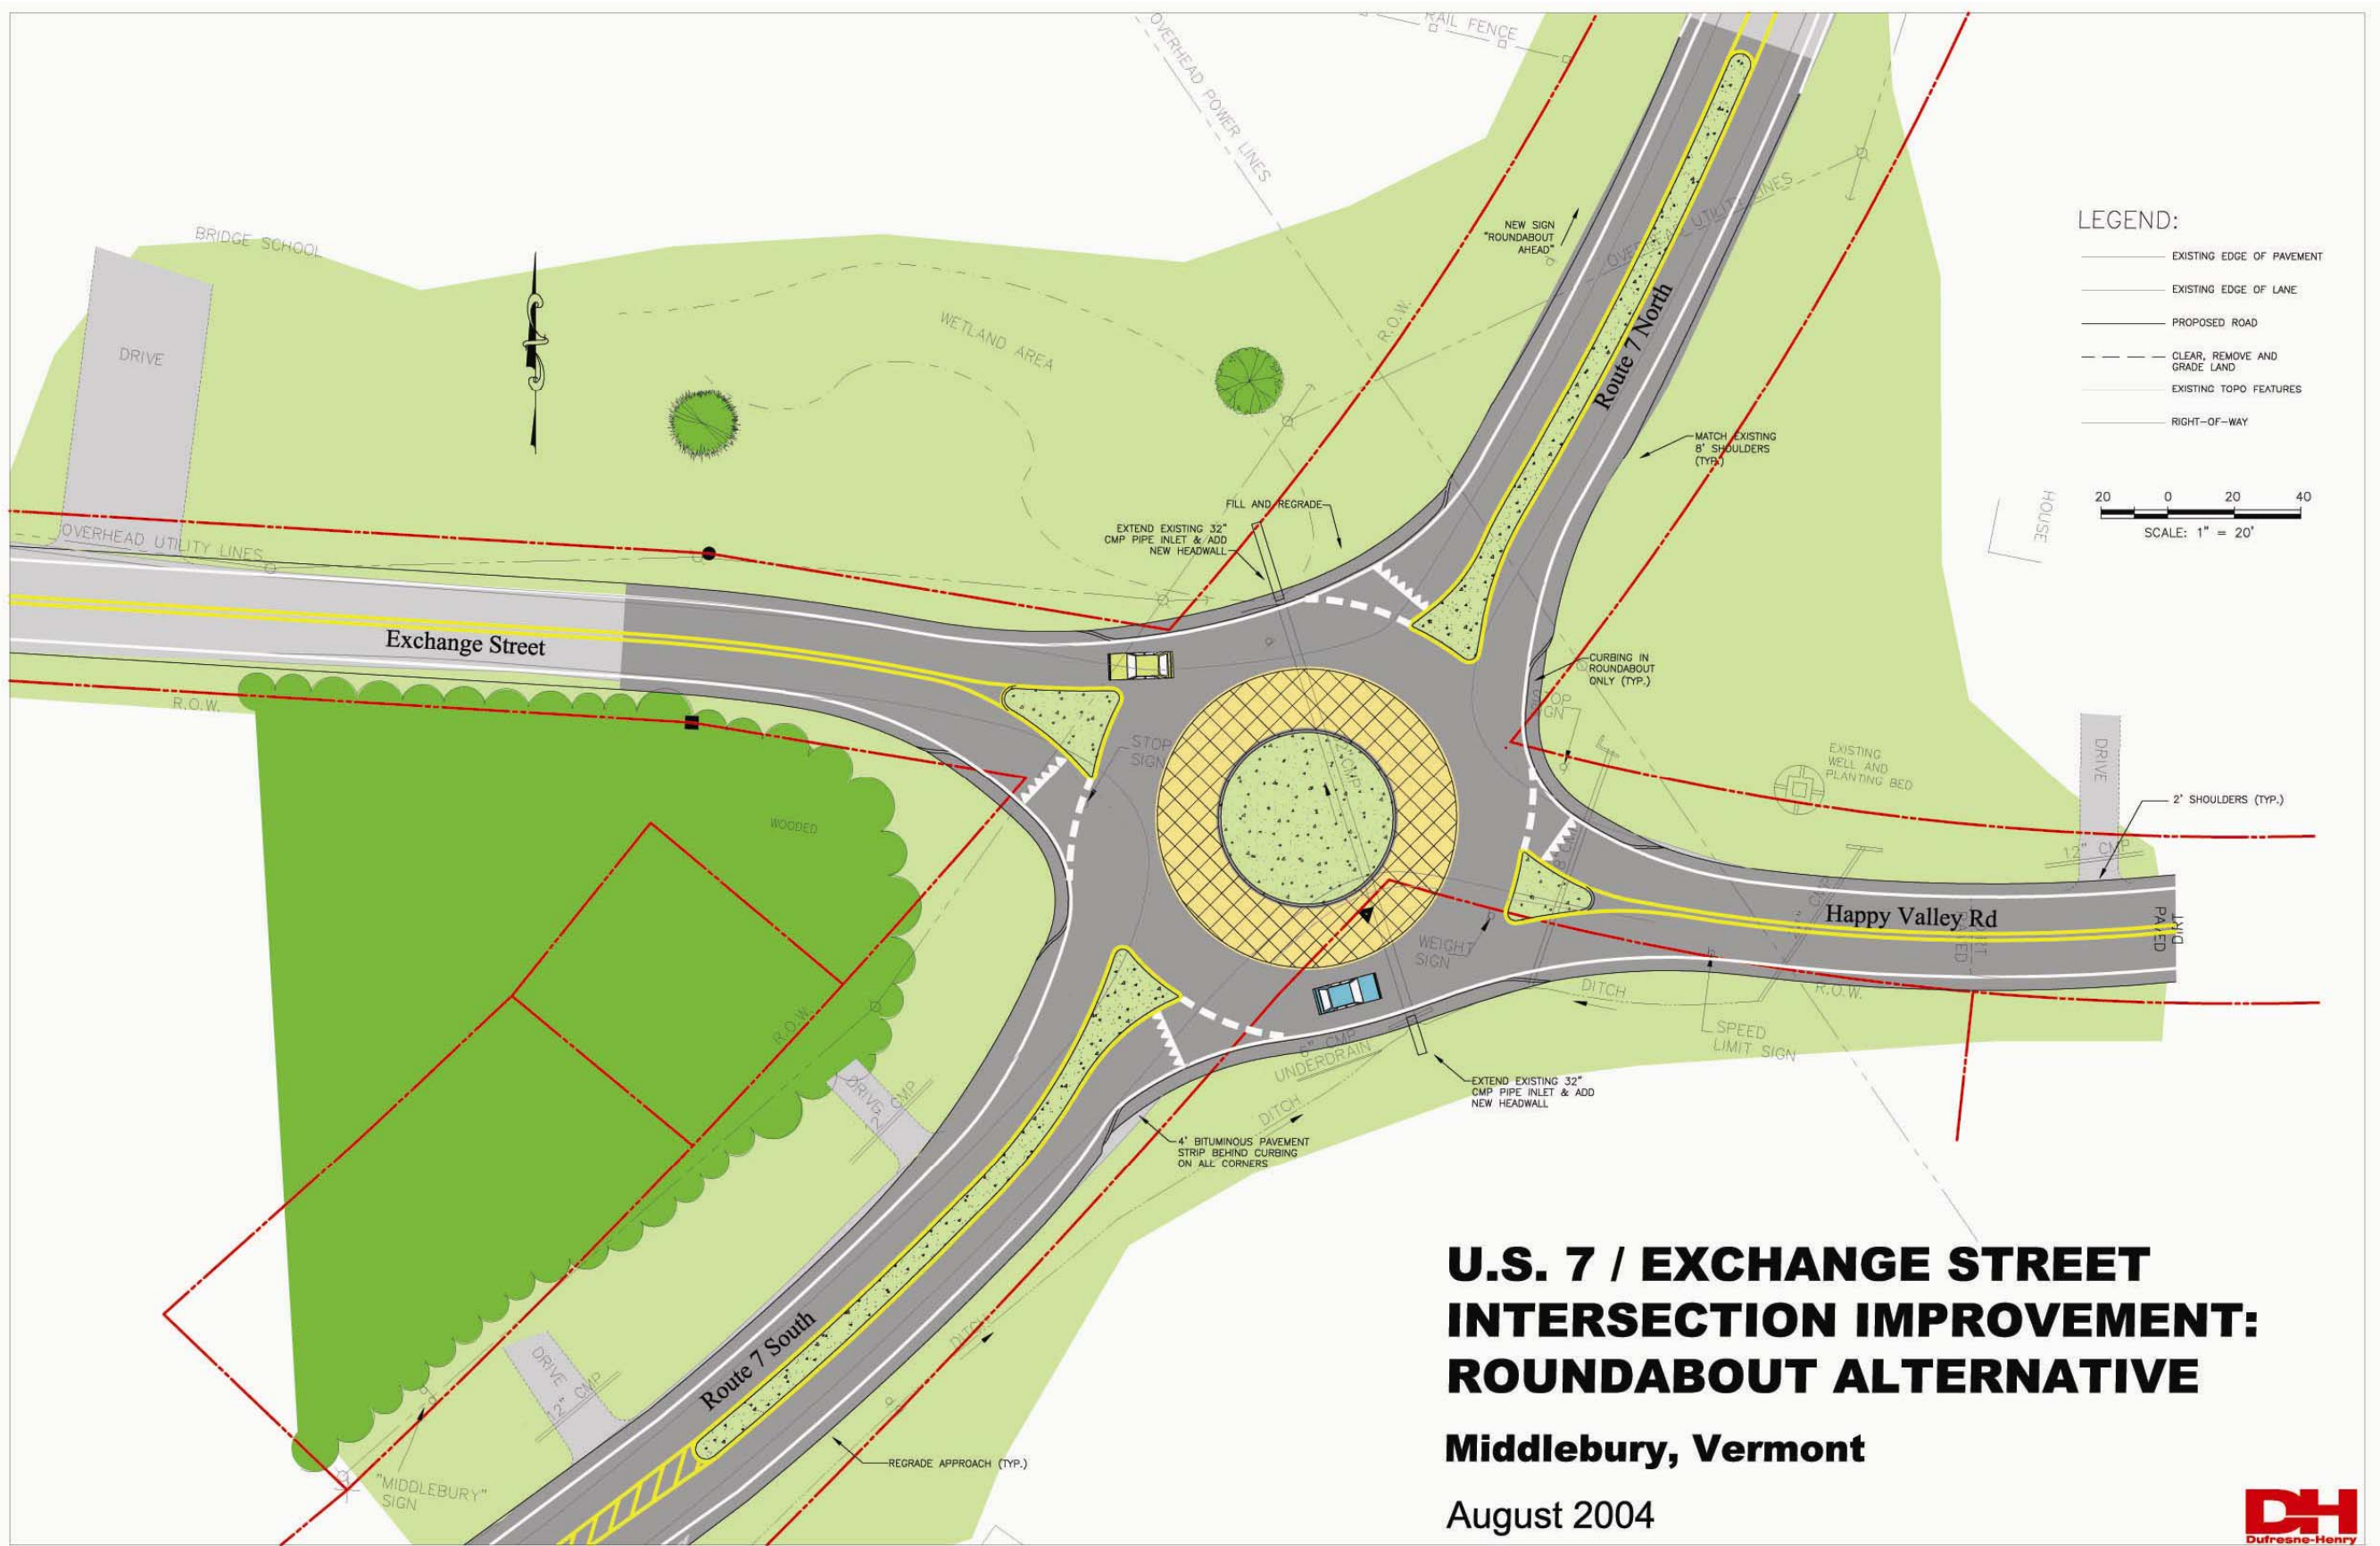
Figure 4: Roundabout Alternative Design Plan.

- ◆ Roundabouts have a higher initial cost than a signalized intersection.
- ◆ There is low public acceptance before construction.
- ◆ Public education may be necessary for smooth transition and proper driver behavior. Many motorists may feel that US 7 has the right-of-way when the vehicle in the roundabout has the right of way.
- ◆ Traffic disruptions may be more significant during construction.
- ◆ Winter maintenance costs are higher than a conventional intersection.
- ◆ A 20 mph roundabout is not desirable in a 50 mph zone. This alternative requires reducing the posted speed on approaches to 40 mph.
- ◆ For VTrans acceptance, it may require the Class I section of US 7 be extended to include this intersection.
- ◆ It restricts left hand turns to driveway on US 7 south approach.

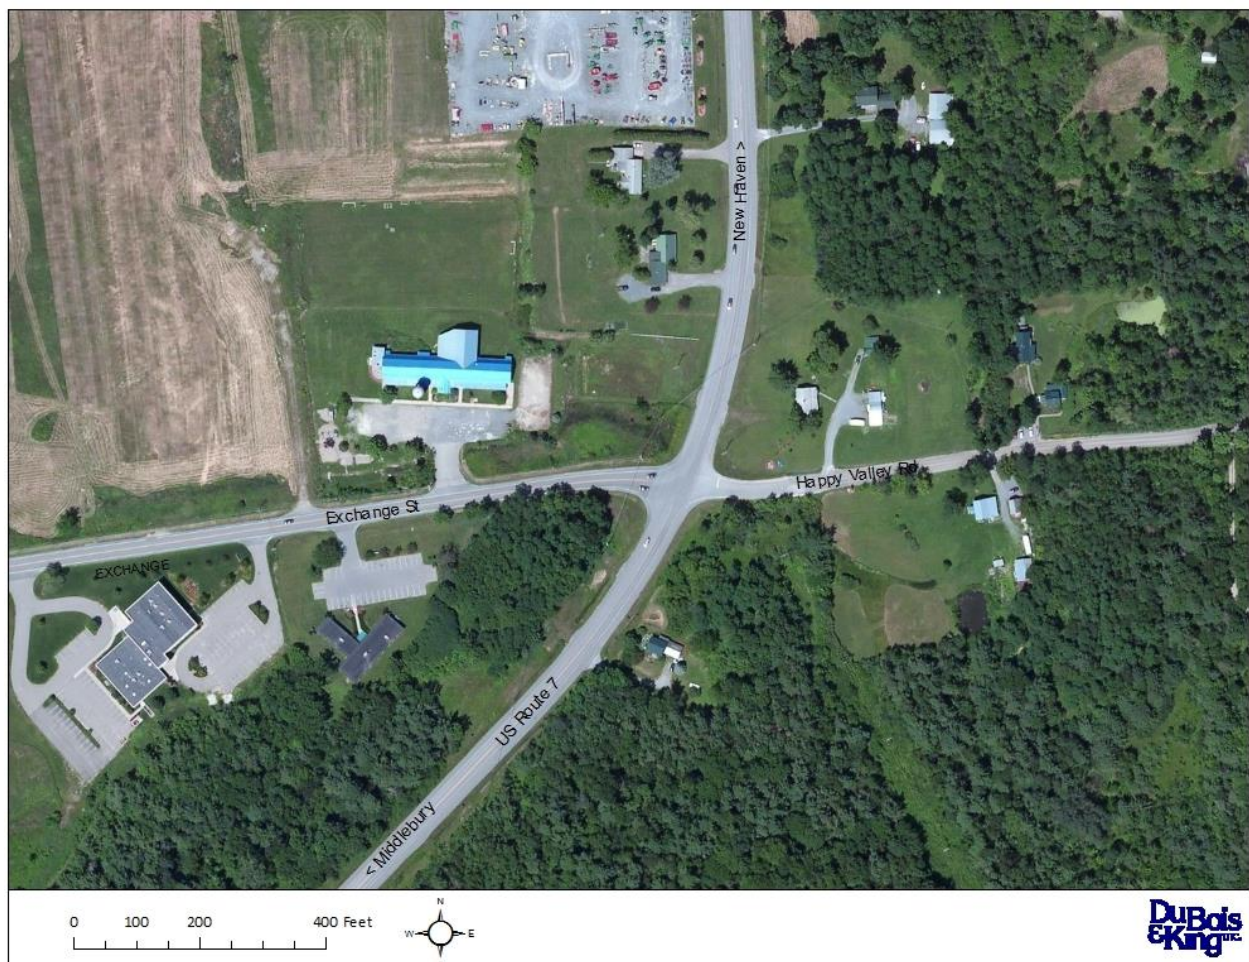
This memorandum presents interim findings on traffic analysis, safety and design to support a cost estimate and impact fee analysis for a roundabout at the intersection of US 7/Exchange Street in Middlebury, VT. The following is an aerial view of the intersection, which is on US 7 about 1.5 miles north of the intersection of US 7/VT 30, in the center of Middlebury.

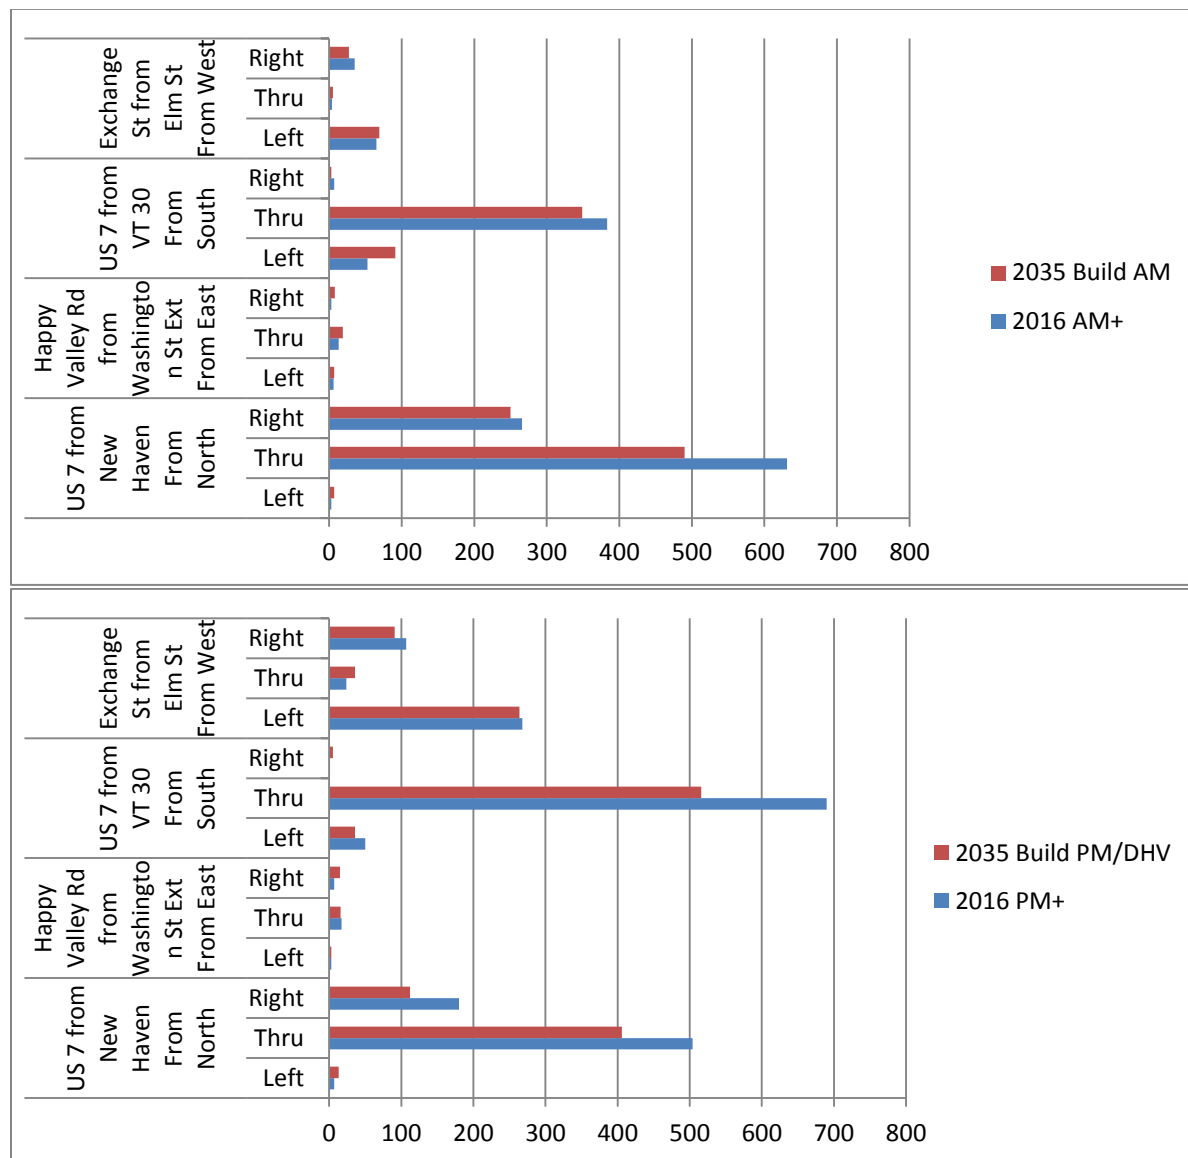
2016 with growth	2035 with growth	Change
AM	1,469	1,325	-10%
PM	1,857	1,513	-19%

Overall, traffic at this intersection has not grown as projected in the DH study. Therefore, the 2035 design volumes are 10% and 19% lower in the AM and PM peak hours respectively.
