US Route 7 - Exchange St & Happy Valley Rd Intersection and Corridor Improvements Scoping Report

Middlebury, VT

May 2, 2024

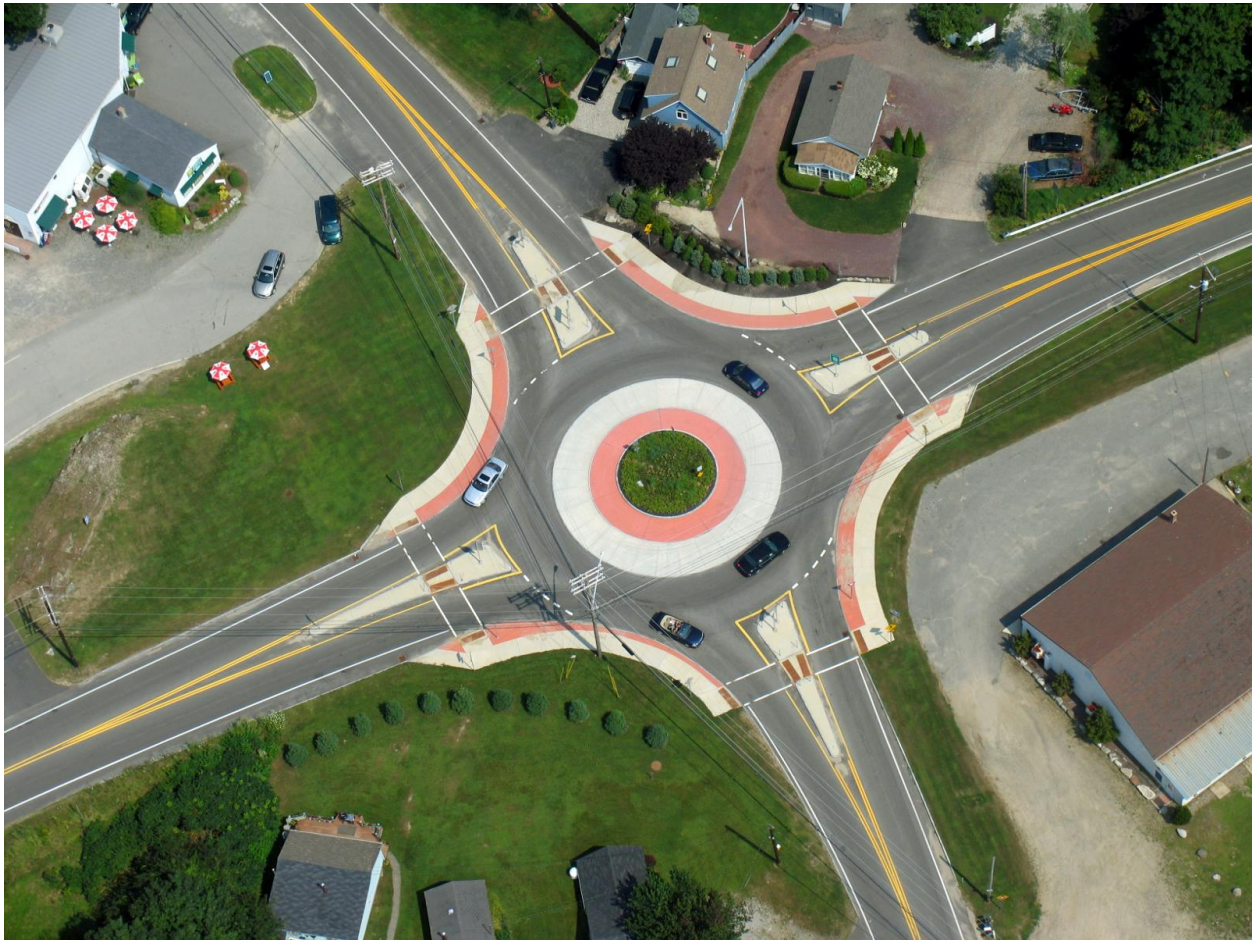
feet. The photo below shows an example of a recently constructed roundabout in Rye, NH that shows the scheme for the sidewalks.

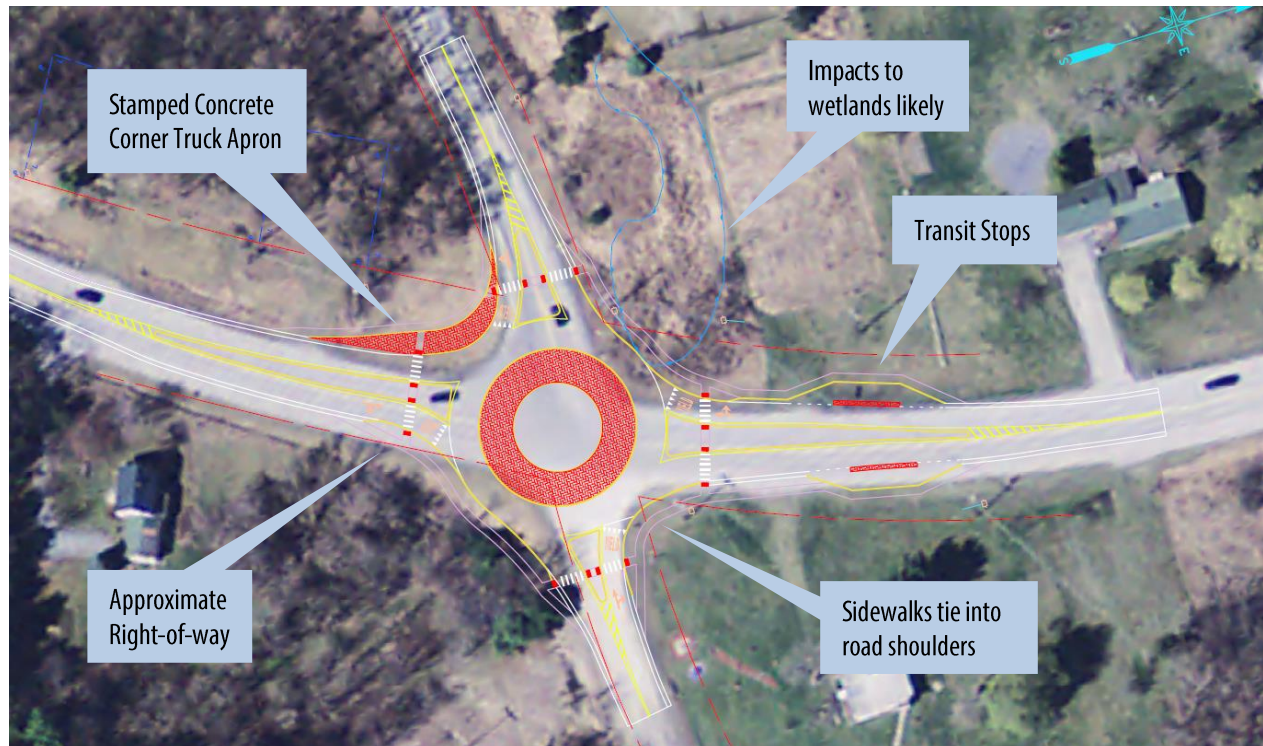
The design assumes that there will be truck apron of stamped colored concrete in the central island, as well as in the southwest corner of the intersection to accommodate WB-67 trucks on the US 7 and Exchange Street approaches. It is assumed that lighting will be provided on both sides of each approach, and stormwater infrastructure will be included in the project.
