Appendix G – Section 106 and Section 4(f) Documentation

Determination of National Register Eligibility for Various Structures and the Rutland Railroad

Re: Middlebury Bridges Replacement Project – Middlebury WCRS (23)
Determination of National Register Eligibility for Various Structures and the
Rutland Railroad

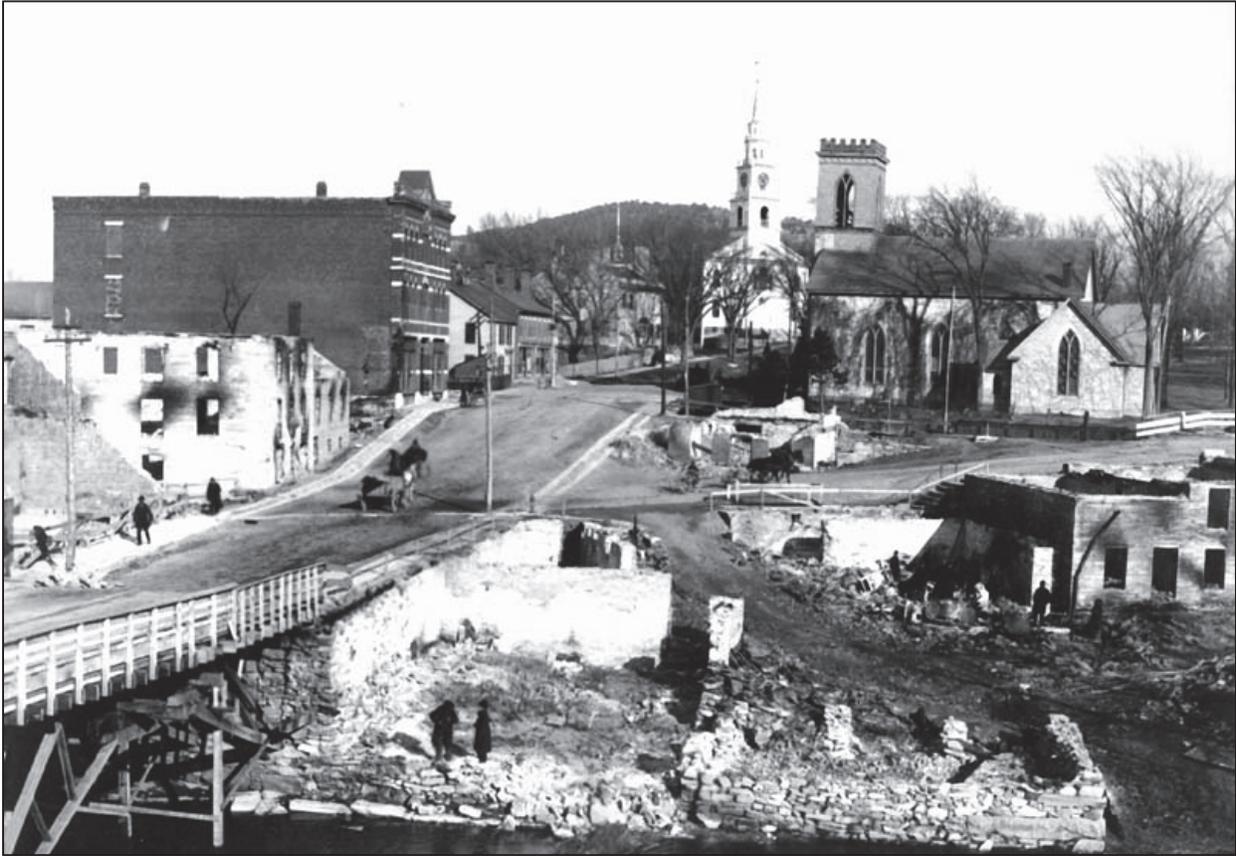
Figure 13. View of Project area after 1891 fire, St. Stephen's Episcopal Church on right, Duclos Building in left background. Note remains of Allen Block in current location of Triangle Park. Vermont Collection at Middlebury College Library online collections, accessed April 2013, <http://middigital.middlebury.edu/SharingVTHistory/Photographs/Middlebury/images/MID0012.jpg>.

1885 Sanborn (Figure 8), burned in the 1891 fire (Figure 13, 1891 photograph showing the aftermath). The 1892 Sanborn shows no building here, but does still note a “reservoir” on the site that was also on the 1885 Sanborn map (Figure 10). The western area, known as Triangle Park, was improved in 1908 by Joseph Battell and the Century Club with a three-tiered cast iron fountain carried by figures of cranes (Figure 17). Increasingly unpopular because its wind-driven spray would dampen the interiors of open cars parked around it, the fountain was dismantled by the town in 1938 and sold for scrap. Another fountain was placed in the park by the Middlebury Garden Club at the time of the national bicentennial in 1976 (Andres 2005, *The Village Tour*, p. 8).

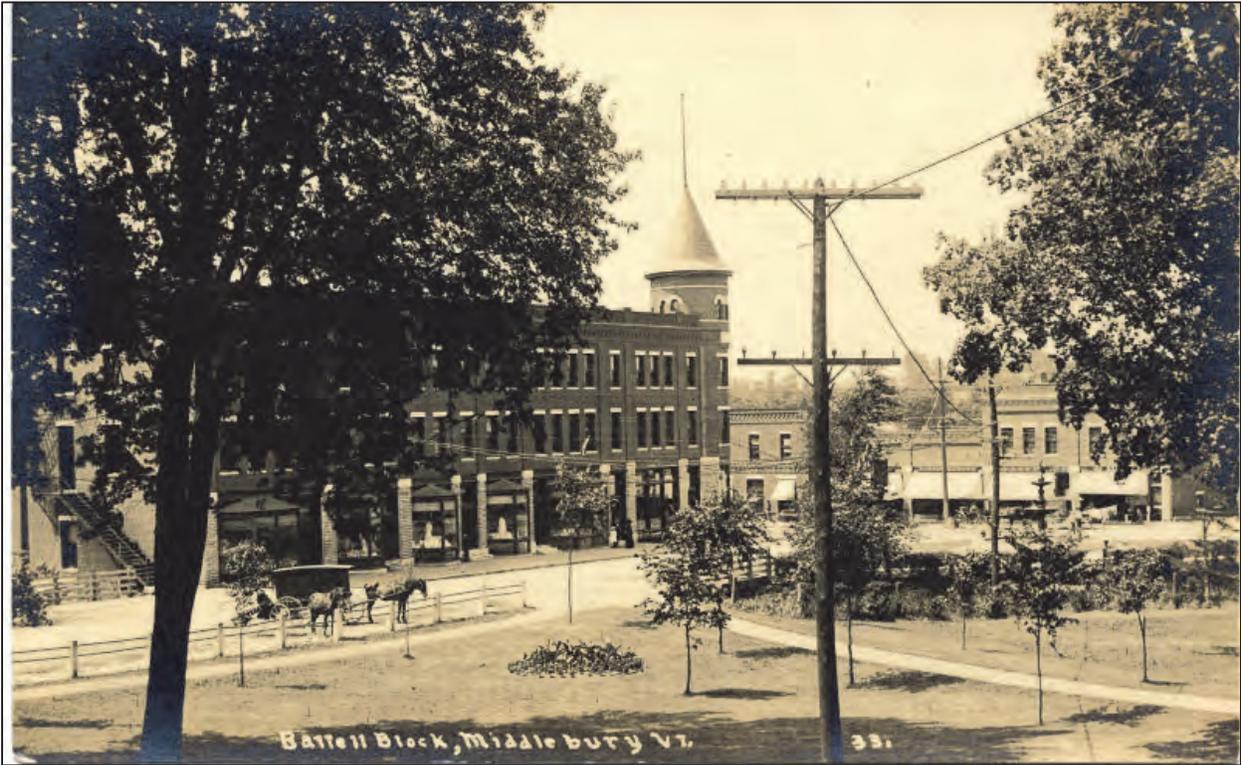
Figure 16. View of Project area, Merchant's Row Bridge in center, Battell Block on left. Vermont Collection at Middlebury College Library online collections, accessed April 2013, <http://middarchive.middlebury.edu/cdm/singleitem/collection/vtpostcards/id/650/rec/2>.

The appearance of the green on the east side of the railroad cut changed minimally over time, based on visual evidence provided by historic photographs and maps (Figure 16). The eastern component was never built upon except for the 1827 construction of St. Stephen’s Episcopal Church in the original center section of the green; a more recently constructed bandstand is also located here.

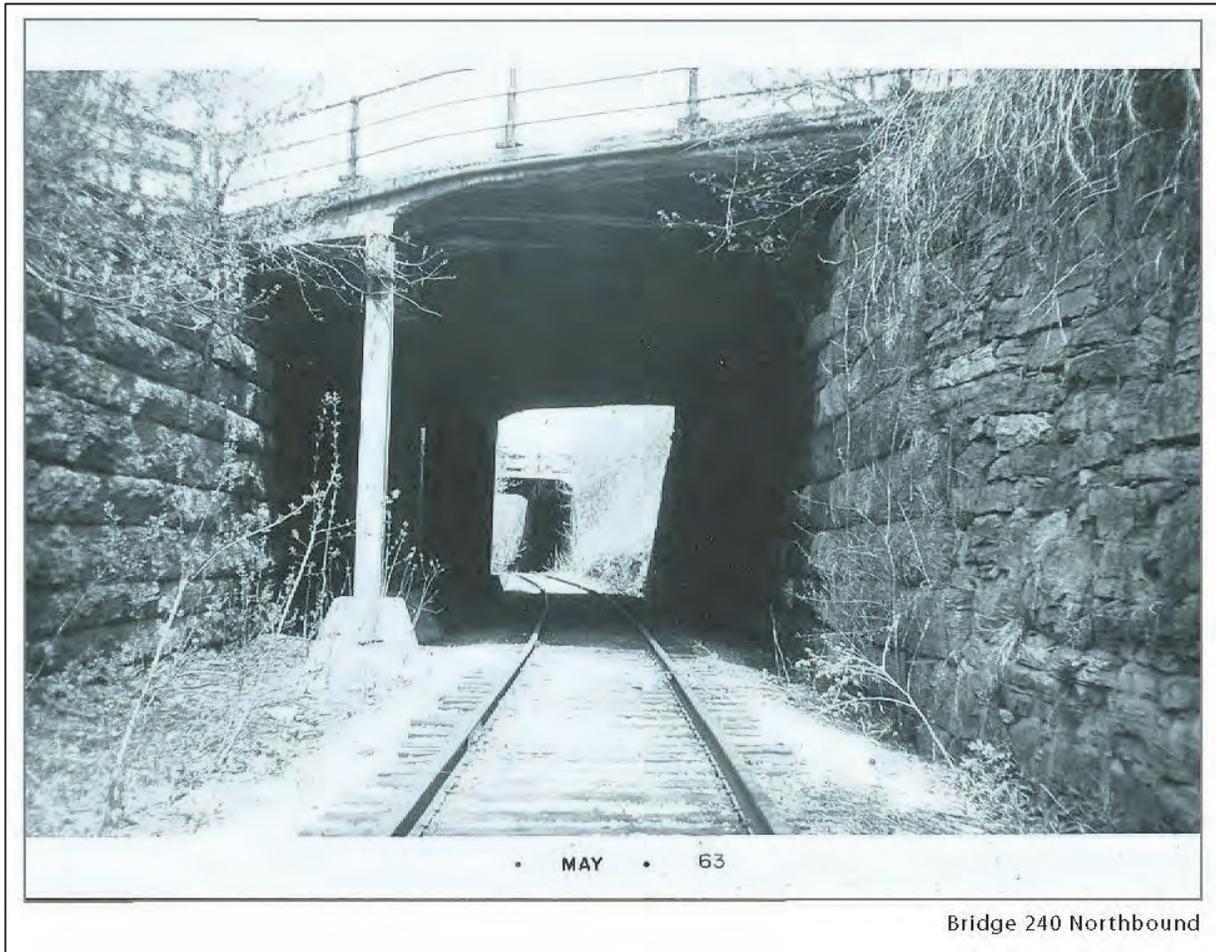
Figure 23. View of Merchant's Row Bridge, 1963, Main Street Bridge in background. Poulin Collection of Rutland Railroad Photographs, accessed March 2013, http://middigital.middlebury.edu/rutland_railroad/RRAPoulinPhotos/.

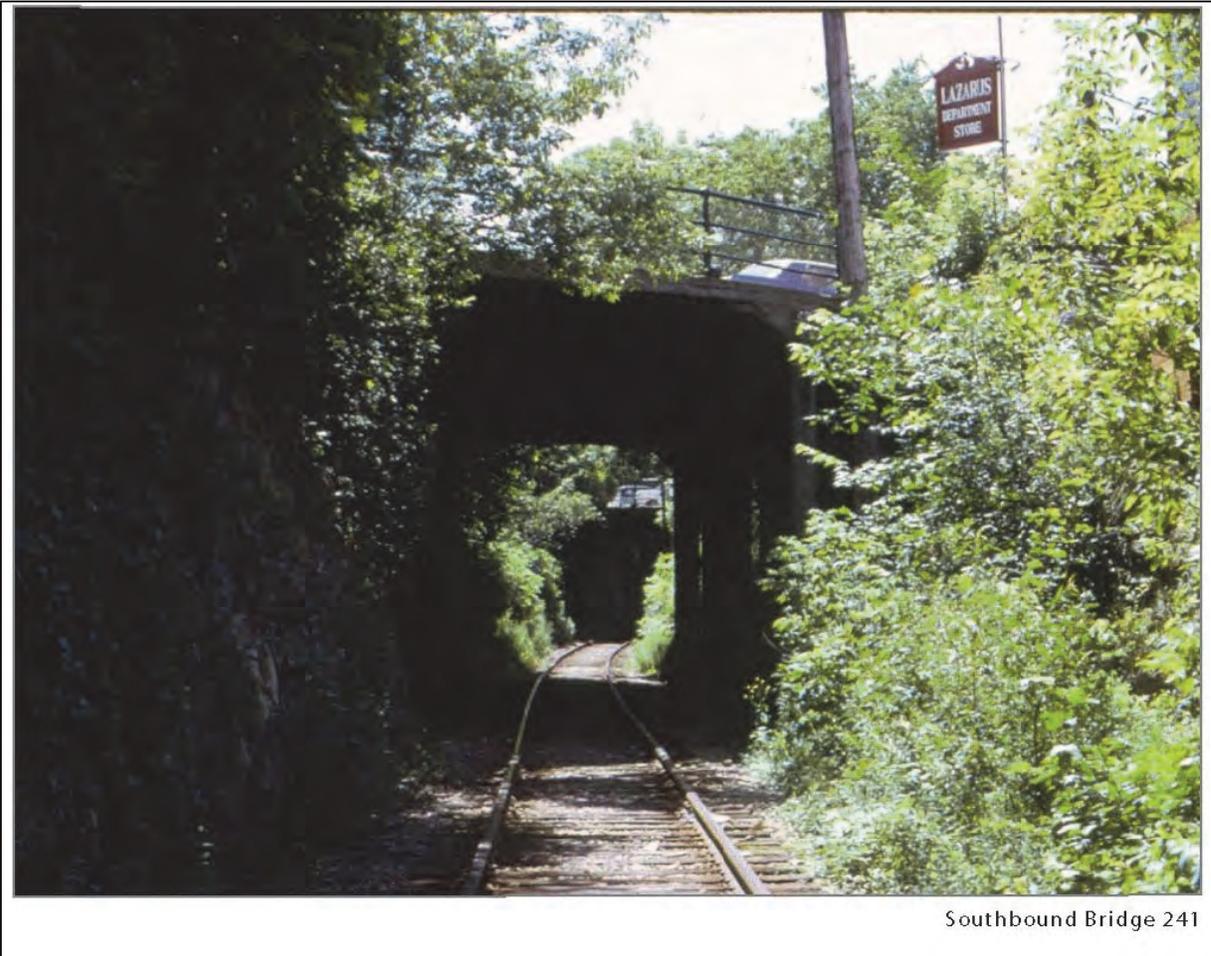
Figure 26. View of Main Street Bridge, 1971 or 1972, note sign for “Lazarus Department Store” on right. Poulin Collection of Rutland Railroad Photographs, accessed March 2013, http://middigital.middlebury.edu/rutland_railroad/RRAPoulinPhotos/.

The current building is a one-story building with a long rectangular footprint and asymmetrical front gable roof. The presumably wood-frame building is sided with vertical aluminum siding and brick veneer with two large single-pane storefront windows on the front that flank the central entrance that contains two separate doors and is topped with a Neo-Colonial Revival broken pediment. A photo taken of and from the railroad line in 1971 or 1972 shows a sign on a pole at the sidewalk in front of this building that reads "Lazarus Department Store," which is similar in style to the Neo-Colonial broken pediment over its central entrance (Figure 26, Poulin Collection).

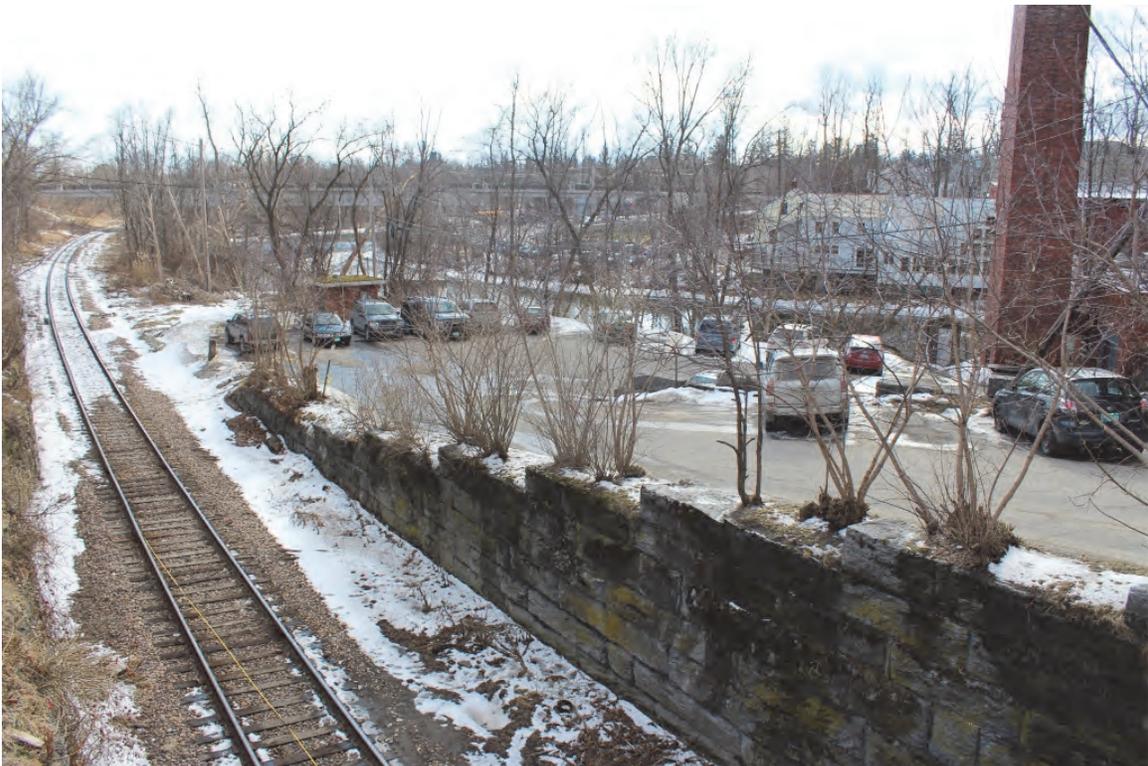
2. Main Street and Merchants Row Bridge Replacement, Middlebury, VT. View of Merchants Row Bridge, west wall at south approach. Photographer facing S, February 15, 2013.

The western retaining wall south of Merchants Row consists of the same granite ashlar blocks as the bridge abutments, and were likely completed as part of a single project, ca. 1880-1890. The western retaining wall is in good condition.

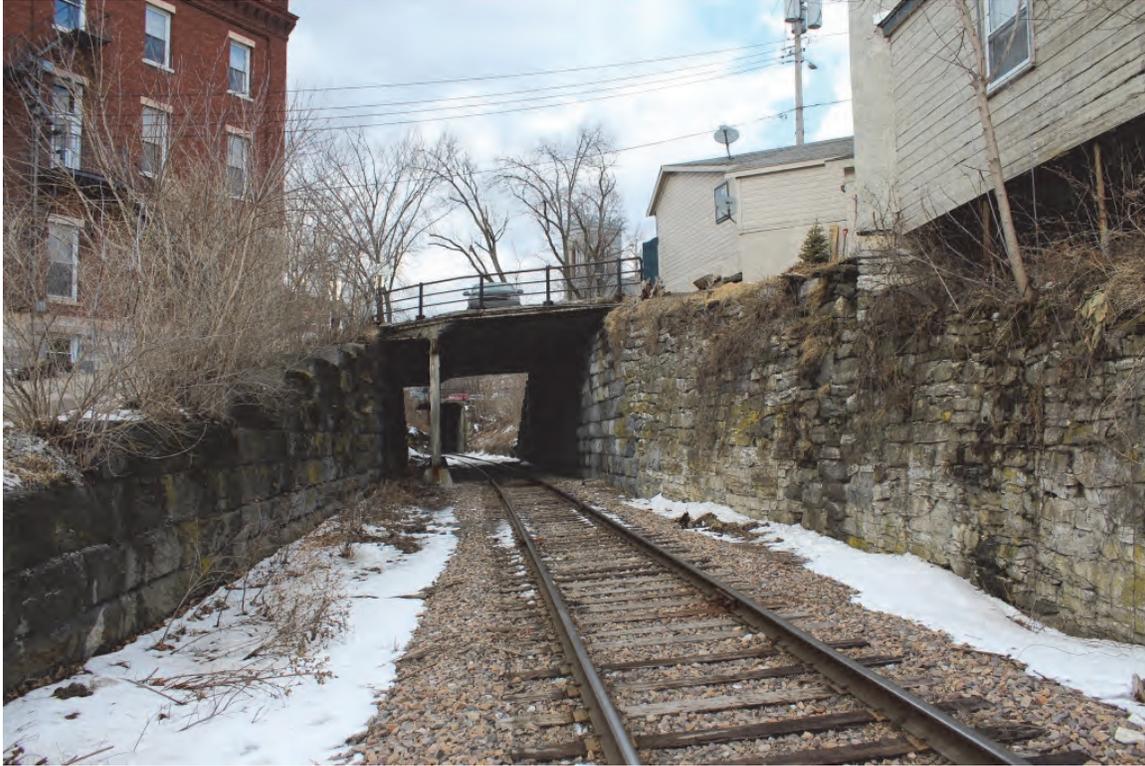
5. Main Street and Merchants Row Bridge Replacement, Middlebury, VT. View of Merchants Row Bridge, east abutment, south side. Photographer facing NW, February 15, 2013.

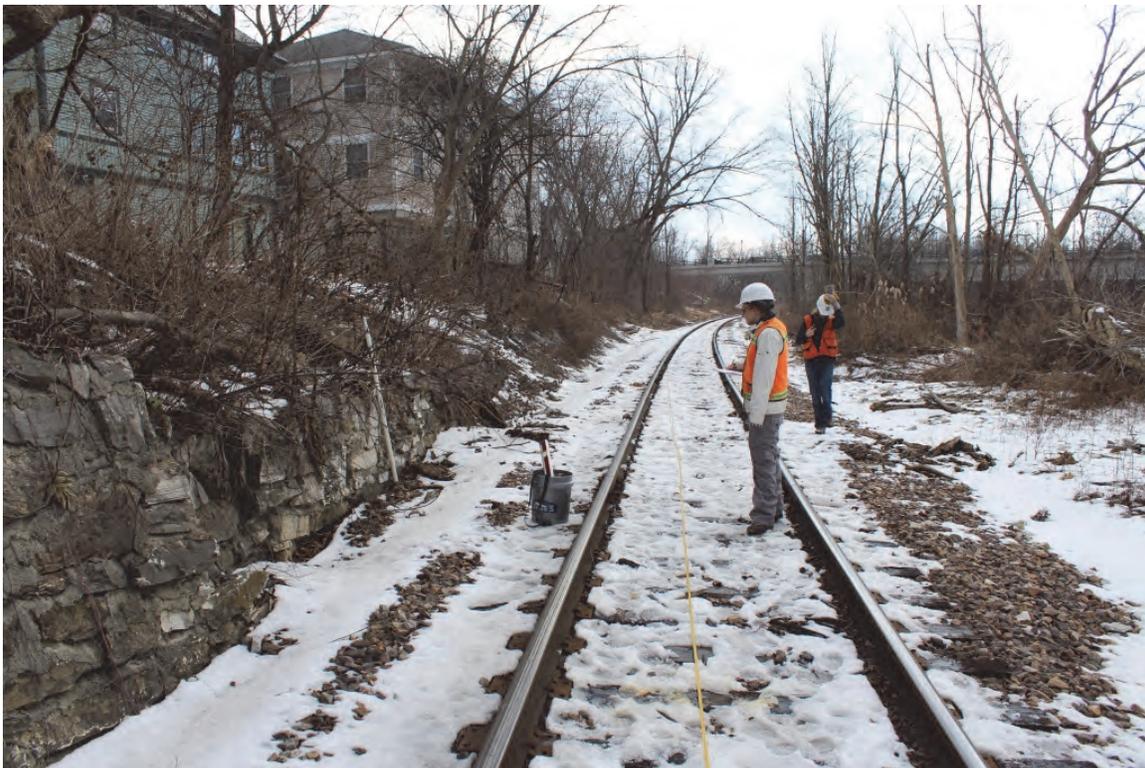
6. Main Street and Merchants Row Bridge Replacement, Middlebury, VT. View of south terminus of east retaining wall, south of Merchants Row Bridge. Photographer facing S, February 15, 2013.

The retaining wall on the east side of the corridor south of Merchants Row consists primarily of granite blocks and limestone that ranges in size from less than 1 foot by 1 foot to up to roughly 1.5 feet high by 3 feet long (Photos 1, 4 to 6). This wall appears to have been dry laid originally, but has been extensively patched with cement mortar post construction. The height of the wall ranges from roughly 5 feet at the southern end to roughly 12.5 feet at the contact with the ashlar abutment. The eastern wall is in good condition with one instance of localized toppling near the southern end. Multiflora rose and other herbaceous plants are present (Photo 4). Overhanging vegetation likely obscures the view of portions of the wall during the growing season.

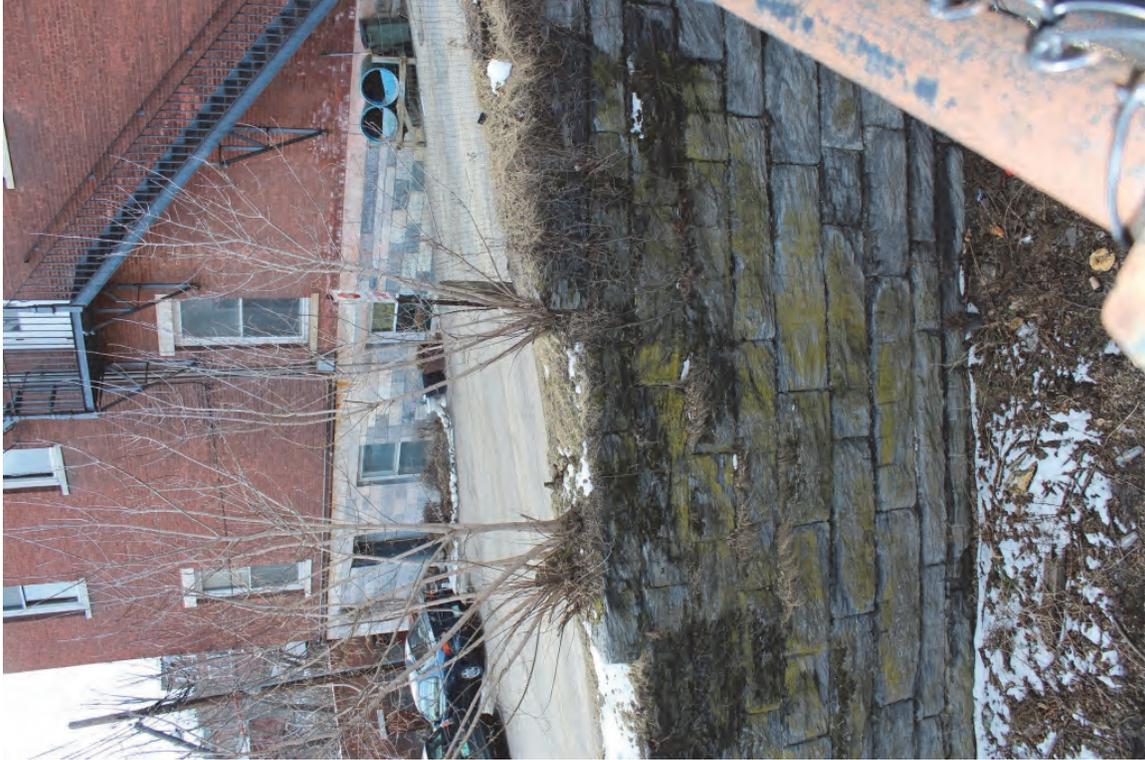
7. Main Street and Merchants Row Bridge Replacement, Middlebury, VT. View of Merchants Row Bridge, west wall and abutment, south side. Photographer facing W, February 15, 2013.

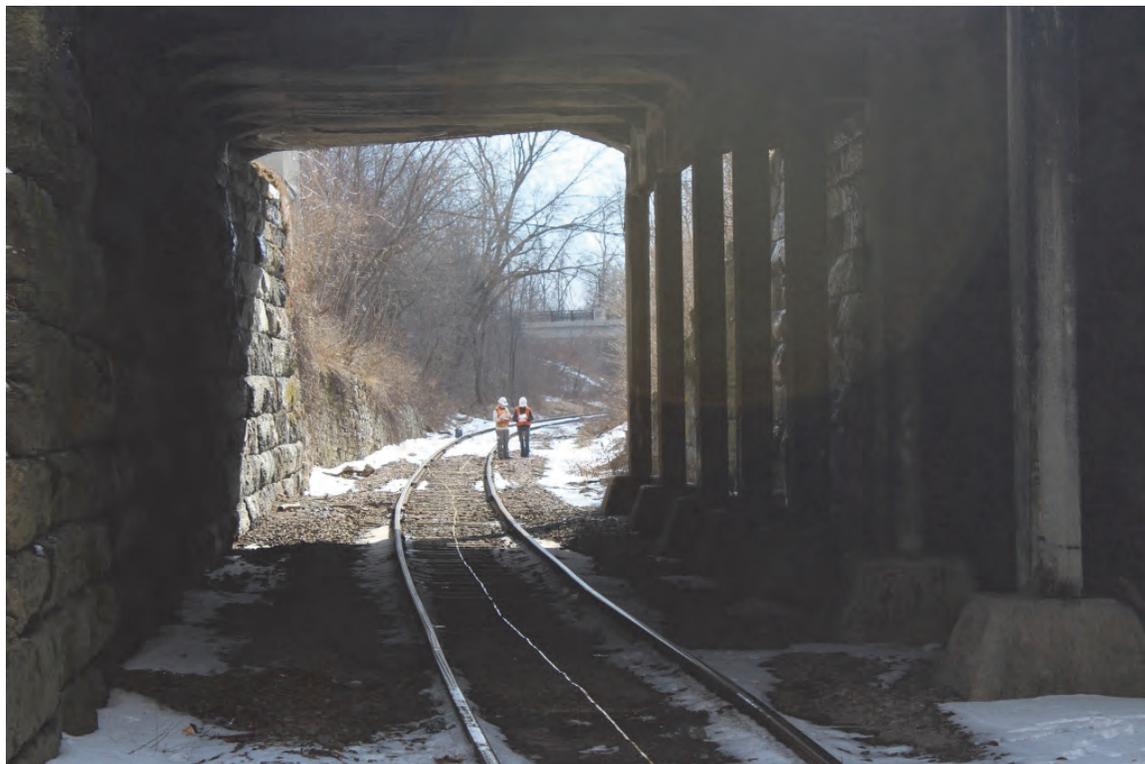
8. Main Street and Merchants Row Bridge Replacement, Middlebury, VT. View of Merchants Row Bridge, piers and abutments. Photographer facing S, February 15, 2013.

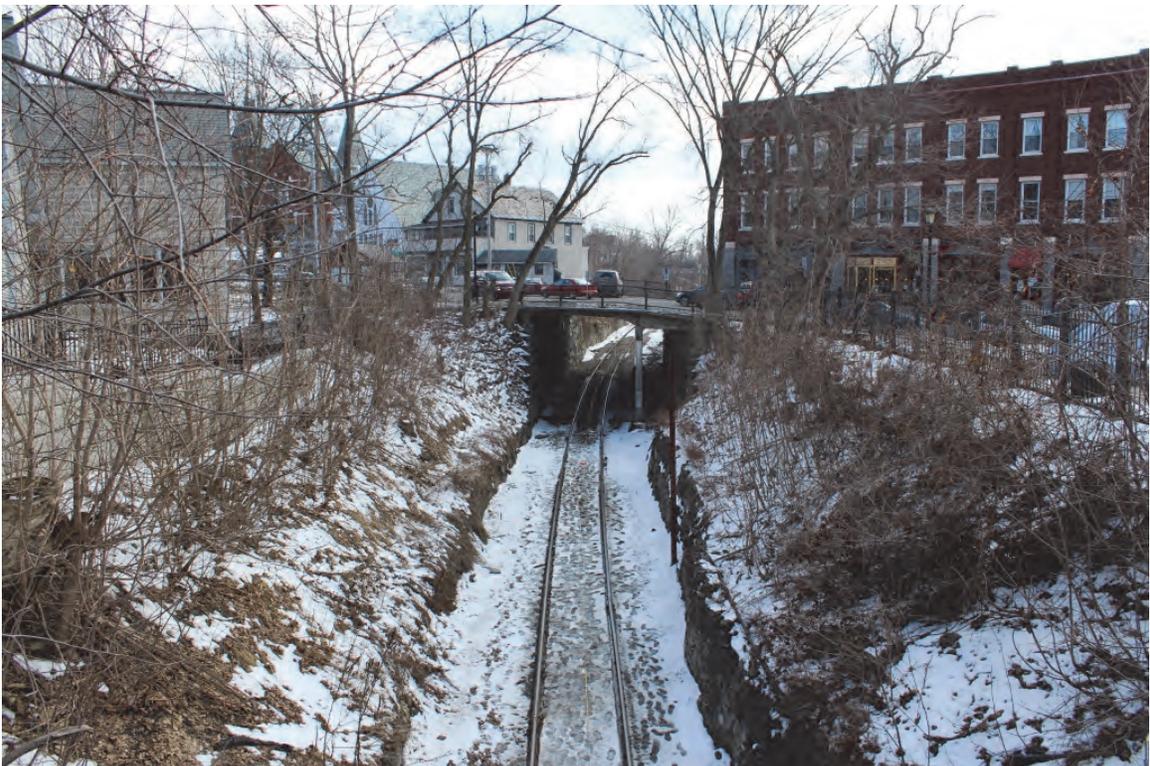
12. Main Street and Merchants Row Bridge Replacement, Middlebury, VT. View of Merchants Row Bridge from Main Street Bridge. Photographer facing SE, February 15, 2013.

Section 2C
Stone retaining wall
115 feet
Photos 12 - 14

Section 1C
Stone retaining wall
129 feet
Photos 11 - 13, 16, 17

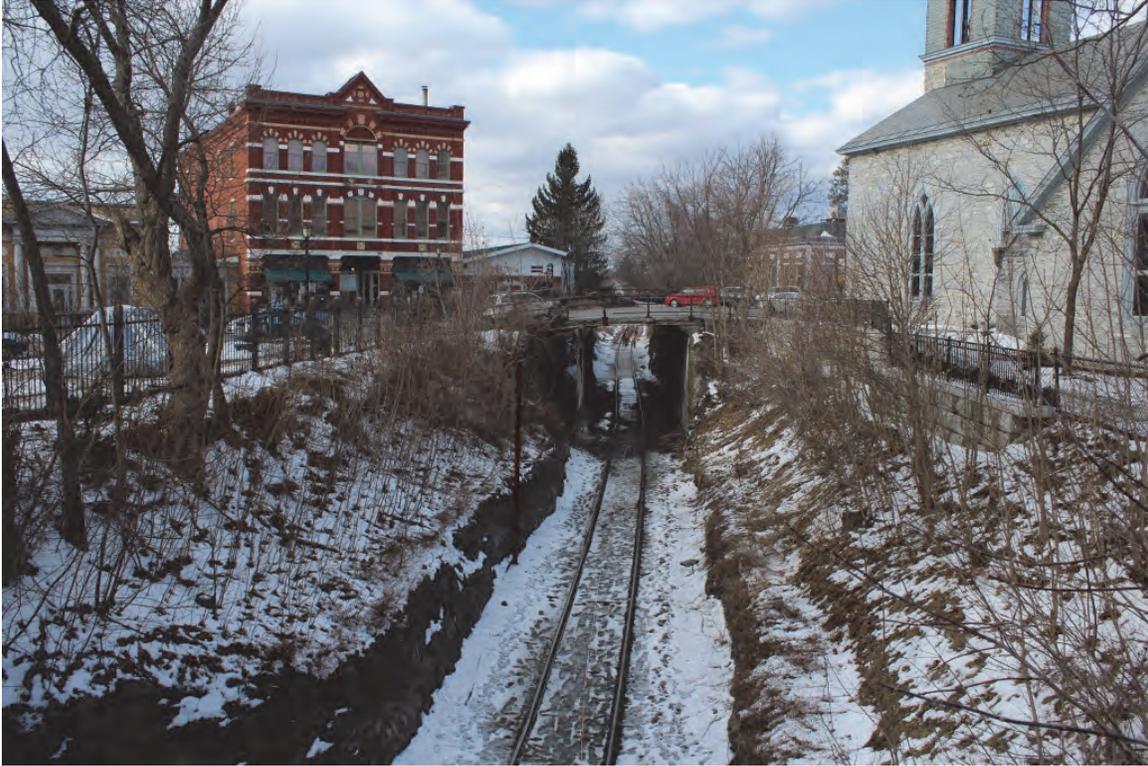
13. Main Street and Merchants Row Bridge Replacement, Middlebury, VT. View of Main Street Bridge from Merchants Row Bridge, Duclos Building and Lazarus Building in left background, St. Stephen's Episcopal Church on right. Photographer facing NW, February 15, 2013.

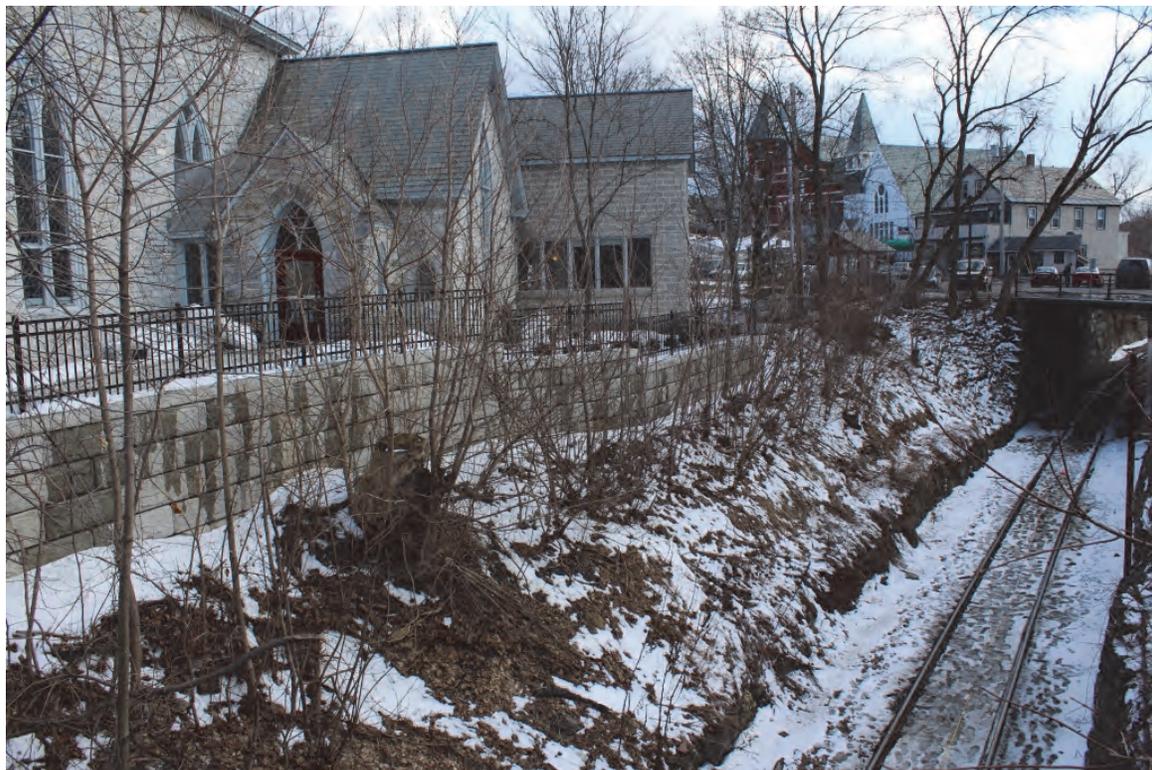
16. Main Street and Merchants Row Bridge Replacement, Middlebury, VT. View of retaining wall southwest of St. Stephen's Episcopal Church from Main Street Bridge, Merchants Row Bridge in right background. Photographer facing SW, February 15, 2013.

Although focused on a small area within the Project limits, the more recent concrete block retaining wall on St. Stephen's Episcopal Church property closer to street level is the latest episode of changes to the railroad retaining walls (Photos 16 and 17). The church building was erected in 1827 near the west end of the Village Green. It was this green that was cut through to build the railroad trench; an undated late 19th century stereopticon photograph and a ca. 1870 photograph show how close the walls of the cut were to the church (Figures 11 and 12). The ca. 1870 photograph of the church shows a simple open railing, and what appears to be a stone retaining wall below the railing in the upper half of the railroad corridor's wall where the current concrete retaining wall is located. Later 19th and early 20th century photographs have not been extensively researched to determine other changes to this area, but it is likely that other walls, railings, or fences have been built here since the time of the ca. 1870 photograph.

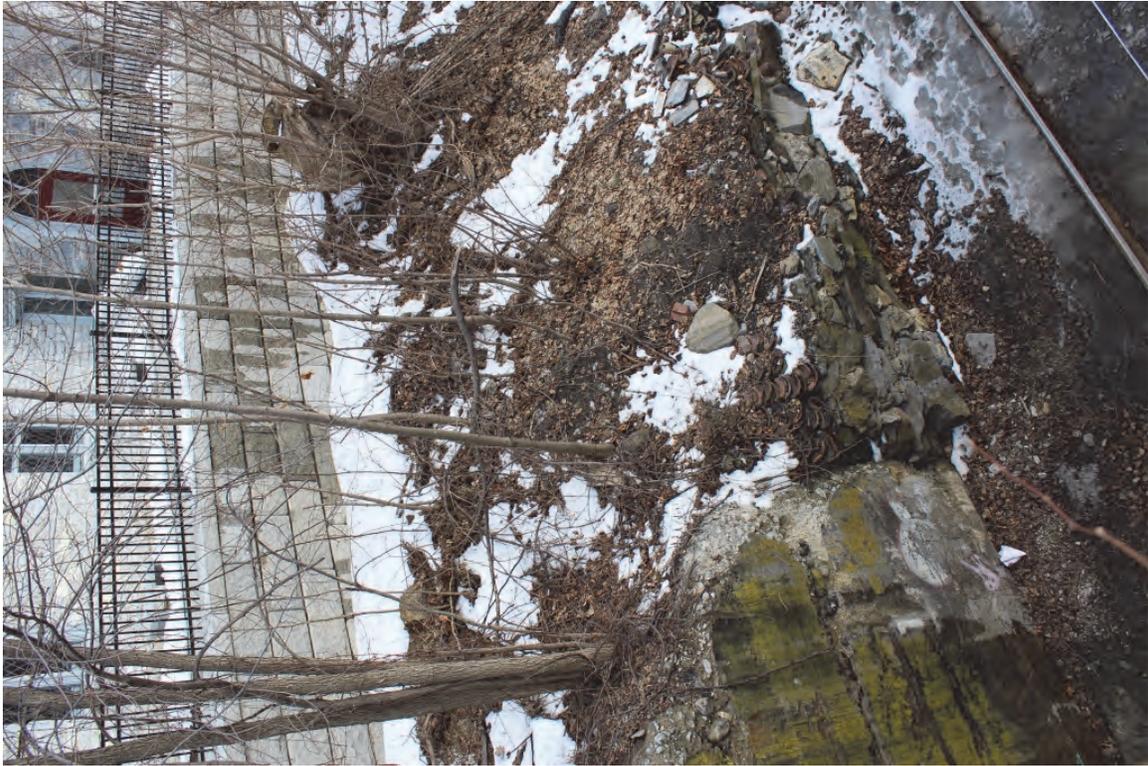
17. Main Street and Merchants Row Bridge Replacement, Middlebury, VT. View of retaining wall southwest of St. Stephen's Episcopal Church and east retaining wall from Main Street Bridge, south side. Photographer facing E, February 15, 2013.

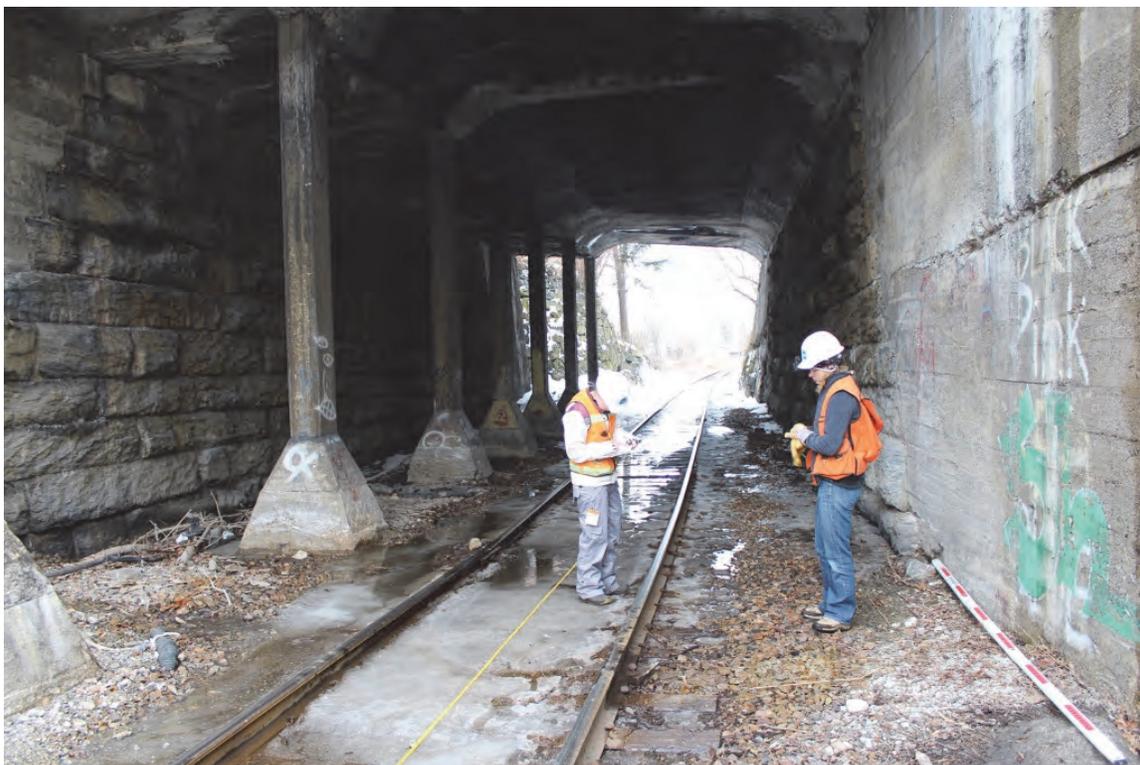
20. Main Street and Merchants Row Bridge Replacement, Middlebury, VT. View of Main Street Bridge, piers and abutments. Photographer facing N, February 15, 2013.

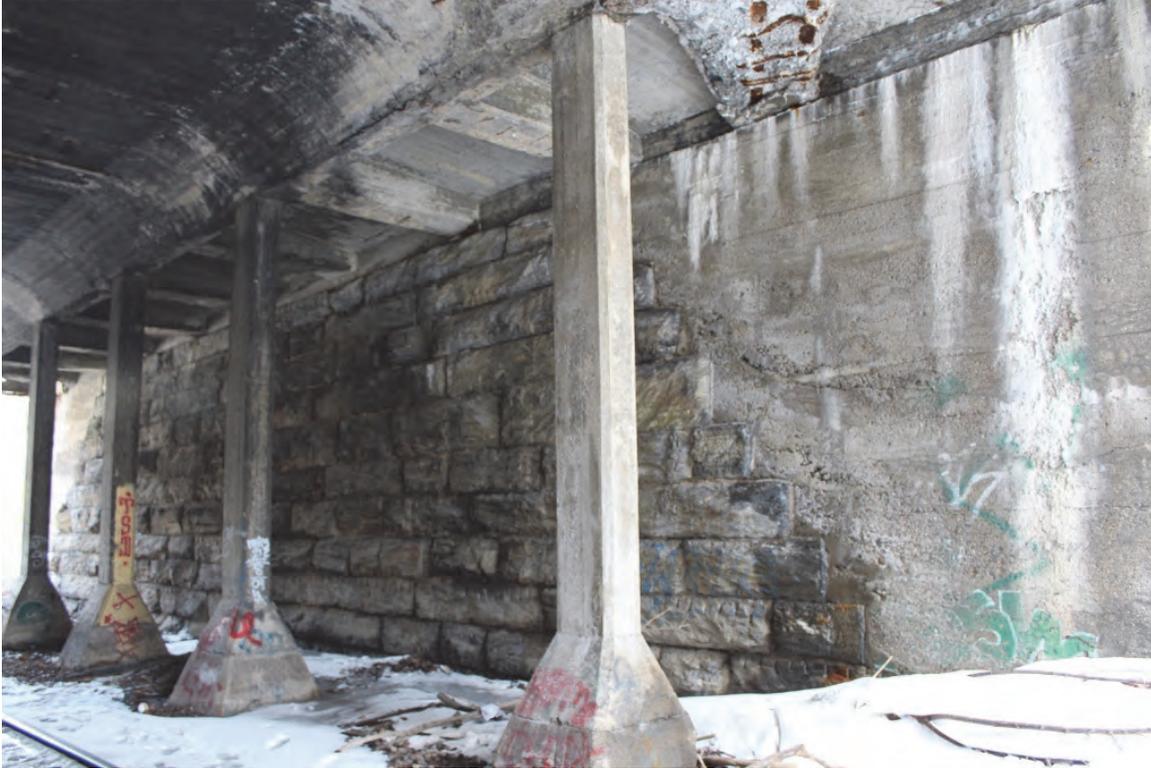
21. Main Street and Merchants Row Bridge Replacement, Middlebury, VT. View of Main Street Bridge, west abutment, north side. Photographer facing S, February 15, 2013.

Section 2D
Granite ashlar abutment
72 feet
Photos 21, 24

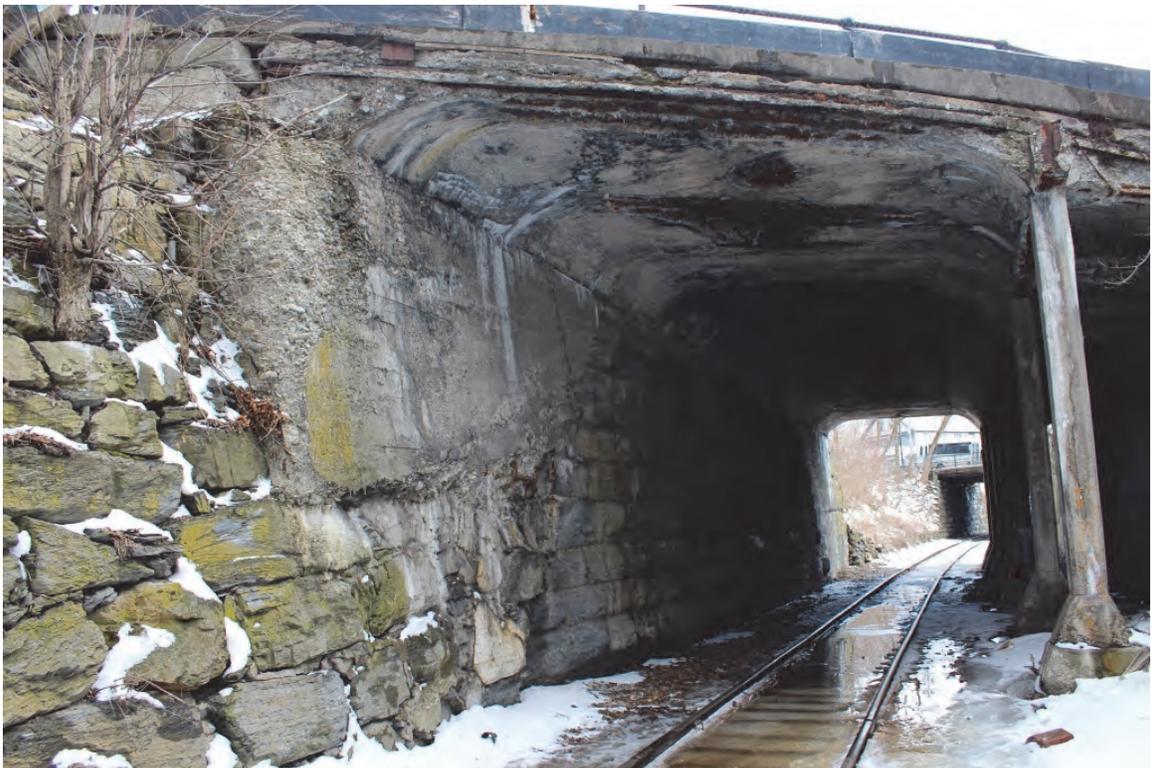
22. Main Street and Merchants Row Bridge Replacement, Middlebury, VT. View of Main Street Bridge, east abutment, north end. Photographer facing SE, February 15, 2013.

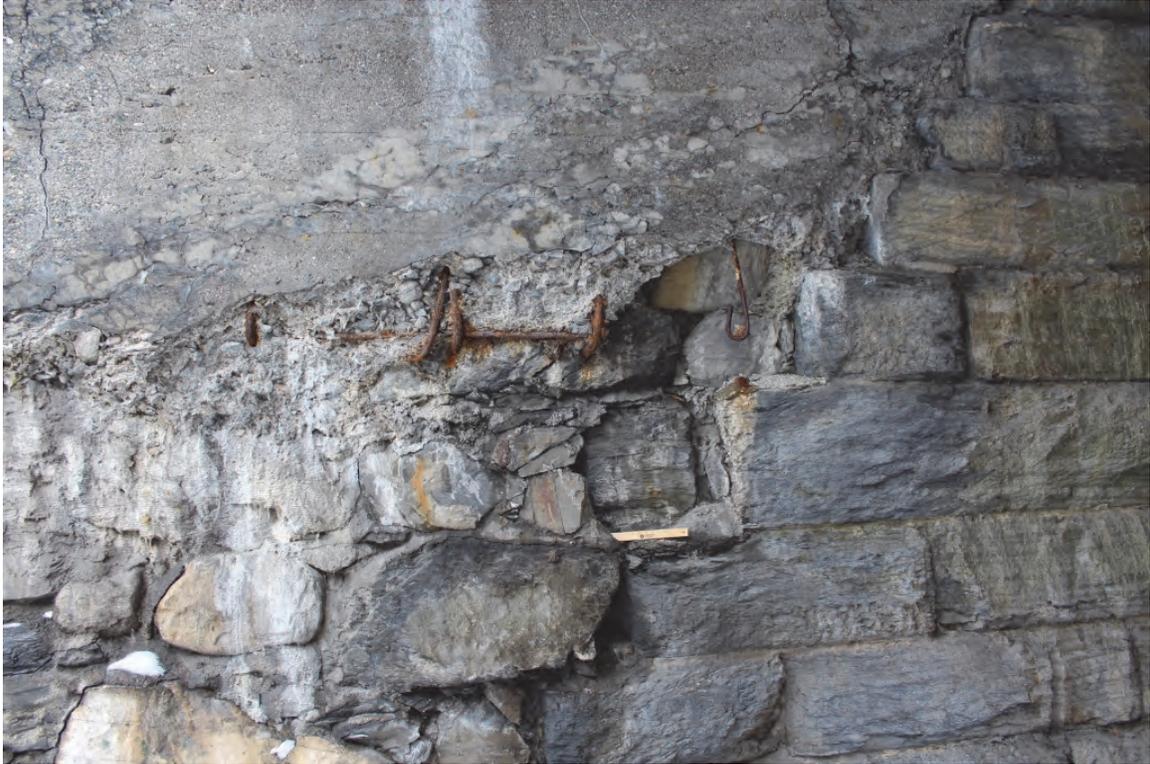
23. Main Street and Merchants Row Bridge Replacement, Middlebury, VT. Closeup of Main Street Bridge, east wall and abutment contact point, north end. Photographer facing E, February 15, 2013.

The Main Street bridge abutments were also extended to the north, though it appears that the existing rubble retaining walls were incorporated into these extensions. Concrete patching here was applied on top of the existing materials for reinforcement (Photos 23 and 23). There is no such concrete extension or repair work on the Merchants Row bridge abutment. The concrete portions of the Main Street abutments are not as well preserved as the stone portions, and the joints between the two materials are showing signs of wear. The concrete patching is relatively uneven in application, and shows modifications such as subsequent mortar applications. Much of the concrete patching likely dates to the late 20th century, as connection points between the ashlar and the adjoining rubble retaining walls failed. Subsequent concrete repairs and/or the addition of rubble retaining walls at both bridges have largely obscured or replaced the original end faces of the stone abutment walls.

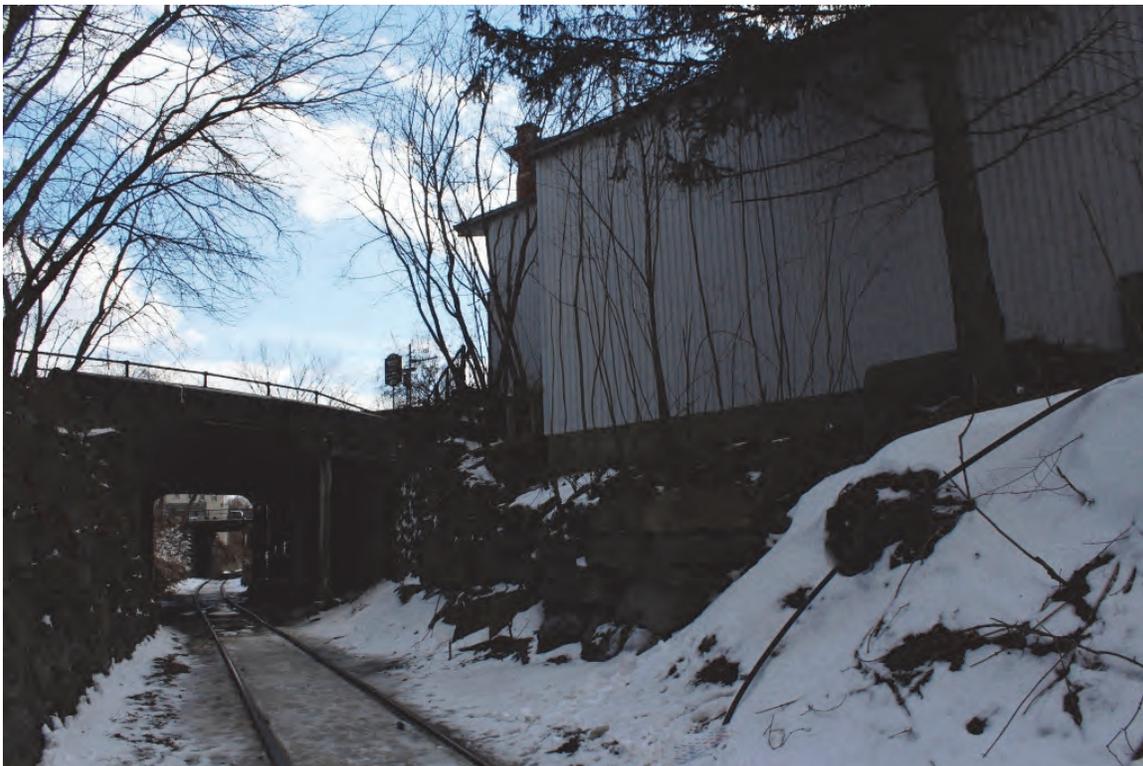
26. Main Street and Merchants Row Bridge Replacement, Middlebury, VT. View of Main Street Bridge, west wall below Lazarus Building. Photographer facing S, February 15, 2013.

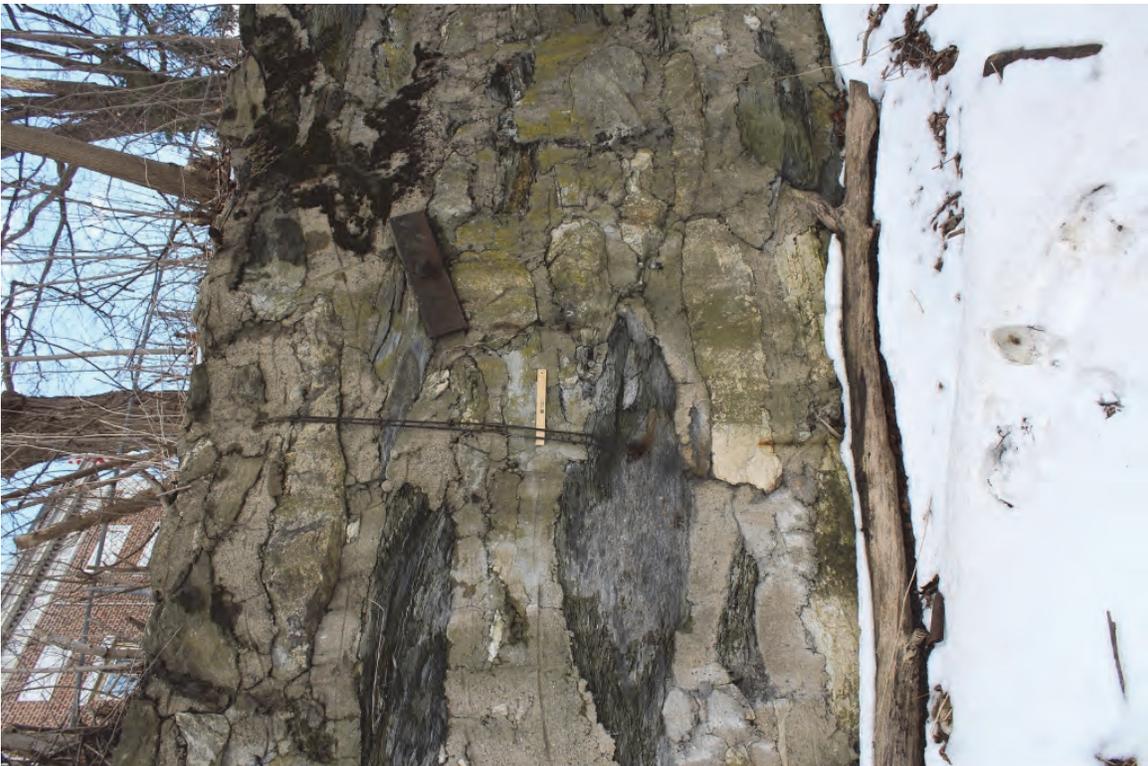
28. Main Street and Merchants Row Bridge Replacement, Middlebury, VT. Closeup of east retaining wall, north of Main Street bridge, showing tie back. Photographer facing E, February 15, 2013.

The retaining walls north of Main Street are composed primarily of large fieldstone blocks, though smaller (less than one foot long) components are present (Photos 24 to 31). The shorter west wall appears to be in good condition and generally lacks post-construction patching. However, the east wall (west of the Post Office) has experienced bulging in the past such that tiebacks and cement mortar have been applied at the northern half of the wall (Photos 28 and 30). Wall displacement is thought to have resulted in one instance of municipal water line damage behind the wall when the embedded line was pulled apart.

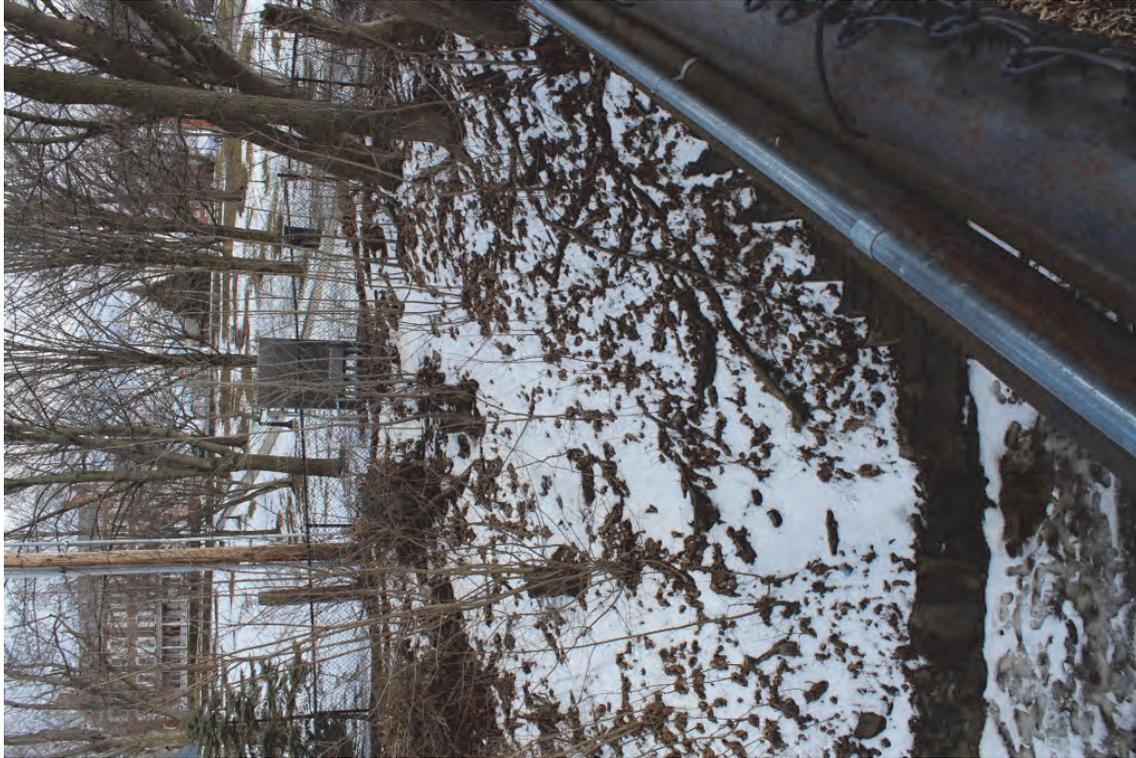
33. Main Street and Merchants Row Bridge Replacement, Middlebury, VT. View from Merchants Row Bridge. Photographer facing NE, February 15, 2013.

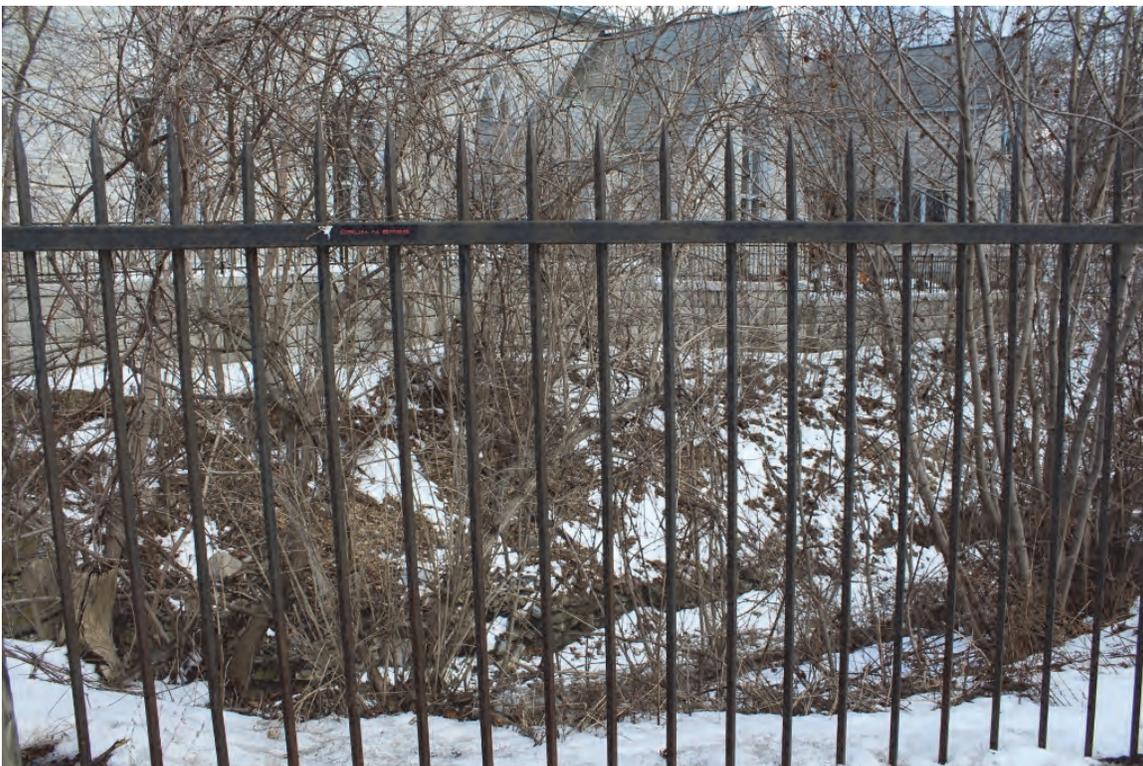
34. Main Street and Merchants Row Bridge Replacement, Middlebury, VT. View of east wall between bridges as seen from Main Street, St. Stephen's Episcopal Church in background. Fence and vegetation growth partially obscures view of wall. Photographer facing SE, February 15, 2013.

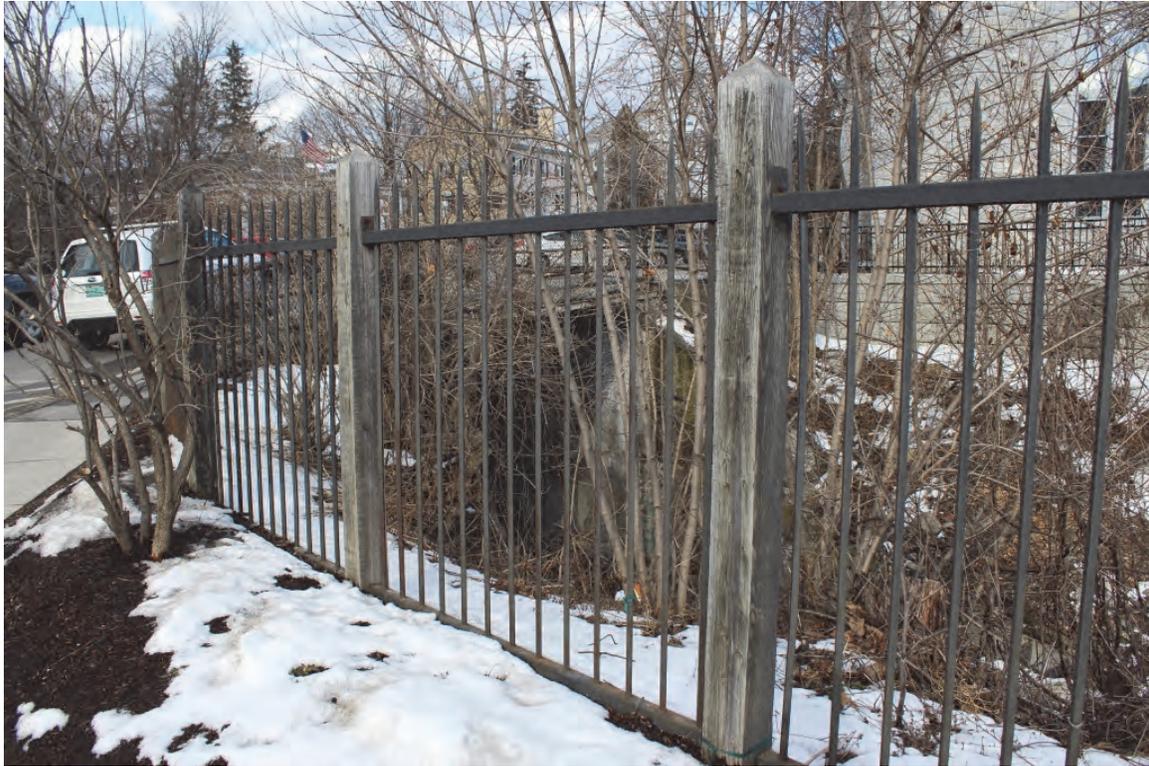
35. Main Street and Merchants Row Bridge Replacement, Middlebury, VT. View of Main Street Bridge and east wall from Triangle Park, fence and vegetation partially obscure view of bridge and railroad right-of-way. Photographer facing NE, February 15, 2013.
