Appendix G – Section 106 and Section 4(f) Documentation

Determination of National Register Eligibility for Various Structures and the Rutland Railroad

Re: Middlebury Bridges Replacement Project – Middlebury WCRS (23)
Determination of National Register Eligibility for Various Structures and the
Rutland Railroad

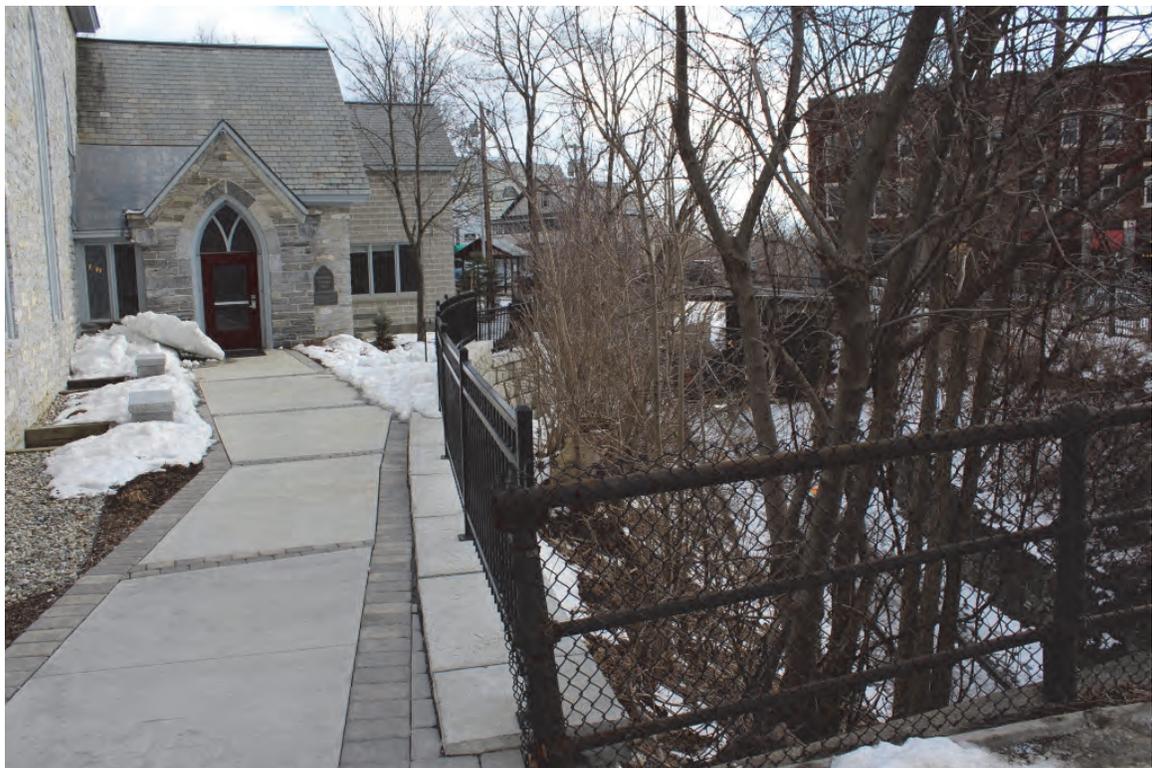
36. Main Street and Merchants Row Bridge Replacement, Middlebury, VT. View of Merchants Row Bridge and railroad right-of-way from north end of St. Stephen's Episcopal Church retaining wall, at Main Street Bridge. Photographer facing S, February 15, 2013.

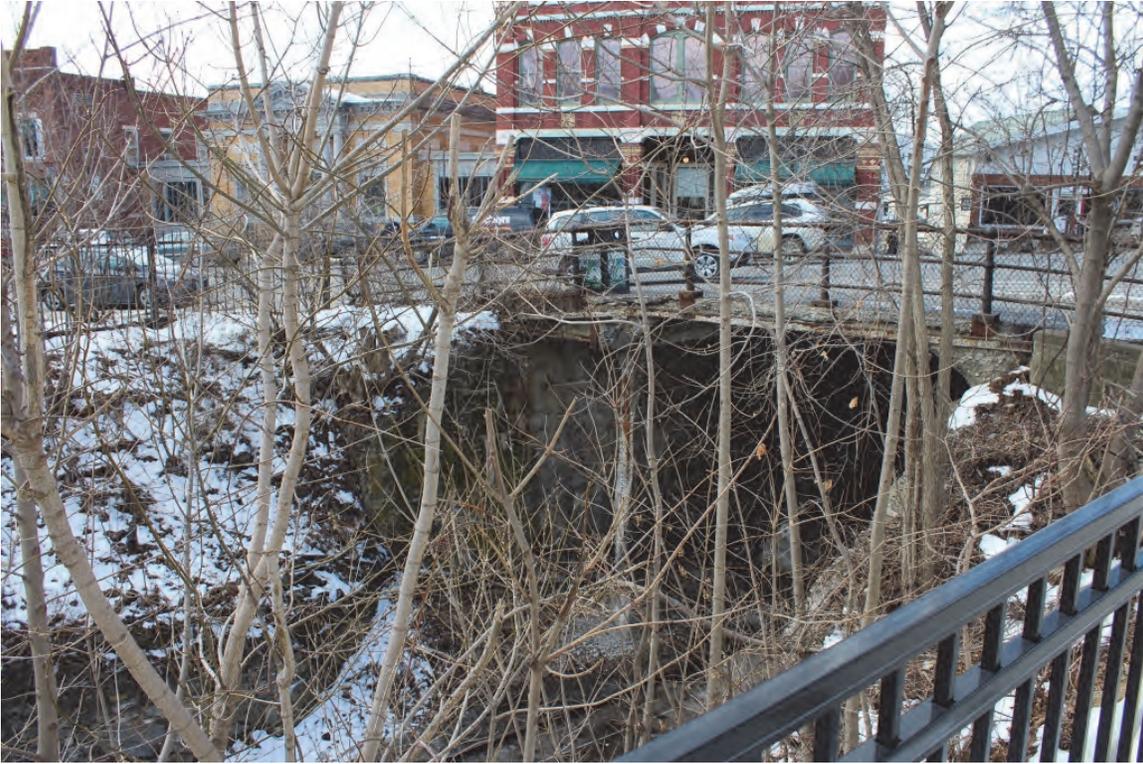
37. Main Street and Merchants Row Bridge Replacement, Middlebury, VT. View of Main Street Bridge from St. Stephen's Episcopal Church retaining wall path, Duclos Building in background. Photographer facing W, February 15, 2013.

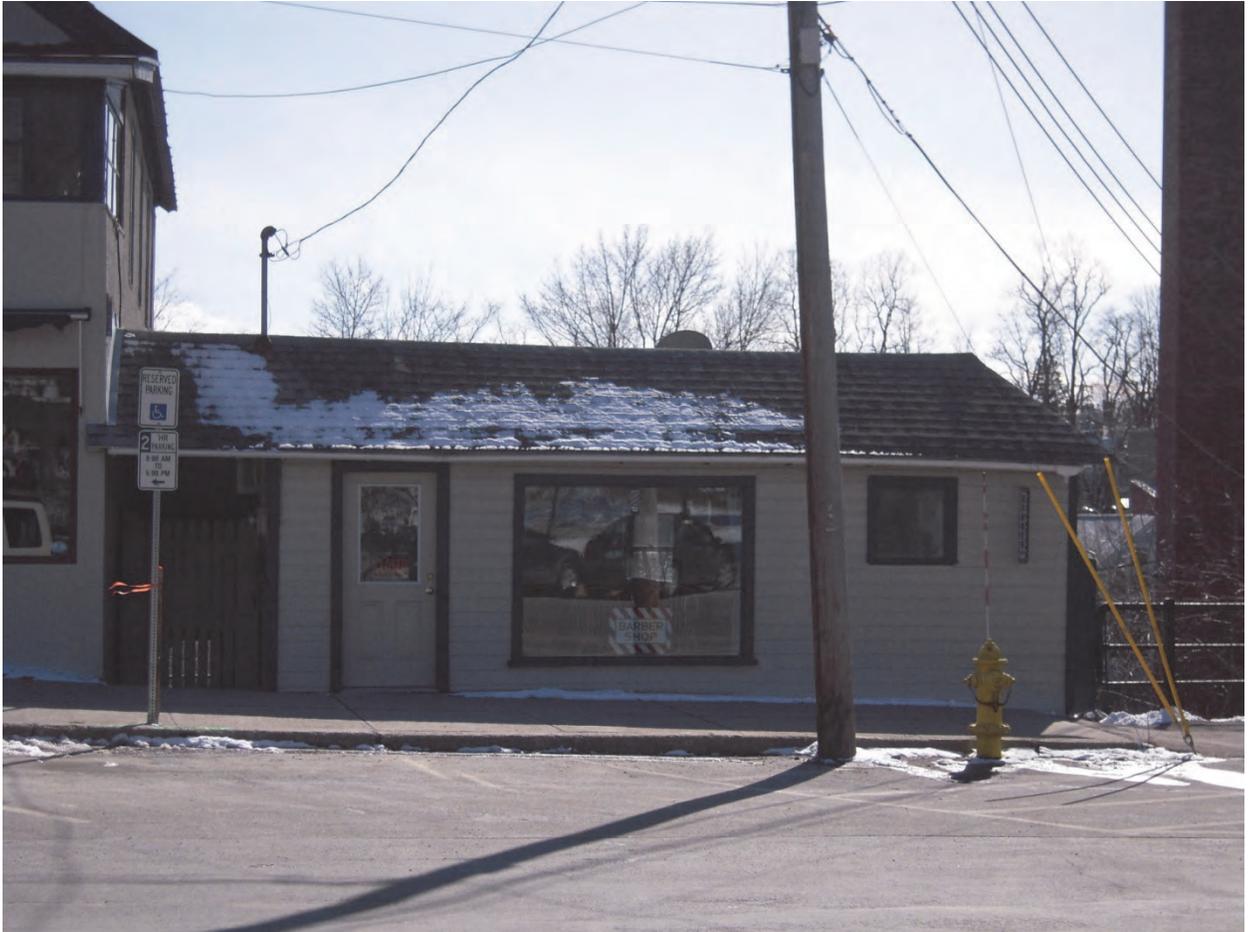
Addition to the Bourdon Insurance Agency Building, 48 Merchants Row, Middlebury, Vermont. View facing south, February 2013.

The Bourdon Insurance Company Building, to which the barber shop is attached, is noted as a contributing resource in the Middlebury Village Historic District National Register nomination as #96. 10 Merchant's Row: a 2½-story (actually the building has 3 stories as it slopes down from the street), stuccoed building set gable end to the road on a random coursed stone foundation. The barber shop extension proposed for removal is not noted or described. Based on the Sanborn maps, the insurance building in its current configuration dates to ca. 1920; earlier Sanborn maps (1905 and 1910) show a 1-story wood-frame building at this location with the same footprint. The 1885 and 1892 Sanborn maps show a similar footprint, but it is not identical. The building was used as a harness shop, grocery, and barber shop. The 1920 Sanborn shows a small concrete building near the location of the subject building, but it has a narrower setback and is not attached to 10 Merchants Row. While it may be presumed it is a different building, it may be possible that the current addition is the earlier concrete building shown on the 1920 map. But the building appears to have received several alterations, including the siding and possibly the storefront window. A 1963 photo of the area does show the building, but it does not present a clear view (Poulin 2013). It is also shown in a photo from 1981-1982 (UVM 2013).

design and to the district as a whole. The addition is not recommended as a contributing feature to either the Bourdon Insurance Company Building or to the Middlebury Village Historic District.

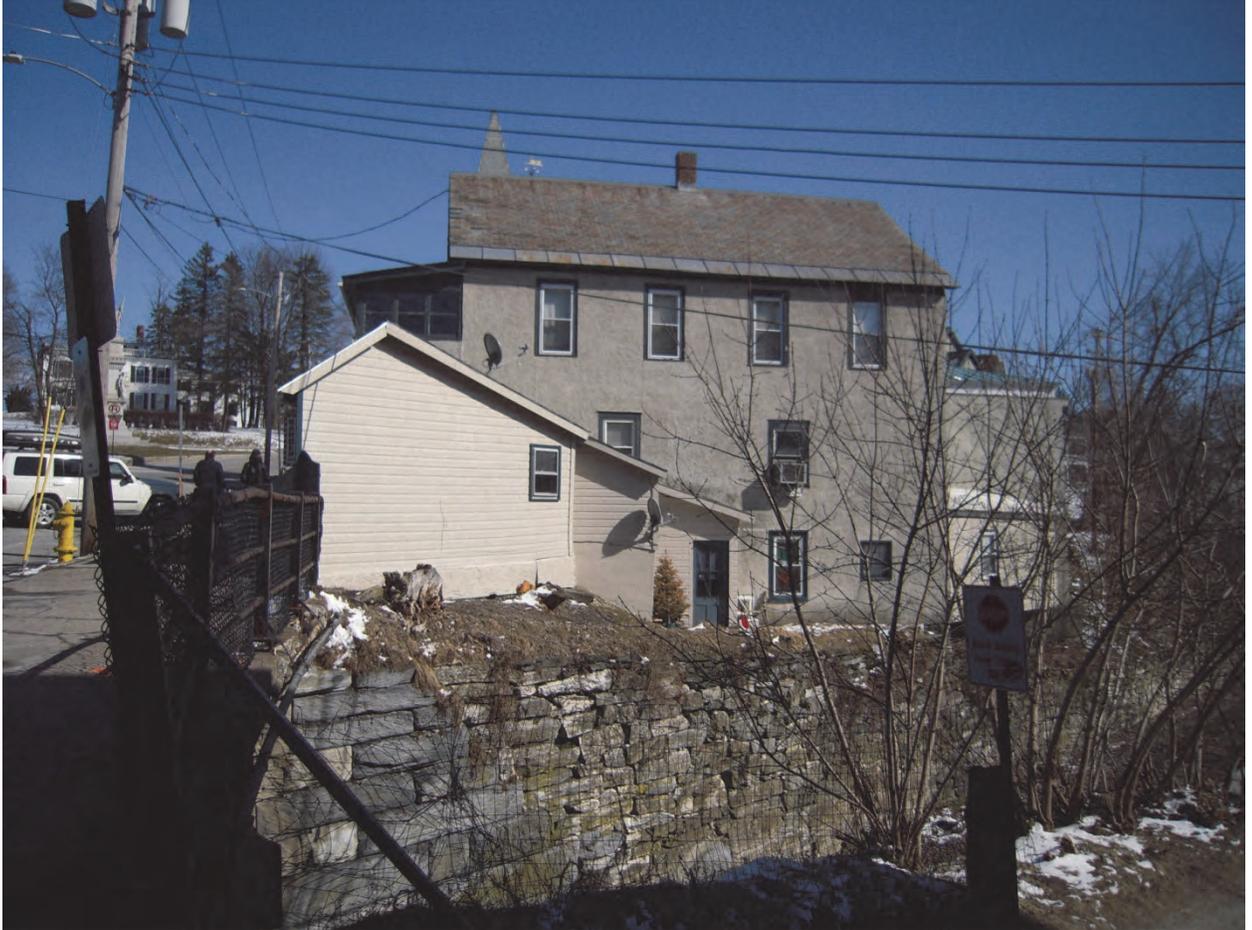
Addition to the Bourdon Insurance Agency Building, 48 Merchants Row, Middlebury, Vermont. View facing west, February 2013.

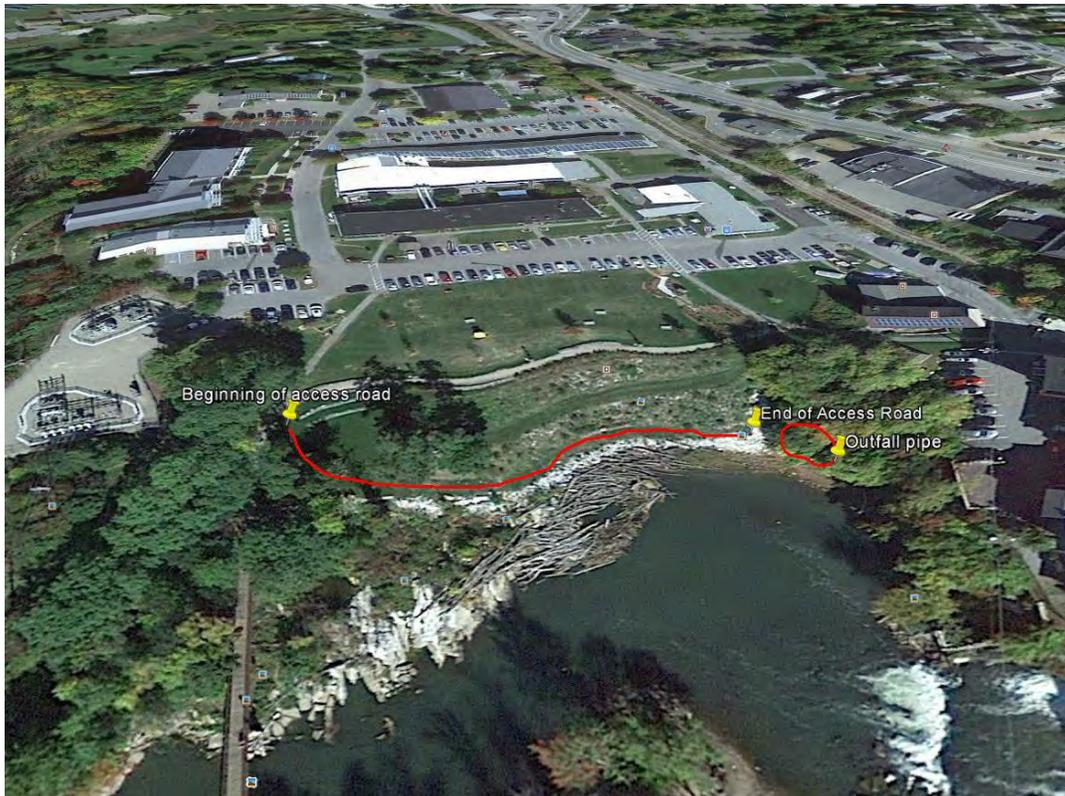
Locations of proposed access road through Riverfront Park and outfall pipe area.

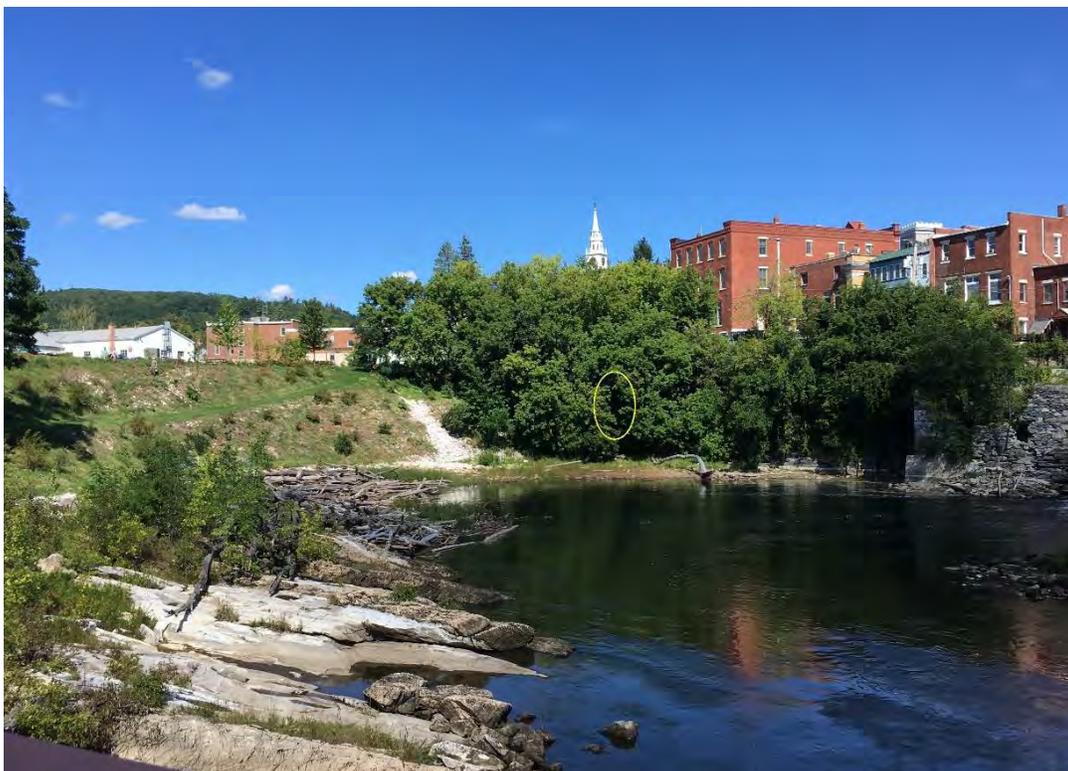
Location of outfall noted with yellow circle. Note Riverfront Park to the left.

The pipe replacement/upgrading in the Marble Works area represents a Project-related disturbance outside the railroad (state) or Town-owned ROW. Utilizing this existing drainage alignment will greatly facilitate Project construction, preventing new ROW from being acquired; the Town has a tacit agreement with the landowner to proceed with these improvements and is investigating whether a drainage easement already exists or will be required. In addition, this existing

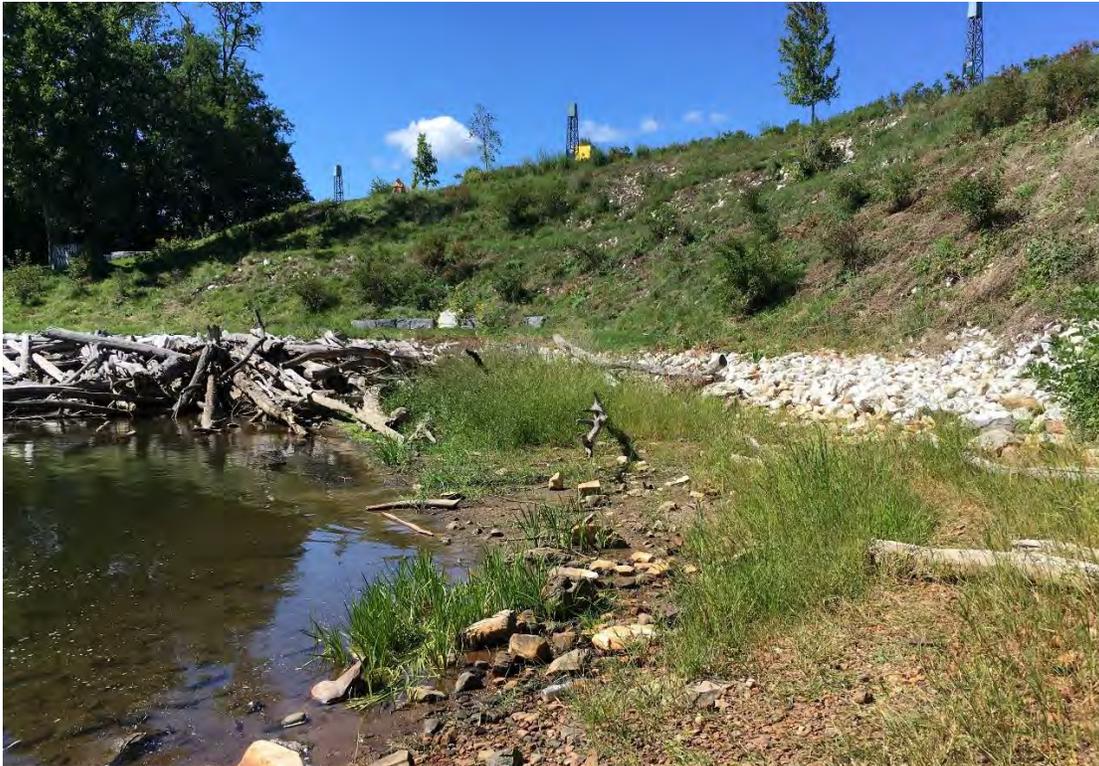
Looking to northwest to Riverfront Park. The access road will descend the bluff and follow the toe of the engineered slope, reoccupying the riprap pathway and extending towards the water.

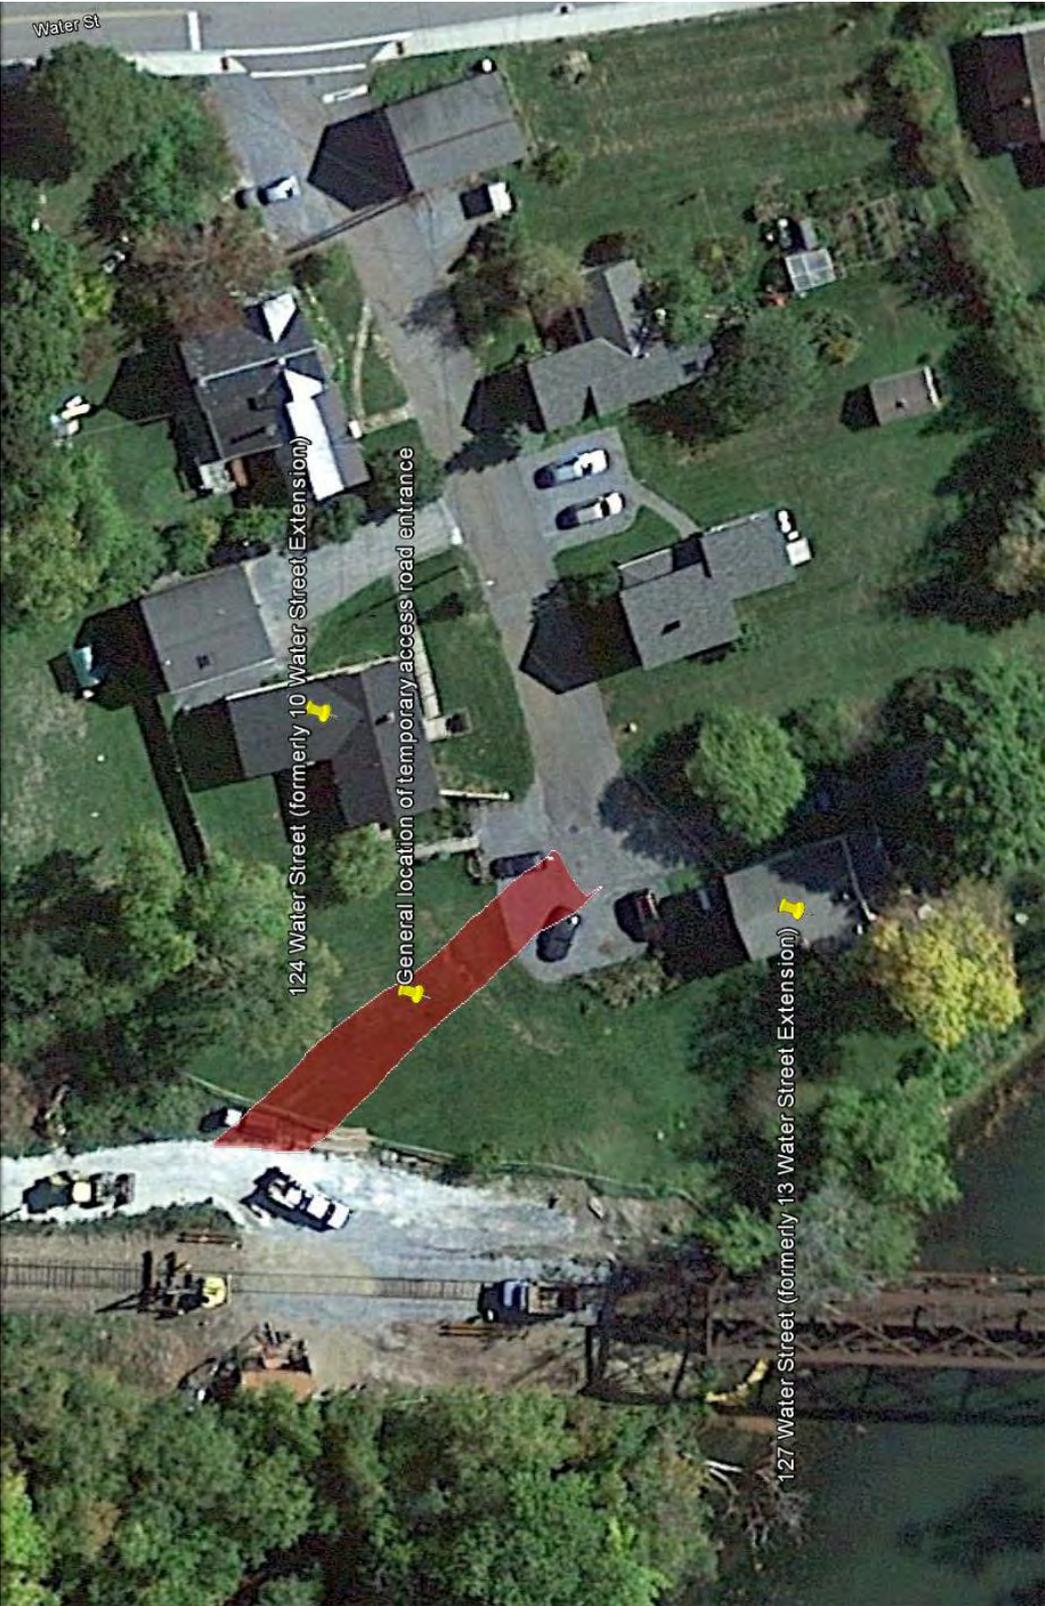
Map noting general location of temporary access road entrance off Water Street and locations of 124 and 127 Water Street.

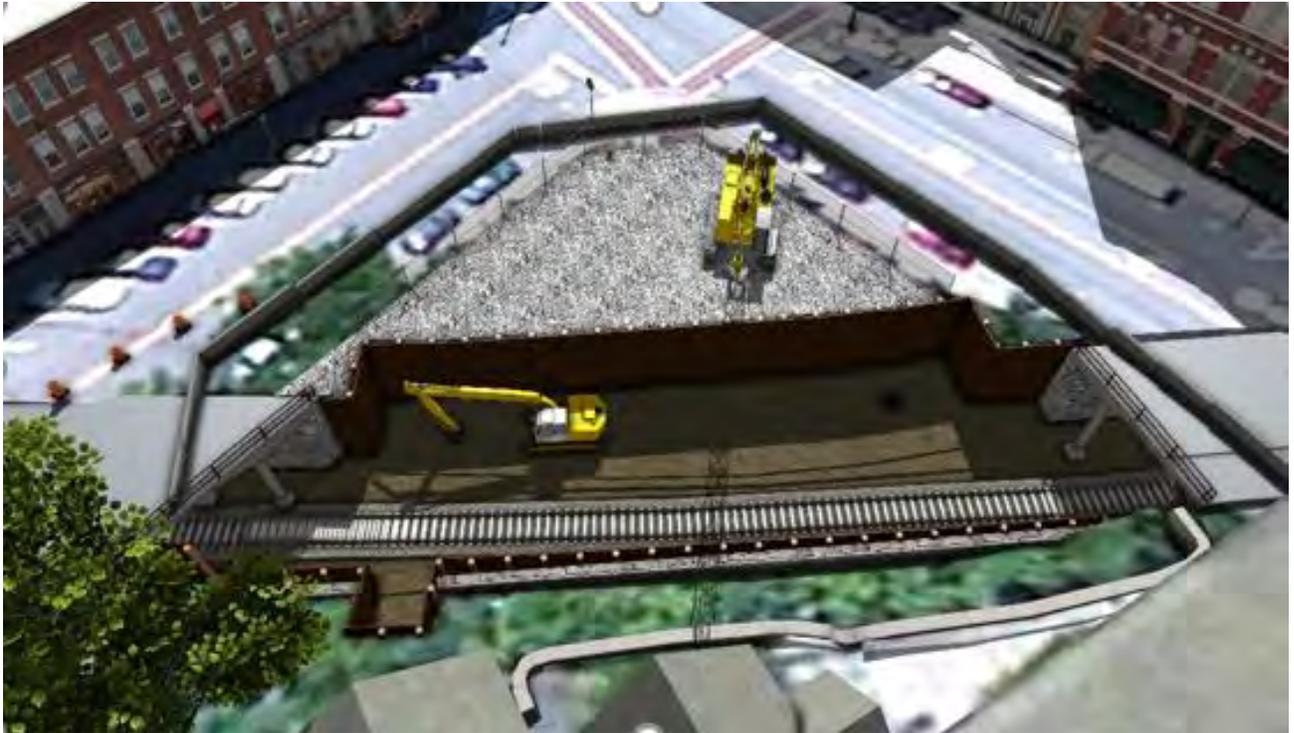
Computer rendering of Triangle Park within the Middlebury Village Green as staging area during Middlebury WCRS(23) construction project.

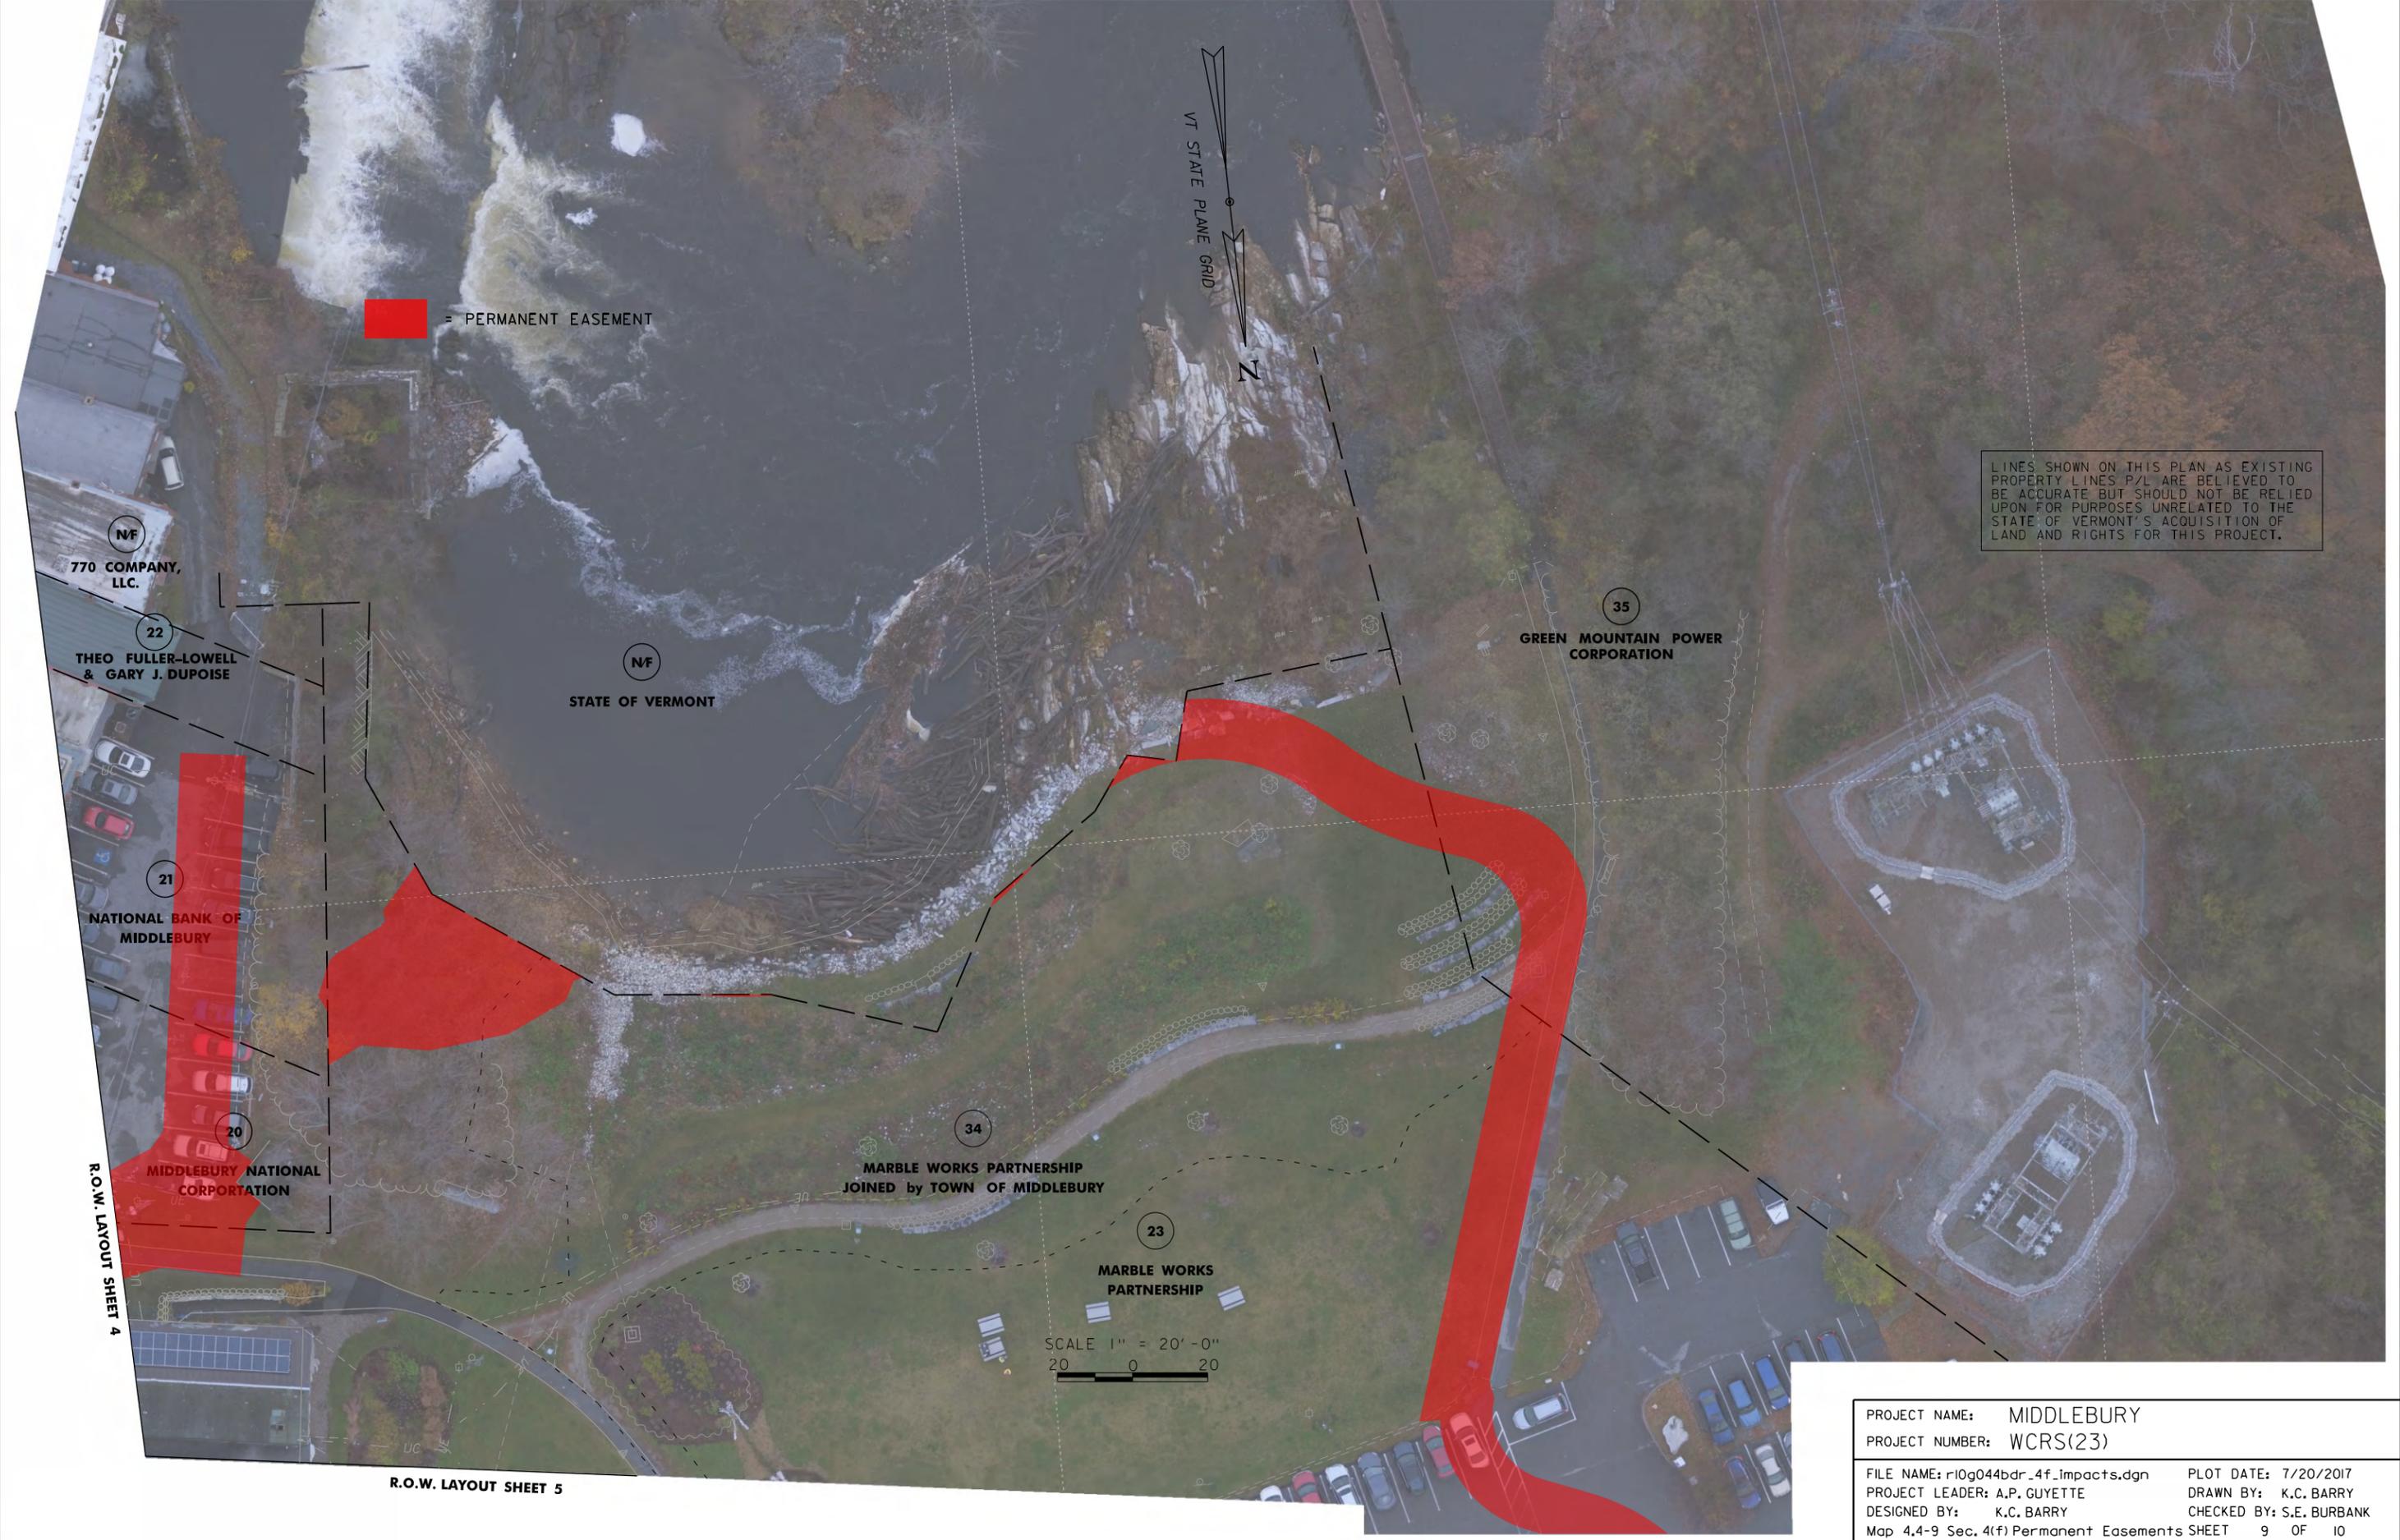
PROJECT NAME:	MIDDLEBURY
PROJECT NUMBER:	WCRS(23)
FILE NAME:	r10g04bdr_4f_impacts.dgn
PROJECT LEADER:	A.P. GUYETTE
DESIGNED BY:	K.C. BARRY
Map 4,4-8 Sec. 4(f) Permanent Easements SHEET	8 OF 10
PLOT DATE:	7/20/2017
DRAWN BY:	K.C. BARRY
CHECKED BY:	S.E. BURBANK

■ = PERMANENT EASEMENT
