Norwich IM 091-2(89) Regional Concerns Meeting

Interstate 91 – Bridges #48 N&S over VT Route 10A

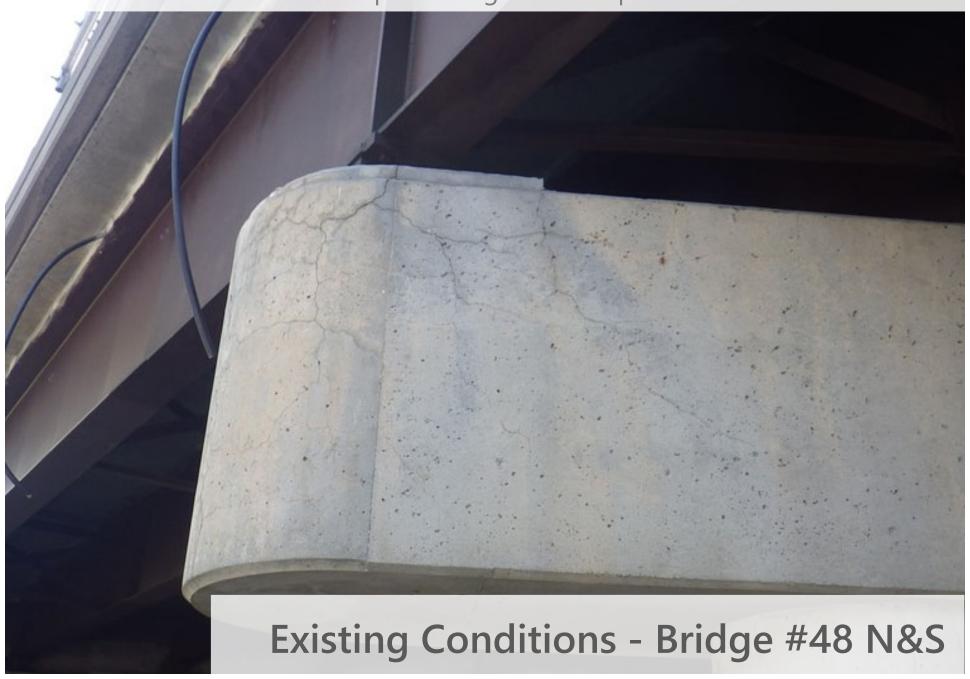
Abutment

- Bridges 48 N&S are both structurally deficient due to the condition of the substructures
 - Spalling with deep voids in the backwalls
 - Spalls have undermined the bearings and have caused minor settlement

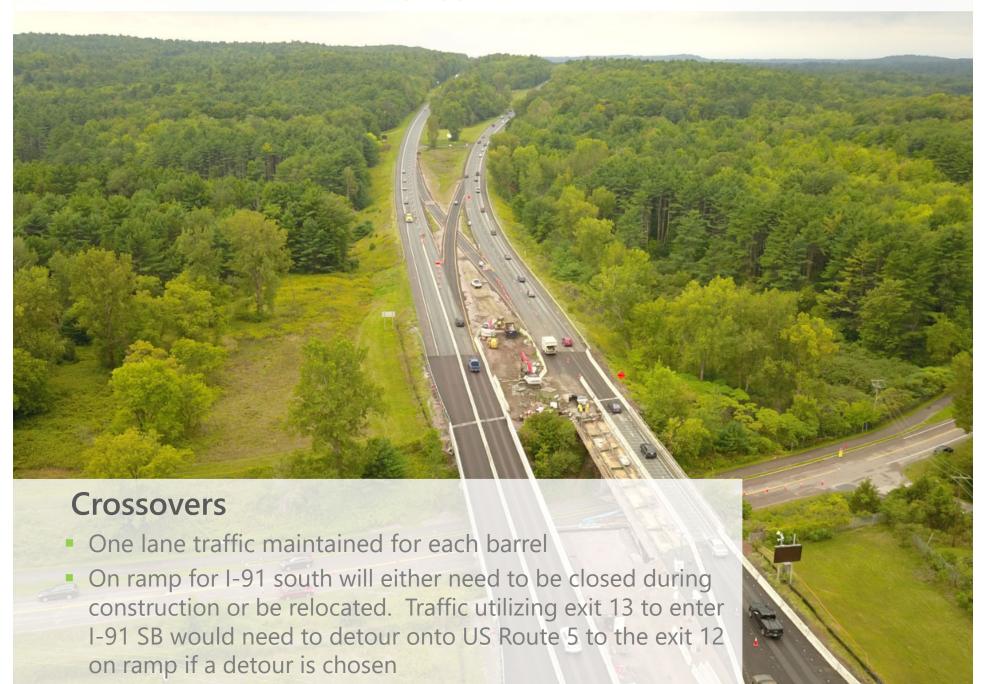
Crossover Layout

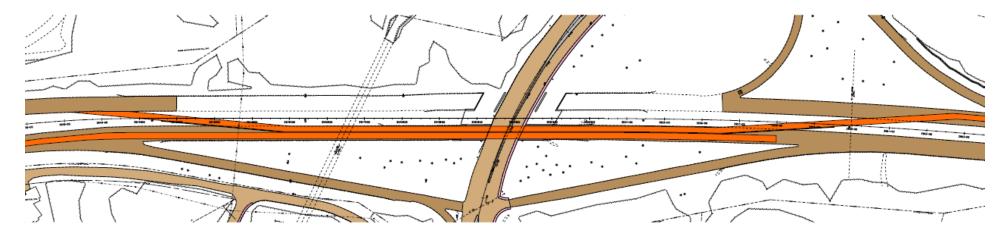
Traffic on northbound structure

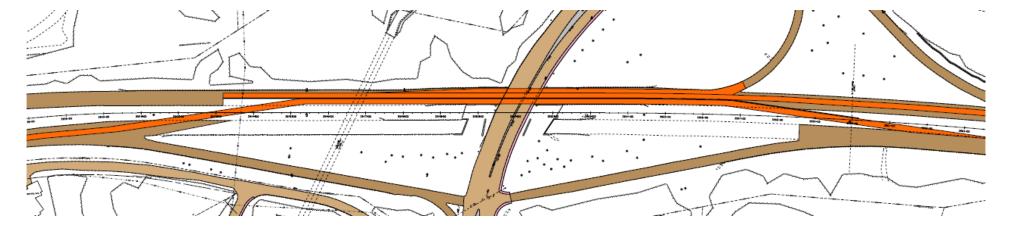
Traffic on southbound structure
