**STATE OF VERMONT
AGENCY OF TRANSPORTATION**

Scoping Report

**Waitsfield BRF 013-4(39)
VT ROUTE 100, BRIDGE 177 OVER THE MAD RIVER**

November 1, 2012

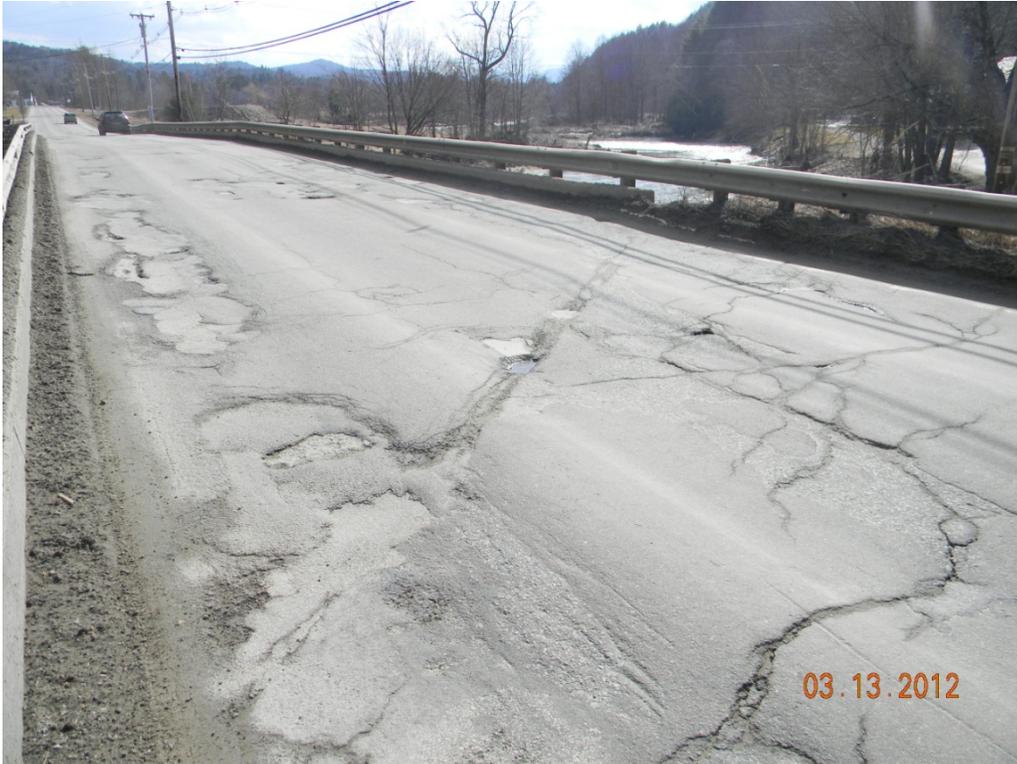
Picture 5: Pavement deterioration

1. The bridge deck is in poor condition. Repairs have been made to full depth holes, which have formed in the deck. As a result of the poor deck, the riding surface is in rough condition; there are many patches, holes, and cracks in the pavement.

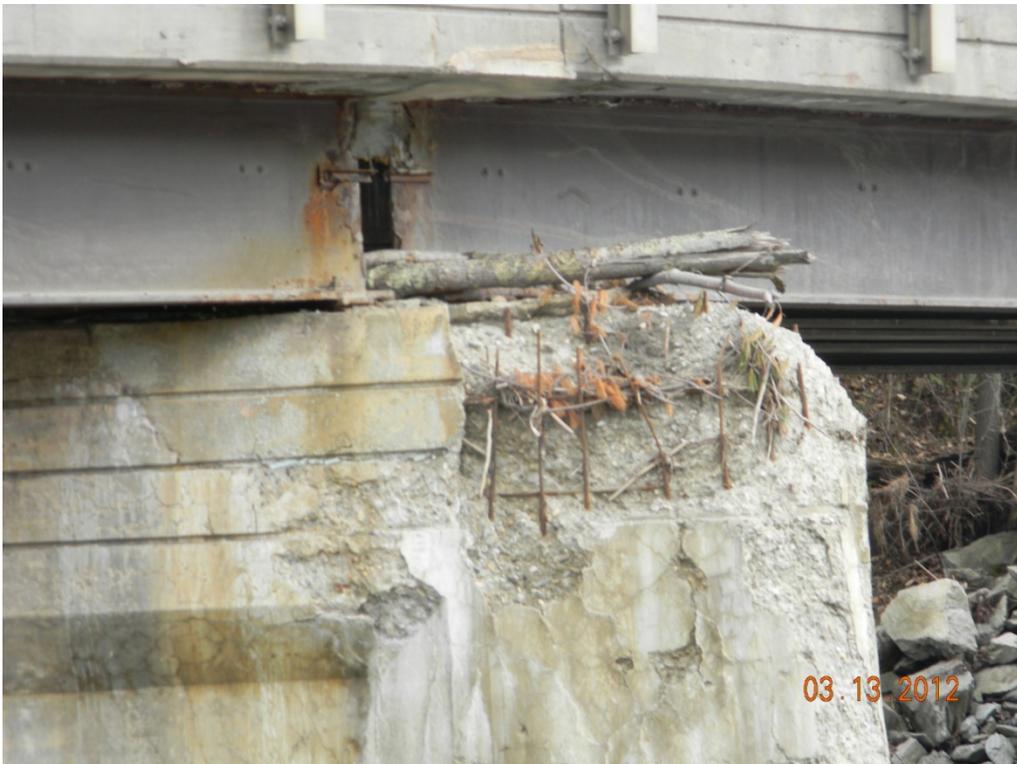
Picture 6: Pier deterioration

3. There are cracks and spalling in the abutments and wingwalls. The pier has a considerable amount of concrete spalling, exposing the underlying reinforcing steel.

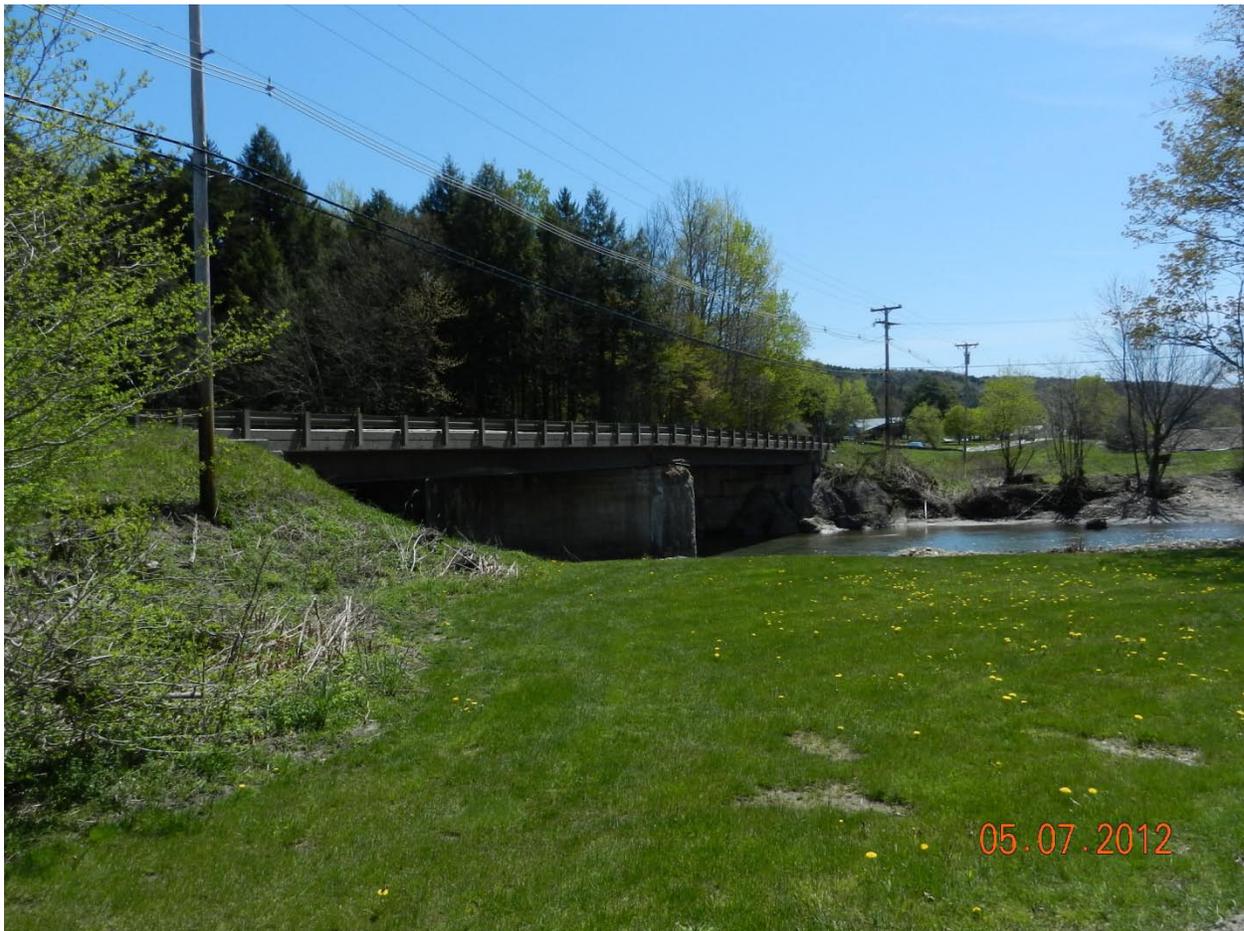
A site visit was conducted to determine potential issues with boring operations, and to make any other pertinent observations about the project. Figure 2 was taken on May 7, 2012.

Figure 2. View of bridge, looking downstream (east)
