**STATE OF VERMONT
AGENCY OF TRANSPORTATION**

Scoping Report

**Calais BHF 037-2(10)
VT ROUTE 14, Bridge 74 OVER PEKIN BROOK**

December 4, 2012

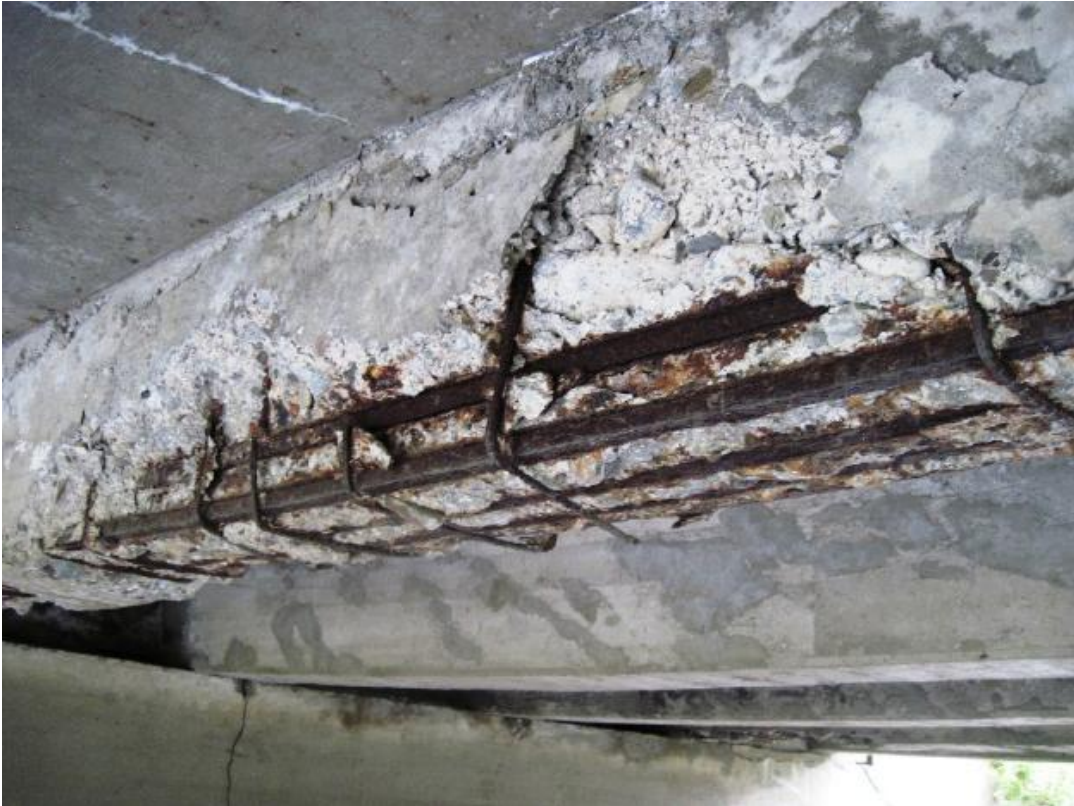
Deteriorated concrete and exposed rebar on the T-beam superstructure.

7/18/2011 – Deck is rated as poor with heavy deterioration along the centerline bay especially. Original T beam superstructure also has some areas of advanced deterioration. Bridge should be scheduled for extensive reconstruction or full replacement within the next 10 years. ~ MJ/DK

This option would involve replacing the existing superstructure. A precast concrete superstructure could be chosen to reduce construction time. This option would resolve the structural deficiencies of the existing bridge and extend the life of the bridge by approximately 40 years. It is assumed that a superstructure with a shallow depth would be chosen to attempt to provide a slightly larger waterway opening. The bridge width would not need to be adjusted, as the current geometry is to standard. However, this option would not address the scour issues.

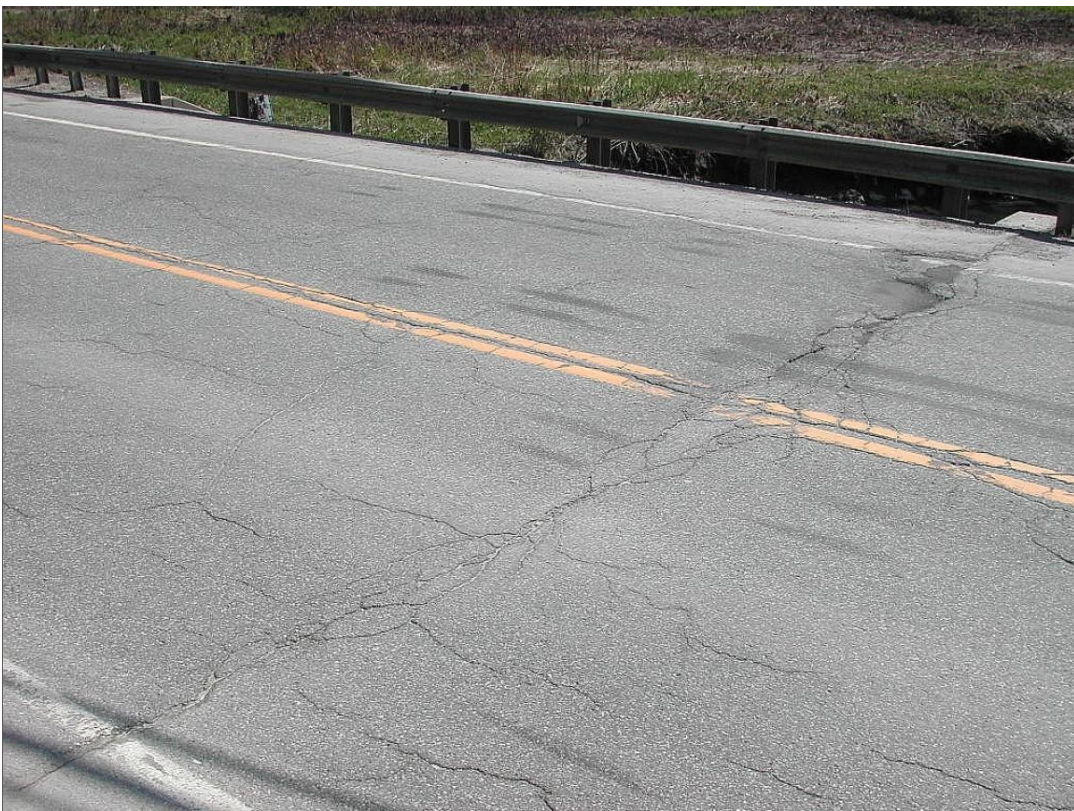
Deterioration and cracking along the deck.

This alternative would involve leaving the bridge in its current condition. This alternative is not recommended. With the deck in its current condition, localized deck failures could occur without warning and need to be repaired or replaced. Therefore it is not in the interest of safety to the traveling public to choose this option. This alternative will not be considered further.

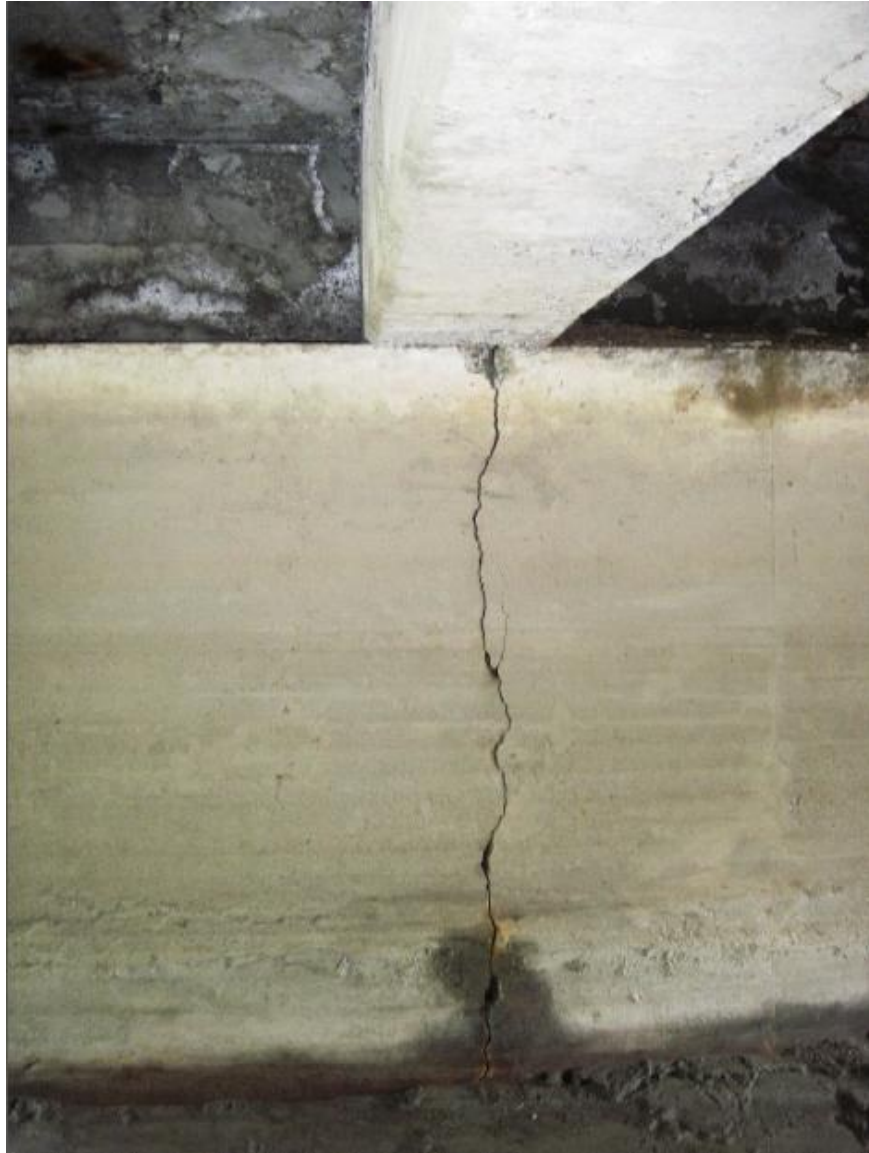
Vertical cracking in abutment.

The stream enters the bridge on a fairly straight line and then curves as it exits the structure. The structure is deteriorating with rebar showing in some of the beams. There are some cracks in the substructure. The inspection report indicates that the deck has heavy deterioration.
