**STATE OF VERMONT
AGENCY OF TRANSPORTATION**

Scoping Report

**Calais BHF 037-2(11)
VT ROUTE 14, Bridge 82 OVER KINGSBURY BRANCH**

December 13, 2012

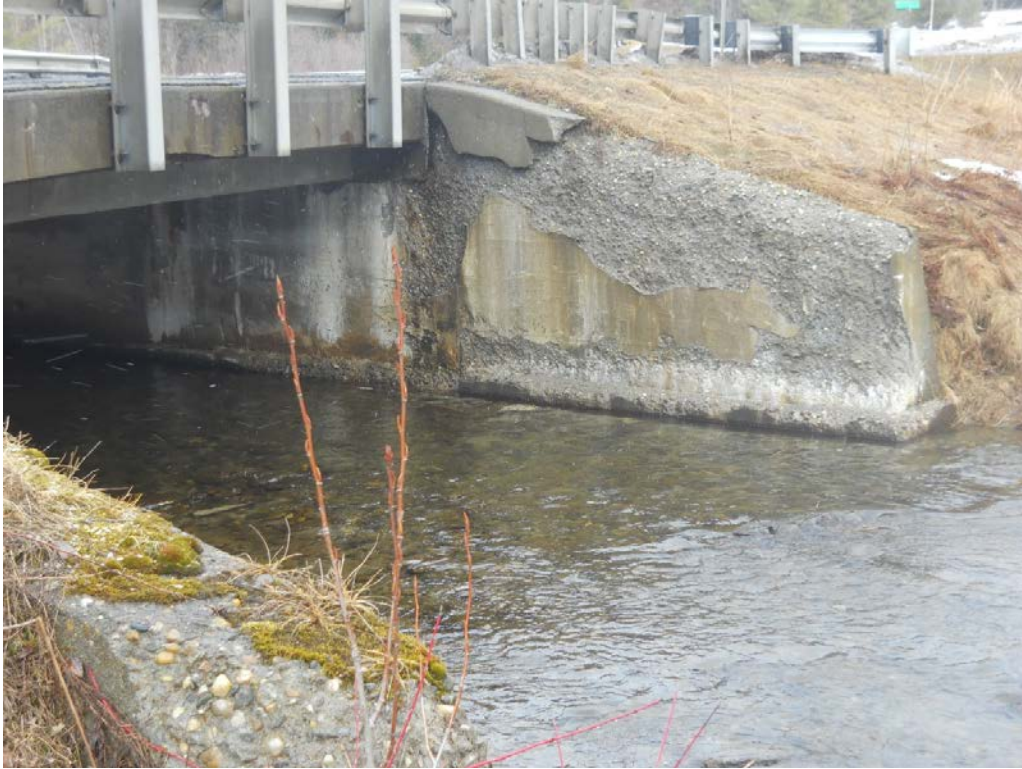
Spalling on a wing wall.

This option involves the replacement of the existing bridge's superstructure. A precast concrete superstructure with a shallow depth could be chosen to reduce construction time. Choosing a superstructure with a shallow depth could slightly increase the waterway opening of the bridge, as the low beam elevation could be raised by doing this. Rehabilitation to the substructure would also need to be completed in the form of repairing cracks and spalling on the abutments and wing walls.

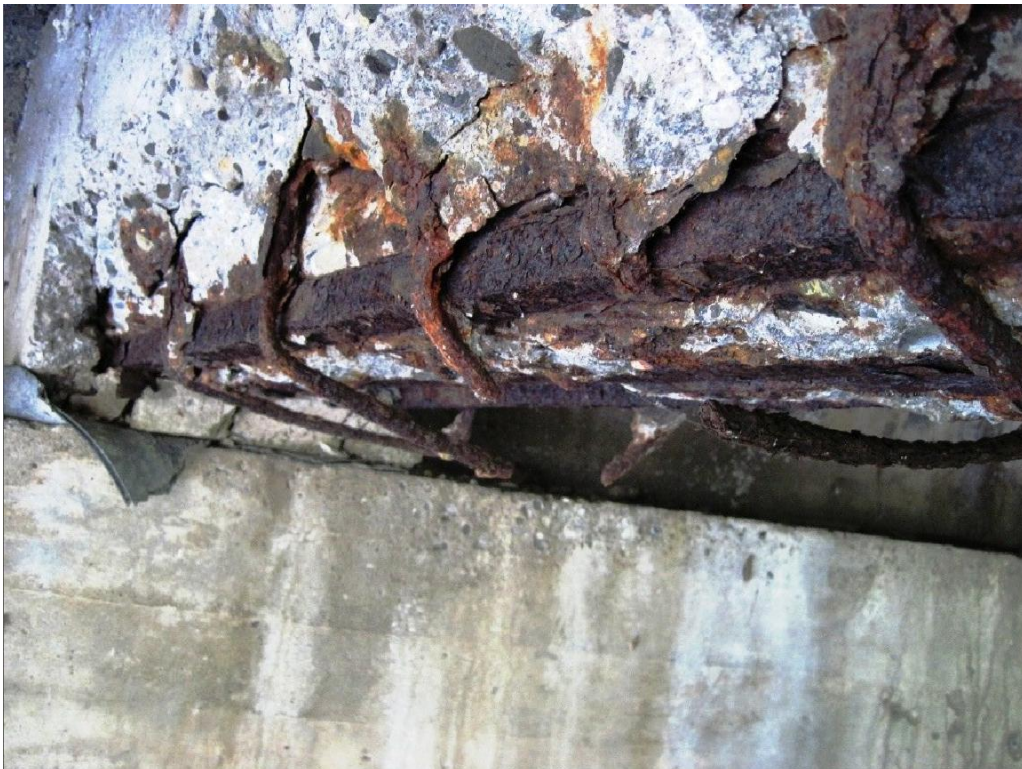
07/18/2011 – Deck is rated as poor with heavy deterioration along the centerline bay especially. Original T beam superstructure also has some areas of advanced deterioration. Bridge should be scheduled for extensive reconstruction or full replacement within the next 10 years. ~ MJ/DK

Exposed reinforcement on the T-beam superstructure.

The alternative of a full bridge replacement with traffic maintained via phased construction is recommended. This alternative addresses the hydraulic inadequacy of the existing structure, and also solves the structural issues with the deck and the superstructure. The lifetime of the structure would be increased to an additional 80 years.

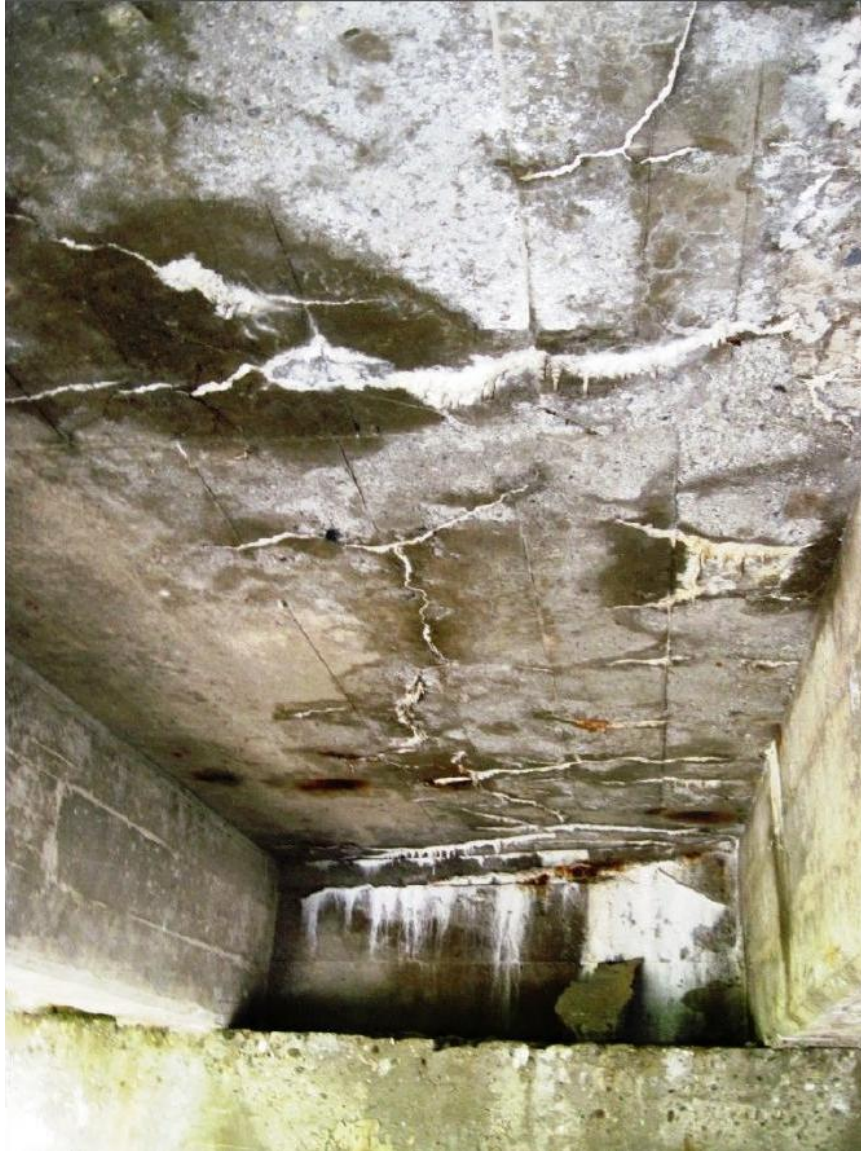
Cracking in the underside of the deck.
